NASA/TM-2006-214505

# Quasi-Static 3-Point Reinforced Carbon-Carbon Bend Test and Analysis for Shuttle Orbiter Wing Leading Edge Impact Damage Thresholds

*Edwin L. Fasanella*  
*Langley Research Center, Hampton, Virginia*

September 2006

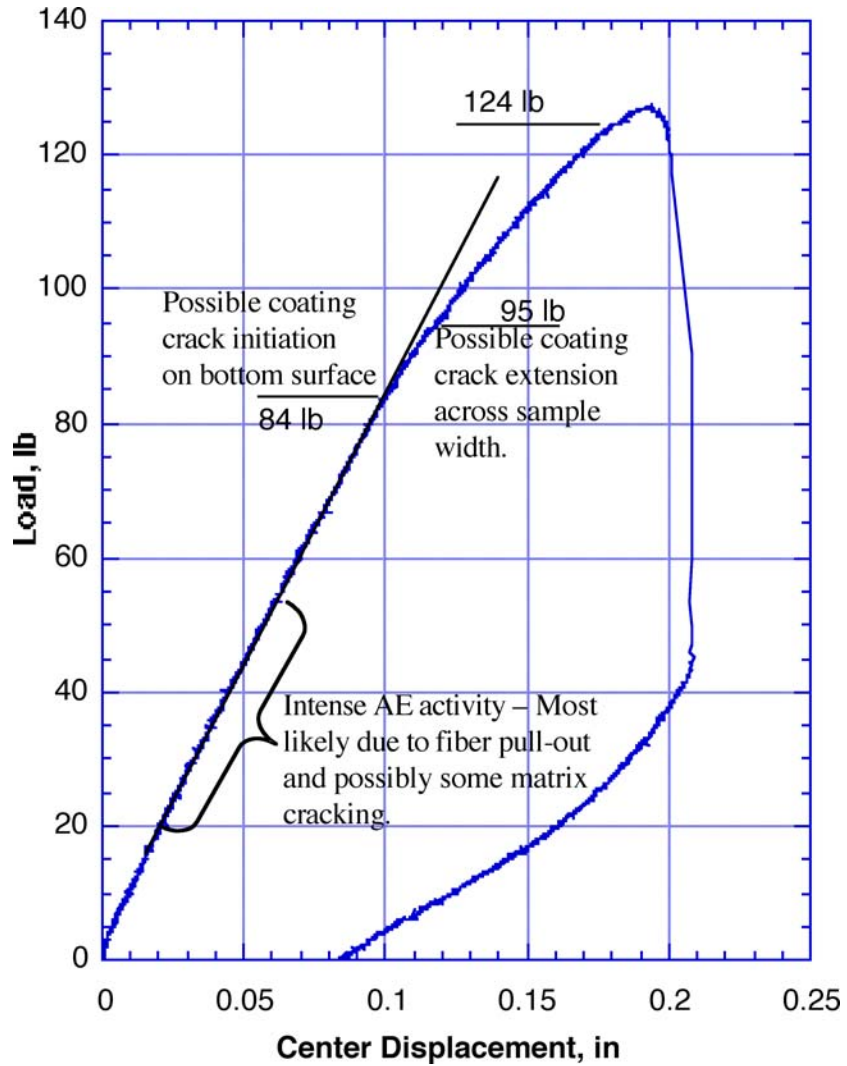
Figure 5. Load vs. displacement for specimen flex-8.

*Sample flex-8.* This specimen was tested in one loading to **failure**, which occurred at 127 pounds. The load versus center displacement curve for this sample is depicted in Figure 5. The plot is labeled to reflect AE activity and load levels where critical events occur such as cracking of the SiC coating, etc.

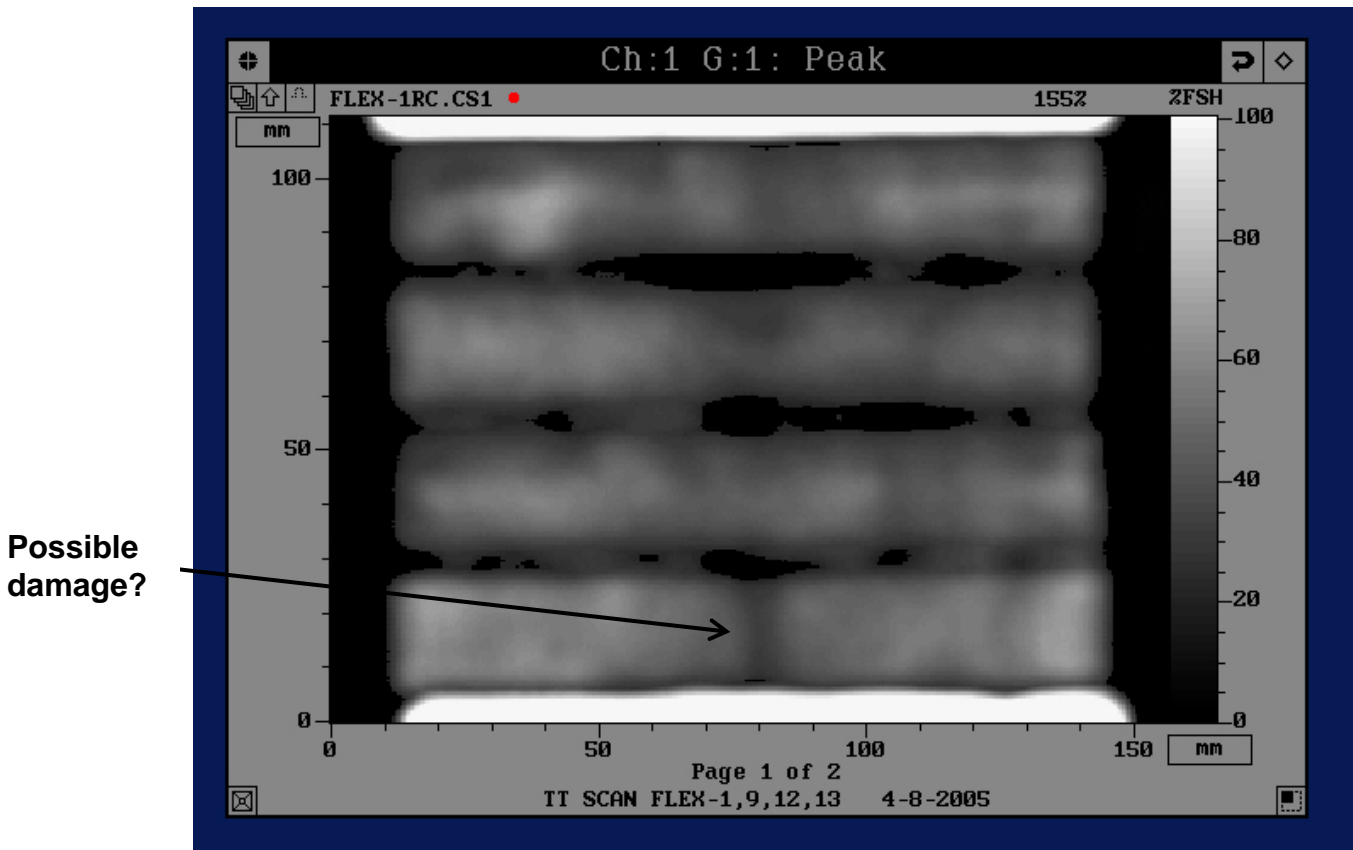
Figure 8. Ultrasonic C-scan transmission NDE results for specimens (from top down) 13, 12, 9 and 1. The arrow points to the dark band at the center of specimen 1.

The following specimens were shipped to NASA Glenn Research Center (GRC) to be evaluated using ultrasonic C-scan through transmission. The results for specimens 13, 12, 9, and 1 are shown in Figure 8. Specimen 1 is the specimen at the bottom of the figure. There is a region at the center of specimen 1 that is slightly darker than for the other specimens. This dark band may indicate some damage accumulation, but is open to question. The average breaking load of all failed specimens was 128.6 lb with a standard deviation of 3.2 lbs. Thus, specimen flex-1 would be expected to have damage accumulation near the center as it was loaded multiple times. The last loading cycle was up to a maximum load of 130 lbs.

Sample flex-1 was loaded at 0.1 ipm in 10-lb increments from 70-130 lb.  
 Sample flex-4 was loaded at 1.0 ipm to 103 and then 126 lb.  
 Sample flex-5 was loaded at 0.1 ipm to 120 and then 130 lb.  
 Sample flex-9 was loaded at 0.1 ipm to 100 lb.  
 Sample flex-12 was loaded at 0.1 ipm 5 times to 100 lb.  
 Sample flex-13 was loaded at 0.1 ipm 5 times to 100 lb.  
 Sample flex-14 was loaded at 20 ipm 6 times to ~105 lb.  
 Sample flex-15 was loaded at 20 ipm 6 times to ~100 lb.  
 Sample flex-16 was loaded at 0.1 ipm 6 times to 110 lb.  
 Sample flex-17 was loaded at 0.1 ipm 6 times to 110 lb.  
 Sample flex-18 was loaded at 20 ipm 5 times to ~100 lb.

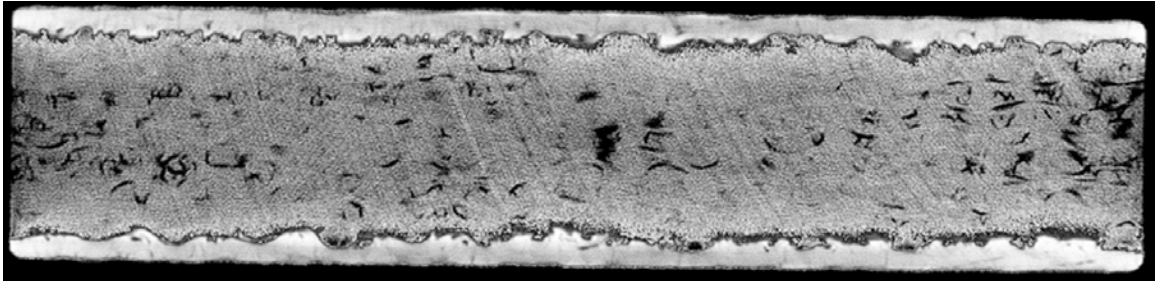
Figure 12. 100-micron scan taken at end of specimen where loading was very low.

Specimen flex-5 was chosen for study using the LaRC microfocus CT-scan equipment. No load was applied. The scans were taken width-wise and are thus 1.0-in. x 0.233-in. in area. Note that “flex-5” was loaded at a load-rate of 0.1 ipm to 120 pounds and then at the same rate to 130 pounds. When examined post loading, no NDE-detectable damage was found using the suite of conventional NDE techniques (radiography, eddy-current, flash thermography). The first set of scanned “slices” for the region of maximum stress (near the center of specimen flex-5) was at 200 microns width. A second set of 100 micron (0.001 mm) slices were then made. Although multiple voids and micro-cracks could be detected, no definitive damage due to the repeated loading could be detected. No long cracks or delaminations or other NDE-detectable damage were found. Images from the second set of scans performed at 100 microns are shown in Figures 10 and 11. Again, voids and micro-cracks can be seen in the substrate as well as a clear view of the SiC coating and its micro-cracks, but no load-induced damage could be seen. Since no pre-test micro-CT scans were performed, micro-CT scans were performed at the ends of the specimen that were expected to be areas of low stress and hence no damage. The scans at the ends, seen in Figure 12 and 13, resembled the scans in the center. That is, there were randomly scattered voids and micro-cracks. Using the micro-CT scans, no conclusions could be reached as to damage of the center region due to loading. A summary of all test results is given in Table I.

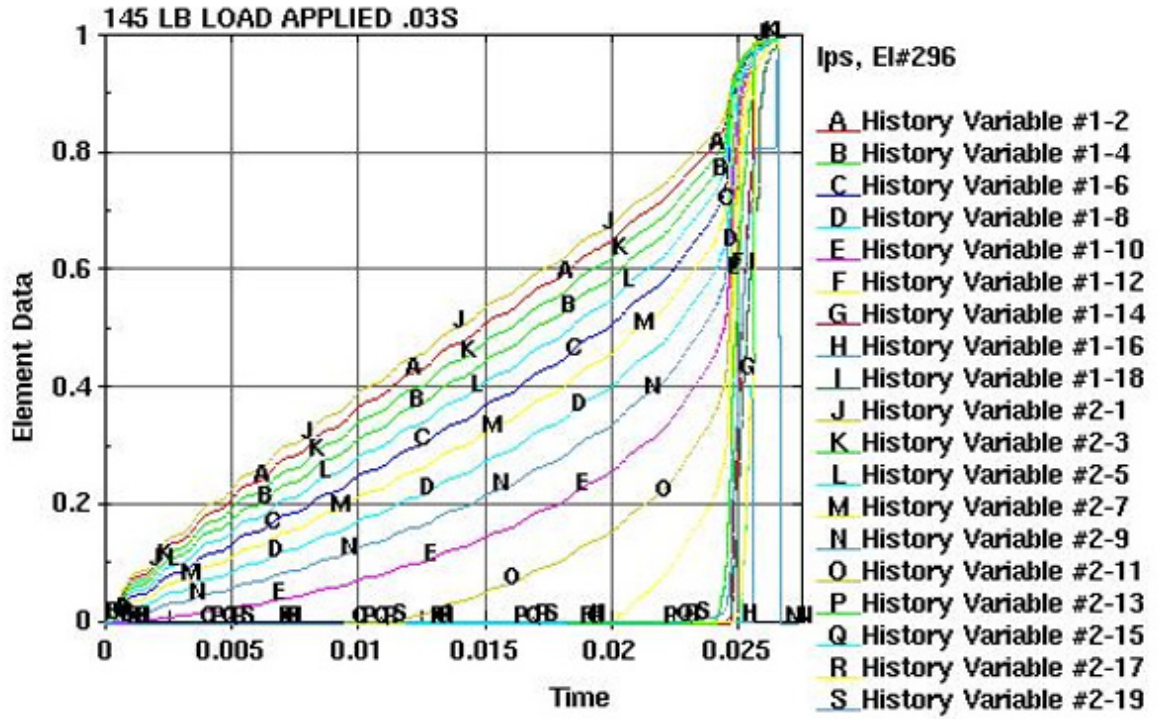
Figure 16. Damage parameter for a center element 296 versus time.

Since Mat58 is not implemented in the implicit version of LS-DYNA that one would ordinarily use for a static simulation, a dynamic simulation was performed sufficiently slowly that the kinetic energy was negligible as compared with the strain energy in the RCC flex specimen. It was found that a total load of 145 pounds applied linearly in time over 30 milliseconds gave reasonable results. The damage parameter in the X-direction (the long axis of the coupon) is shown in Figure 16 for each of the 19 layers versus time for shell element 296 located near the center of the specimen. Note that RCC is weaker in tension than in compression. Since 1 and 2 are the principal directions in the local axis system, the damage parameters for the X-direction alternate with each +/- layer. History variable #2 is maximum for layer 1, which is labeled "J" in Figure 16. The history variable (damage parameter) in the X-direction increases dramatically from 0.88 to 0.94 around 0.025 seconds, which is about 120 pounds. This behavior should correspond theoretically to large damage accumulation and perhaps the threshold of NDE detectable damage. The average failure load occurred in the tests at 128.6 pounds, which was well predicted as shown in Figure 17. As noted in the experimental section, the suite of NDE techniques had difficulty in finding either internal damage or the cracking of the SiC. A hint of RCC damage was not detected by ultrasonics in flex-1 until 130 lbs, which corresponded to a damage parameter of 1.0 as shown in Figure 17. However, the model predicted complete failure at 128 pounds. The initial failure for the bend tests was always a tension crack in the lower ply. In the static bend tests, delaminations either did not occur, or if delaminations did occur, they occurred very late in the loading sequence as for the short beam shear test. For dynamic impact tests, internal damage/delamination can be readily detected by NDE such as thermography and ultrasonics. Internal NDE detectable damage for dynamic impacts onto RCC occurs early in the damage sequence (before through cracks and before coating loss). For dynamic tests, the maximum damage parameter for NDE detectable damage ranged from 0.95 to 0.98. The static bend tests were not useful for accurately calibrating the damage parameter to internal NDE detectable damage.

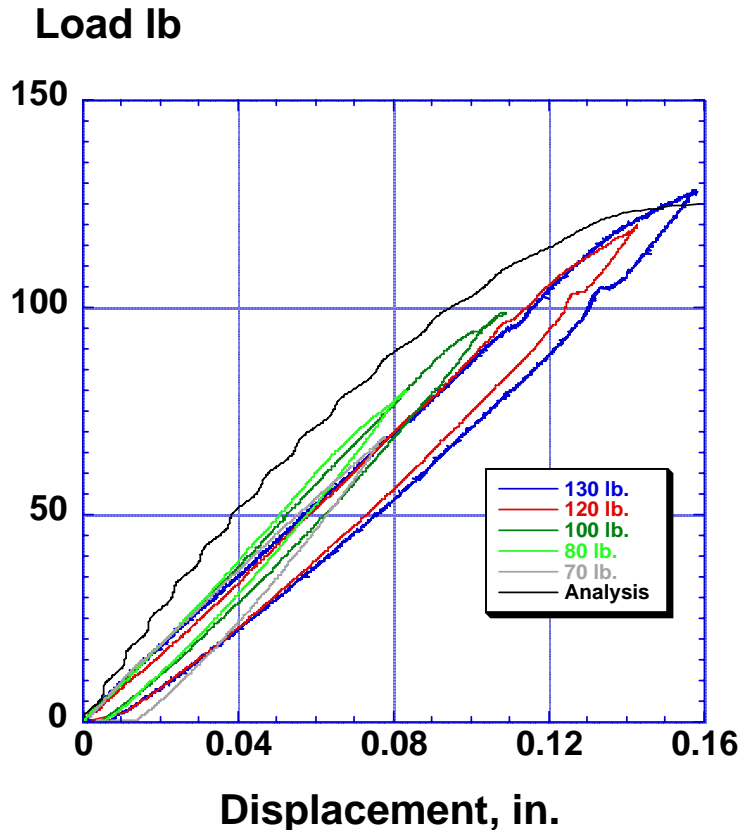
Figure 18. Load versus displacement of test versus analysis.

In addition to damage predictions, the maximum center displacement versus time is used in dynamic validation studies. Statically, a comparison of displacement versus load is a good indicator of model validity. Thus, a comparison of experimental load versus displacement (colored curves) with analysis (black) is shown in Figure 18. Note that the analysis used smeared (laminated) RCC properties. Young's modulus in tension is smaller than the modulus in compression for the laminate. Since the initial modulus (E) used in this study is the compression modulus, the analytical displacements at first lag the measured displacements. However, by 0.16-inches of displacement, the analysis, and test data intersect.
