# DEVELOPMENT OF EDDY CURRENT TECHNIQUES FOR THE DETECTION OF STRESS CORROSION CRACKING IN SPACE SHUTTLE PRIMARY REACTION CONTROL THRUSTERS

**ABSTRACT.** A recent identification of stress corrosion cracking in the Space Shuttle Primary Reaction Control System (PRCS) thrusters triggered an extensive nondestructive evaluation effort to develop techniques capable of identifying such damage on installed shuttle hardware. As a part of this effort, specially designed eddy current probes inserted into the acoustic cavity were explored for the detection of such flaws and for evaluation of the remaining material between the crack tip and acoustic cavity. The technique utilizes two orthogonal eddy current probes which are scanned under stepper motor control in the acoustic cavity to identify cracks hidden with as much as 0.060" remaining wall thickness to the cavity. As crack growth rates in this area have been determined to be very slow, such an inspection provides a large safety margin for continued operation of the critical shuttle hardware. Testing has been performed on thruster components with both actual and fabricated defects. This paper will review the design and performance of the

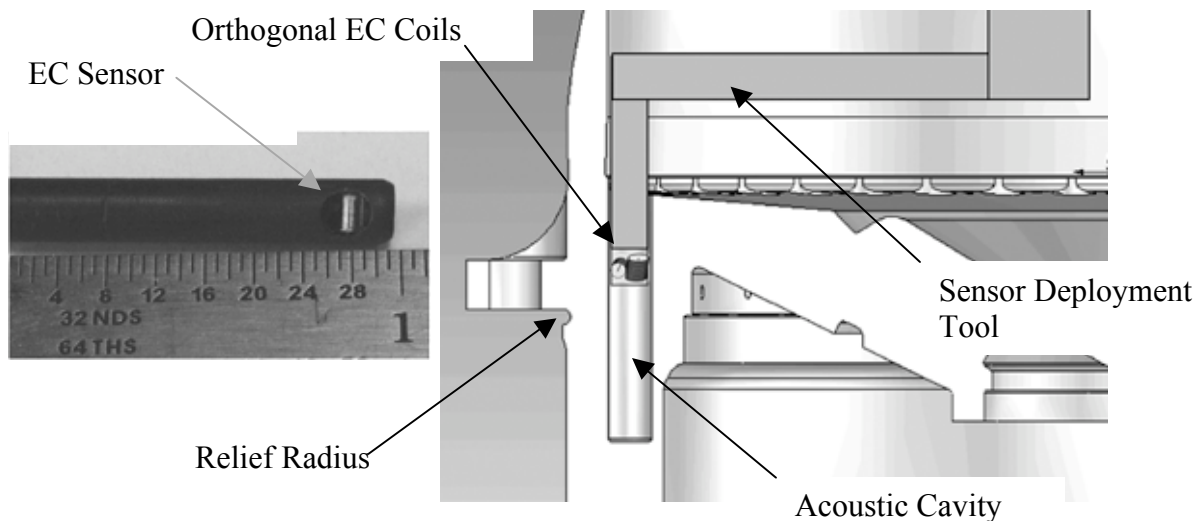
Figure 1 displays a photograph of the prototype eddy current (EC) sensor and a conceptual diagram of the eddy current inspection technique. Matched eddy current coils are arranged orthogonally to each other and scanned into the acoustic cavity of the thruster. In the conceptual diagram in Figure 1, the inspection coil on the left is arranged with its axis along the circumferential direction. This orientation enables a relatively deep field penetration with the small diameter coil required to fit into the acoustic cavity, and induces current in a direction that will have a strong interaction with cracking originating in the relief radius and growing towards the acoustic cavity. The second coil is arranged with its axis parallel with the axis of the acoustic cavity. This second coil is designed to provide a local reference for the inspection coil while minimally interacting with damage originating at the acoustic cavity.

**Figure 1.** Photograph of prototype eddy current sensor and schematic diagram of eddy current thruster inspection tool.

Initial testing performed with the sensor design shown in Figure 1 found a good sensitivity to nearly through-wall flaws, but damage that had not progressed to within approximately 0.020" – 0.040" of the acoustic cavity was difficult to detect due to the complex geometry of the part. The presence of varying material thickness, fuel passageways, and a potentially rough surface of the acoustic cavities was further complicated by the need to deploy the probe through the injector nozzle, past a narrow throat, and into the acoustic cavity for inspection. To minimize the combined effects of these attributes, a stepper motor controlled scanning system was incorporated into the inspection system. The stepper motor scanning system, designed in conjunction with NASA White Sands Test Facility, is deployed in the reaction chamber and rests on the face of the thruster. Once positioned, a pre-programmed scan of the sensor through the area of interest is performed. The use of the stepper motor scanning system significantly reduces lift-off effects associated with probe tilt and wobble, which are extremely difficult to control under hand scanning. In addition, the stepper motor scanner provides for indexed scanning such that eddy current response data can be plotted directly against location of the probe within the acoustic cavity. Probe responses associated with edge effects and varying wall thickness throughout the scan region can then be directly accounted for and filtered out, greatly enhancing the flaw detectability of the system.

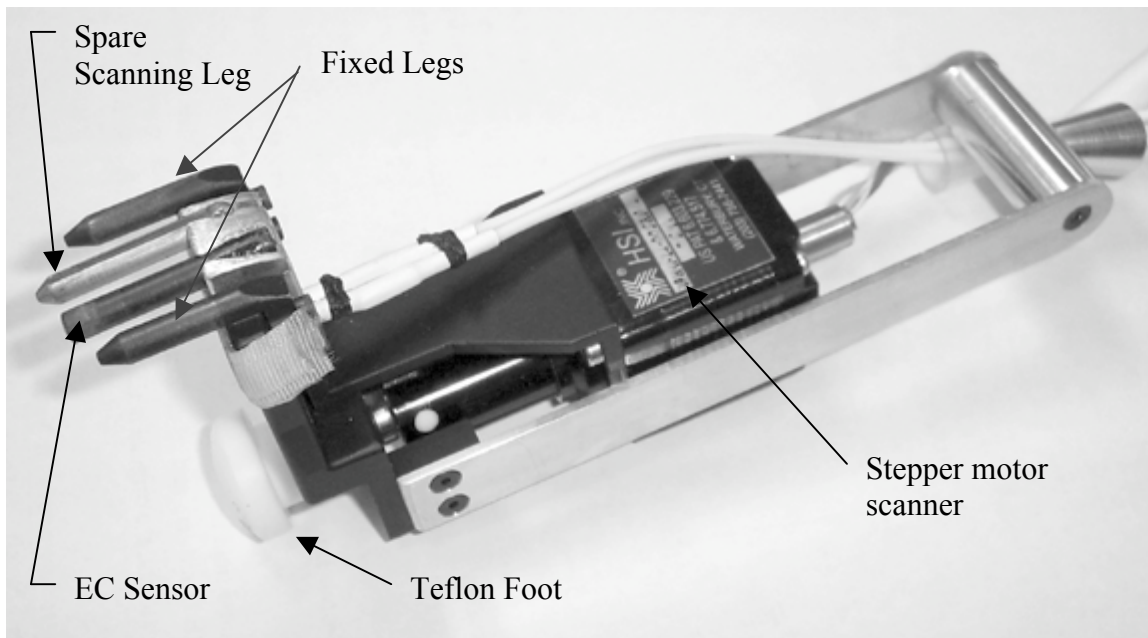
Figure 2 shows a photograph of the eddy current sensor attached to the stepper motor scanner. The eddy current coil pictured in Figure 1 is now mounted in a probe housing that is attached to the stepper motor. In addition to the eddy current sensor, the probe housing holds a second, spare, scanning leg. Two other, fixed legs are attached to the scanning system to provide mechanical stability during scanning. When the scanner is positioned within a thruster, the four legs are spaced to fit into adjacent acoustic cavities. After receiving a trigger signal the stepper motor pulls the probe housing (along with the eddy current sensor and spare scanning leg) away from the thruster face, moving the eddy

**Figure 2.** Stepper motor controlled eddy current PRCs thruster scanner.

current sensor through the region of interest. Immediately after withdrawing the probe the stepper motor reverses, moving the sensor once more through the region of interest and back to its start position.

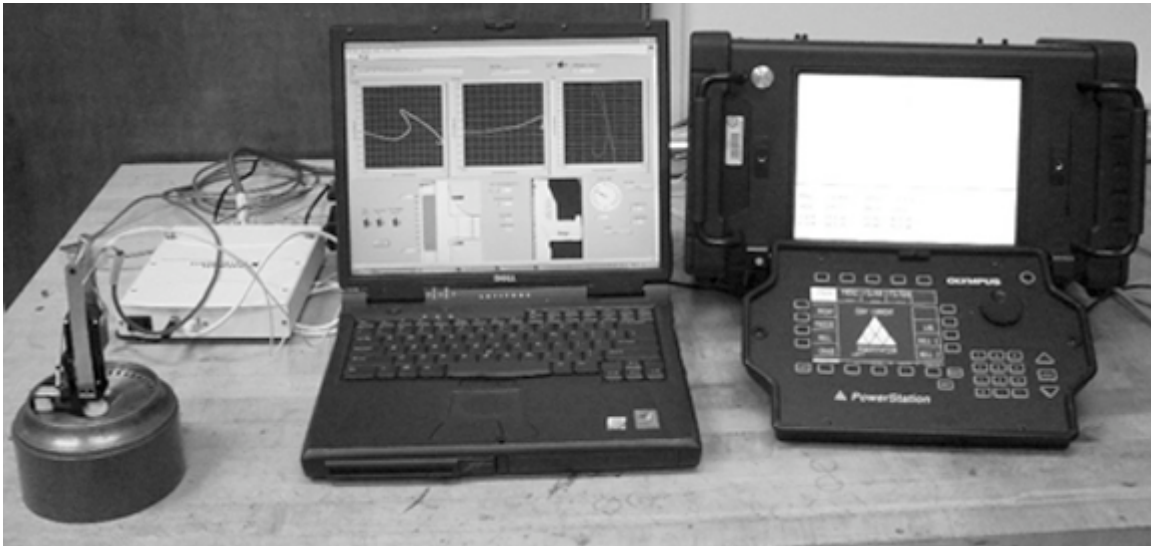
**Figure 3.** Complete eddy current PRCS thruster inspection system.

The complete eddy current PRCS thruster inspection system is pictured in Figure 3. Along with the eddy current sensor and scanner, the system consists of a dual frequency eddy current instrument, laptop computer, A/D converter, and custom software. The scanner is shown inserted into a thruster mock-up used for setup and calibration.

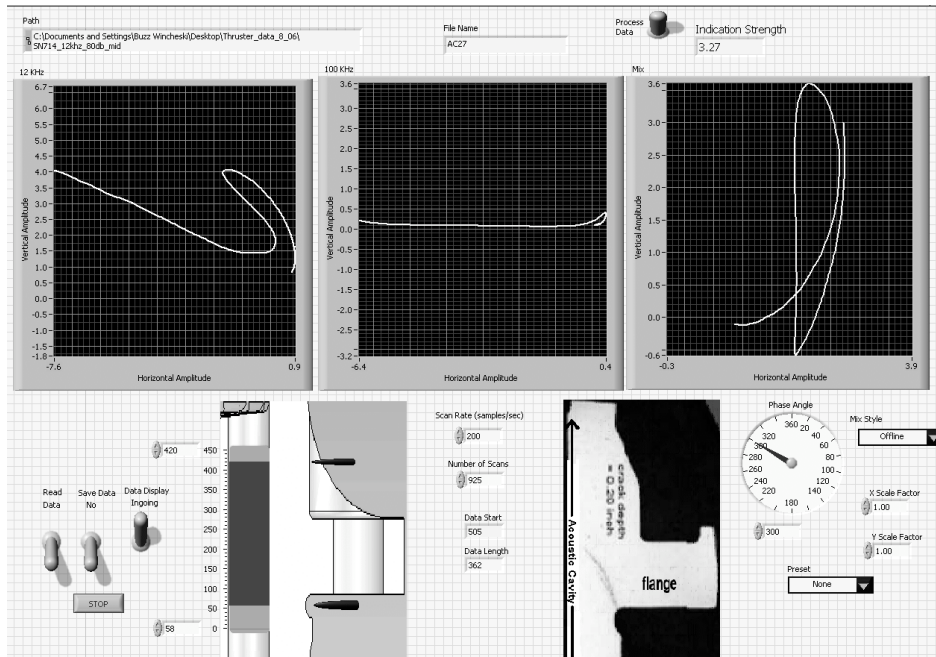
**Figure 4.** Front panel display of system control and data processing software.

software with data acquired during an inspection of a notched reference standard with 0.020” remaining wall thickness between the notch and the acoustic cavity. The three plots from left to right across the screen display the 12 kHz, 100 kHz, and frequency mix results, respectively. The nearly through-wall flaw is clearly detected in the low frequency and mix signals, with a slight indication of the flaw apparent even at 100 kHz. Toggle and slide switches are incorporated to enable the plotting of data over any region within the complete scan range, as well as of data acquired during the outgoing or ingoing scan of the probe. Controls are also present to adjust the mix signal parameters for data analysis on the selected portion of the scan data. The front panel also contains a micrograph of a stress corrosion-cracking site dissected from a PRCS thruster. The typical crack profile displayed in the micrograph is useful for interpreting the eddy current response in relationship to potential damage in the hardware.

The system control and data processing software initiates a scan sequence by sending a trigger signal to the stepper motor. Analog output data from the eddy current instrument are then acquired by the computer as the sensor scans partially out of and then back into the acoustic cavity. After the scan completes the acquired data at 12 kHz, 100 kHz, and frequency mix (calculated as the difference between the 12 kHz and 100 kHz responses) are displayed. Figure 4 shows a close up view of the front panel of the system

A final feature to be noted on the front panel is the calculated “Indication Strength”, given in the upper right hand corner of the display. This value is calculated by fitting the eddy current response to the anticipated profile for the sensor scanned through an unflawed acoustic cavity region. Due to the edge effect as the probe nears the acoustic cavity opening, a sharp increase in the low frequency signal level is seen in this region. As the sensor moves into the cavity, a minimum in the low frequency vertical response is detected, most likely due to increasing wall thickness in this area. As the probe passes deeper into the cavity an increase followed by a final slight decrease in the probe output is detected. Subtracting the high frequency vertical component from low frequency vertical component helps to remove other artifacts, such that subsequent analysis is performed on this difference signal. Analysis of this signal profile has led to a signal processing technique employing curve fitting to a cosine modulated exponential function. The vertical component of the low frequency probe response minus that of the high frequency is fit to a curve of the form

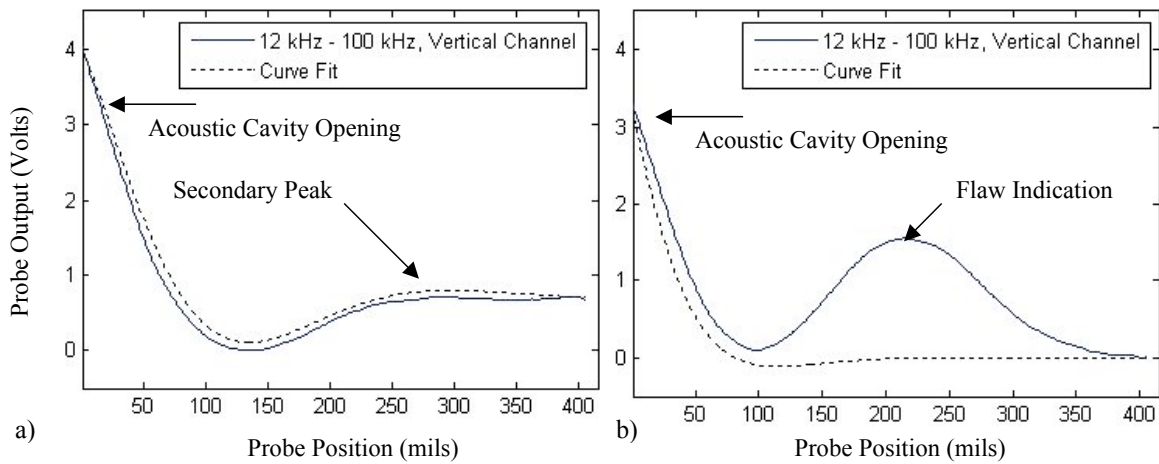
with  $L$  = the secondary peak location,  $x$  = scan position inside the cavity, and  $A$  = the curve fit parameter. The fit is also constrained to match the data at each end of the scan. Figure 5 displays the results of applying this curve fitting procedure to an unflawed acoustic cavity (left plot) as well as a region where a notch approaches an acoustic cavity to within 0.040” remaining wall thickness (right plot). The difference between the raw data and the curve fit highlights the flawed region in the plot on the right. This technique is particularly useful for flaws growing at a steep angle, projecting to an intersection of the acoustic cavity near the cavity opening. It has been found that a calculation of the peak amplitude in the plot of the difference between the curve fit and the raw data correlates well with remaining wall thickness between the acoustic cavity and damage originating in the relief radius area. This calculated peak amplitude is the “Indication Strength” displayed on the system software front panel.

**Figure 5.** Plot of curve fit results for (a) unflawed cavity and (b) cavity with notch approaching to within 0.040” of the acoustic cavity wall. Error between curve fit and raw data highlights flawed regions near the acoustic cavity.

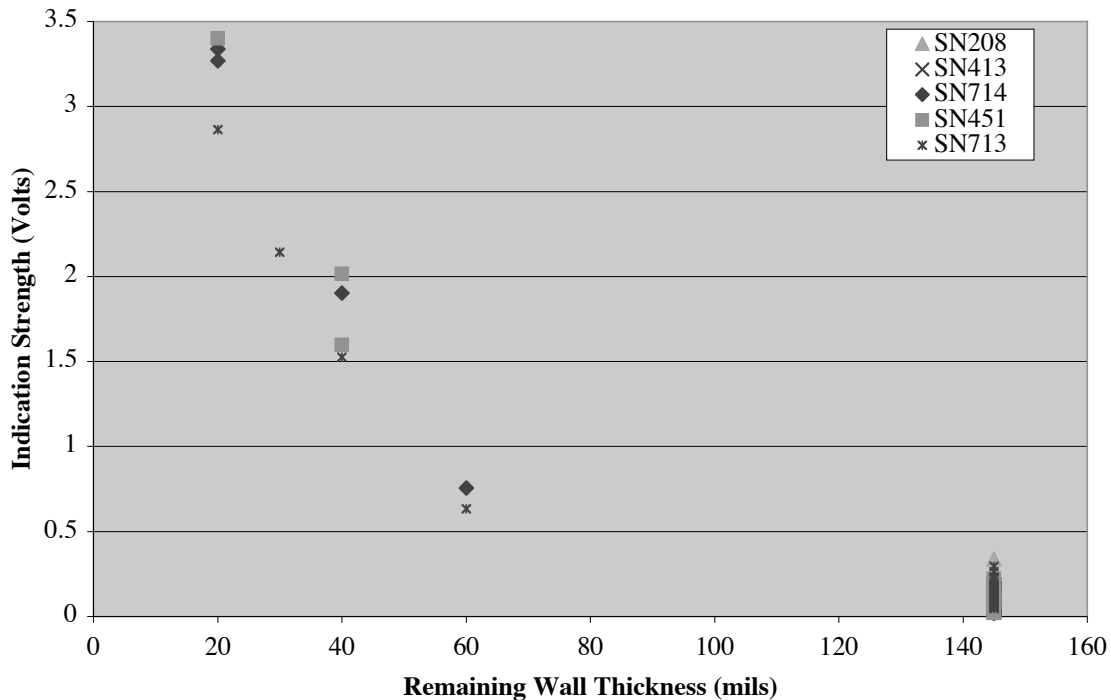
Figure 6 displays a plot of the calculated indication strength, as described above, versus remaining wall thickness between the acoustic cavity and relief radius. The data in Figure 6 was acquired on three thruster reference standards fabricated with electric discharge machine (EDM) notches and two non-flight (Class 3) thrusters. The EDM notch standards contained flaws at angles of 30, 45, and 60 degrees with remaining wall thicknesses of 0.020”, 0.030”, 0.040”, and 0.060”. There are no known flaws in the two Class 3 thrusters. The minimum distance between the relief radius and the acoustic cavity in an unflawed thruster is roughly 145 mils, such that the cluster of points at that value in Figure 6 represents all of the inspected unflawed cavities, 170 sites.

**Figure 6.** Calculated indication strength for all cavities with calibration notches originating across from the acoustic cavity as well as all unflawed cavities in PRCS thruster serial numbers 208, 413, 714, 451, and 713.

Based upon the data depicted in Figure 6, a clear threshold can be established between unflawed thruster regions and areas with notches approaching to within 0.060” of the acoustic cavity wall. It should be noted that the data shown in Figure 6 corresponds to notches originating directly across from the acoustic cavity. As the eddy current coil is aligned in this direction, the sensor has maximum sensitivity for flaws in this orientation. As a part of the reference standard development, flaws originating at an off angle have also been fabricated. Test results have shown that the signal response for flaws originating between cavities as opposed to directly across from a cavity does drop, although flaws up to 0.060” away from the acoustic cavity are still detectable.

Naturally occurring stress corrosion cracking in PRCS thrusters has also been studied. A limited number of stress corrosion cracking sites identified in the thruster inventory have been maintained for NDE development and system calibration. The indication levels from this naturally occurring damage have been found to be as high or higher than those for simulated damage using EDM notches. The likely cause for the increased signal levels on naturally occurring damage is the flaw profile. All naturally occurring damage sites identified to date have shown a very high aspect ratio of crack length to crack depth. The notch standards were all fabricated with a two to one aspect ratio, and therefore likely underestimate the crack length at a given remaining wall thickness. The natural crack profile with a long circumferential direction also makes the occurrence of deep cracking between cavities with little damage directly across from the cavity unlikely. It therefore is reasonable to anticipate flaw detection capabilities for naturally occurring stress corrosion cracking to be at least as reliable as those for the calibration data shown in Figure 6.
