Nondestructive Methods and Special Test Instrumentation Supporting NASA Composite Overwrapped Pressure Vessel Assessments

AIAA-2007-2324

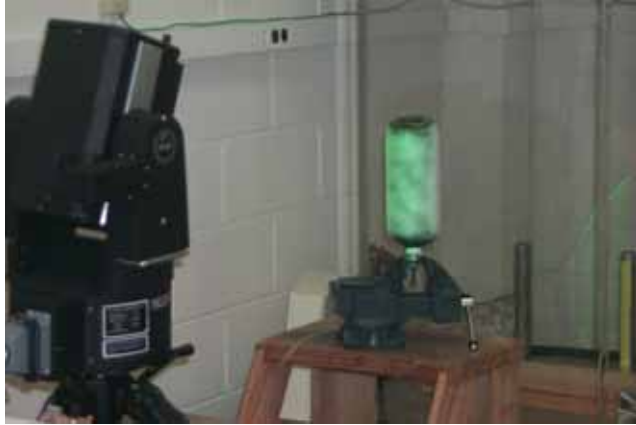
Figure 1. Shearography setup.

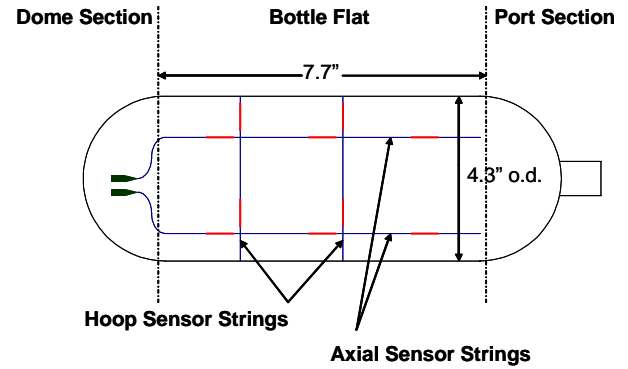
Figure 2. FBG sensor layout.

When looking down at the bottle from the pressure port, the origin is designated to be at the transition from curved surface to the bottle flat directly below the first digit of the serial number on the bottle pressure port (see Figure 2), the axial sensors are centered in the flat along the y direction (along the bottle axis) with 2.5 in. between sensors, and are placed every 90 degrees in the ϕ (hoop) direction. The hoop sensors were placed as close as possible to six of the axial sensors.

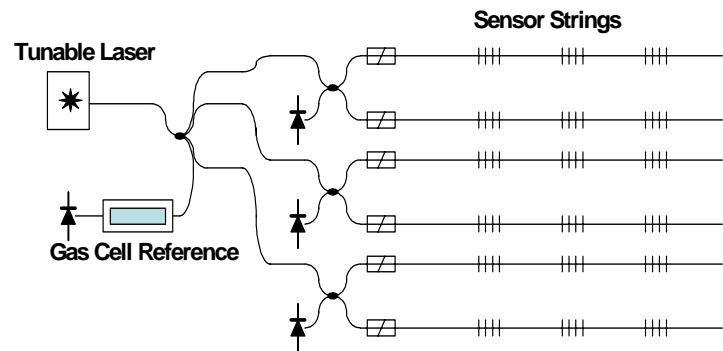
Figure 3. Sensor interrogation unit.

The sensor interrogation unit consisted of a tunable laser module, beam coupling optics, wavelength reference, light detectors, and a personal computer with a high-speed data acquisition card. An optical diagram of the interrogation unit is shown in Figure 3. Light emitted from the tunable laser was split equally into four paths: three sensor channels and one reference channel. In each sensor channel the light was split equally into each of two sensor strings. The sensor reflections passed back through the 2 x 2 coupler to the detector. In the reference channel, light passed through a gas reference cell in which it was absorbed at a series of well-known wavelengths. As the laser swept through its wavelength range, the channel waveforms were collected by an external computer using a high-speed analog-to-digital (A/D) data acquisition card that monitored the voltages output by the detector amplifier modules. Each channel supported six sensor wavelengths, three each on two strings. A spare A/D channel was used to collect the pressure transducer voltage so that the FBG sensor strain values could be directly plotted with bottle pressure.

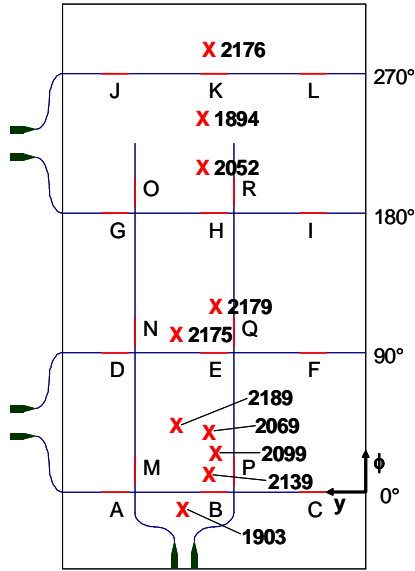
Rupture Position Indicated By X

Figure 4. Bottle burst location depicted on the same plot as sensor location.

After the bottles were burst and removed from the test chamber, the burst locations were recorded. The burst locations for each bottle are depicted in Figure 4 and listed in Table 1. All of the burst locations were within 1 in. of the center of the bottle in the axial direction, and were well distributed in the hoop direction.

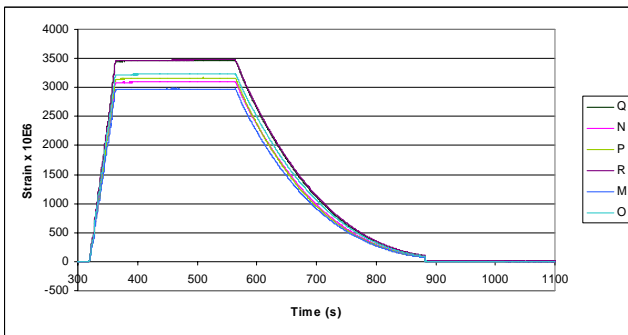
Figure 5. Strain as a function of time during the 50-percent load cycle for the channel 3 sensors (all in the hoop direction) for bottle No. 2179.

The graphs in Figures 5 through 9 depict the data corresponding to the 50-percent pressure cycle and burst cycle. The plots display the ramp up to 2000 psi, the 3-min hold, the ramp back down to 0 psi, and the following 3-min hold. The plots are of the sensor strains as a function of time. These plots are useful when looking for creep during the 50-percent load cycle: creep is indicated if the sensor strains do not return to their starting position. An example of this effect is depicted in Figures 5 and 6: the strain curves during the 50-percent load cycle for the hoop sensors for a previously cycled bottle, No. 2179, and a pristine bottle, No. 2139. The hoop strains all return to within 15 microstrains of their starting strain for the previously exercised bottle, but remain as much as 600 microstrains above their starting strain for the pristine bottle, indicating residual fiber stress.

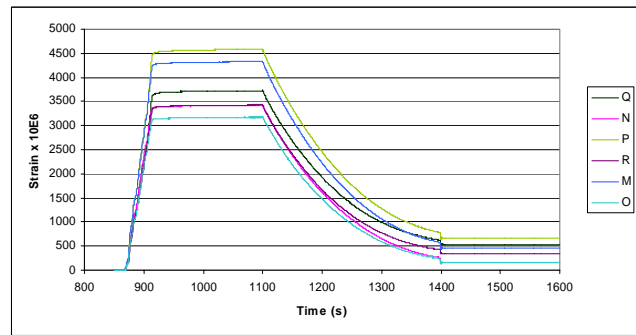
Figure 6. Strain as a function of time during the 50-percent load cycle for the channel 3 sensors (all in the hoop direction) for bottle No. 2139.

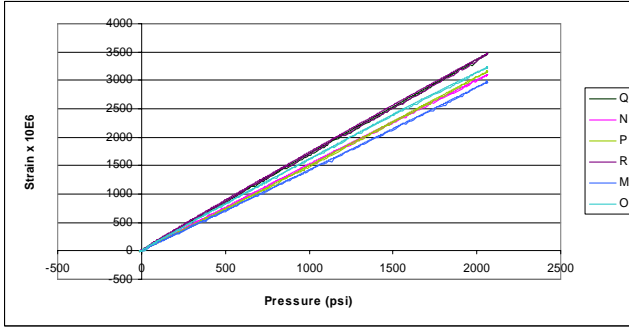
Figure 7. Strain as a function of pressure during the 50-percent load cycle for the channel 3 sensors (all in the hoop direction) for bottle No. 2179.

For an elastic material, assuming that the bottle stress is proportional to bottle pressure, the strain-versus-pressure plots should be linear, and should not show any appreciable gap between the rising and falling pressure curves. Most of the well-conditioned bottles exhibit elastic behavior during the 50-percent pressure cycle, as shown in Figure 7. However, a similar plot for a pristine bottle exhibits a far larger degree of hysteresis (Figure 8), indicative of material stretching in the hoop direction during the load cycle. There is also a difference in onset of non-elastic behavior during the burst testing between the pristine and well-conditioned bottles. Although the burst pressures for bottle Nos. 2179 and 2139 were different by only 220 psi (4430 psi versus 4210 psi, respectively),

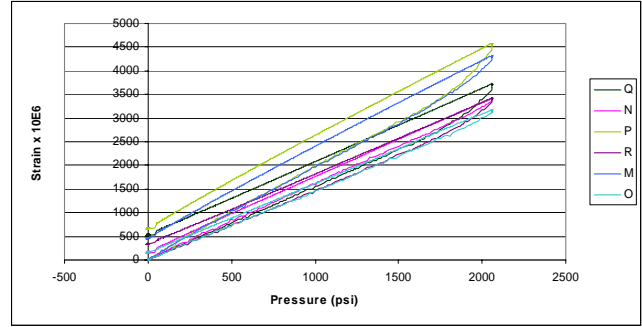
Figure 8. Strain as a function of pressure during the 50-percent load cycle for the channel 3 sensors (all in the hoop direction) for bottle No. 2139.

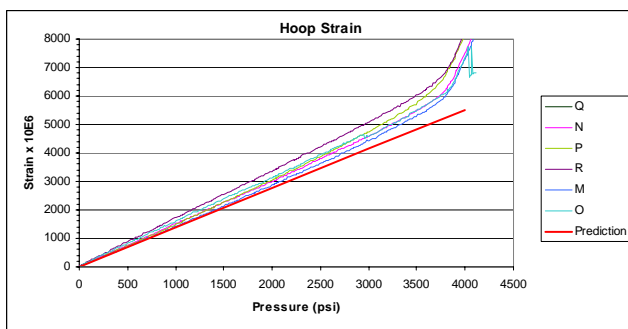
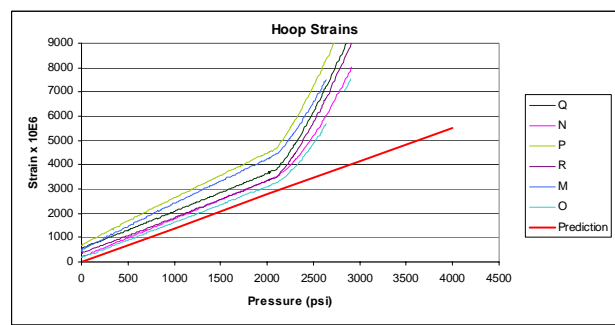
Figure 9. Strain as a function of pressure during the burst cycle for the channel 3 sensors (all in the hoop direction) with predictions made with ANSYS software.

Figure 9 shows that a large increase in slope of the strain curve occurs at approximately 3700 psi for the well-conditioned bottle (left), but close to 2300 psi for the pristine bottle (right). This increase in slope is likely a first indication of fiber and liner realignment of load sharing characteristics. This occurs at different pressures depending on the previous stress state of the bottle. Figure 9 also shows the first attempt to model the bottles and compare it with the actual measurement. This was done using ANSYS^{®**} failure analysis software, without taking plastic behavior of the aluminum liner into account; hence it did not predict the liner's behavior at the point of rapid strain transfer to the fiber.

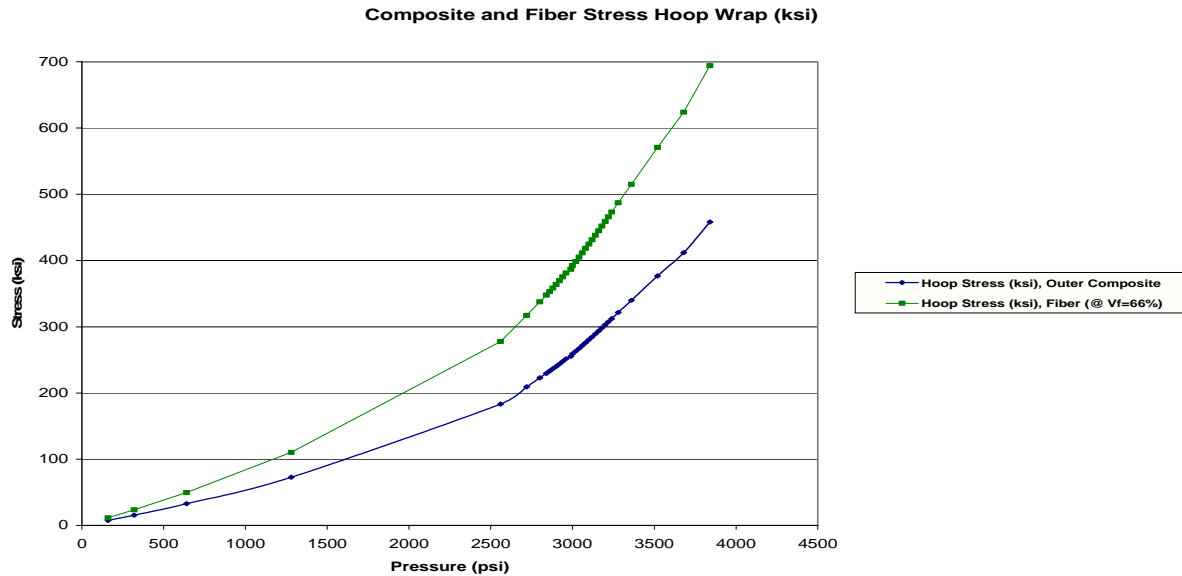
Figure 10. Strain plots using the Genoa software to predict structural failure.

A second model, constructed using the GENOA Progressive Failure Analysis (PFA)^{††} software, applied nonlinear elastic/plastic behavior for the liner material and micromechanics modeling of the fiber/matrix composite layers based on the manufacturing wind patterns. This particular model was only performed using data for a pristine vessel. The GENOA model indicates the onset of plastic behavior and the subsequent shift of stress to the composite layers. A plot of the stress at the surface in the hoop direction near the equator of the vessel is shown in Figure 10. The lower curve represents the stress in the composite, while the upper curve is the computed stress in the fibers themselves. The plot supports the assessment of the knee occurring near the same point as measured by the Bragg sensor.

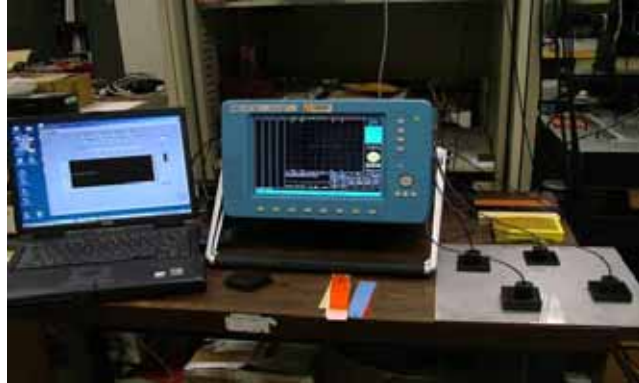
Figure 11. Eddy current inspection system for COPV composite thickness measurement

eight on the larger gaseous helium tanks. The coils, shown in the right-hand side of Figure 11, are each enclosed in a housing 1-in. in diameter and 0.75-in. tall. Each coil has been placed on an insulating surface (Delrin[®] sheet) over a stainless steel conductor. In this laboratory environment, the simple geometry mimics the Kevlar composite over a COPV with a metal. A laptop computer is used to acquire and archive the data in real-time during testing. In the figure, the normalized impedance of the four coils is displayed in the four dots in the center of the MIZ-27 screen. The signals have been nulled, or balanced, at the respective composite thicknesses seen by each probe and rotated such that a change in lift-off results in a vertical deflection of the eddy current signal. The probe response is digitized and stored on the laptop computer, while the vertical components of the signals are displayed in a strip chart on the computer screen. A separate analog input channel is reserved to acquire timing information from the pressurization tests.

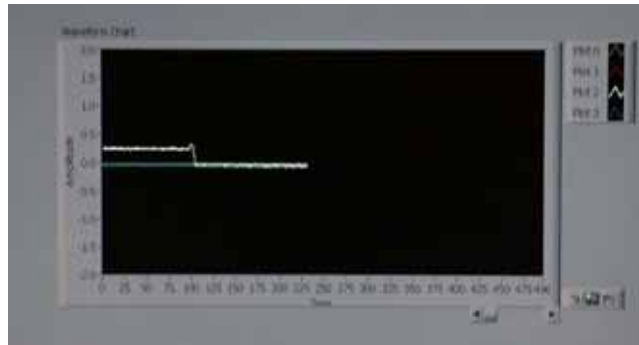
Figure 12. Screenshot of data in Plot 2 shows voltage change associated with change in thickness from 0.251 to 0.250 in. as a 1-mil shim is removed from probe 2 at T ~ 100. All other channels remained at nominal coating thicknesses.

In order to determine the voltage change caused by a given change in composite thickness, calibration of the probes and equipment is needed. This is performed using nonconductive shim material to measure the change in probe output for a known thickness change. The calibration range should encompass the range-of-thickness change anticipated during the test. In Figure 12, the computer display for the removal of a 0.001-in. plastic shim over the 0.25-in. insulator block is shown.

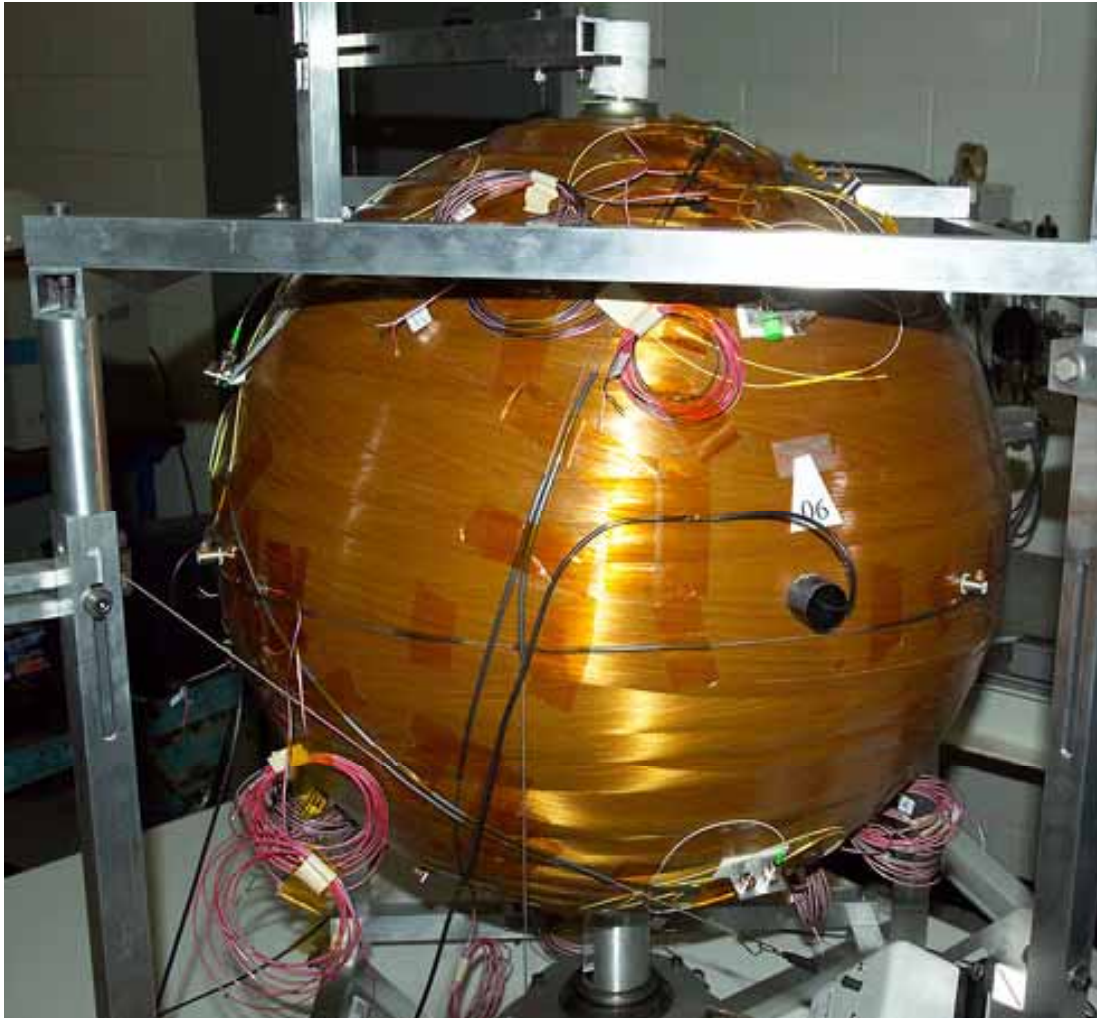
Figure 13. Eddy current sensors installed on COPV.

Following laboratory calibration, COPVs were installed on at the pressurization facility. Various pressurization cycles were applied while the composite overwrap thickness was measured with the eddy current sensors. Figures 14 and 15 display resulting composite and liner thickness change in a sample final ramp to burst. A decrease in the composite and liner thickness is measured on all channels as the pressure increases. An x-ray correlation was accomplished on the first vessel to help validate the eddy current thickness measurements and found the eddy current measurements to be accurate to the resolution of the x-ray technique. Although data from up to eight eddy current sensors per COPV was sometimes a bit time consuming to reduce and analyze, it has been instrumental and has indicated how the composite and liner strain together through yield and all the way to burst.

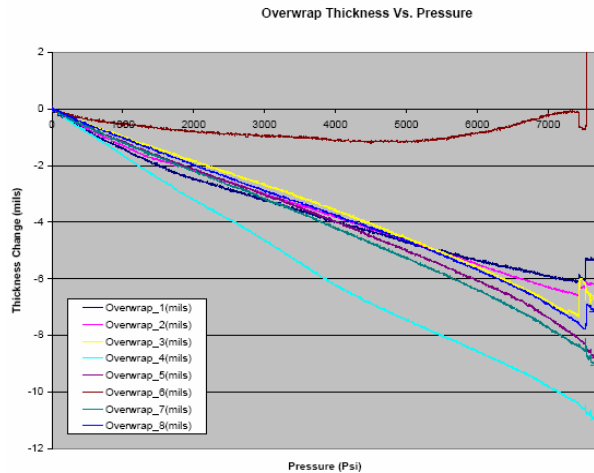
Figure 14. Example Composite thickness reduction with pressure.

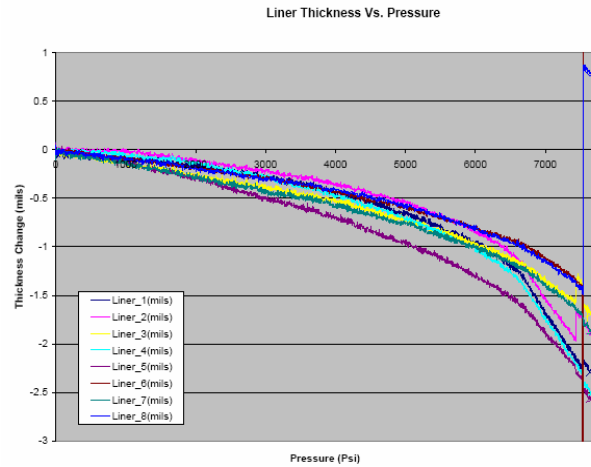
Figure 15. Example Liner thickness reduction with pressure.

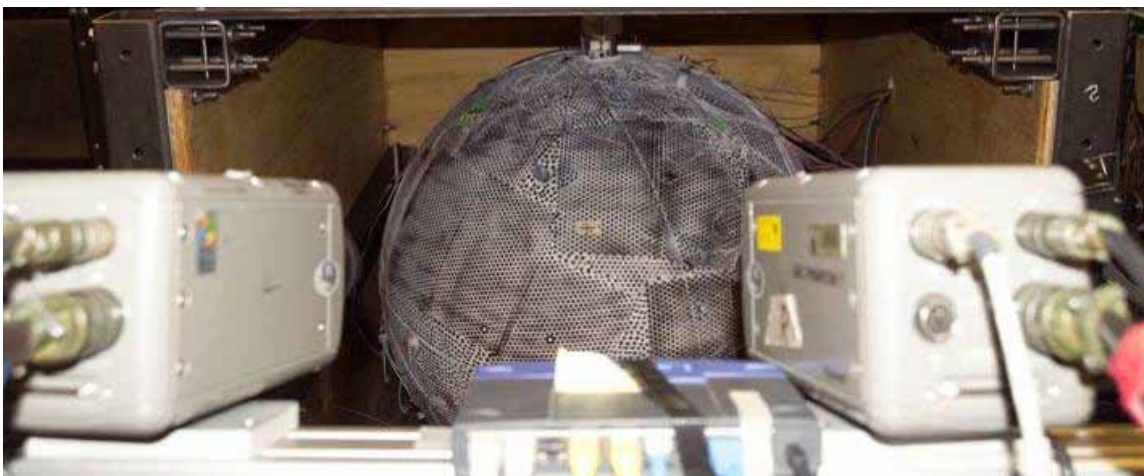
Figure 16. Digital image correlation camera view of COPV (Black dots sprayed over area of interest).

For the typical WSTF COPV installation (Figure 16), digital high-speed Phantom^{®***} v7.0 cameras were used at a resolution of 512 x 512 pixels, giving a recording speed ranging from 100 to 3000 frames per second (fps). Lower speeds were used for some tests due to the negative heating affect that supplemental lighting had on other COPV surface mounted instrumentation. The Phantom cameras act as a stereo pair to create a volume of area in which the ARAMIS software can take measurements. The volume varies with the calibration method and field of view. This camera setup consisted of 35-mm lenses with the cameras at a typical angle of 15.7 degrees, giving a measuring volume of 1060 mm/875 mm/875 mm. To calibrate for this volume, the camera resolution was set at 800 x 1200 pixels, and a 1200 mm NIST-traceable calibration cross was rotated and moved in specified locations to calibrate the sensor. After successful computation, the calibration deviation was below 0.04 and the angle variance was larger than the 15 degrees required for a successful calibration. The cameras used inter-range instrumentation group (IRIG) time for synchronization, which provided accuracy within 1 microsecond between images. The pattern sprayed on the vessel consisted of a white background with 0.25-in. black dots sprayed on the surface viewed, as noted in Figure 16. The system was particularly useful in indicating overall principal strain fields that developed higher in the COPV pressurization range as indicated in Figure 17 and indicating surface fiber failure near burst. The system also provided excellent strain data in areas where conventional strain gauges were not installed and correlated well to these, as indicated in Figure 18, except where cables or other instrumentation interfered.

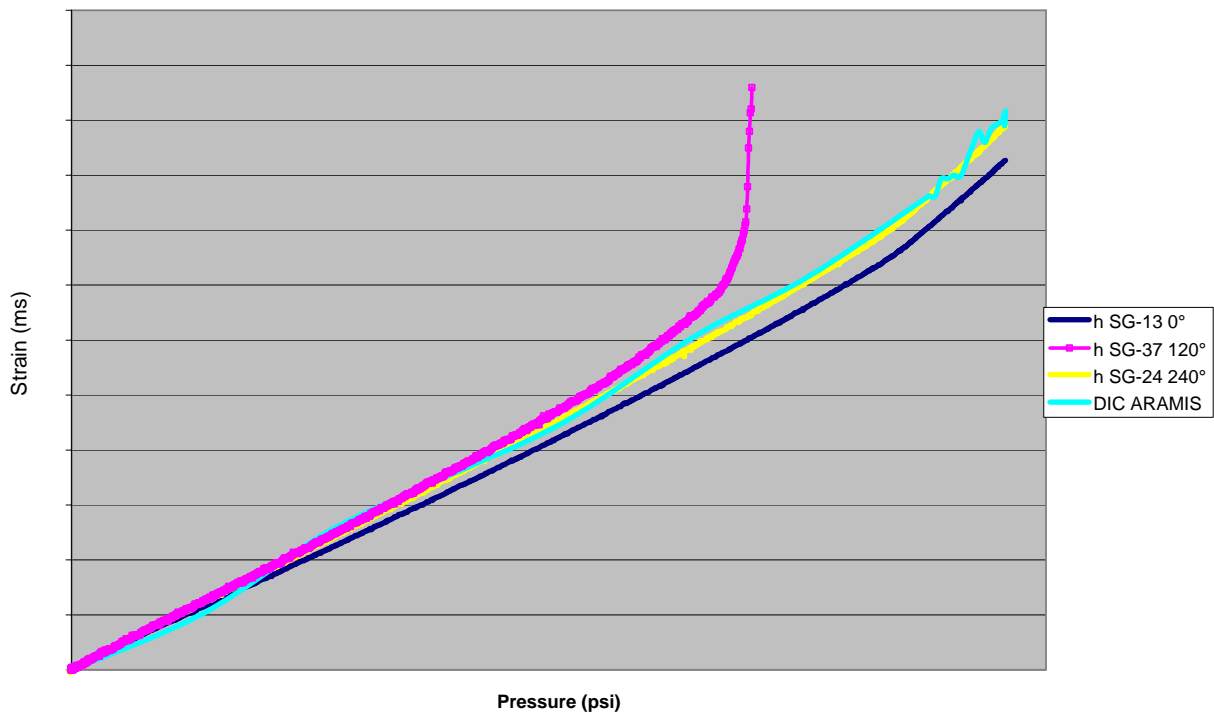
Figure 18. Digital image data correlation to conventional strain gauges

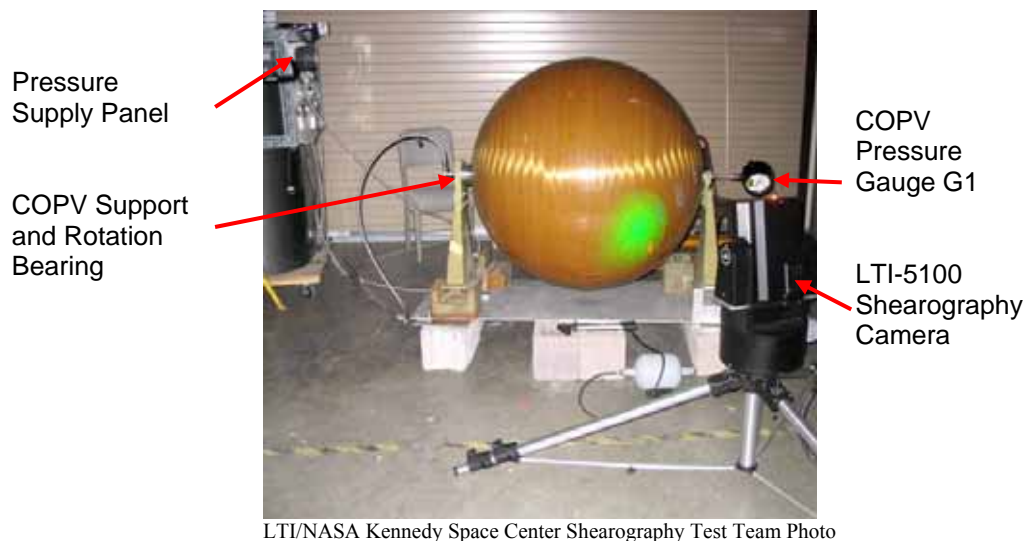
Figure 19. LTI SC-5100 system being applied to Kevlar COPV.

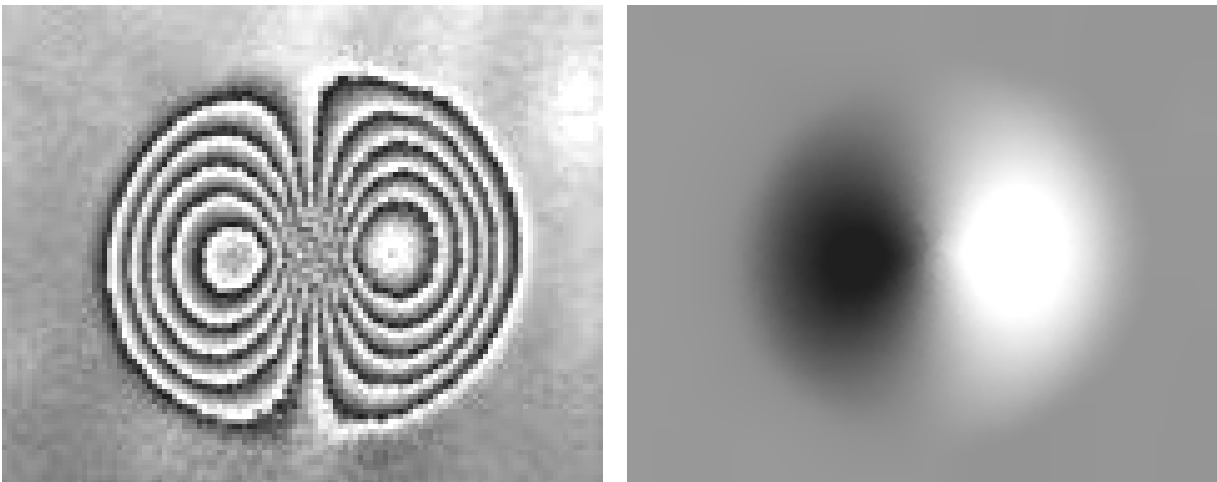
Figure 20. A phase map shearogram with horizontal shear vector yields a fringe pattern showing the first derivative of the out-of-plane deformation, $\partial w / \partial x$. Using an unwrapping algorithm, the image at right shows the positive (white) and negative (black) slope change. The metal plate with a 4.0-inch diameter flat-bottomed hole was deformed by $7.0 \mu\text{m}$.

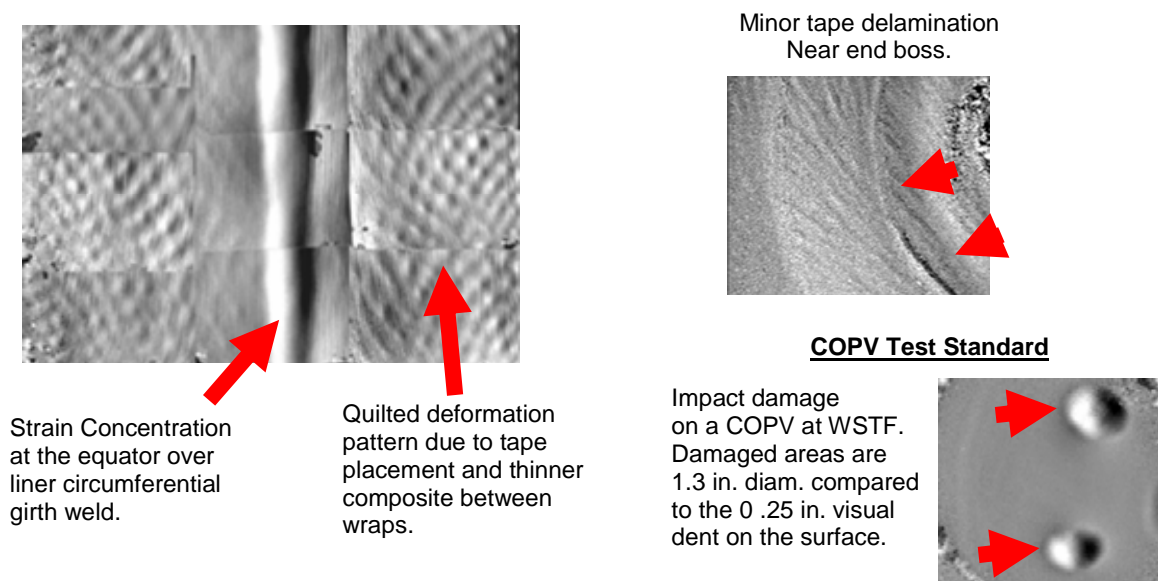
Figure 21. Example Shearography image of Kevlar COPV as compared to a damage standard.

An example of composite shearography images of a Kevlar test tank is shown in Figure 21. The pressure was cycled between 70 and 90 psi to create a delta strain for each image. The sensitivity is noted by very slight strain indicated in the overwrap pattern and from tank features such as the girth weld area. Minor delaminations are also indicated in the upper right where wrap patterns cross. However, no impact damage was noted as seen on the impact standard image shown on the lower right. Shearography of a carbon test COPV is also shown in Figure 22. In this figure, damage from calibrated impacts are clearly imaged and the sensitivity of the system is indicated by the less substantial and unexpected un-programmed damage noted on the lower left.

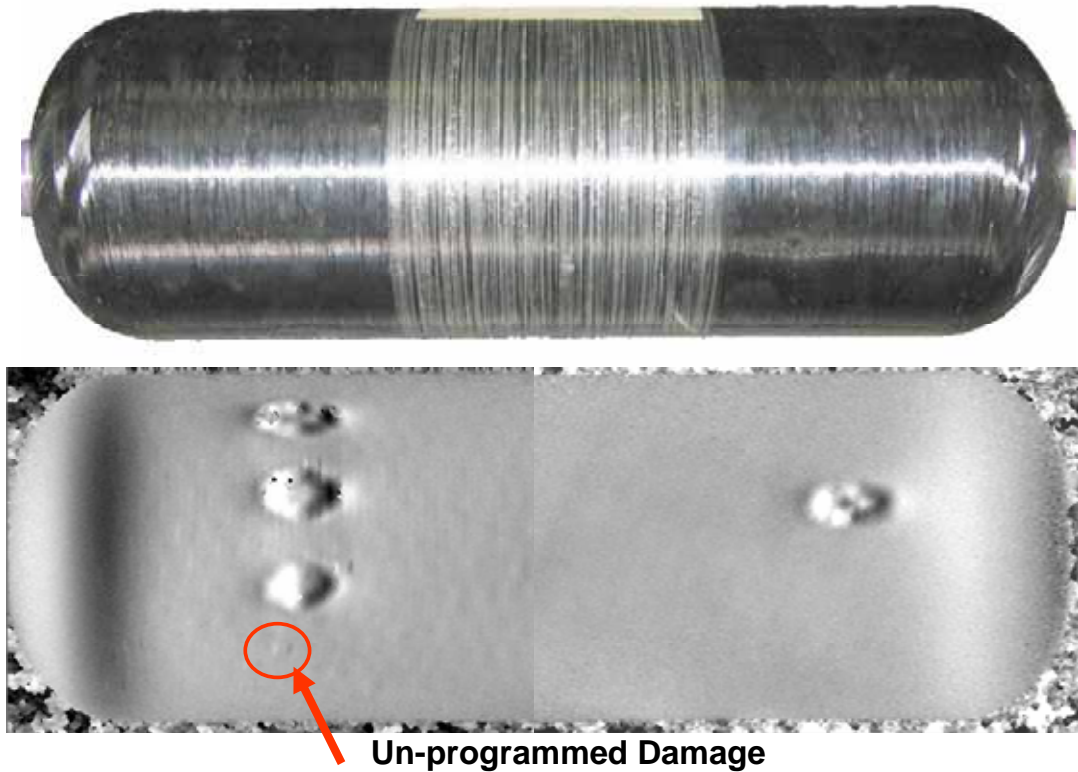
Figure 22. Shearography Inspection of Impact Damaged Carbon COPV

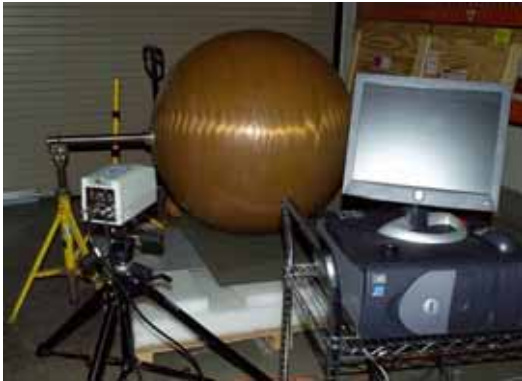
Figure 23. Heat soak thermography application to Kevlar COPV.

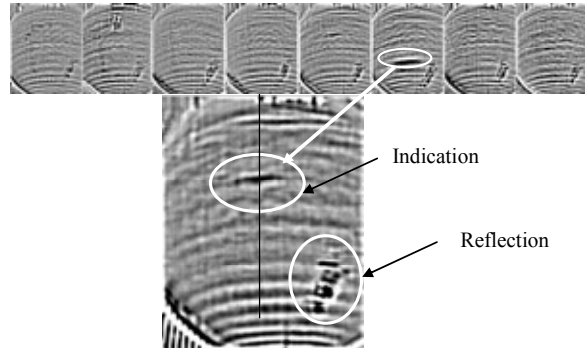
Figure 24. Example Kevlar COPV heat soak thermography images.

Only one minor indication, possibly a small near-surface ply disband or resin lean area, was noted real-time during data collection (Figure 24). However, additional heat soak thermography and ultrasound were done of the area and it was deemed not to be a concern.

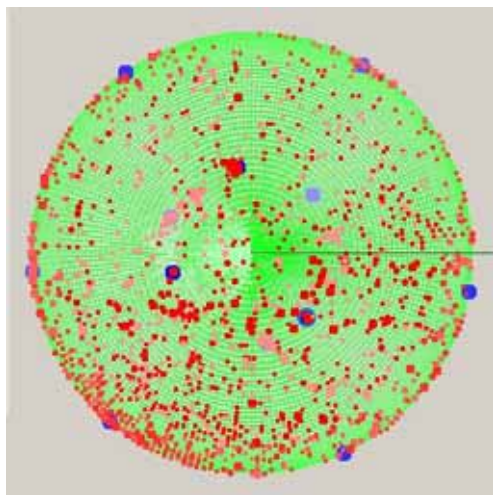
Figure 25. Example Unfiltered AE COPV Data - All Events

Technical support for the AE test support was provided by the NASA Langley Research center. AE sensors were installed typically in 5 locations on smaller COPVs and 12 positions on larger COPVs. Three were installed on the upper boss, three others on the lower boss and six were installed around the equator. Using this configuration, sensors were used to triangulate the source locations for the acoustic activity. Sample data is shown super imposed on the 2D symbolic view of a spherical COPV shown in Figure 25. Lighter indications depict activity locations on the lower side. An example of the total number of acoustic events plotted during a pressurization and hold is indicated in Figure 26. In this case it is significant to note that acoustic activity continued during the pressure hold from 1500 to 2000 seconds. At lower pressure holds, this acoustic activity did not continue. This may be indicating that damage is profligating and the overwrap may be slowly failing. As more data is added to the COPV AE database, this type of data may be very valuable for COPV *in situ* health monitoring. During the WSTF COPV testing, a timeline of all COPV failure events was assembled and AE data was reviewed in detail and was extremely useful for correlation to DIC and other measurement techniques to substantiate and map locations of fiber breakage and fully characterize COPV performance.

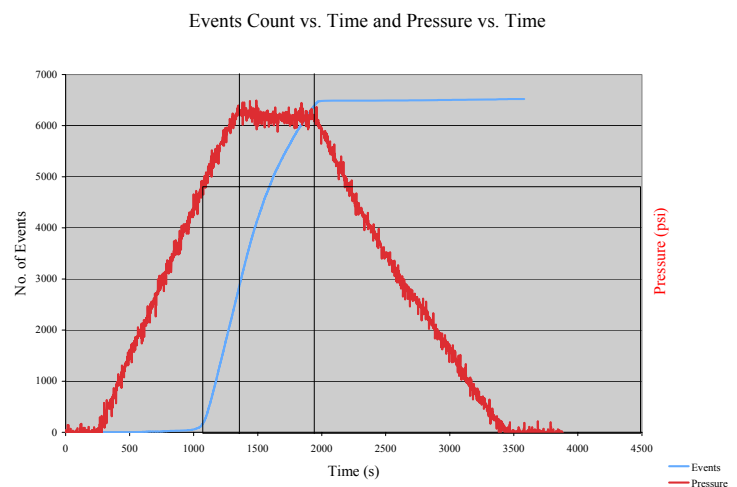
Figure 26. Example AE Events vs. Time during a pressurization and hold

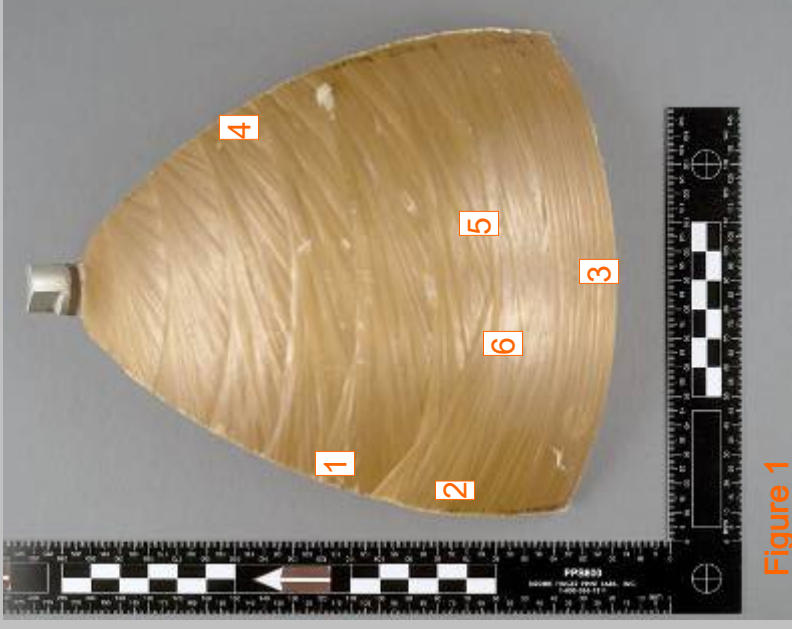
Figure 1

- Sectioned COPV with defects for use as a standard
- 1 – 4: delaminations of Kevlar fibers
 - Defects 5 & 6: hole drilled into the liner

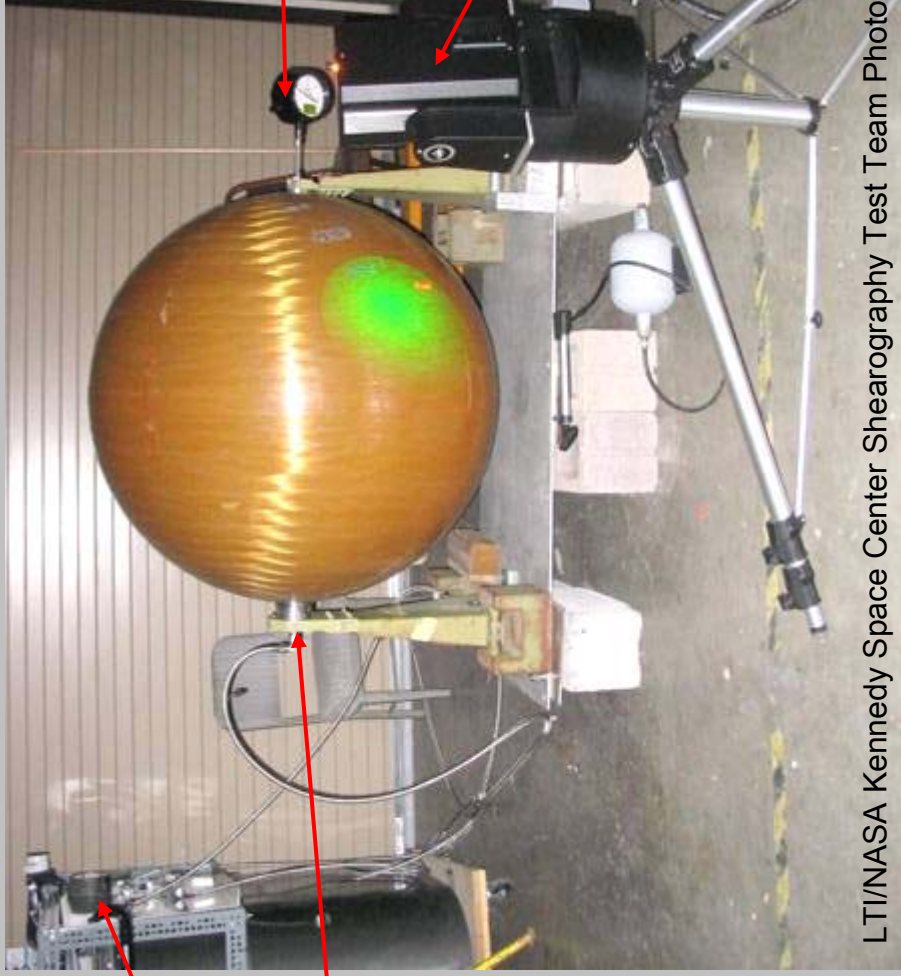
LTI-5100 Shearography Camera

Shearography Test Set-Up for COPV Testing Pneumatic Operation/Shearography Data Capture

- Shearography shows surface deformation derivatives due to pressure change in tank.
- White areas are surfaces sloping towards the camera, dark areas are sloping away from the camera.
- Deviation from a neutral gray value of 128 (8-bit, 256 gray levels) determine deformation amplitude.
- Features yielding a strain response due to low internal pressure change: Tape delamination, impact damage, COPV design strain concentrations

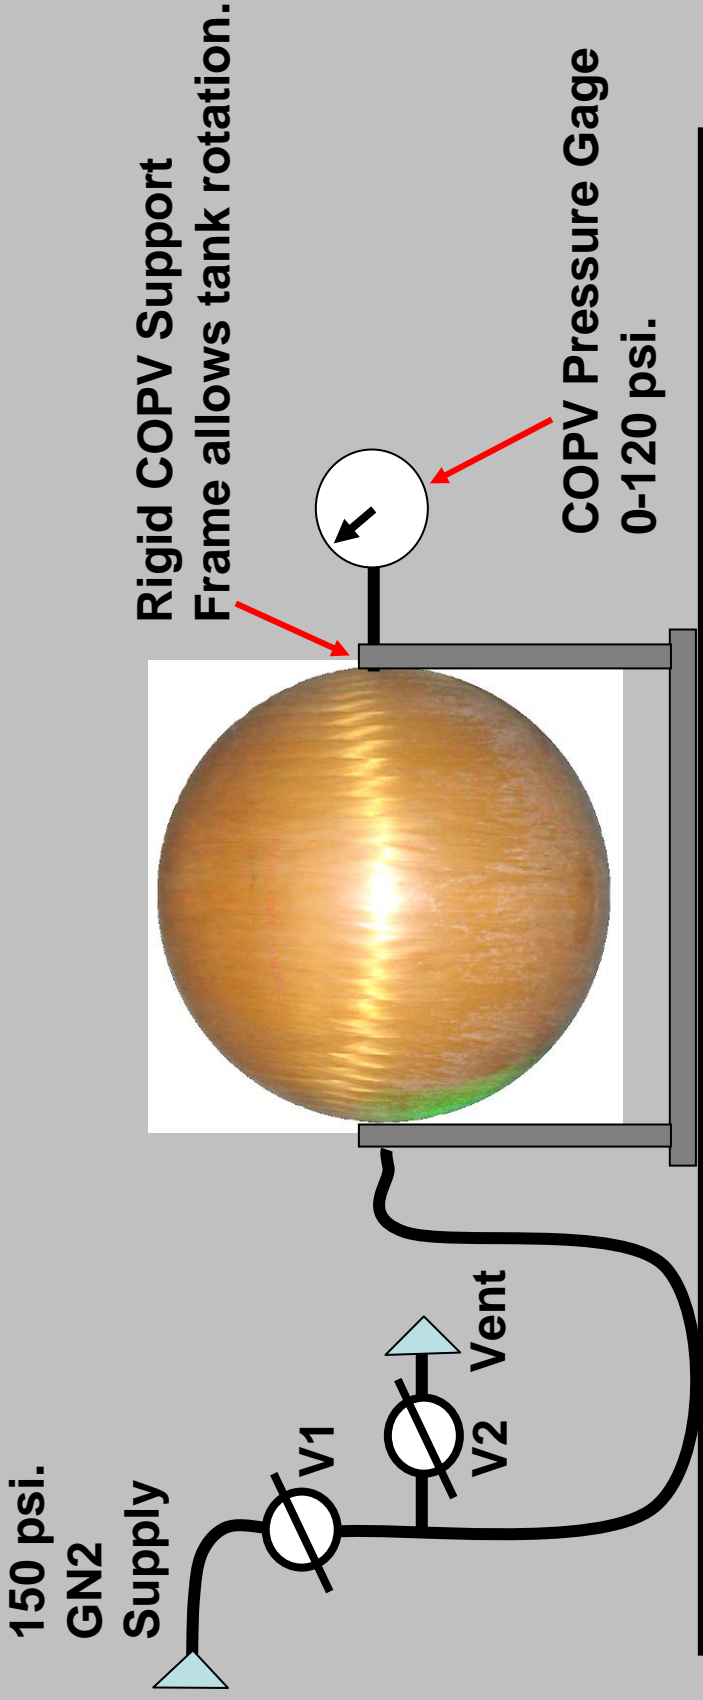
1. V1 opened, pressure raised to 70psi., V1 closed.
2. Shearography reference image captured @ 70 psi.
3. V1 opened, pressure raised to 90psi., V1 closed.
4. Shearography Stressed image captured @ 90 psi.
5. Final shearography image computed.

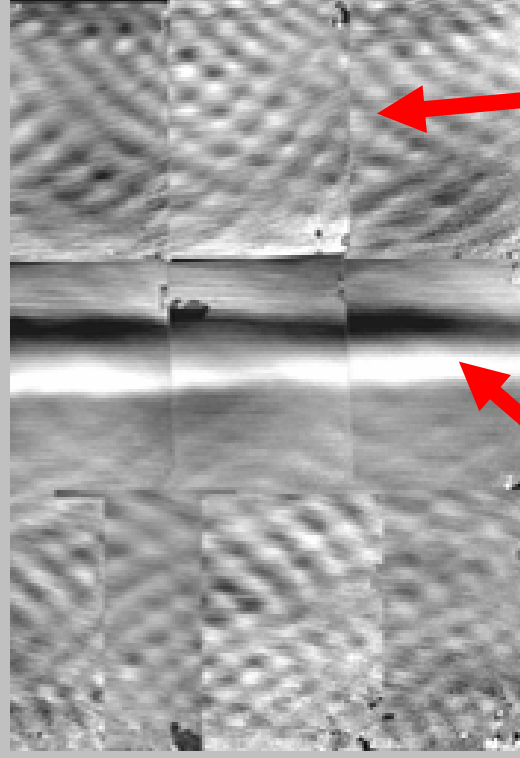
Strain Concentration
at the equator over
liner circumferential
girth weld.

Quilted deformation
pattern due to tape
placement and thinner
composite between wraps.

Minor tape delamination
Near end boss.

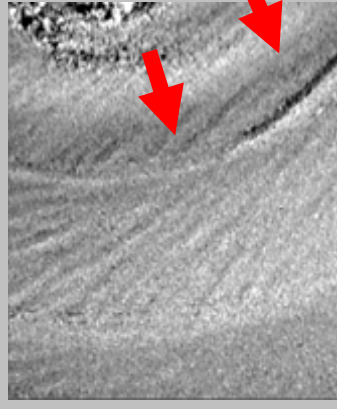
COPV Test Standard

Impact damage
on a COPV at WSTF.
Damaged areas
are 1.3 in. diam.
compared to the
0.25 in. visual
dent on the
surface.

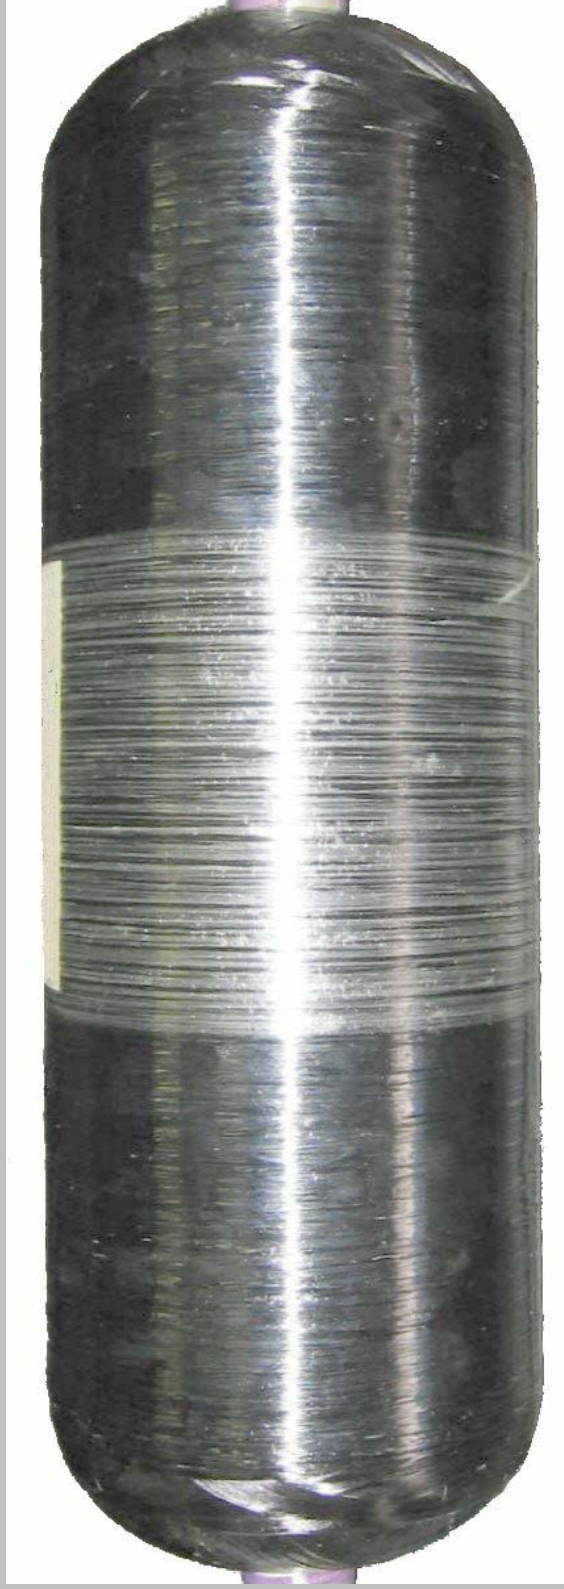
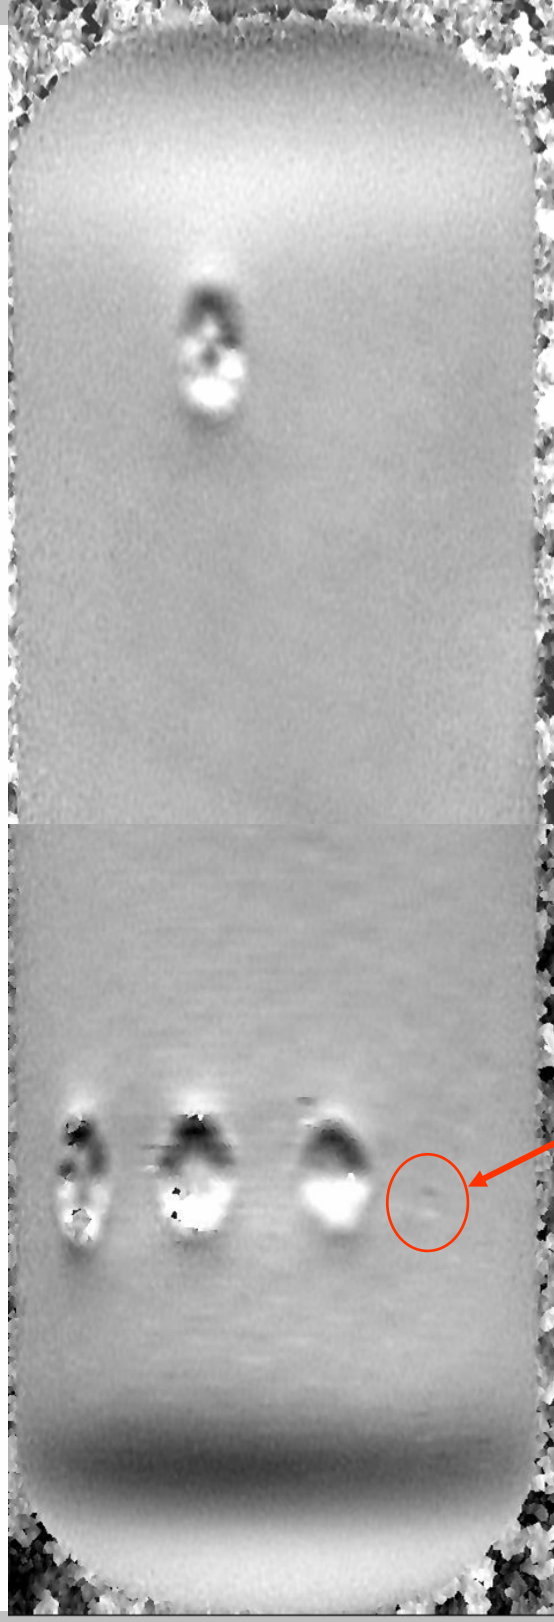
Carbon COPV Shearography Inspection - 10 psid

Damage undetectable visually

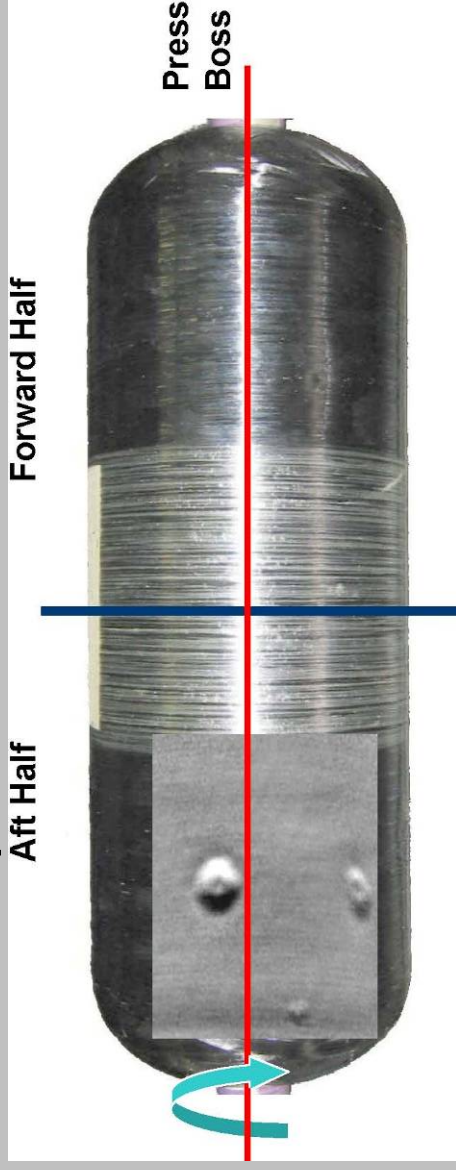
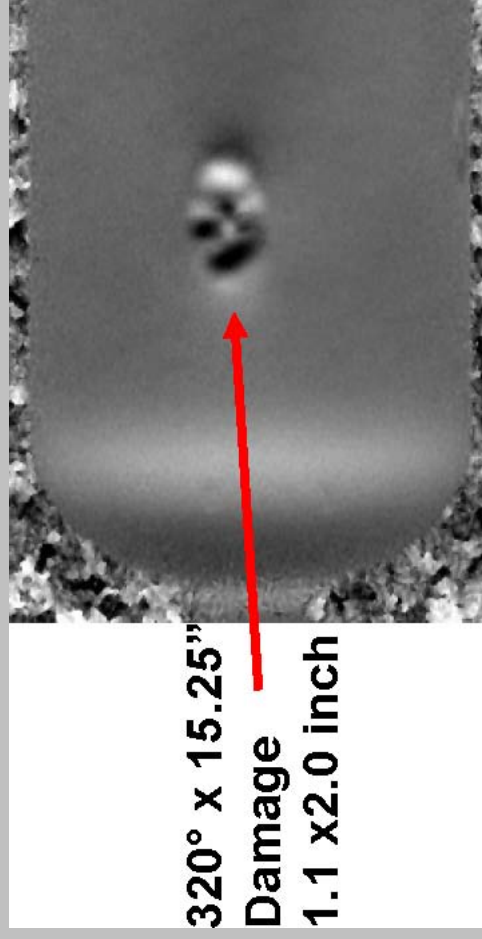
Correlation of Shearography Response to Impact damage

- Provides excellent image and effective damage area to compare with impact characteristics

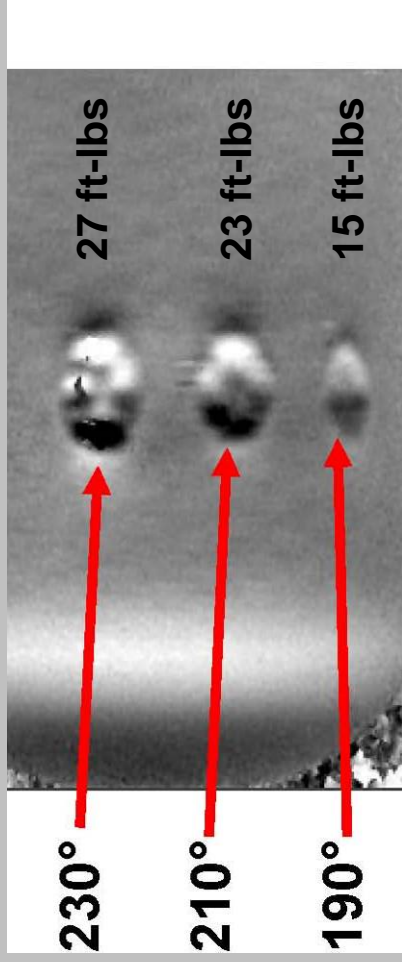
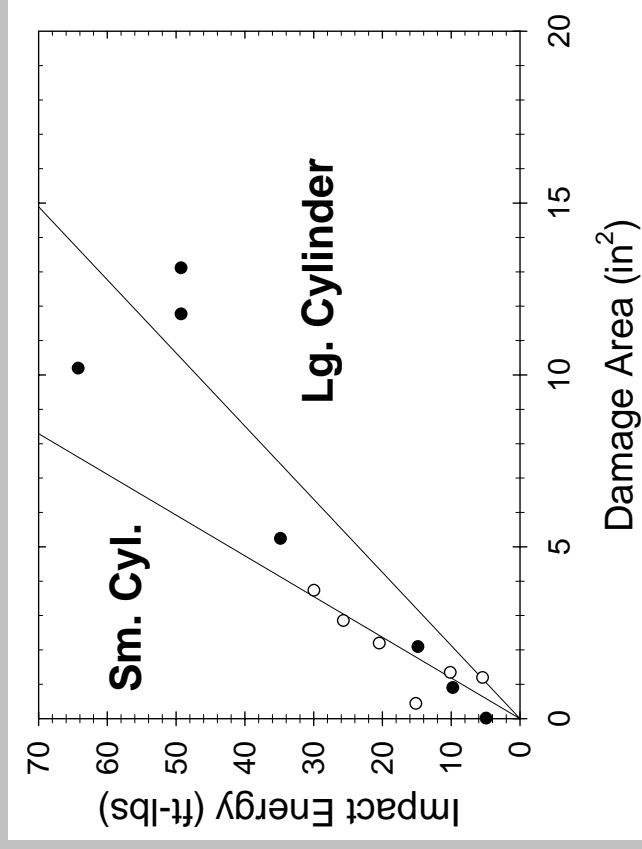
Correlation of Shearography Response to Impact damage Con't

- Detects areas not revealed by visual inspection
- Damage areas for different impact energies visually evident
- Damage area increases with impact energy for all COPVs
