Nondestructive Methods and Special Test Instrumentation Supporting NASA Composite Overwrapped Pressure Vessel Assessments

AIAA-2007-2324

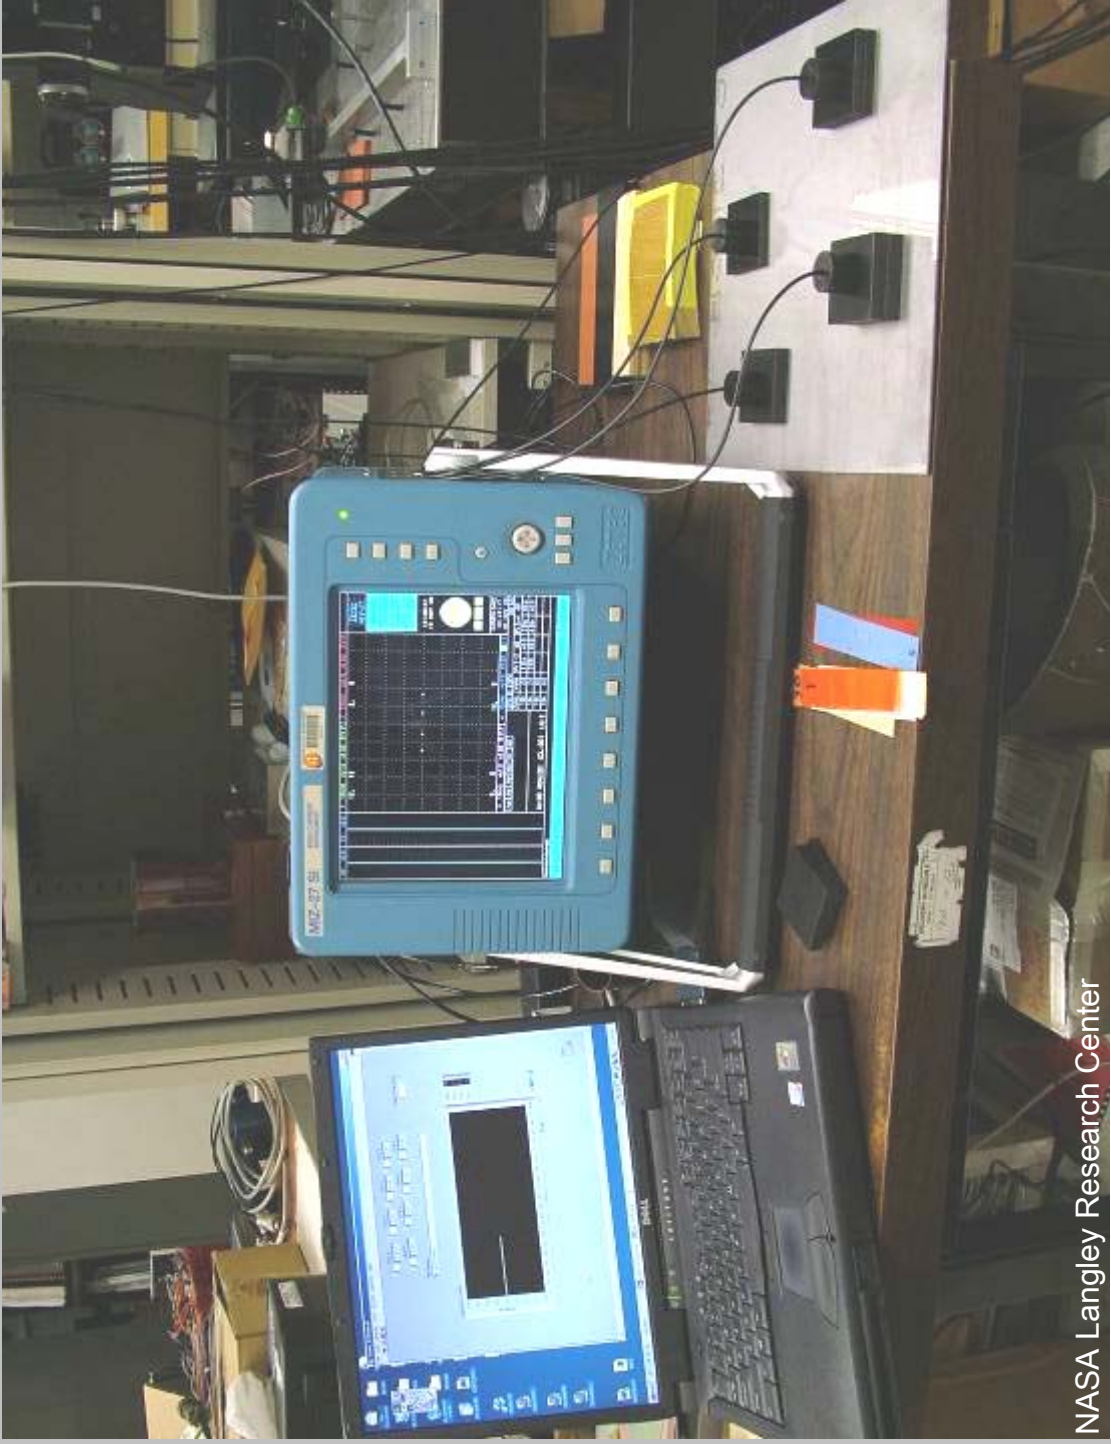
Composite/Liner Thickness Measurement

Eddy current system for real-time COPV composite thickness

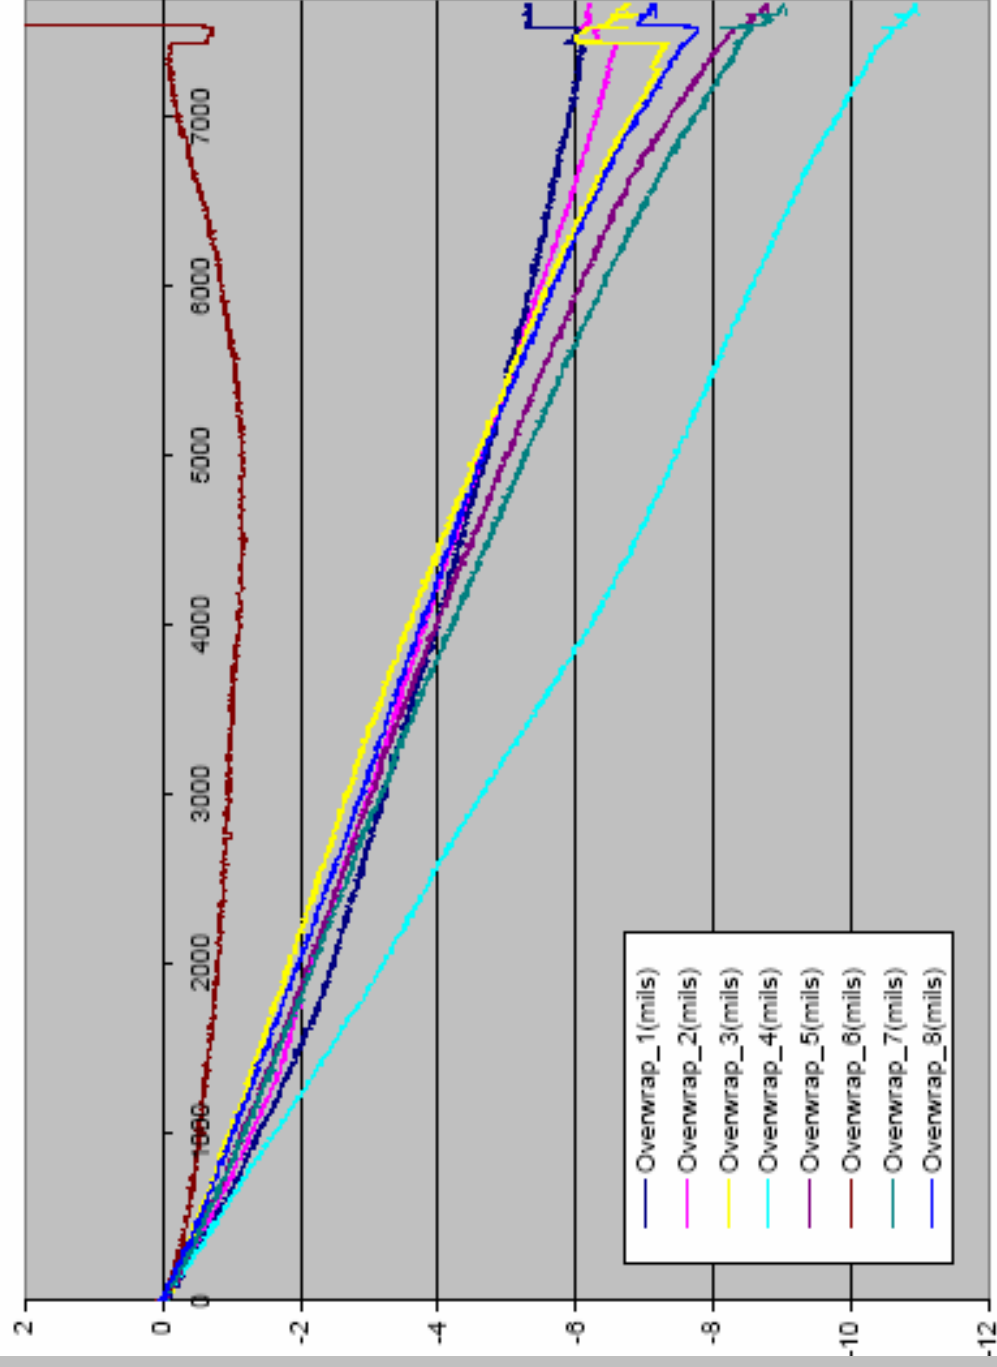
Example Overwrap Thickness Evaluation by Eddy Current

Overwrap Thickness Vs. Pressure

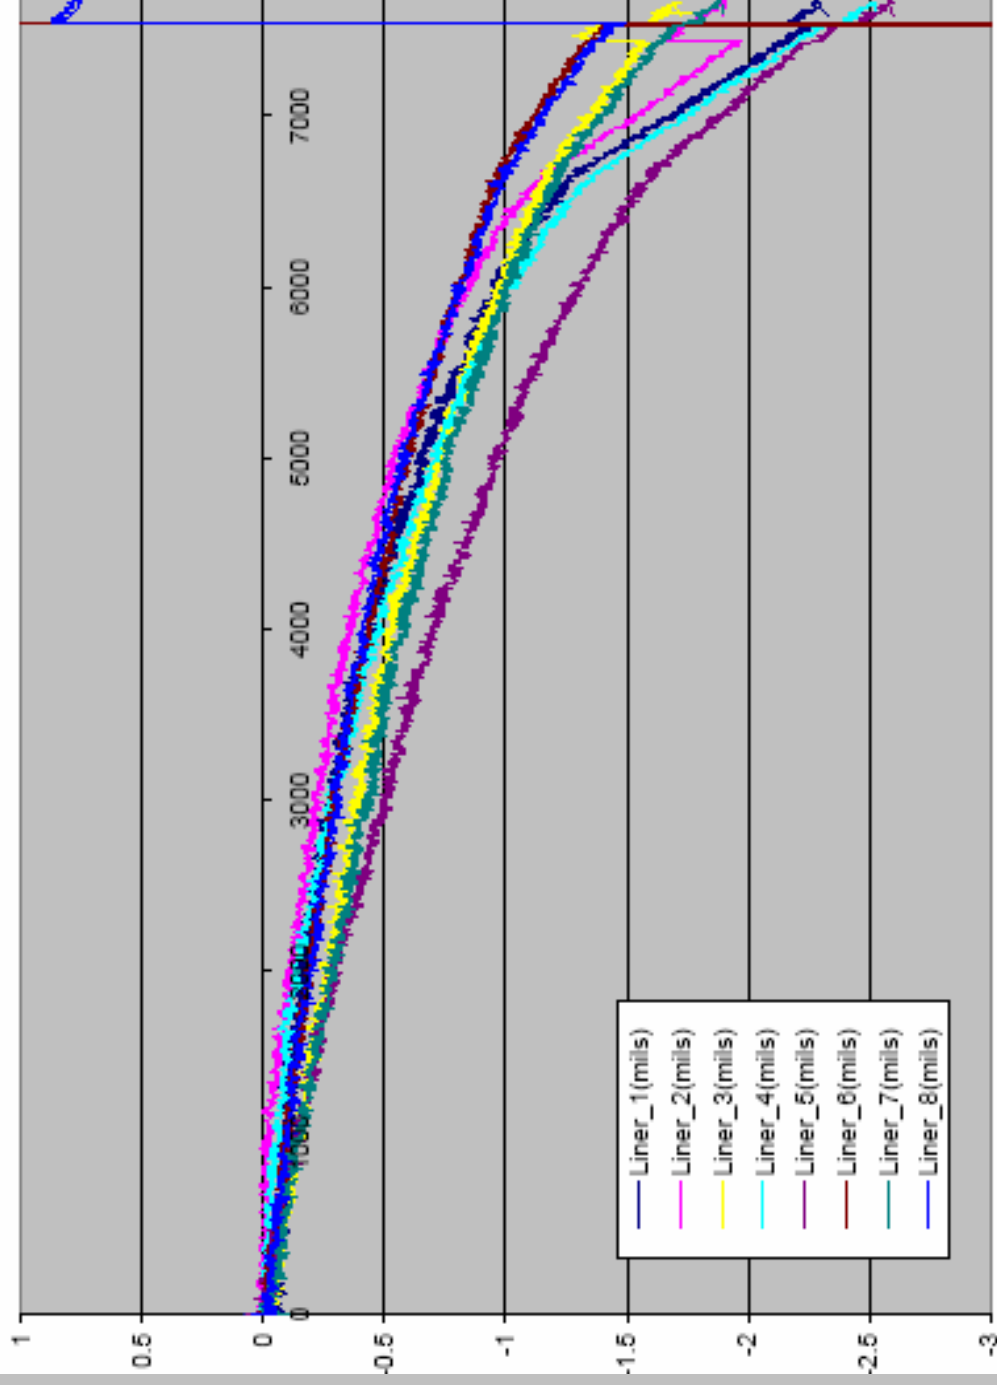
Example Liner Thickness Evaluation by Eddy Current

Liner Thickness Vs. Pressure

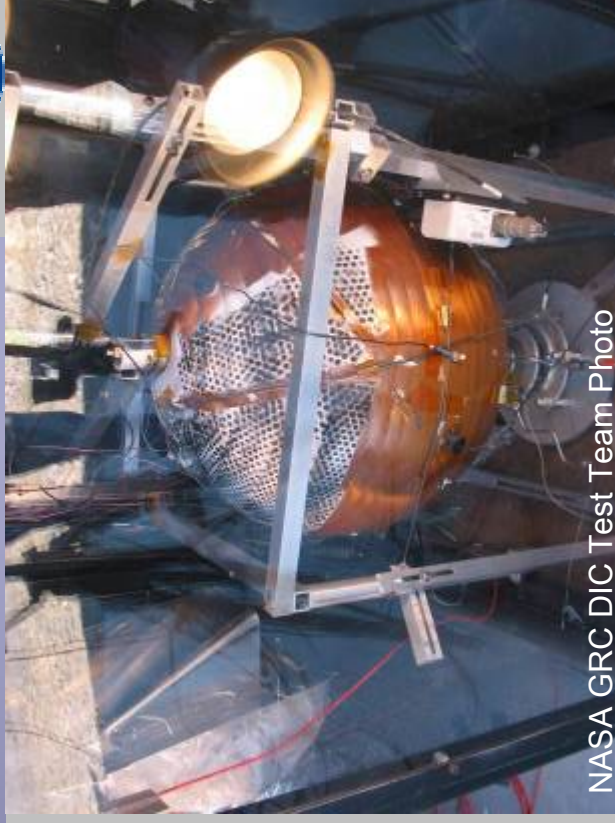
Black dots sprayed over area of interest

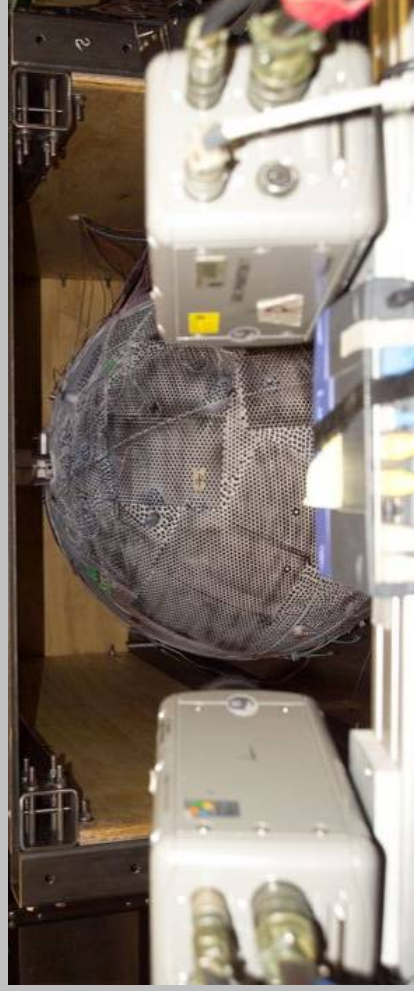
Digital Image Correlation Video

Green to Red
area indicating
asymmetric
stress field
during
pressurization
(area of
accelerated
Stress Rupture
and greater
failure risk)

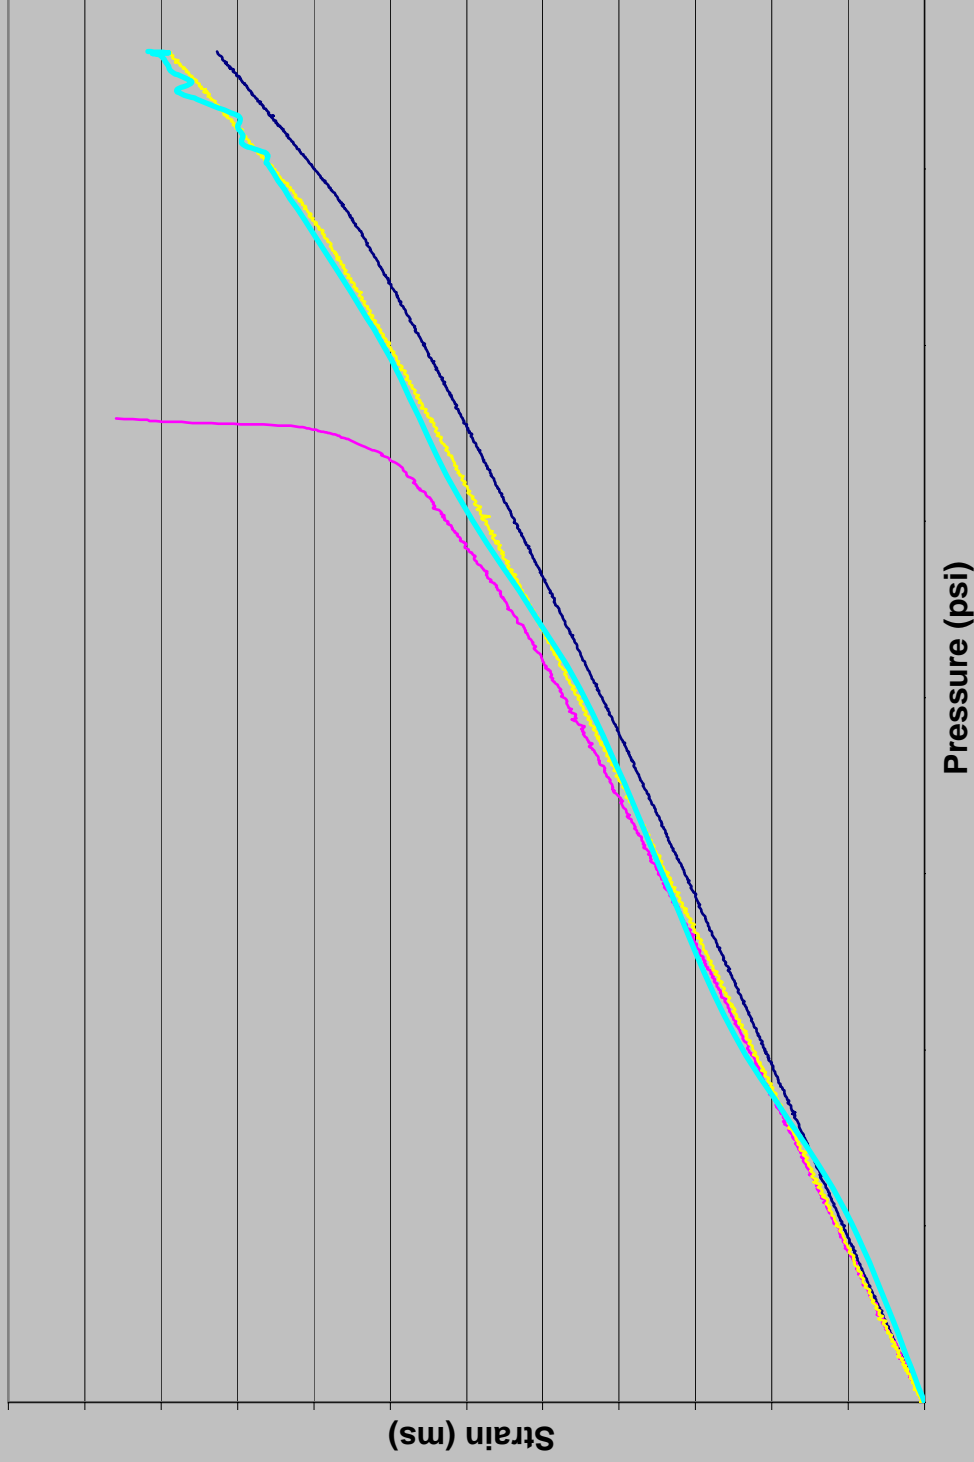
Normalized Strain vs. Pressure, Hoop Wrap on NASA COPV Test

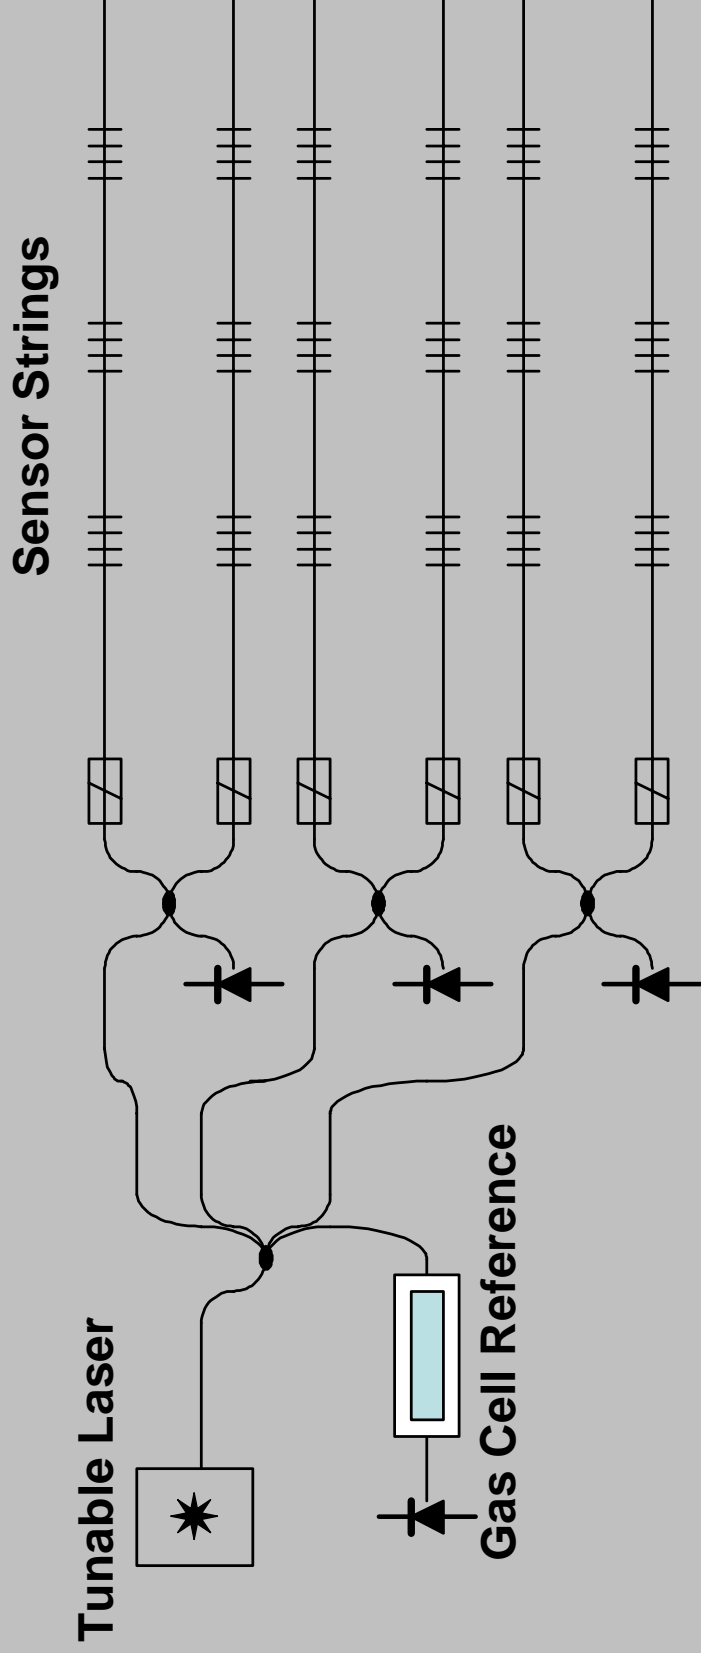
General Schematic of COPV FBG Strain Measurement System
