# Stress Rupture Testing and Analysis of the NASA WSTF-JPL Carbon Overwrapped Pressure Vessels

**[Abstract] Carbon composite overwrapped pressure vessels (COPVs) are widely used in applications from spacecraft to life support. COPVs are used primarily for propellant storage and actuation pressure storage. COPV technology provides a pressurized media storage advantage over amorphous technology with weight savings on the order of 30 percent. The National Aeronautics and Space Administration (NASA) has been supporting the development of this technology since the early 1970s<sup>i</sup> with an interest in safe application of these components to reduce mass to orbital insertion and on orbit. NASA White Sands Test Facility (WSTF) has been testing components in support of this objective since the 1980s and has been involved in test development and analysis to address effects of impact, propellant and cryogenic fluids exposure on Kevlar<sup>®</sup> and carbon epoxy<sup>ii</sup> structures.**

The focus of this paper is to present results of a recent joint WSTF-Jet Propulsion Laboratories (JPL) effort to assess safe life of these components. The WSTF-JPL test articles consisted of an alum

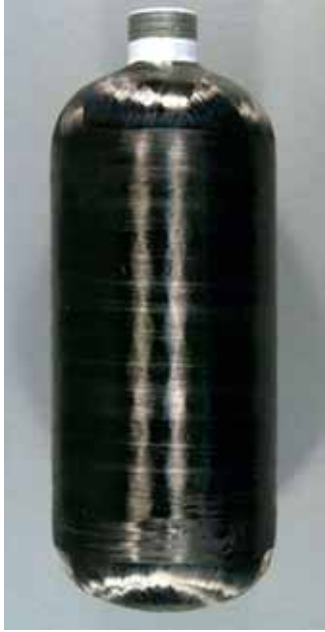
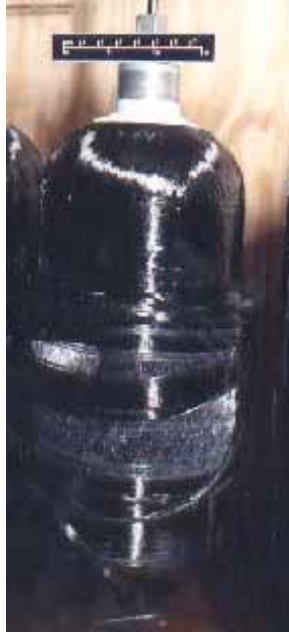
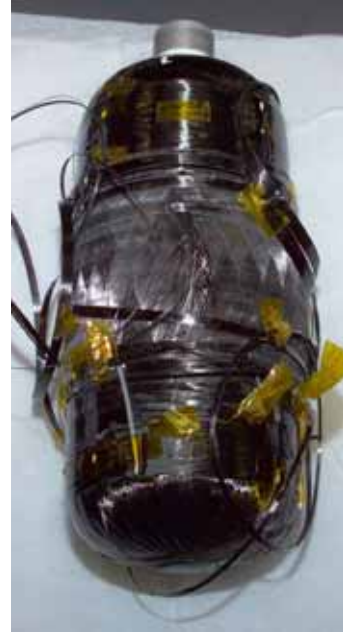
**Figure 1. WSTF-JPL Test Article (left to right) before Pressurization, in Test with a “Hoop Tow Failure” and after a “Burst Failure”**

The vessels were specially designed with a hoop wrap over the helical wrap to force failure in the hoop wraps. During test, the hoop tows would be observed to fail and unraveling of the overwrap would occur as is shown in Figure 1. Failures were noted to occur in the hoop region of the COPV. Modeling showed that all but the S/N 2141 failure at 3200 psi could be explained by the statistics of strand failure. A full investigation into the causes of the failures are discussed in a companion paper titled, *Unexpected Shelf-life Degradation Phenomenon of the WSTF-JPL Carbon COPV Test Articles: An Analysis and Independent Assessment.*<sup>v</sup> and the NASA Engineering Safety Center Report.<sup>vi</sup>

Two types of COPV failure were observed to occur during testing. The first type was when a strand of fiber was observed to break and begin to unwind from the hoop region of the COPV. This type of failure of the overwrap did not compromise the liner or cause loss of pressure in the test article. Failures of this type were noted as “hoop” failures. The test continued until the second type of failure occurred in that test group. The second type was a “burst” failure, where the liner was compromised resulting in loss of pressure and observation of fiber failure. This type of failure ended the testing.

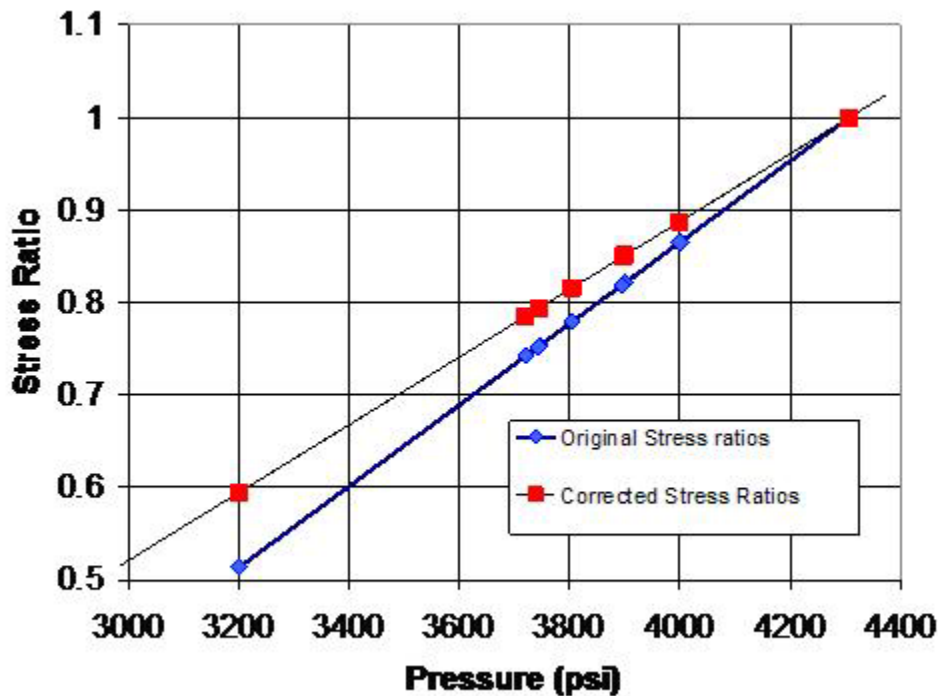
Figure 2. Stress Rupture Chart for WSTF-JPL COPVs

A sample of 73 test articles have been placed into stress rupture testing to date with achieved pressure ratios of 93.3, 91.2, 91.0, 88.7, 87.5, 87.2, 86.4, and 74.6 percent based on the average burst pressure of the 20 initial burst tests. Three test articles burst on pressurization or early in stress rupture at unexpected times and pressures. Expected times and pressures for failure were established before test using an industry standard model<sup>iii, iv</sup> based on carbon epoxy strand test results. Fiber stress ratios were provided from the manufacturer and were used to set target stress levels. A later NESC assessment of stress ratios showed that actual fiber stresses in test were up to 11 percent higher than the fiber stress that was provided. A higher fiber stress ratio at burst brought results closer to model predictions; however, this was not sufficient to explain the unexpected failures. Figure 2 compares the original and the corrected fiber stress ratios.

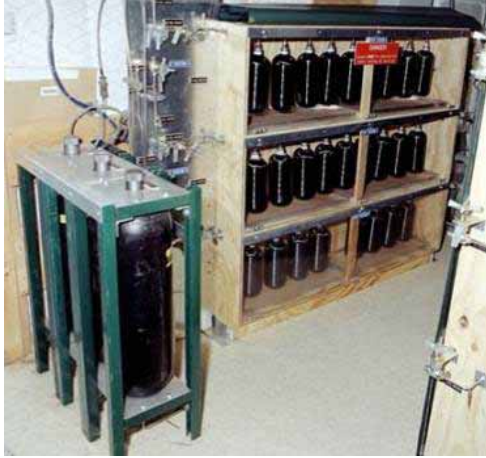
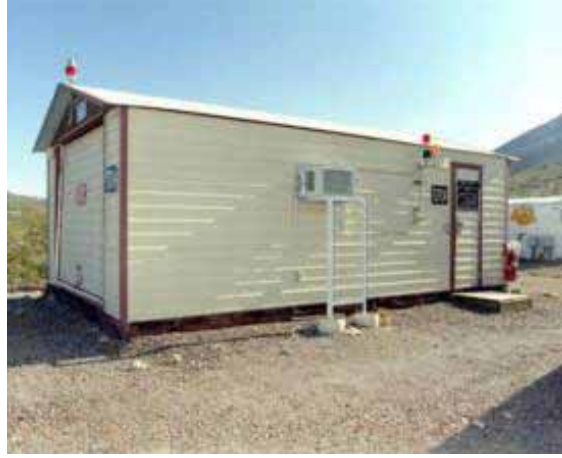
**Figure 3. Carbon Epoxy Three-bank Test System with Accumulator and Stress Rupture Test Facility**

The test articles were placed into test systems consisting of nine test articles each, connected by a manifold and pressurized simultaneously. Tests were run at pressure ratios based on a percentage of the burst pressure value. Four test articles from various groups either did not make test pressure or failed much more quickly than expected at test pressure. This outcome from testing resulted in a white paper and an investigation initiated by NESC. Figure 3 shows views of one of the STEB stress rupture test facilities. Table 1 contains WSTF-JPL COPV data.
