NASA Shuttle Orbiter Reinforced Carbon Carbon (RCC) Crack Repair Arc-Jet Testing

ASME District E Student Professional Development Conference

April 13, 2007

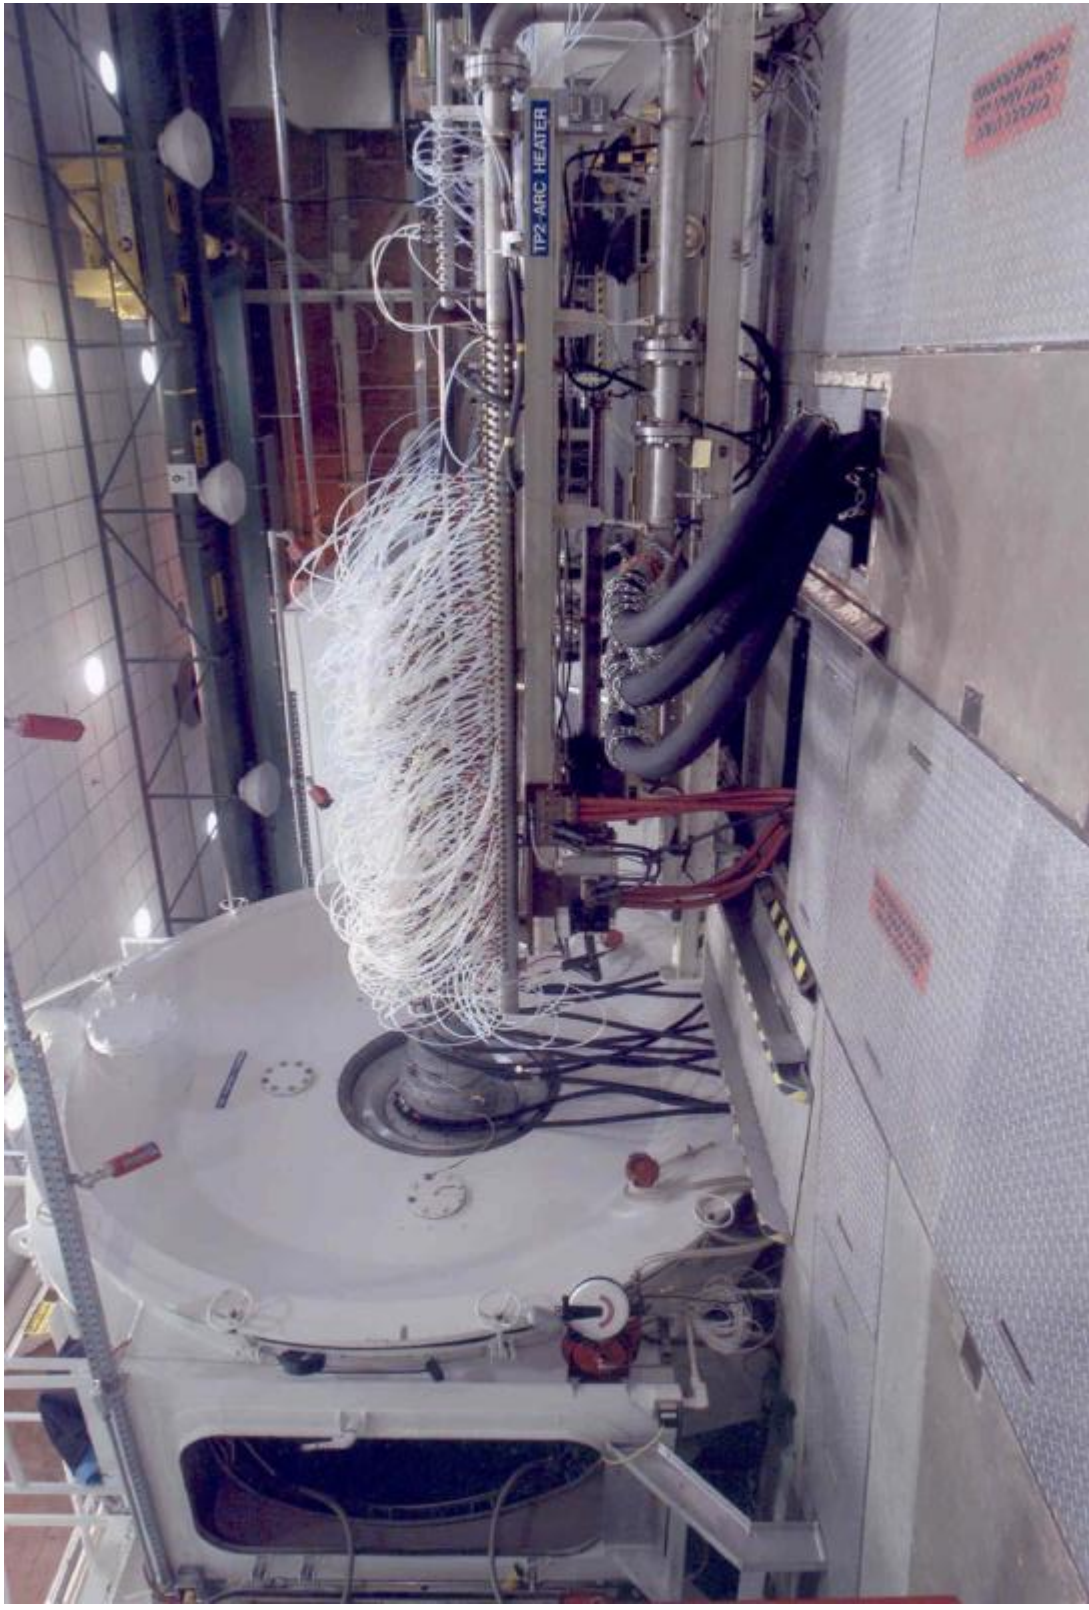
Photo of Test Position 2 (TP2) at JSC Arc-Jet Facility

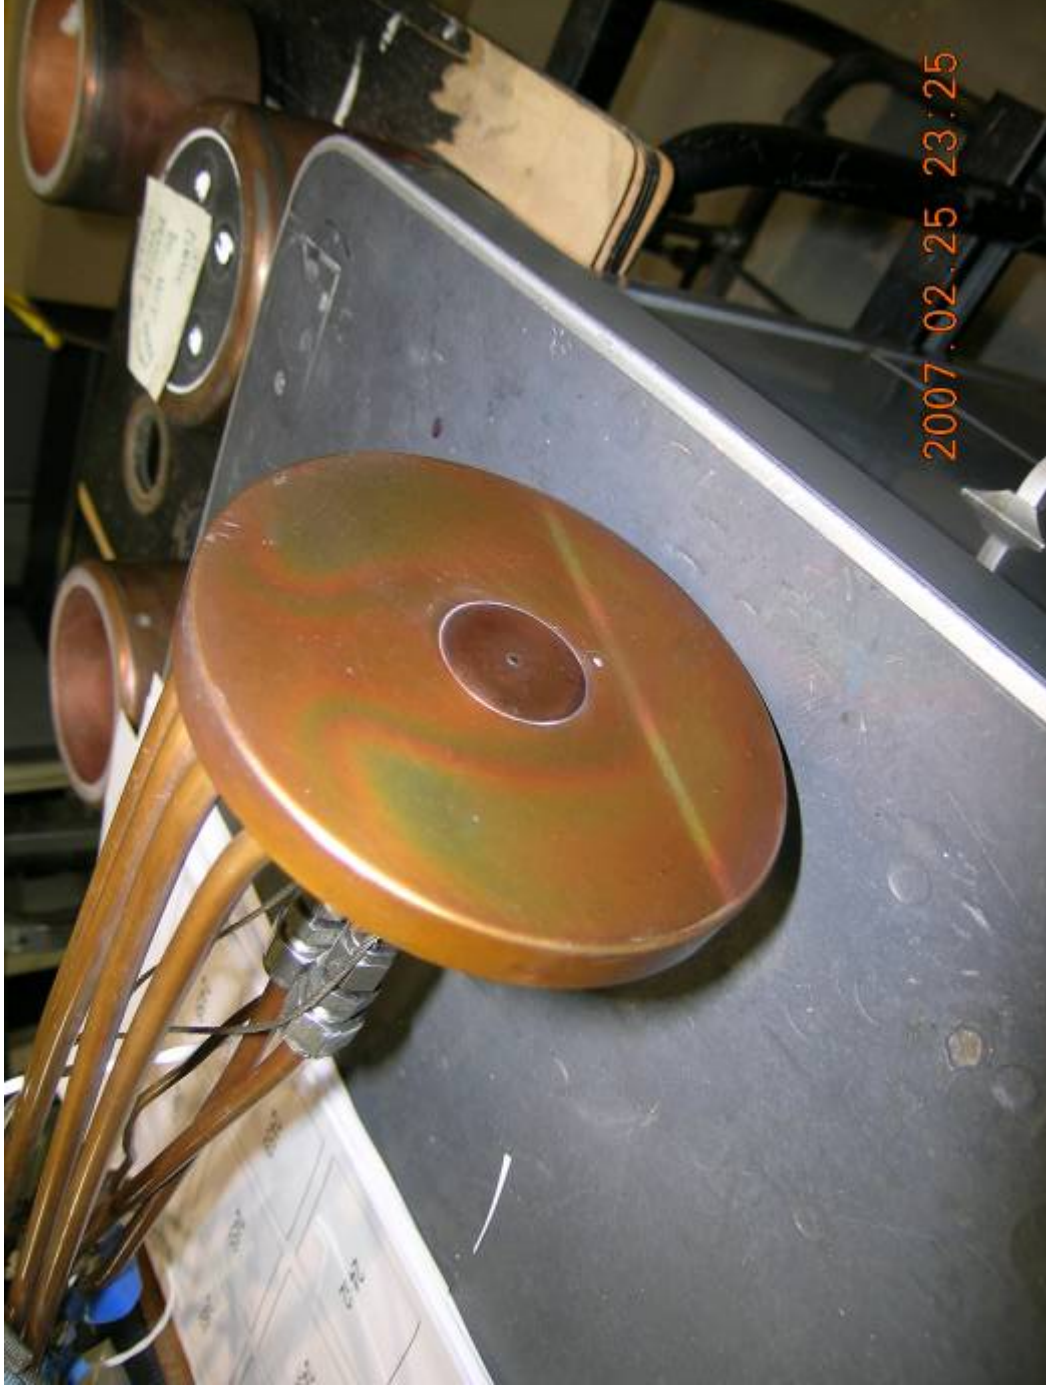
Dual-Cal Probe to Measure Stagnation Heat Rate and Pressure

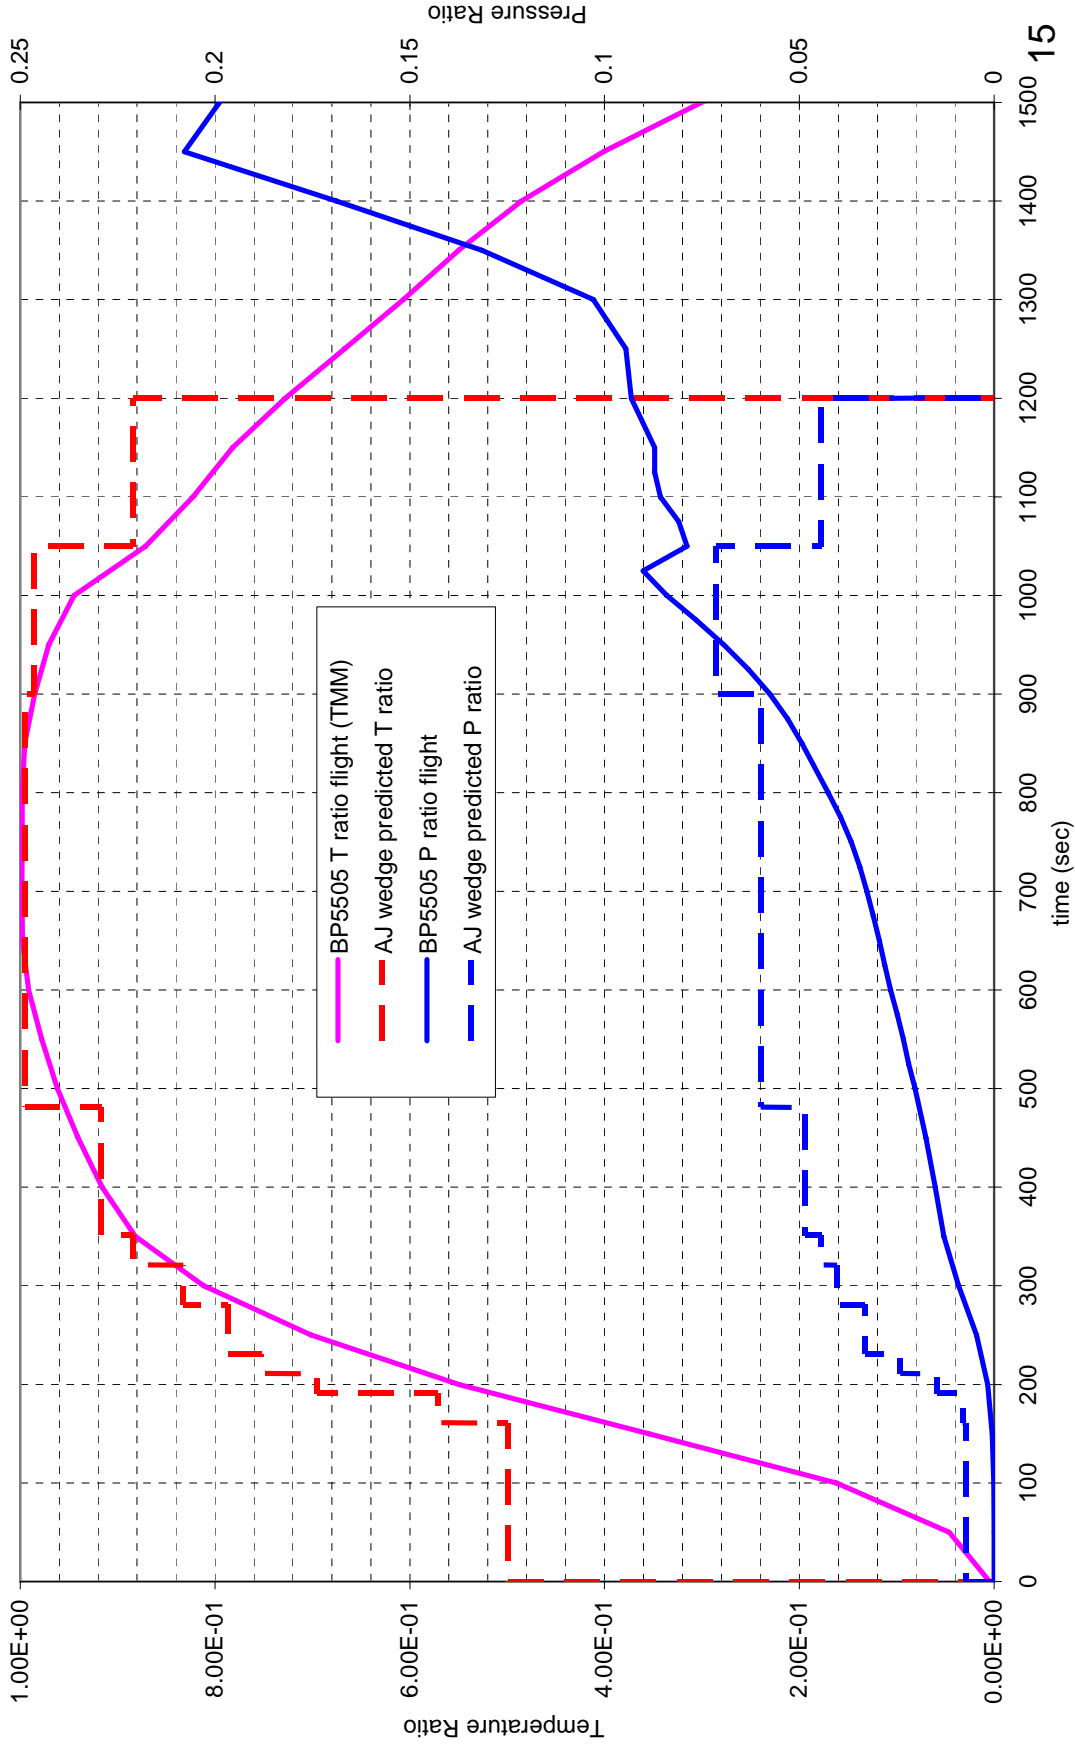
Flight and Arc-Jet Temperature and Pressure Ratios for BP5505
