High Pressure Burner Rig Testing of Advanced Environmental Barrier Coatings for Si₃N₄ Turbine Components

Dongming Zhu, Dennis S. Fox and Robert T. Pastel

Durability and Protective Coatings Branch
Materials and Structures Division
NASA John H. Glenn Research Center
Cleveland, Ohio 44135, USA

The 31st International Cocoa Beach Conference & Exposition on Advanced Ceramics & Composites
Daytona Beach, Florida, January 22-26, 2007

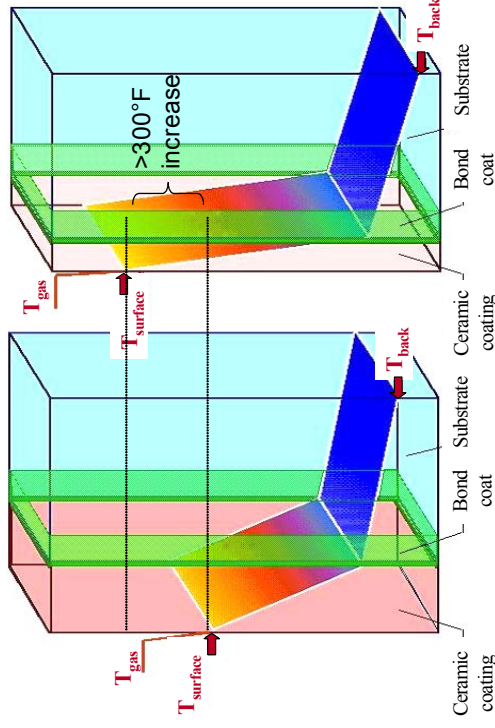
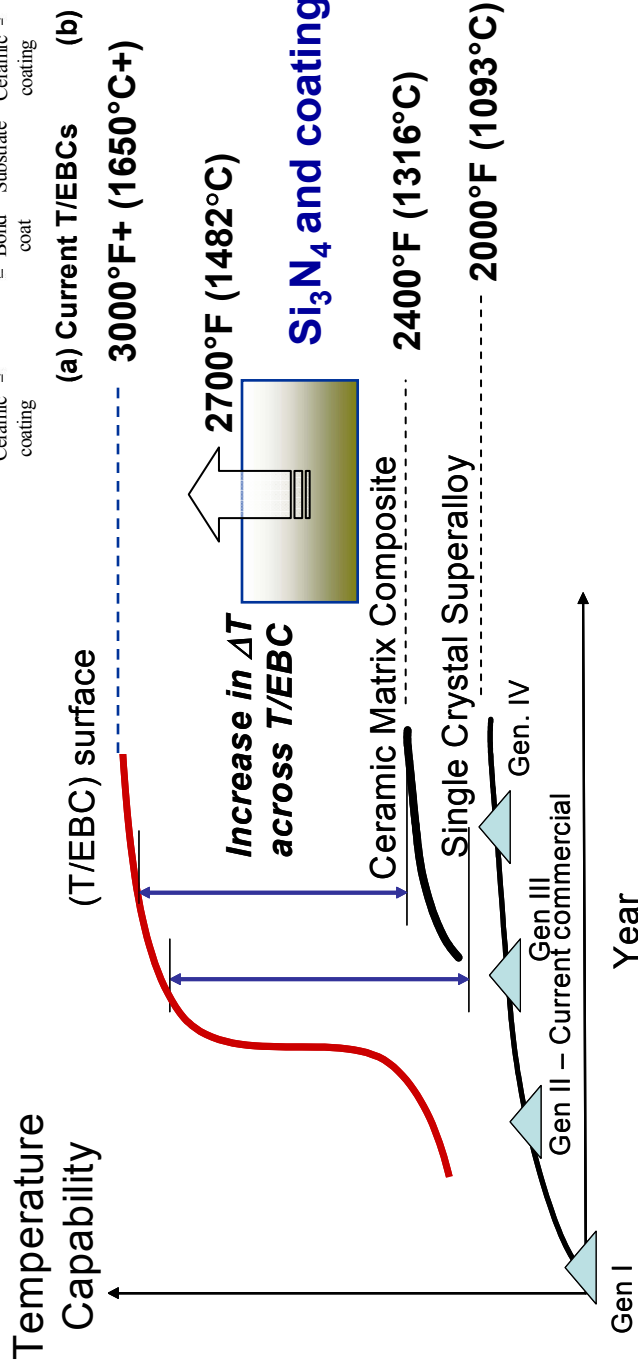
(a) Current T/EBCs (b) Advanced T/EBCs

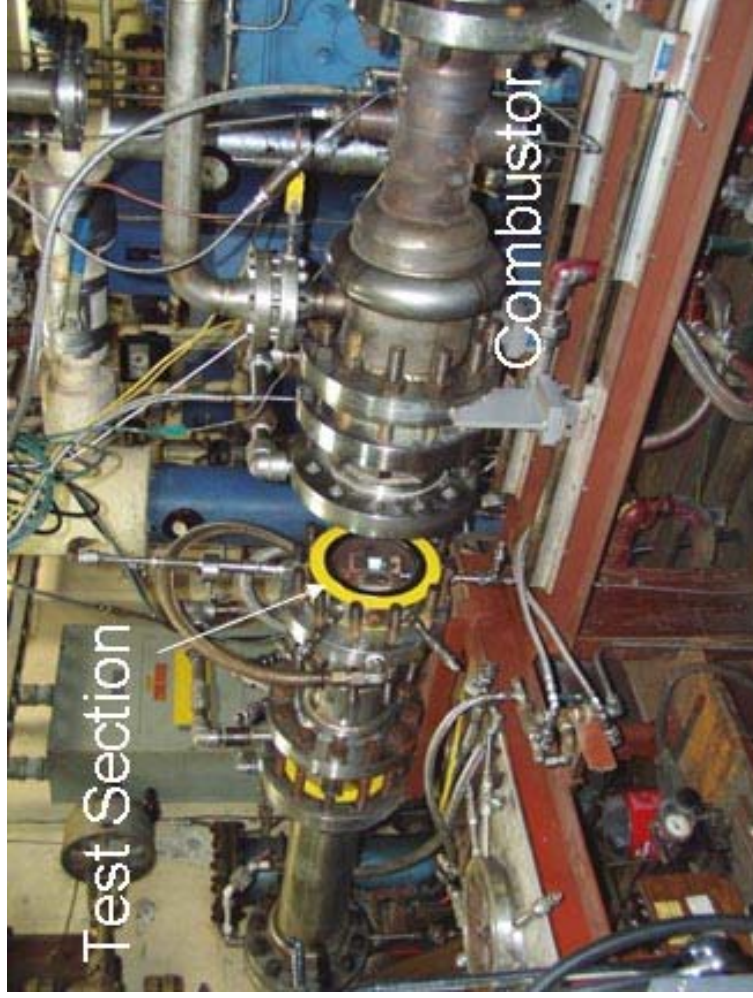
High Pressure Burner rig (6 to 12 atm)

- Realistic engine combustion environments for specimen and component testing

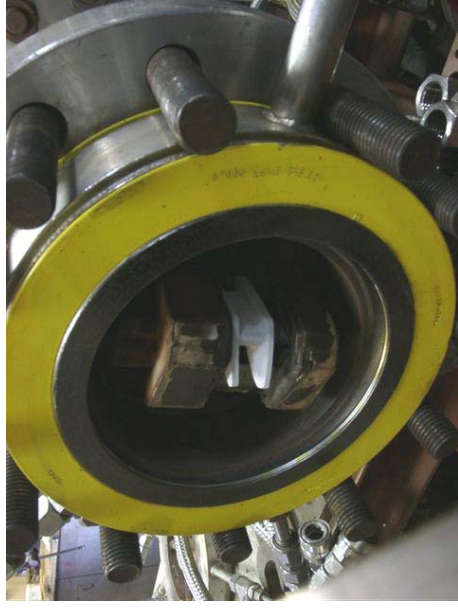
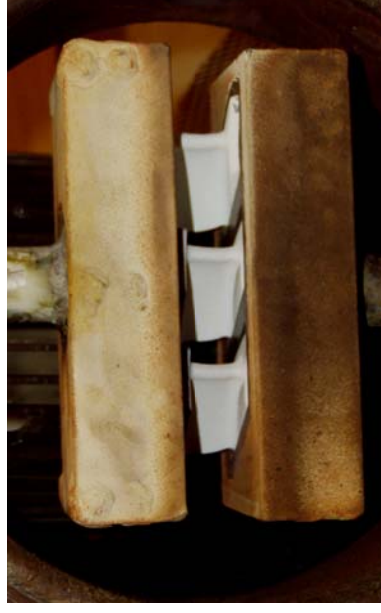
Coated turbine vane test fixtures

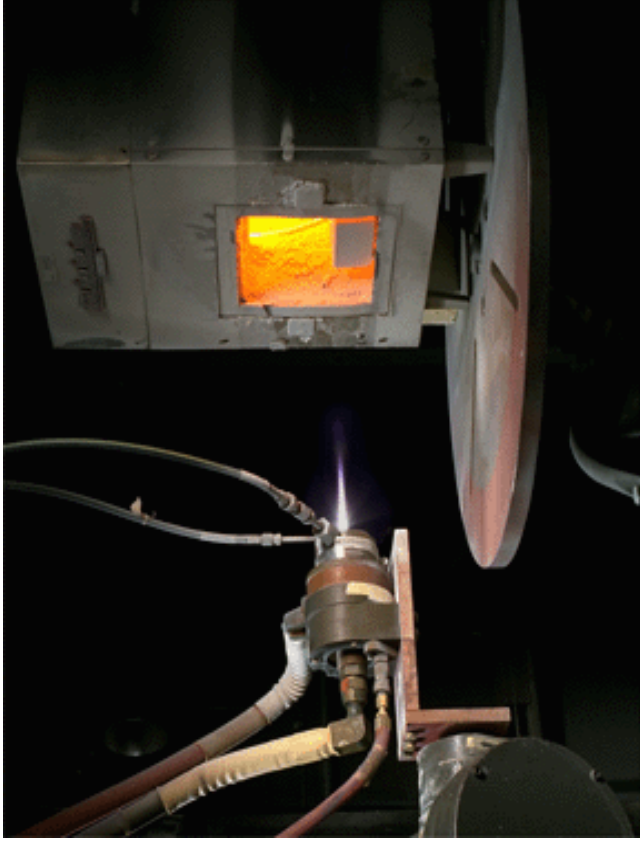
Plasma-spray processing of Environmental barrier coatings for various components

- **The coating processing technologies developed for complex shaped components**

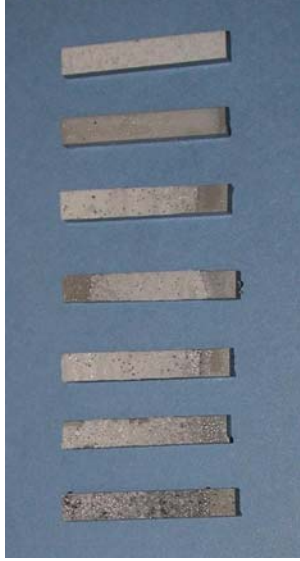
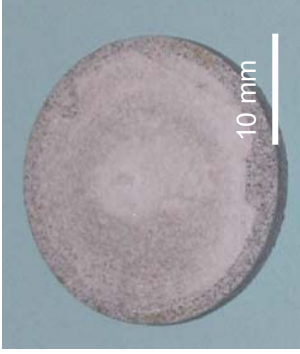
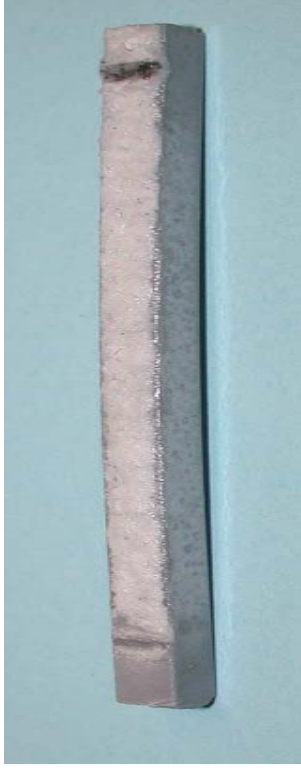
Furnace/laser heat flux/high pressure burner rig testing

- The coatings tested using cyclic furnaces, laser rig and the high pressure burner rig at the temperatures up to 2650°F (1450°C)
- Coating temperature capability, water vapor stability and durability emphasized

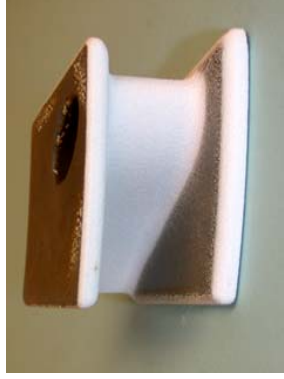
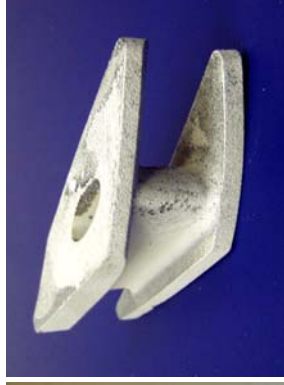
Fracture strength and high temperature rupture testing

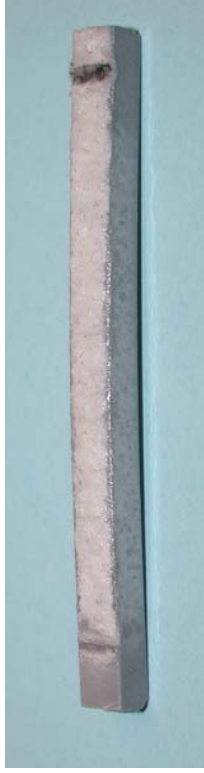
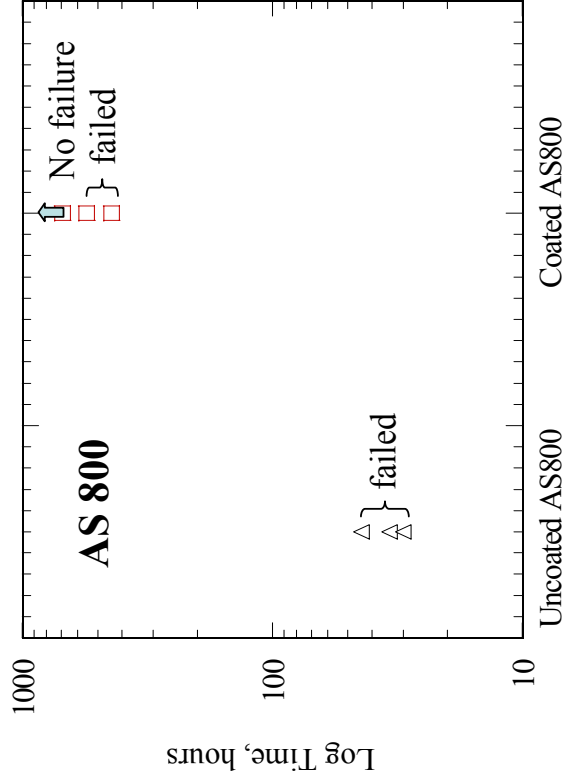
(a)

Composite EBC coated AS 800 Si₃N₄ rupture testing (completed 691 hrs 2500°F 1371°C, 250 MPa without failure)

- The coated specimens demonstrated significantly improved slow crack growth resistance at high temperatures

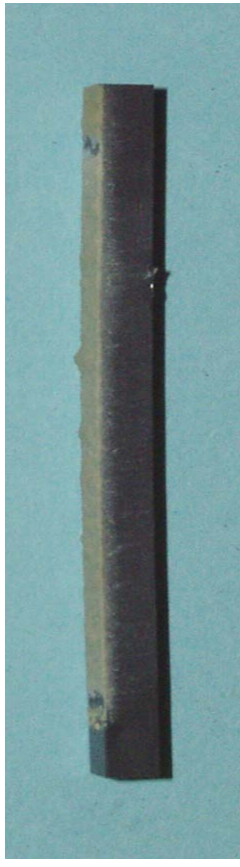
(b)

EBC coated SN 282 rupture testing
(completed 815 hr testing at 2500°F (1371°C) at 200MPa without failure)

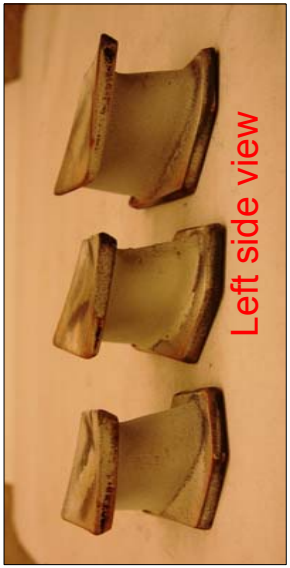
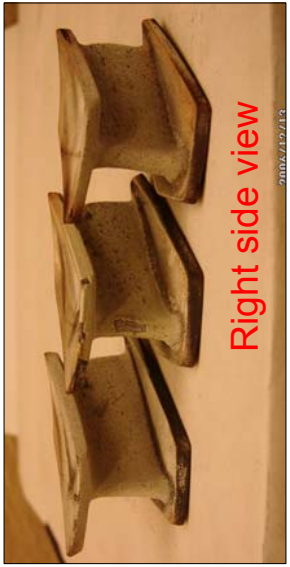
- The coated miniature Si₃N₄ vanes demonstrated 50hr durability in the high pressure burner rig test at up to 2500°F

After 50 hot hr testing

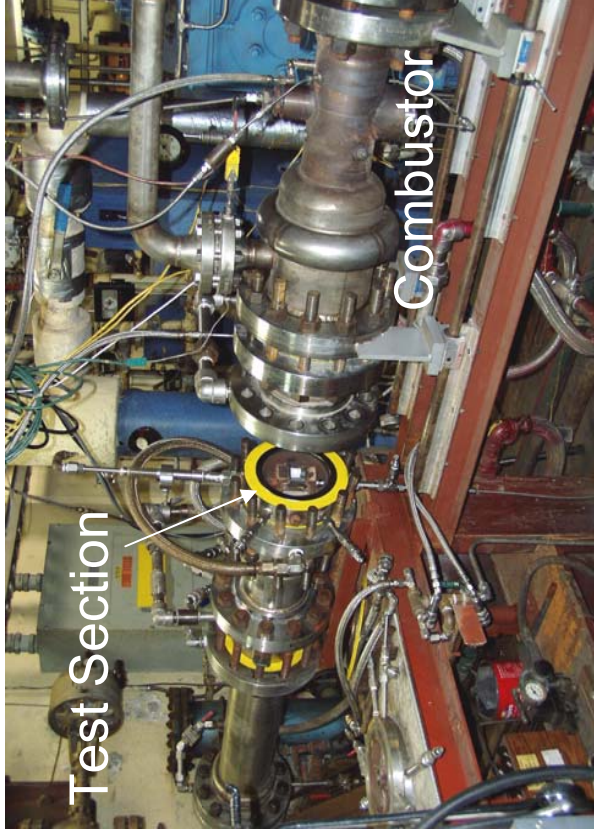
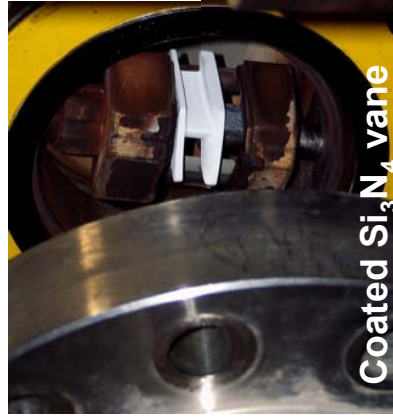
- A coated Si₃N₄ vane also demonstrated 50hr durability in the high pressure burner rig test at up to 2700°F

Tested coated Si₃N₄ vane

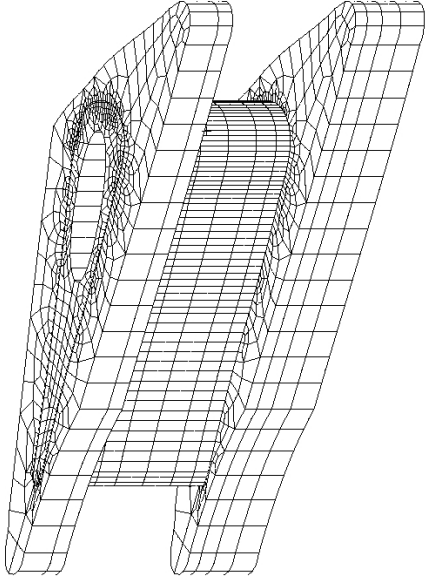
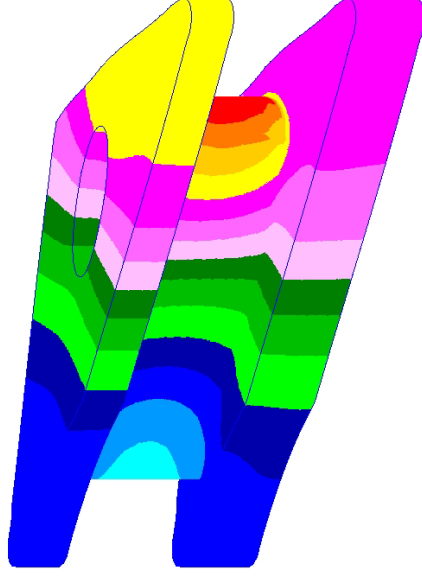
Modeled temperature distributions
