Infrared Camera Characterization of Bi-Propellant Reaction Control Engines During Auxiliary Propulsion Systems Tests at NASA's White Sands Test Facility In Las Cruces, New Mexico

ABSTRACT

This paper describes the application of a FLIR Systems A40M infrared (IR) digital camera for thermal monitoring of a Liquid Oxygen (LOX) and Ethanol bi-propellant Reaction Control Engine (RCE) during Auxiliary Propulsion System (APS) testing at the National Aeronautics & Space Administration's (NASA) White Sands Test Facility (WSTF) near Las Cruces, New Mexico. Typically, NASA has relied mostly on the use of ThermoCouples (TC) for this type of thermal monitoring due to the variability of constraints required to accurately map rapidly changing temperatures from ambient to glowing hot chamber material. Obtaining accurate real-time temperatures in the IR spectrum is made even more elusive by the changing emissivity of the chamber material as it begins to glow. The parameters evaluated prior to APS testing included: (1) remote operation of the A40M camera using fiber optic Firewire signal sender and receiver units; (2) operation of the camera inside a Pelco explosion proof enclosure with a germanium

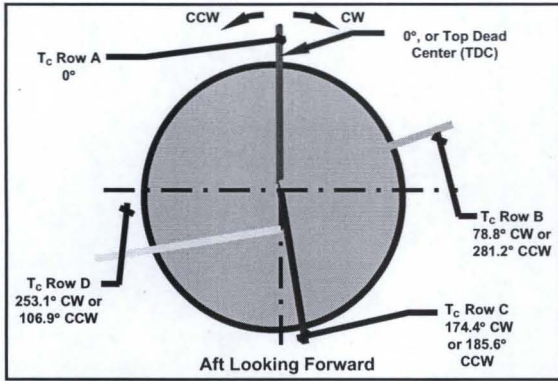
Figure 5. ATP thermocouple location section.

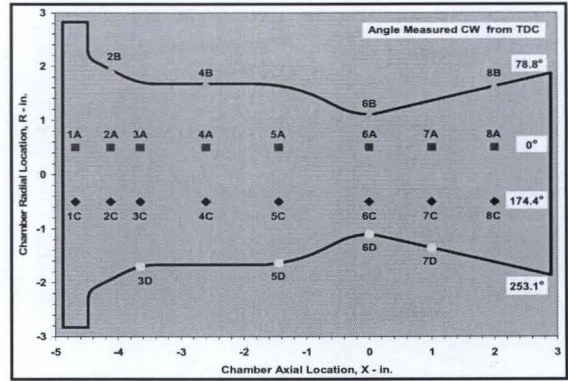
Figure 6. ATP thermocouple location diagram.

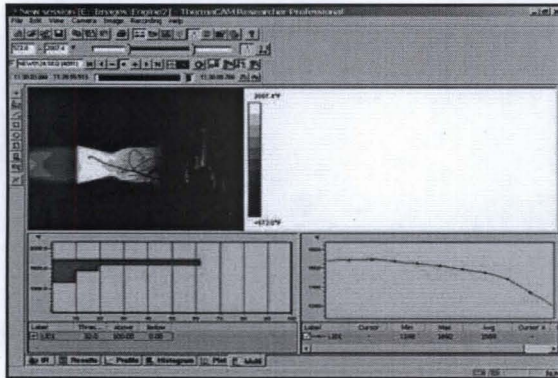
Figure 7. ThermoCAM Researcher Pro 2.8.

Figures 7 & 8 indicate parallel trending for the heat affected zones where the main chamber thermocouples are located to the FLIR A40M camera data displayed within the ThermaCAM Researcher Pro 2.8 screen. Axial locations 4 to 5 are represented. Again, the thruster vendor data shown with the WinPlot traces is shown in degrees Rankine (Fahrenheit ≈ 460) and the ThermaCAM Researcher Pro 2.8 traces are shown in degrees Fahrenheit.

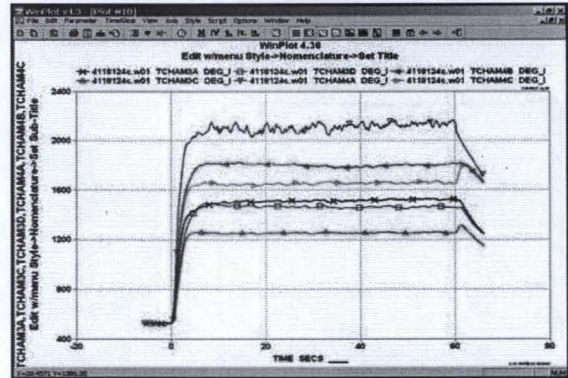
Figure 8. WinPlot traces.

The WinPlot traces are shown in degrees Rankine (Fahrenheit $\approx 460^{\circ}$) and the FLIR print screen images are shown using degrees Fahrenheit since Rankine is not an option within the software.

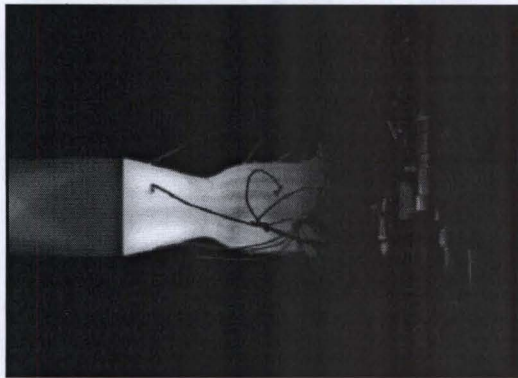
Figure 9. Hot-fire Test 124.

Test 124 was used to compare data recorded by the FLIR Systems A40M infrared camera using the ThermaCAM Researcher Pro 2.8 software to that of the vendor's Data Control Acquisition System (DCAS) using Winplot. Test 124 was a 60 second steady-state hot-fire test. The thermal data shown in Figures 5-8 represent the time just prior to the main valves being powered "off". The Winplot traces, Figure 8, from the thruster vendor thermocouple data represent the time duration for the entire test, but the temperatures are mostly constant within a horizontal band by thermocouple location. The maximum temperature from the thruster vendor's data from Thermocouple 7D indicates a temperature of 2450° Rankine whereas the maximum temperature from the A40M infrared camera LI01 indicates 2462° Rankine or 2002° Fahrenheit. The temperature slope of LI02 from the A40M infrared camera appears consistent with the temperature slope recorded by the thruster vendor thermocouples.

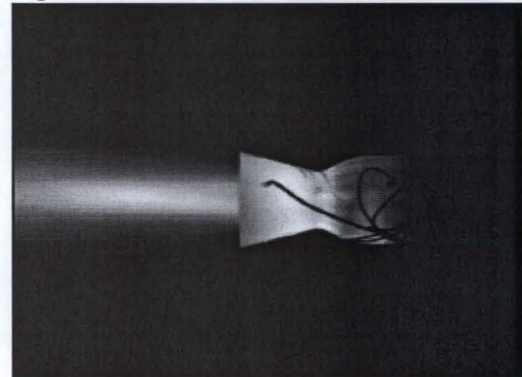
Figure 12. Hot-Fire Test 131 post pulse abating.

The infrared pallet shown in Figure 12 is optimized for visual clarity specific to the heat affected zones and features discussed within the text of this document. Generally, Rainbow10, Gray10, and Iron10 are best suited for visually defining heat affected zones without utilizing the excessive gradation of tone commonly seen in images such as with Figures 9-12. The ability of the FLIR A40M camera to capture the total seamless radiometric signature of the RCE main chamber during hot-fire testing is perhaps best exemplified within Figures 9-12. While associated mainly with heat radiation, they do have some properties which are the same as those of visible light.¹

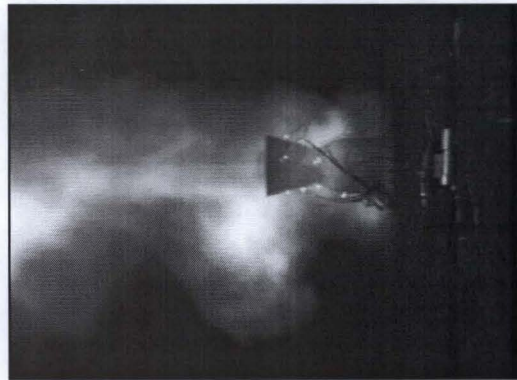
Figure 13. This IR imagery indicates the ignition of pooled propellant (hot gas) as the result of a previous non-ignition. The ignition occurred after the propellant was expelled from the chamber and ignited by the subsequent pulse.

Figure 13. Hot gas from a previous non-ignition.

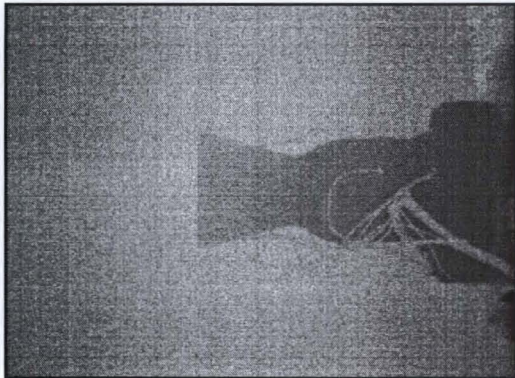
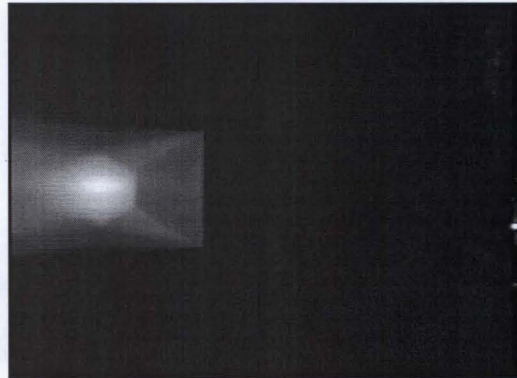
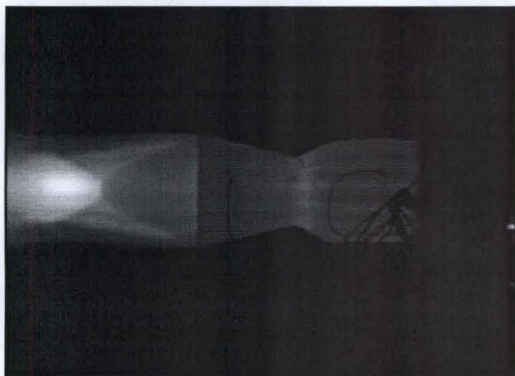
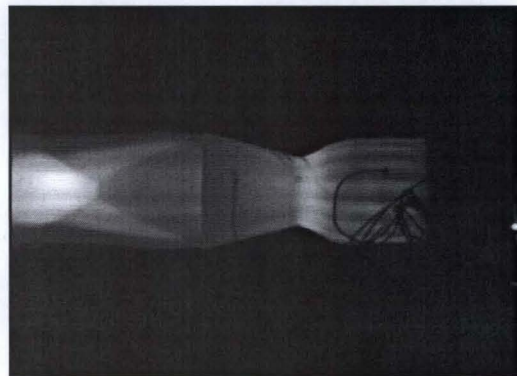
Figures 14-17. In the following figures, the first 4 frames of the 5 second pre-burn are shown. The images were recorded at 7.5 frames per second. In Figure 15 the rocket plume is imaged within the calibrated scale of the camera +572° Fahrenheit. The main chamber heating is not visible until the second frame in Figure 16. In Figure 17, the radial Fuel Film Cooling (FFC) pattern is easily seen upstream of the throat section.

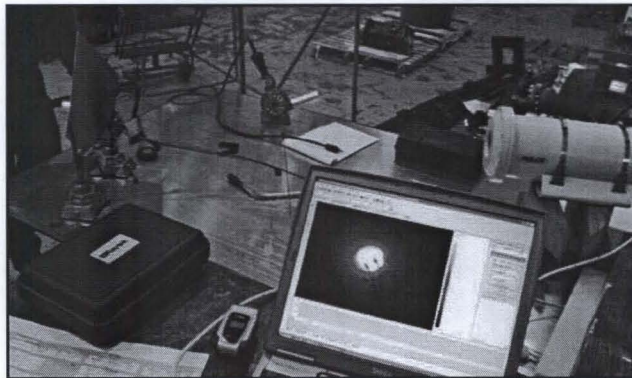
Figure 21. Typical setup from Sequence Tests 30-35 using the Pelco enclosure.

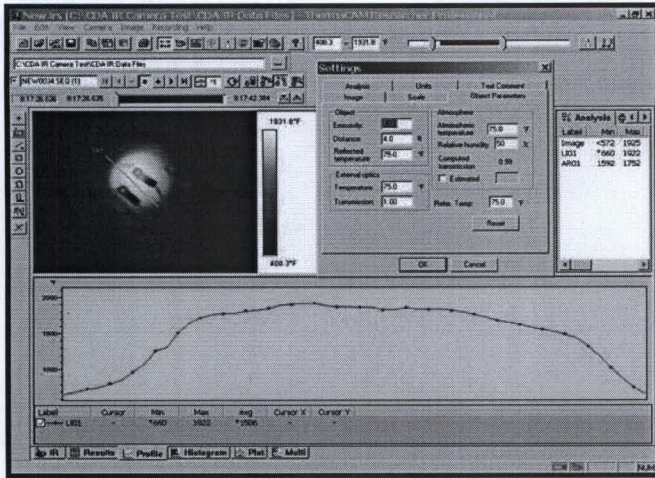
The temperature goal for this test was 1750°F. The general thermocouple arrangement is represented by the ThermaCAM Researcher Pro 2.8 screen as shown in Figure 22. Figure 24 contains the analog thermocouple data of 1742°F from Thermocouple 3 during the same time frame as Figure 23 from the IR screen. The string data exported from the ThermaCAM program is represented in the tabular data shown in Figure 25 which is representative of the pixel arrangement contained within the white-bordered box in Figure 23.

Figure 22. ThermoCAM screen image.

From the afore-mentioned figures, the alignment of the analog thermocouple data to that of the IR data is easily recognizable. This example is also true for other Sequence Tests where the stainless steel begins to glow from the torch's applied heat.

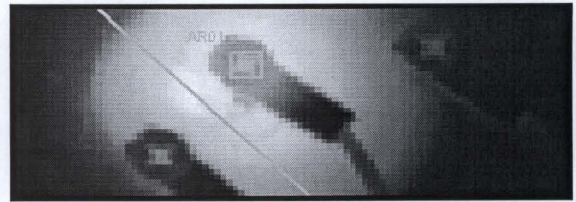
Figure 23. Enlarged Thermocouple analysis area.

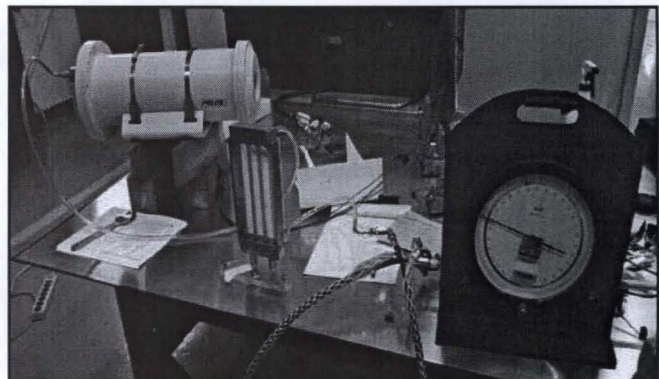
Figure 27. Pressure test with Kellum tether.

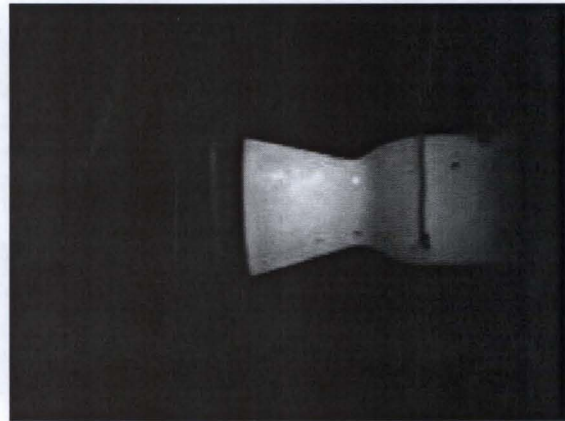
Figure 33. Missed ignition/cold chamber.

- Unplanned usage (detection of non-ignitions during pulsed mode operations).
- The FLIR A40M IR camera was a minor expense compared to overall test budget.
