NASA/TM—2007-214921

Assessment of Creep Capability of HSR–EPM Turbine Airfoil Alloys

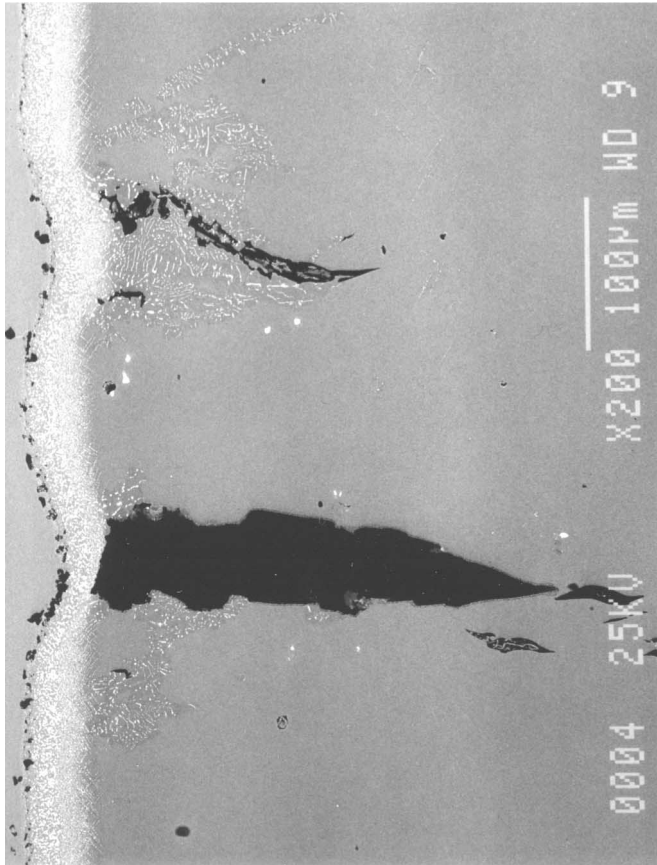
Figure 8(c). Secondary cracking associated with SRZ in coated EPM102C+ after creep rupture at 1800°F/45ksi. Stress axis is horizontal.

As discussed in an earlier section and seen in Figure 8c, secondary cracks were observed in creep ruptured specimens along the incoherent boundary between the SRZ and superalloy matrix or within the SRZ colony itself, when SRZ was present under the PtAl coating. However, the interrupted creep tests showed that the incoherent boundary surrounding the SRZ colony did not crack early in the creep test. In fact, in the creep test interrupted at 159hr and 2.7% strain, which was after the onset of tertiary creep, only one or two colonies of SRZ had cracks associated with them. The majority of SRZ colonies exhibited no cracking whatsoever. It is apparent that the cracking that is associated with the SRZ in the failed specimens occurred late in the creep test. Thus, the notion that the SRZ leads to premature cracking and early failure [5] is not consistent with the observations after interrupted creep.

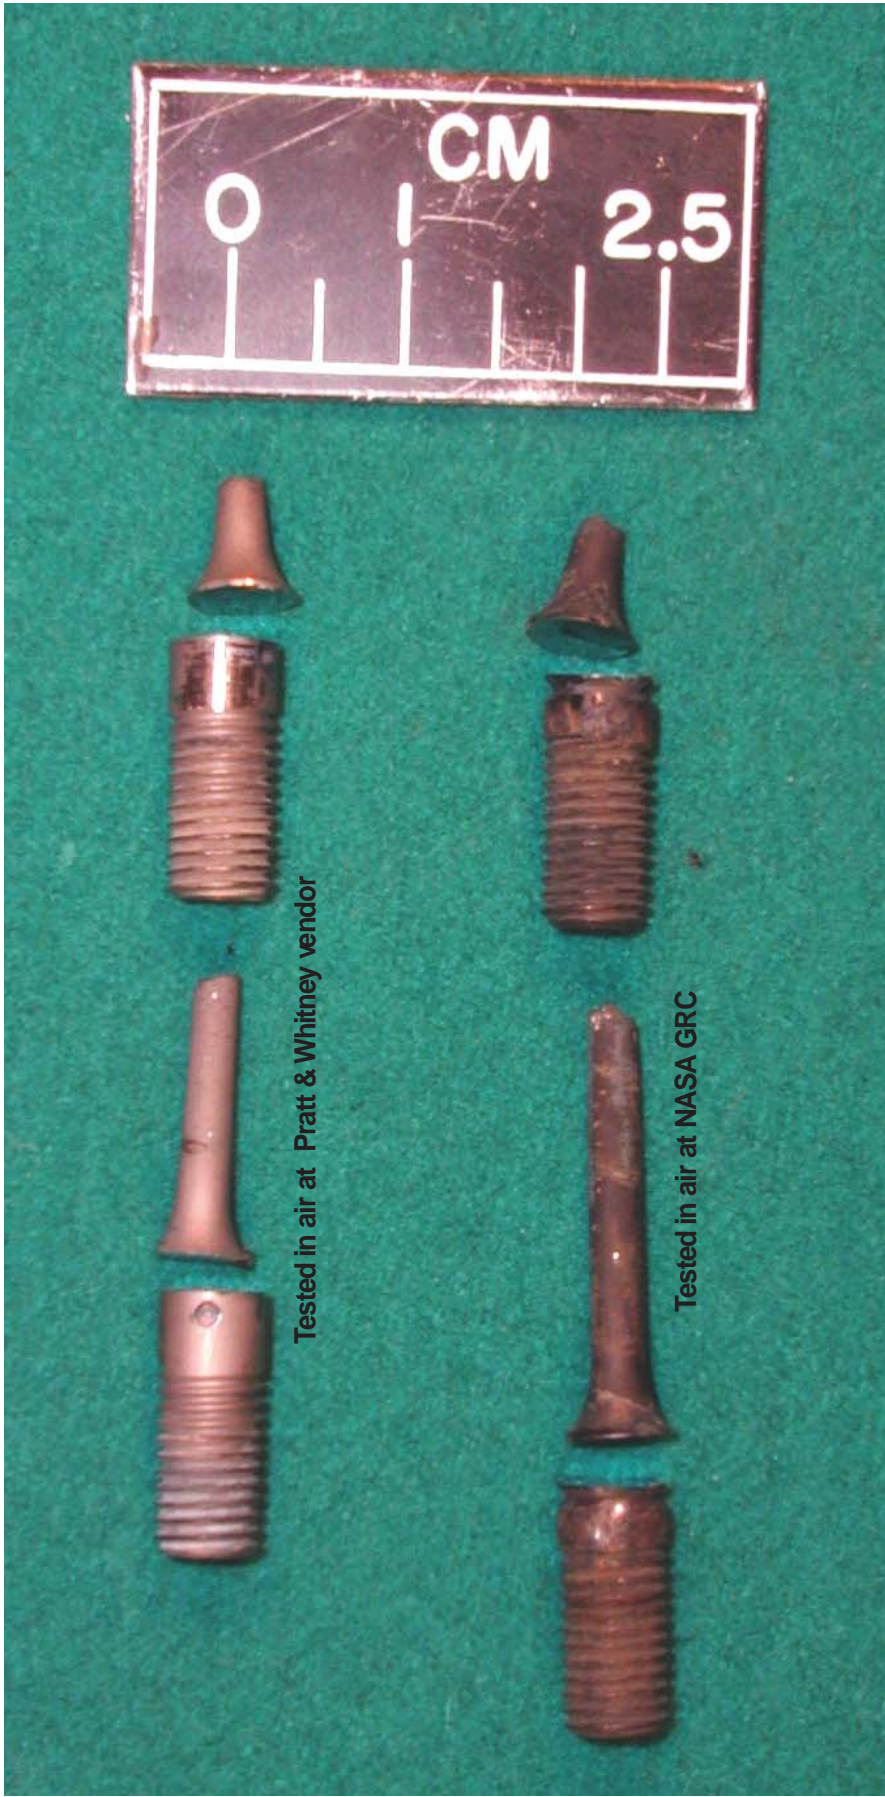
Figure 12. Comparison of as-tested surfaces of uncoated specimens of EPM102A after creep rupture testing in air at 1800 °F and 45 ksi. Both specimens were heat treated by Pratt & Whitney. However, the top specimen was creep ruptured tested at a Pratt and Whitney vendor and had a 449 hr life; the bottom specimen was tested at GRC and had a 232 hr life.

Another unexpected difference emerged between the uncoated specimens tested at NASA GRC and the uncoated specimens tested at the Pratt & Whitney vendor. A dramatic difference in the oxidation behavior is evident in Figure 12, where the as-tested surfaces of the specimens tested at the Pratt & Whitney vendor are compared to the as-tested surfaces of the specimens tested at NASA GRC. All uncoated specimens of the alloys tested at the Pratt & Whitney vendor exhibited a silvery surface after creep rupture in air and those tested in air at NASA GRC all had a charcoal gray surface. X-ray diffraction and electron dispersive spectroscopy (EDS) of the as-tested specimen surfaces have both indicated that the specimens tested at the Pratt & Whitney vendor developed Al_2O_3 as the primary oxide, whereas the primary oxide in the NASA GRC tested specimens was NiO. The reason for the difference in surface oxides could either be from: a) differences in heat treatments prior to testing, b) heat treatments that were unintentionally omitted, c) specimen handling differences that caused oxide removal or spallation, or d) the creep testing methods themselves. None of these explanations is entirely satisfactory, however. Presumably, Pratt & Whitney heat treated all of the uncoated specimens in argon under the same conditions, including the uncoated specimens tested at NASA GRC. Furthermore, both facilities performed the creep testing in air, and neither testing lab controls humidity which is known to encourage spallation. So, in the absence of additional specimens, the exact reasons for this behavior remain elusive.
