NASA/TM—2008-215014

AIAA—2007—5275

# Environmental Testing of the NEXT PM1 Ion Engine

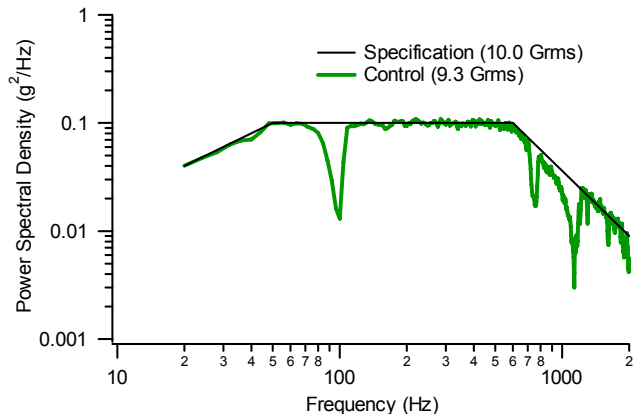
**Fig. 5.—Comparison of random vibration specification with force-limited test inputs, Z-axis excitation.**

Dynamic testing began with the Z-axis (i.e. thrust-axis) testing, shown in the photograph of Fig. 2. Initial tests and then the two-minute full random vibration test were completed without incident. The vibration test inputs, which were notched automatically and in real time during the test according to the force limit specifications, are shown in Fig. 5. Significant notches were observed at 100, 750, and 1150 Hz.

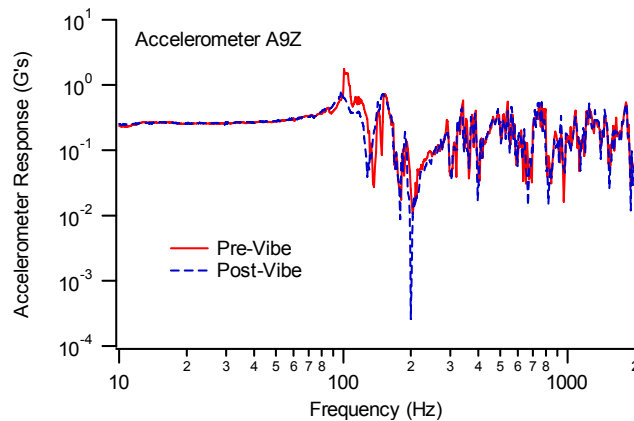
**Fig. 6.—Comparison of sine survey results before and after full-level Z-axis random vibration, gimbal thruster bracket leg C.**

Comparison of the pre- and post-vibe sine surveys showed significant changes on some locations of the test assembly near the fundamental mode. One of the largest changes, shown in Fig. 6, was observed on the gimbal thruster bracket at leg C. Two different effects are observed near 100 Hz, a small change in frequency and a significant damping of the response. The observed frequency shift of roughly 5 percent is within what is nominally observed in run-to-run comparison. The change in damping is not necessarily an indicator for a serious problem but may be, for example, a fastener loosening somewhat. The two issues are not necessarily the same and could result from different effects. Similar changes were observed in the accelerometer mounted on the thruster gimbal pad, on the other side of the gimbal-thruster interface from the data of Fig. 6.

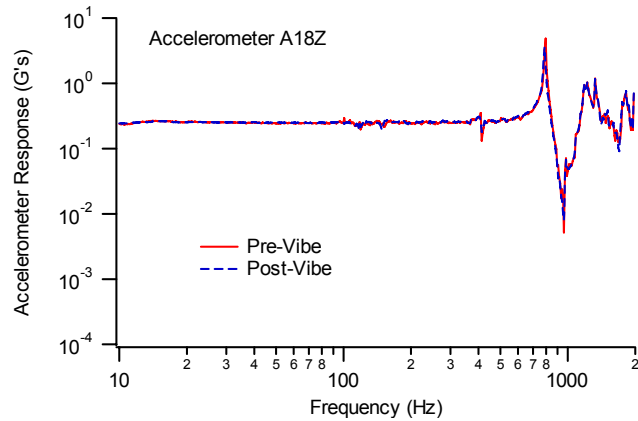
**Fig. 7.—Comparison of sine survey results before and after full-level Z-axis random vibration, vibe test mount C, near motor.**

In contrast to the changes observed at leg C, there was little change observed in the data from accelerometers location near the other two gimbal thruster brackets on legs A and B. Moderate differences in sine surveys were seen in the other accelerometers located on the engine. There was little if any change in the sine survey data for the accelerometers on the vibration test mounts, as shown in the representative data of Fig. 7. These results collectively indicate that changes occurred in the test article near the thruster/gimbal interface at leg C and not at the structural bolting interface between the vibration fixturing and the vibe table. Taken by themselves, the sine survey shifts are not especially troubling but when combined with the other observed thruster anomalies they required further review.

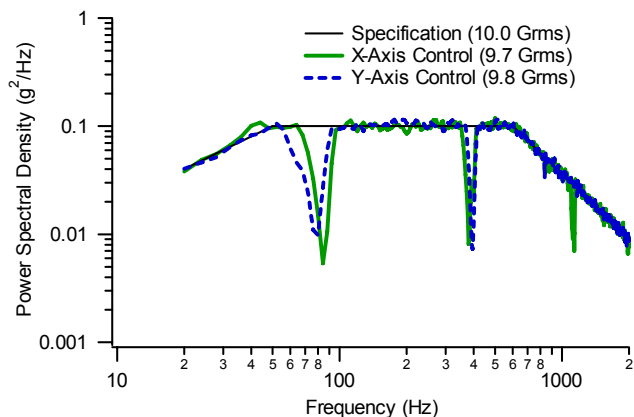
**Fig. 9.—Comparison of random vibration specification with force-limited test inputs, lateral axis excitation.**

After completion of the Y-axis testing the test assembly shown in Fig. 8 was rotated 90° to perform the X-axis random vibration testing. The X-axis test sequence including the two-minute full random vibration test was completed without incident. The vibration test inputs for both X and Y excitation are shown in Fig. 9. Significant notches in the control acceleration spectrum were observed at 80 and 390 Hz for the Y-axis excitation, and at 82, 380, and 1150 Hz for X-axis excitation.

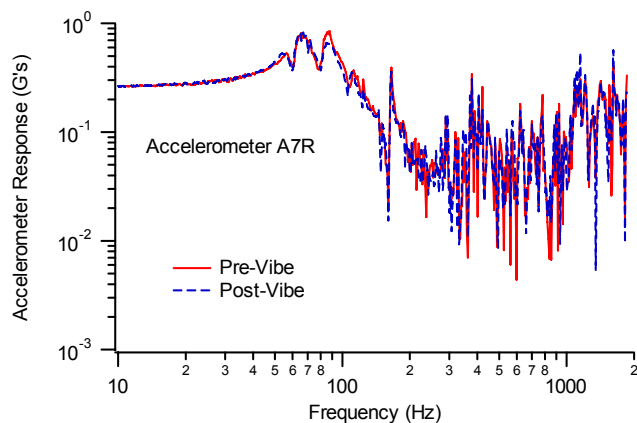
**Fig. 10.—Comparison of sine survey results before and after full-level Y-axis random vibration, gimbal thruster bracket leg A.**

Comparison of the Y-axis pre- and post-vibe sine surveys showed minor changes on the test assembly near the fundamental mode in the frequency range of 50-100 Hz. Typical data are shown in Fig. 10; similar differences were observed throughout the other accelerometers on the test article. Minor changes near the fundamental mode were also observed after X-axis testing among the accelerometers located on the test article. These sine survey differences are considered to be quite minor and are not an indication of a significant change in the test hardware. As for the Z-axis results, the accelerometers on the vibration test mounts did not show any significant difference for either Y-axis or

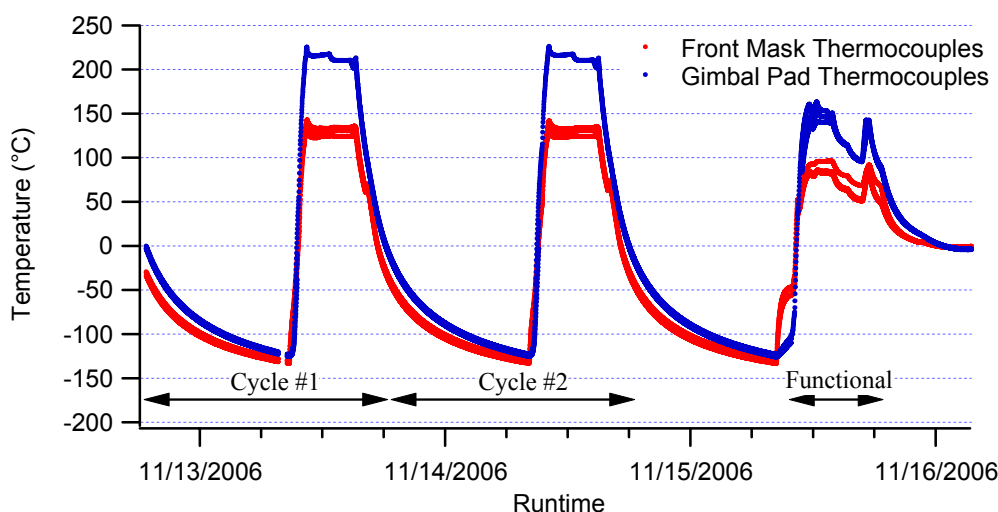
Fig. 12.—Thermal vacuum testing temperature profile.

The second thermal cycle was performed on the subsequent day. The cathode ignition process was initiated two hours after the reference temperature cooled to the target of  $-120\text{ }^{\circ}\text{C}$ . The engine started nominally and was brought to full power per the test plan. Heat lamp power was turned on and the temperature reference location ramped to the  $203\text{ }^{\circ}\text{C}$  control temperature in 48 minutes. Thruster operation was held steady at full power and the control temperature for 133 minutes before transitioning to the lower power. After 120 minutes of operation at this condition the thruster was shut down and the cathode heaters immediately turned on for the hot start. The hot start was nominal and the engine operated in discharge-only mode per the test plan then at full power before finally turning the engine off. The engine and thermal shroud were allowed to cool for the next thermal cycle.

On the third day of thermal-vacuum testing the neutralizer heater failed open-circuit when attempting to perform the cold start. After application of environmental heating (i.e. discharge-only operation and low-level lamp heating) for 38 minutes the neutralizer heater was able to operate. At this point it was decided to skip the third thermal cycle and proceed to functional testing.

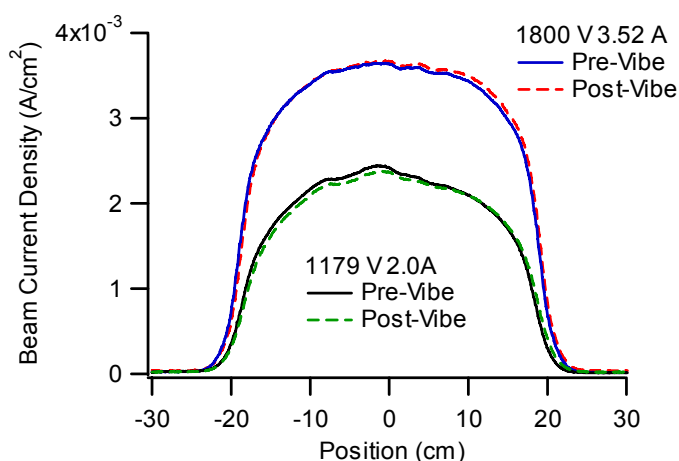
**Fig. 13.—Pre- and post-vibration beam current density measured 45 mm from accelerator grid.**

A significant amount of beam current density data were acquired during the pre- and post-vibration functional testing. Unfortunately, the mechanical stage used to articulate the Faraday probes failed at the beginning of the thermal vacuum testing and could not be used to collect data at the standard test conditions for the remainder of the testing. A subset of the available data is presented here to compare the functional results before and after vibration testing. Shown in Fig. 13 are data acquired during two functional test operating conditions at the standard 45 mm distance from the ion optics face. The slight differences between data collected before and after the vibration test are typical of those seen at the other operating conditions and distances. To investigate if a significant shift had occurred as a result of vibration testing, the probe data were examined in greater detail and it was determined that the differences observed were not significantly larger than the errors associated with collecting and analyzing the data. This conclusion is consistent with the similar results obtained for ion optics measurements.

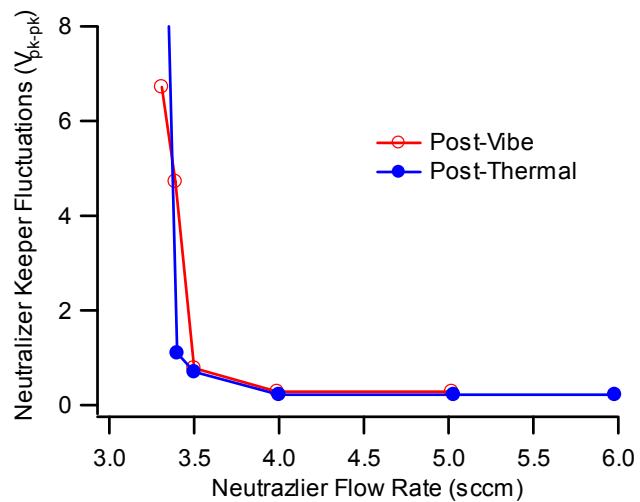
Fig. 14.—Neutralizer characterization test results.

Results of the neutralizer characterization for the post-vibe and post-thermal functional tests are shown in Fig. 14. Results for the pre-vibration testing are not shown because interpretation of the data was difficult due to experimental complications. The spot-to-plume-mode transition, as defined by the presence of 5 V peak-to-peak fluctuations in the neutralizer keeper voltage, was at 3.3 sccm for both tests in Fig. 14. This value is the same as that measured in the PM1 performance evaluation conducted prior to the thermal development test (Ref. 11).
