NASA/TM—2008-215058

Environmental Testing of the NEXT PM1R Ion Engine

Prepared for the
30th International Electric Propulsion Conference (IEPC 2007)
cosponsored by the Alta, S.p.A., Centropazio, and the Electric Rocket Propulsion Society
Florence, Italy, September 17–20, 2007

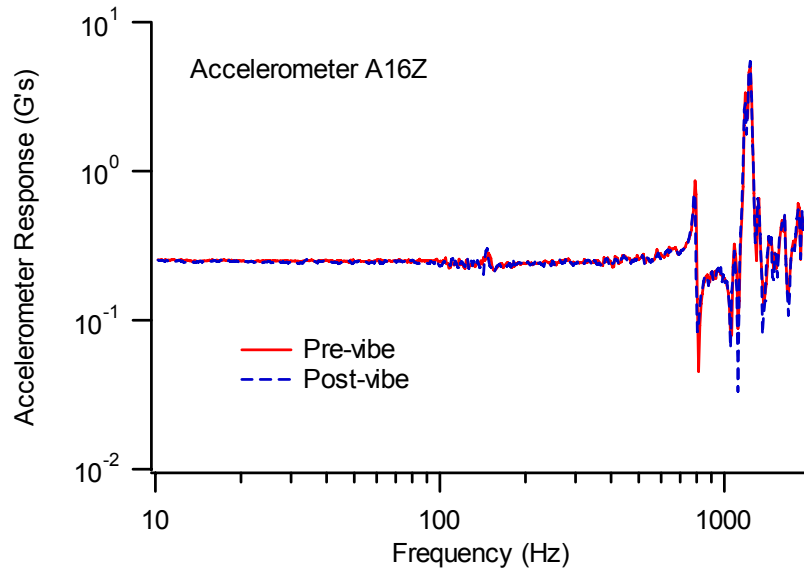
Figure 7.—Comparison of sine survey results before and after full-level Z-axis random vibration, vibrate test mount C, near free leg.

In contrast to the changes observed on the thruster and gimbal, there was little change observed in the data from accelerometers located on the vibration test mounts, as shown in the representative data of figure 7. These results collectively indicate that changes occurred in the test article and not at the structural bolting interface between the vibration fixturing and the vibrate table.

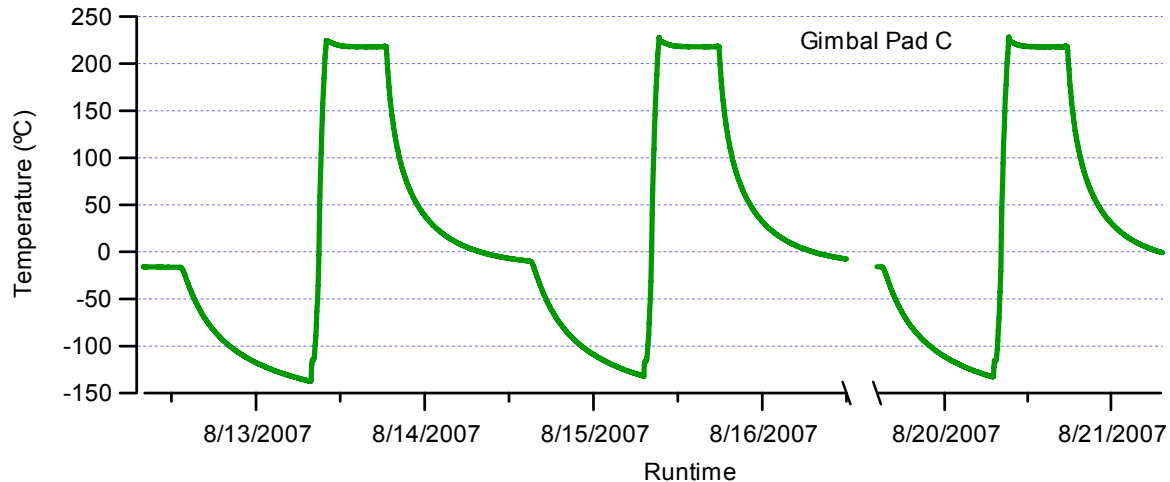
Figure 11.—Thermal vacuum testing temperature profile.

The temperature history for all of the thermal-vacuum testing is shown in figure 11. All three gimbal pad temperatures were within a few degrees of each other during the testing, hence only gimbal pad C is shown in the figure for clarity. Note that the coolest of the three gimbal pads was chosen for the control thermocouple. In the hot equilibrium condition, gimbal pad C measured $218\text{ }^{\circ}\text{C}$.
