NASA/TM—2006–214603

Qualification Testing of Solid Rocket Booster Diagonal Strut Restraint Cable Assembly Part Number 10176–0031–102/103

Marshall Space Flight Center, Marshall Space Flight Center, Alabama

September 2006

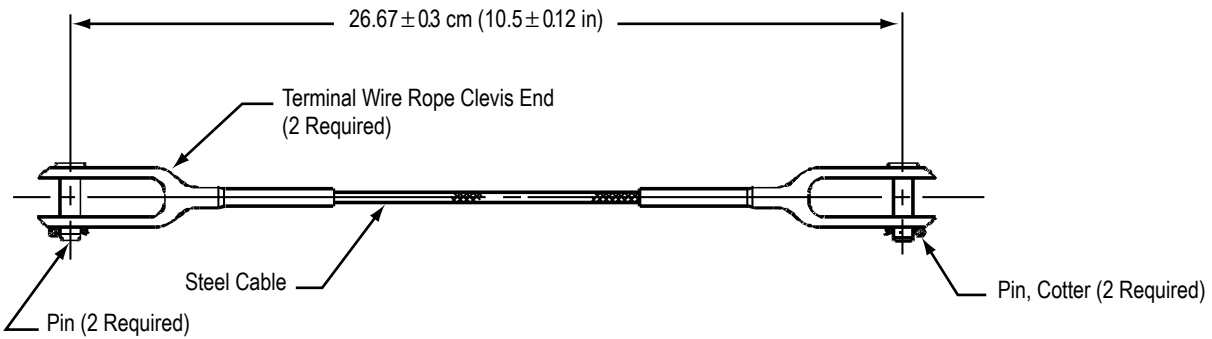
Figure 1. Strut retainer assembly.

The restraint cable assembly is a steel cable with two terminal wire-rope clevis ends, pins, and cotter pins. The clevis ends and pins are picked from standard military specification hardware to interface with the external tank attachment ring and the diagonal strut assembly (figs. 1 and 2). The terminal wire-rope clevis ends are swaged onto the steel cable in accordance with MIL-T-6117.⁴

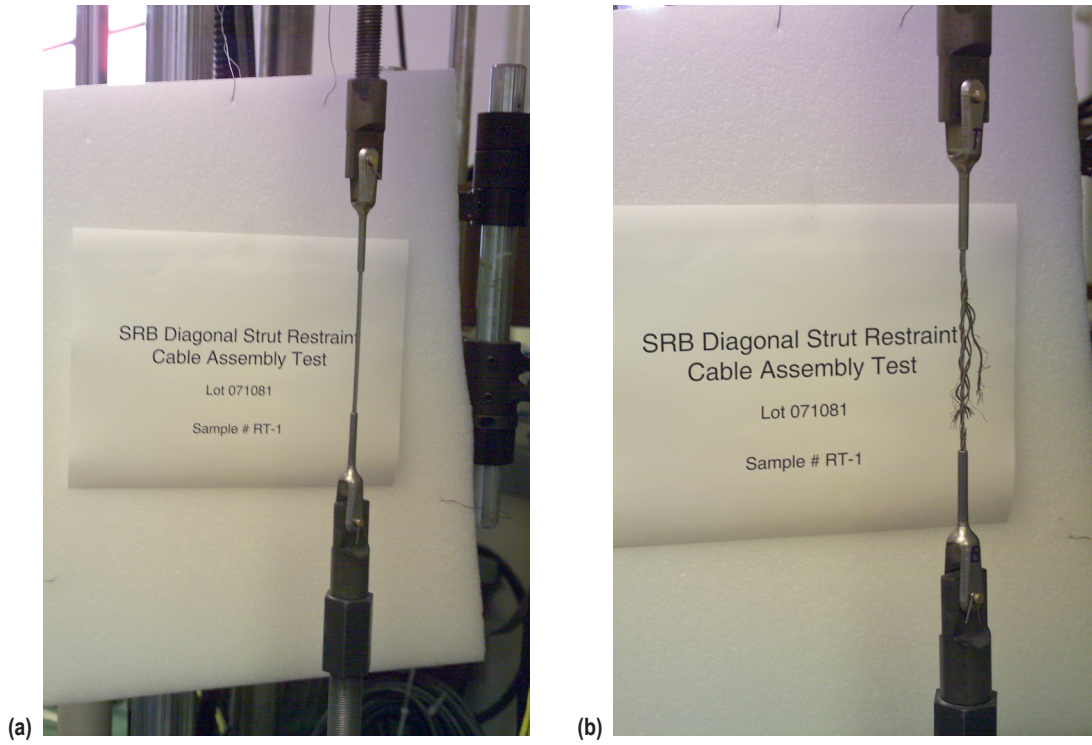
Figure 3. 071081–RT–1 (a) before testing and (b) after testing.

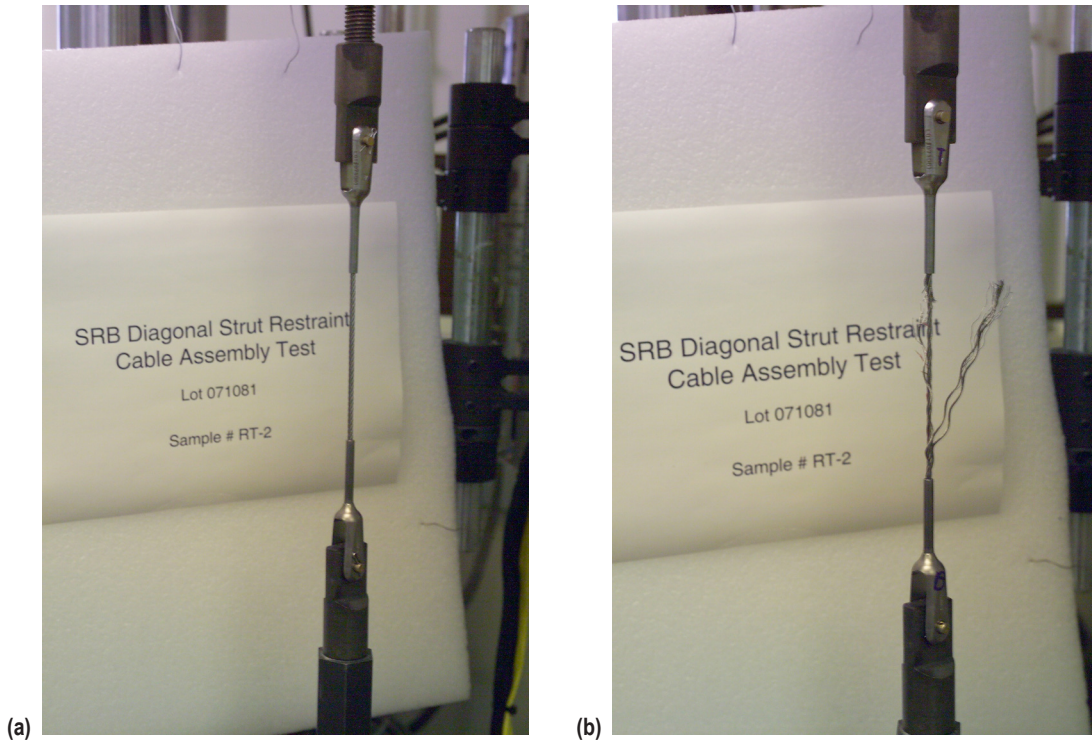
Figure 4. 071081-RT-2 (a) before testing and (b) after testing.

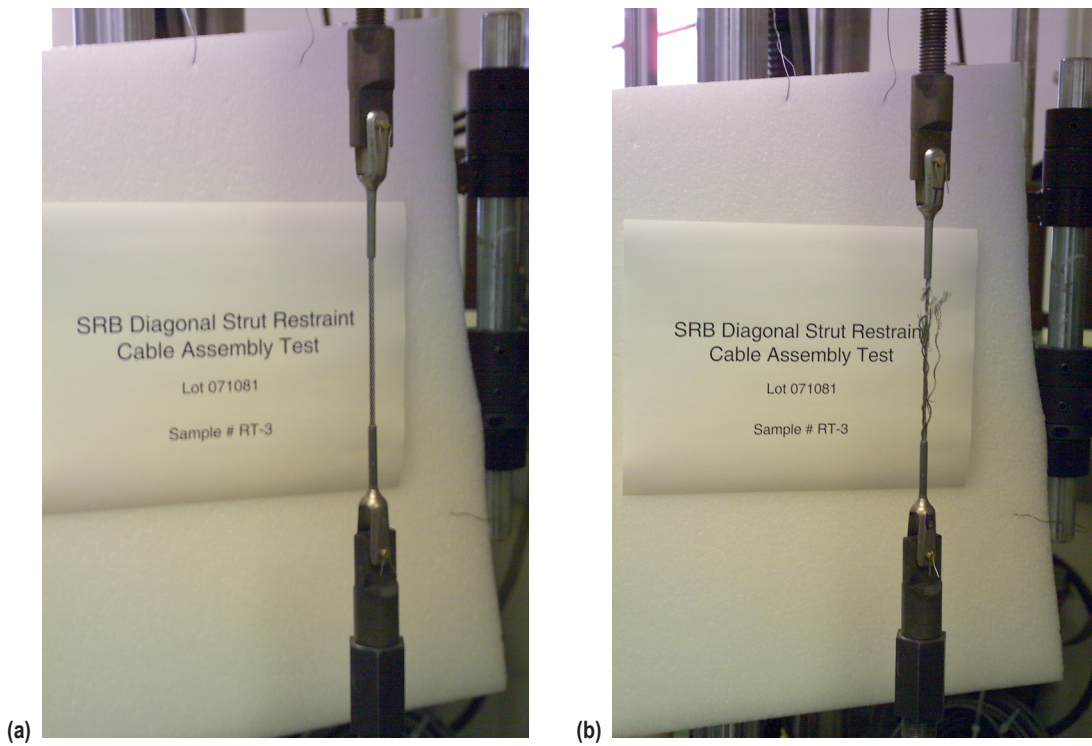
Figure 5. 071081-RT-3 (a) before testing and (b) after testing.

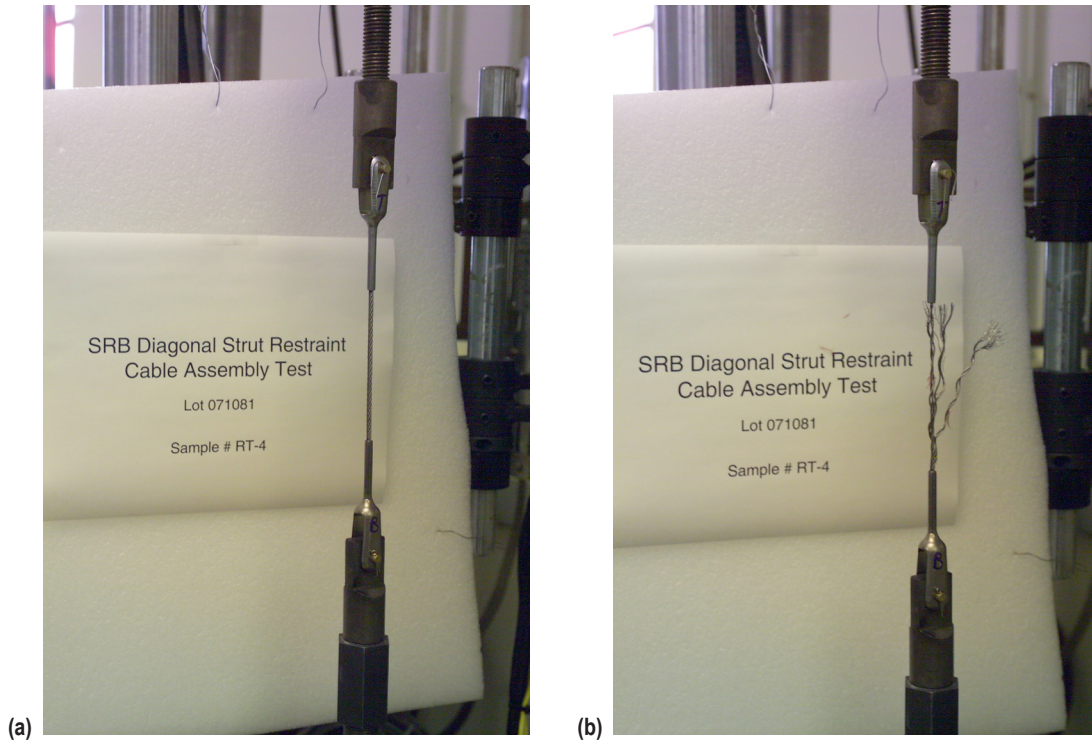
Figure 6. 071081-RT-4 (a) before testing and (b) after testing.

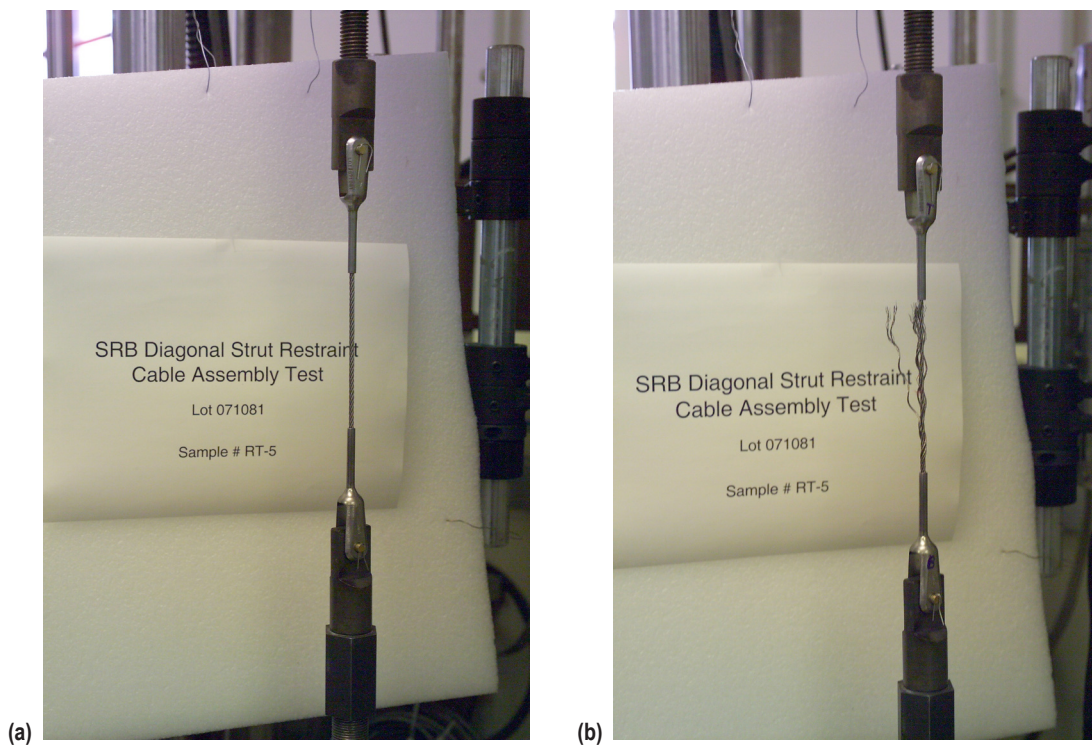
Figure 7. 071081-RT-5 (a) before testing and (b) after testing.

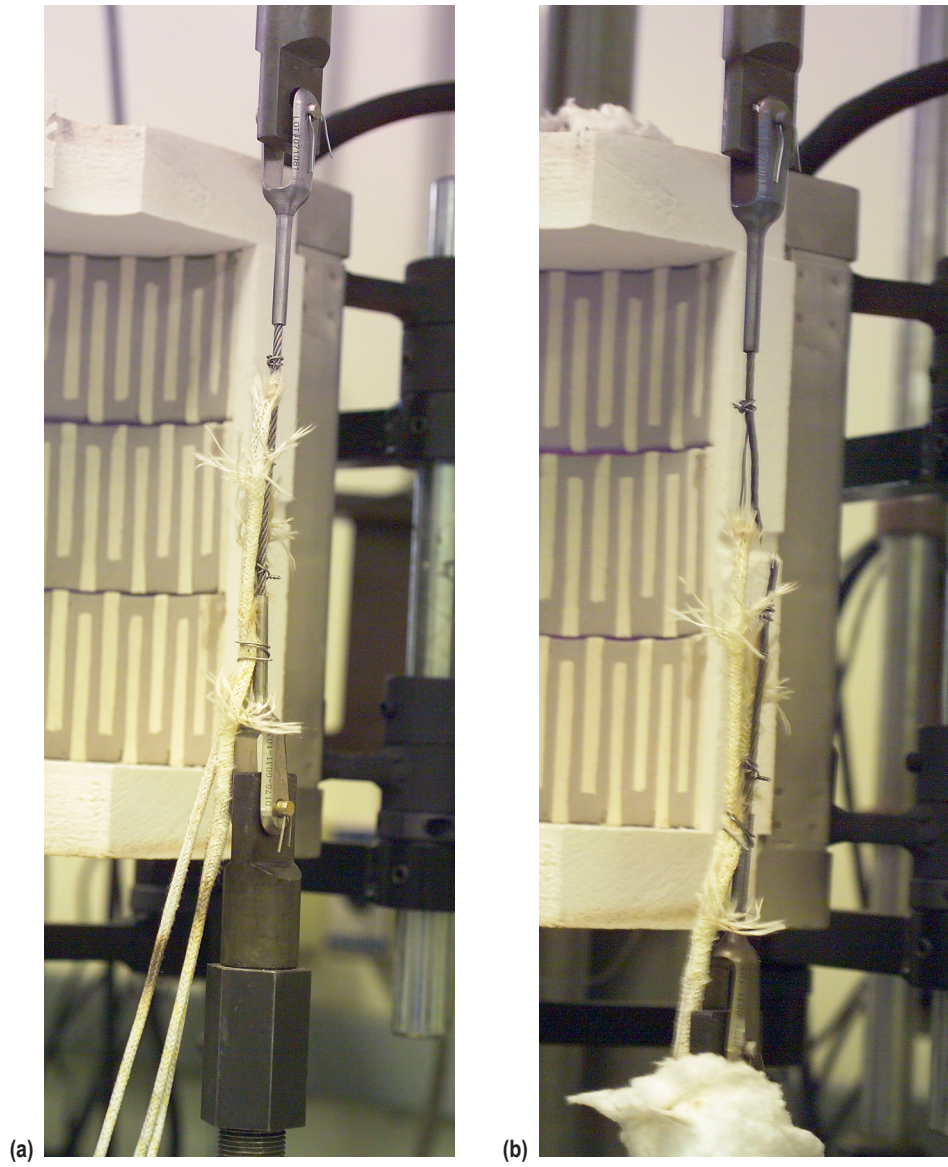
Figure 8. 071081-ELV-6 (a) before testing and (b) after testing.

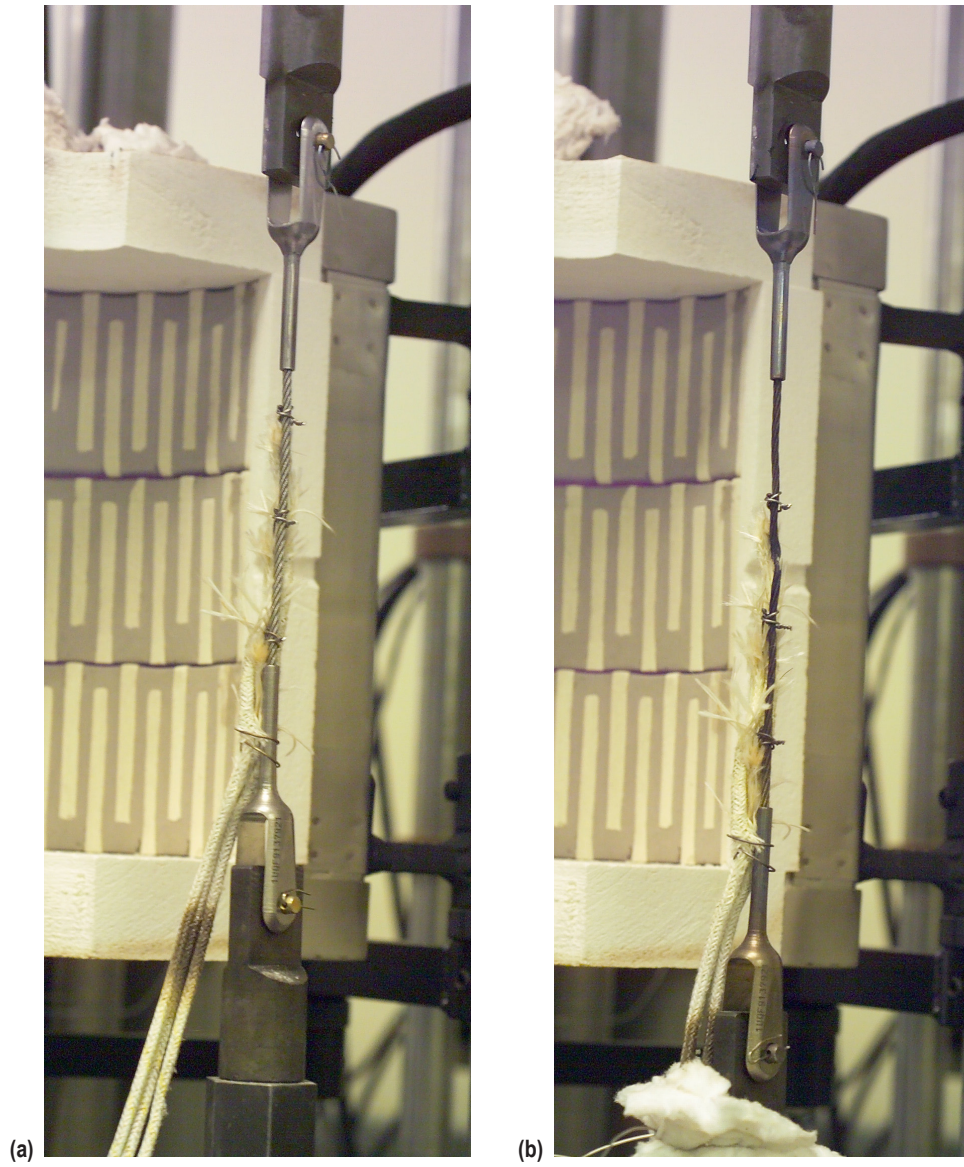
Figure 9. 071081-ELV-7 (a) before testing and (b) after testing.

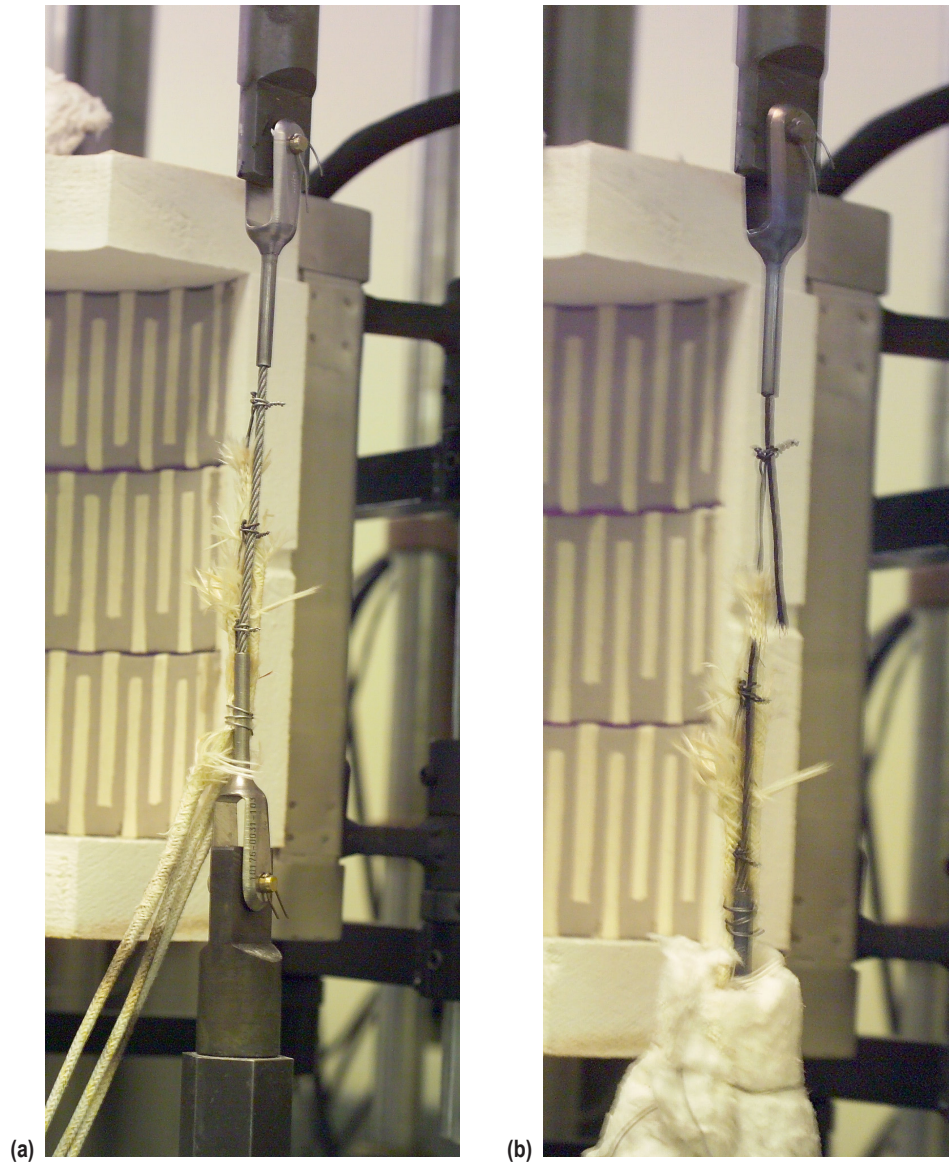
Figure 10. 071081-ELV-8 (a) before testing and (b) after testing.

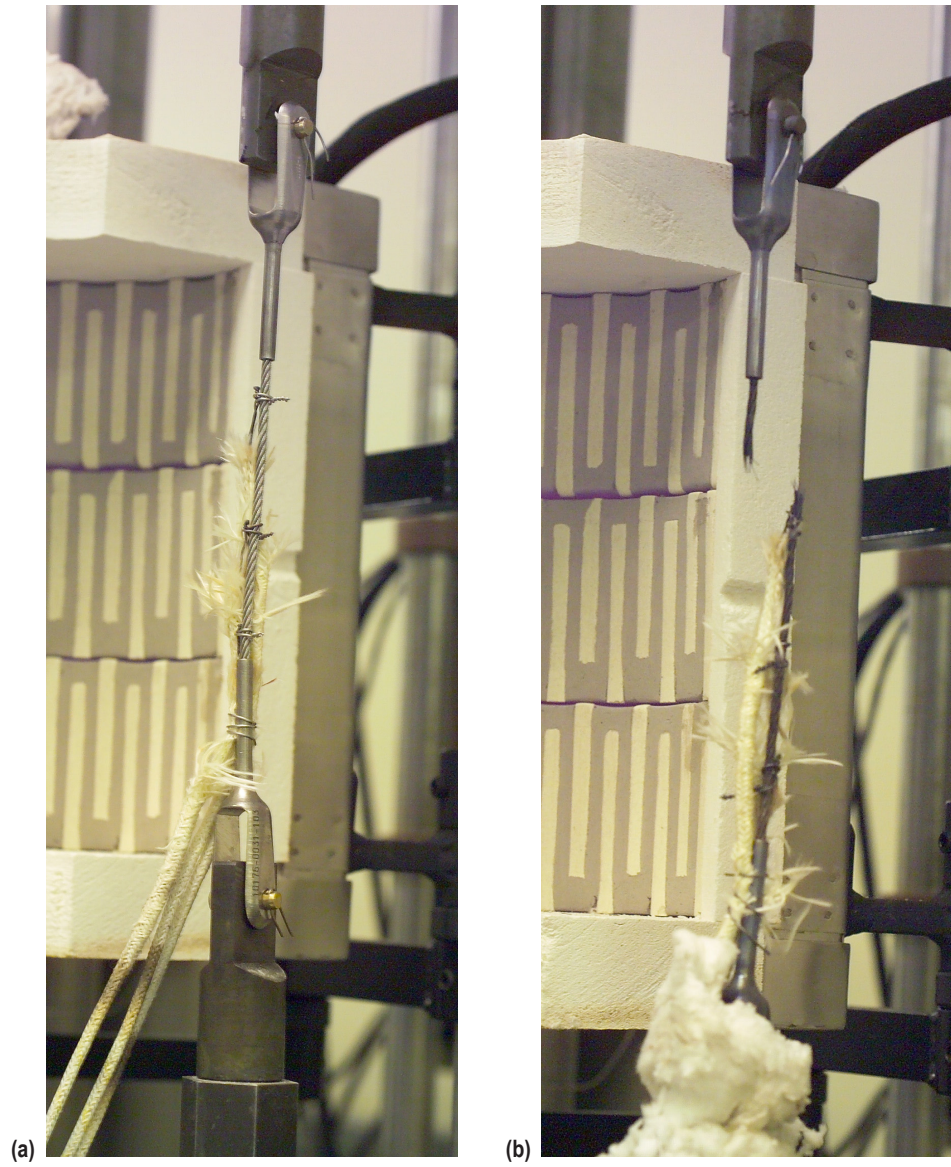
Figure 11. 071081-ELV-9 (a) before testing and (b) after testing.

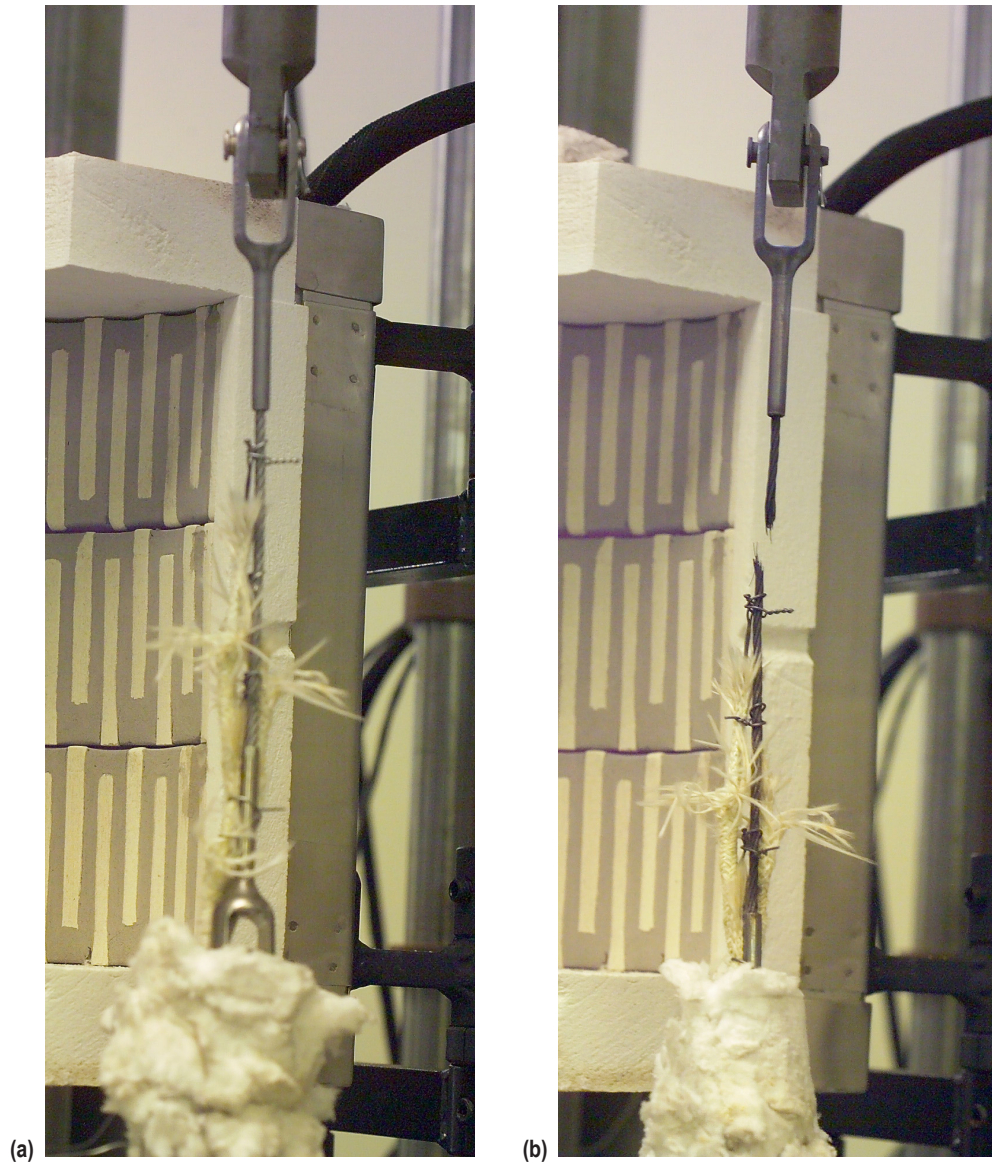
Figure 12. 071081-ELV-10 (a) before testing and (b) after testing.

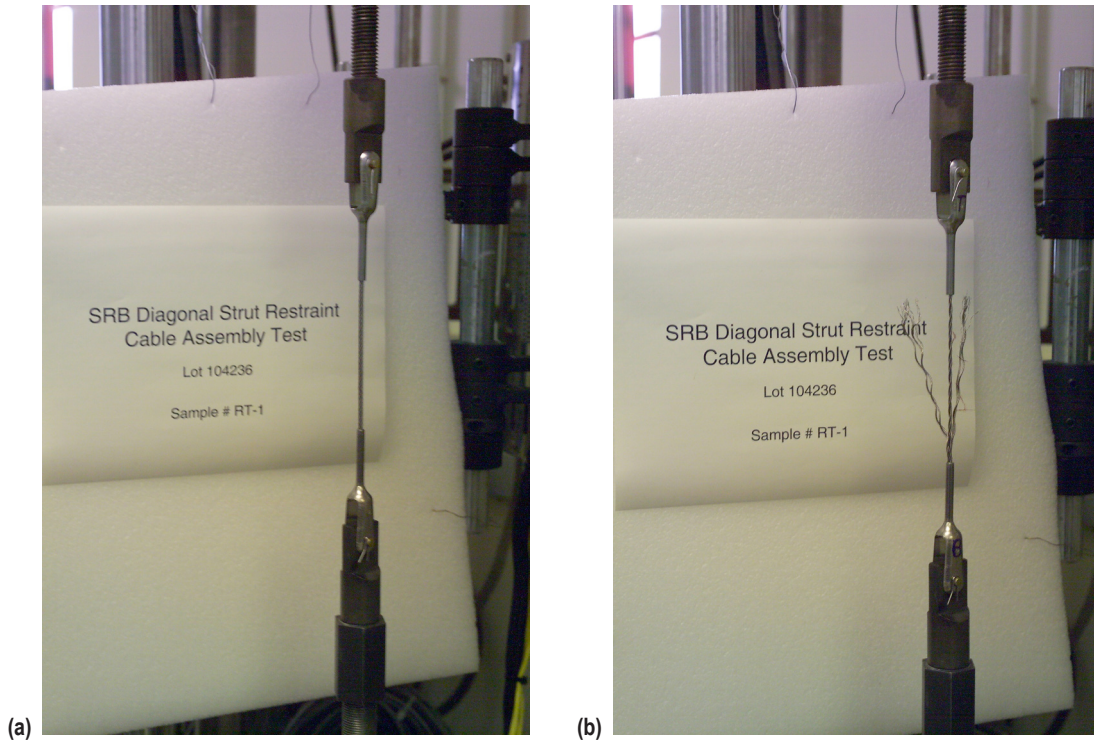
Figure 13. 104236–RT–1 (a) before testing and (b) after testing.

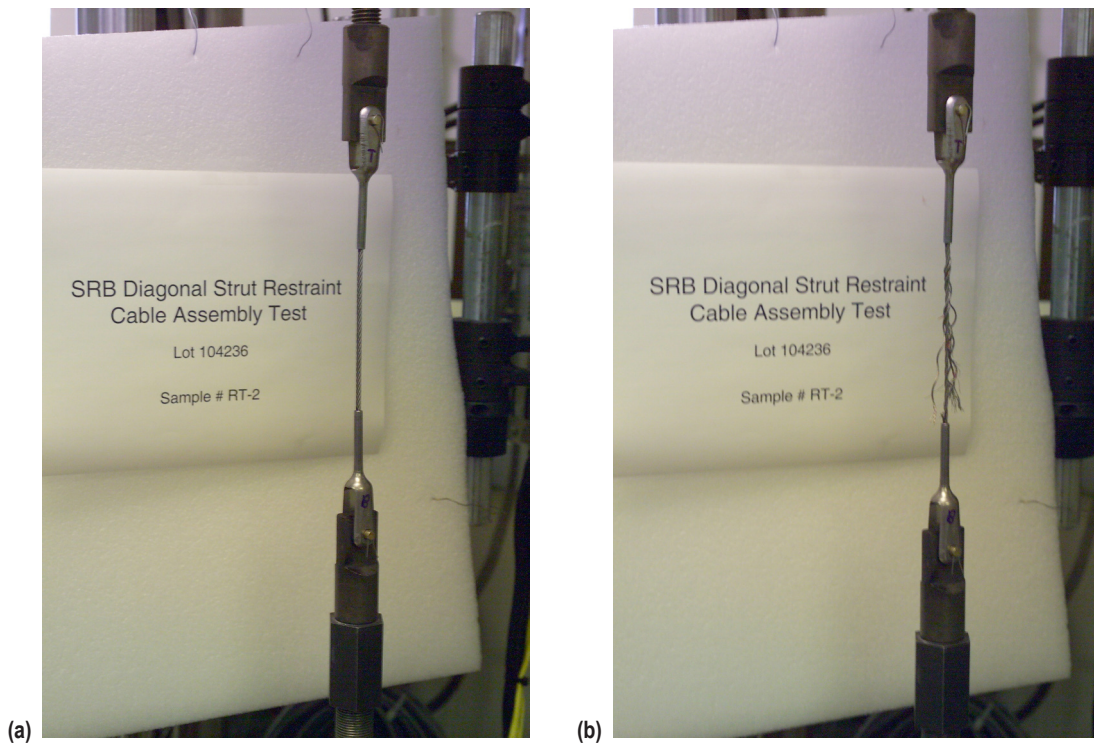
Figure 14. 104236–RT–2 (a) before testing and (b) after testing.

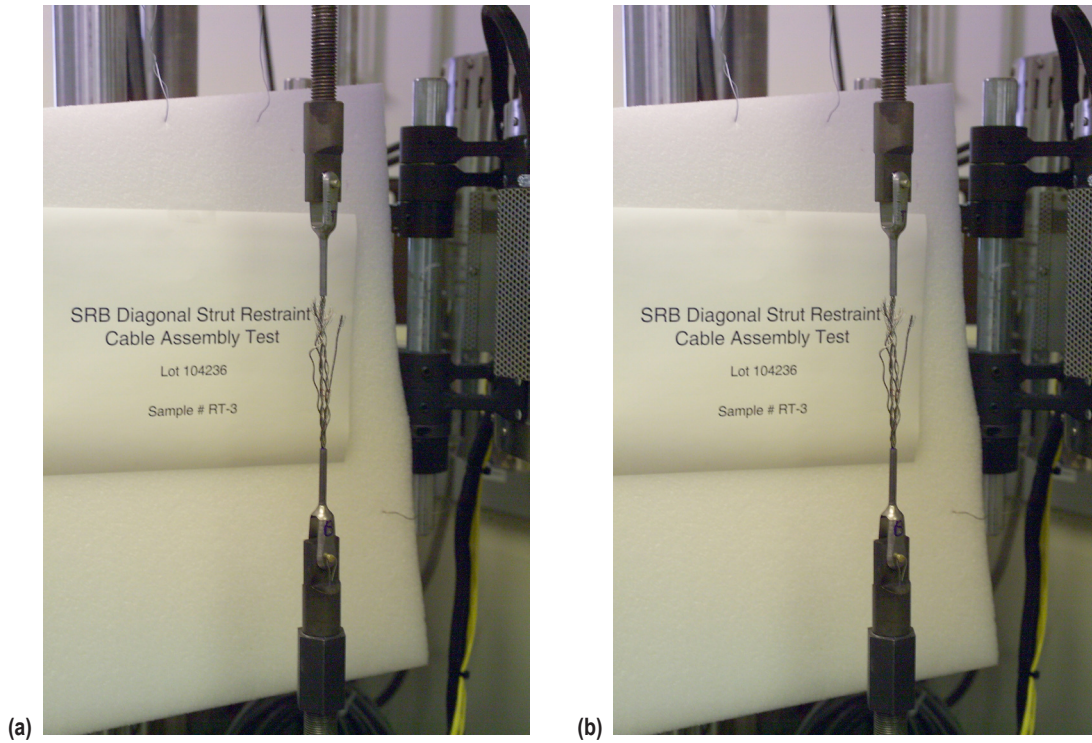
Figure 15. 104236–RT–3 (a) before testing and (b) after testing.

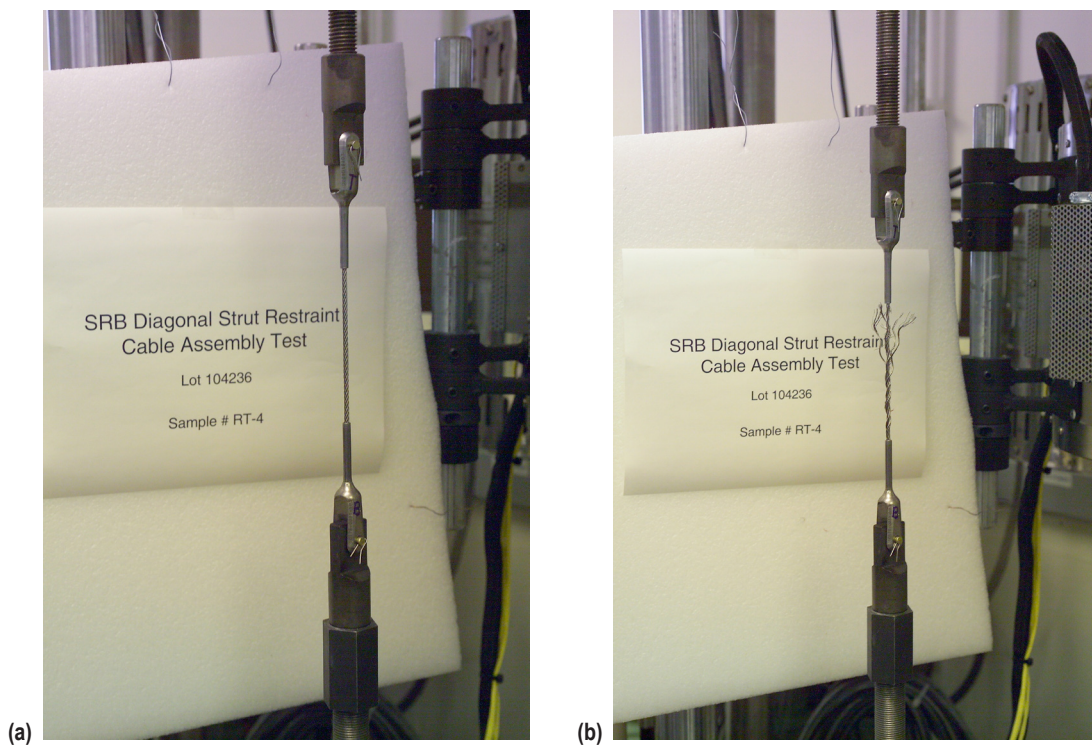
Figure 16. 104236–RT–4 (a) before testing and (b) after testing.

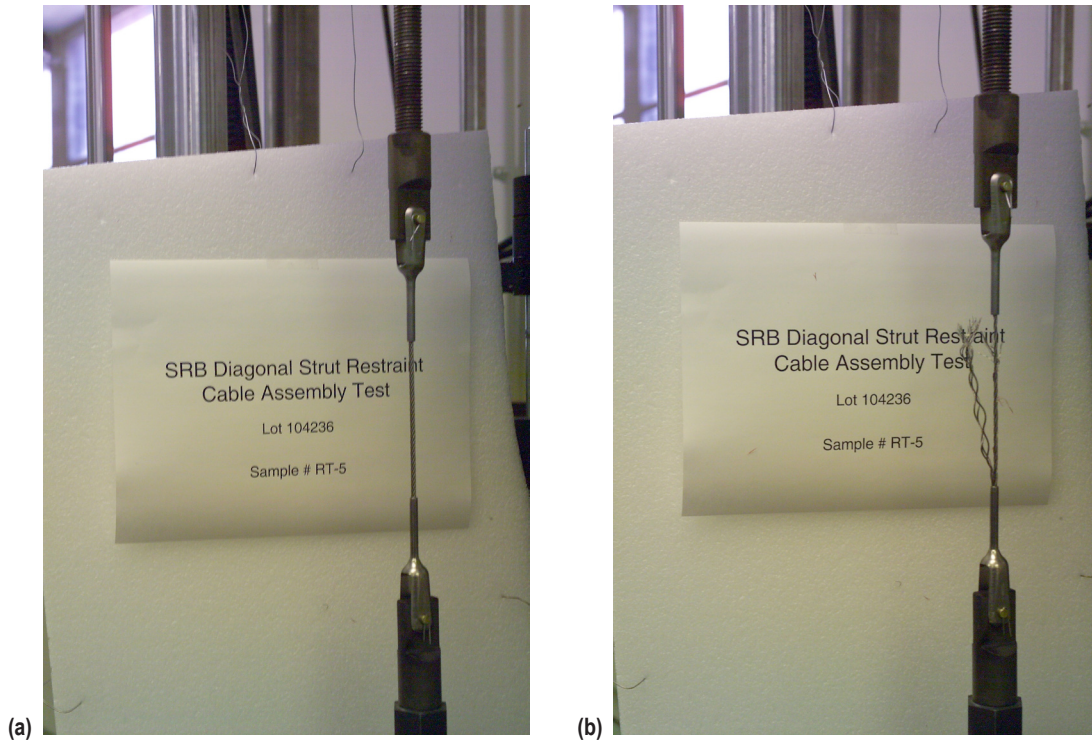
Figure 17. 104236–RT–5 (a) before testing and (b) after testing.

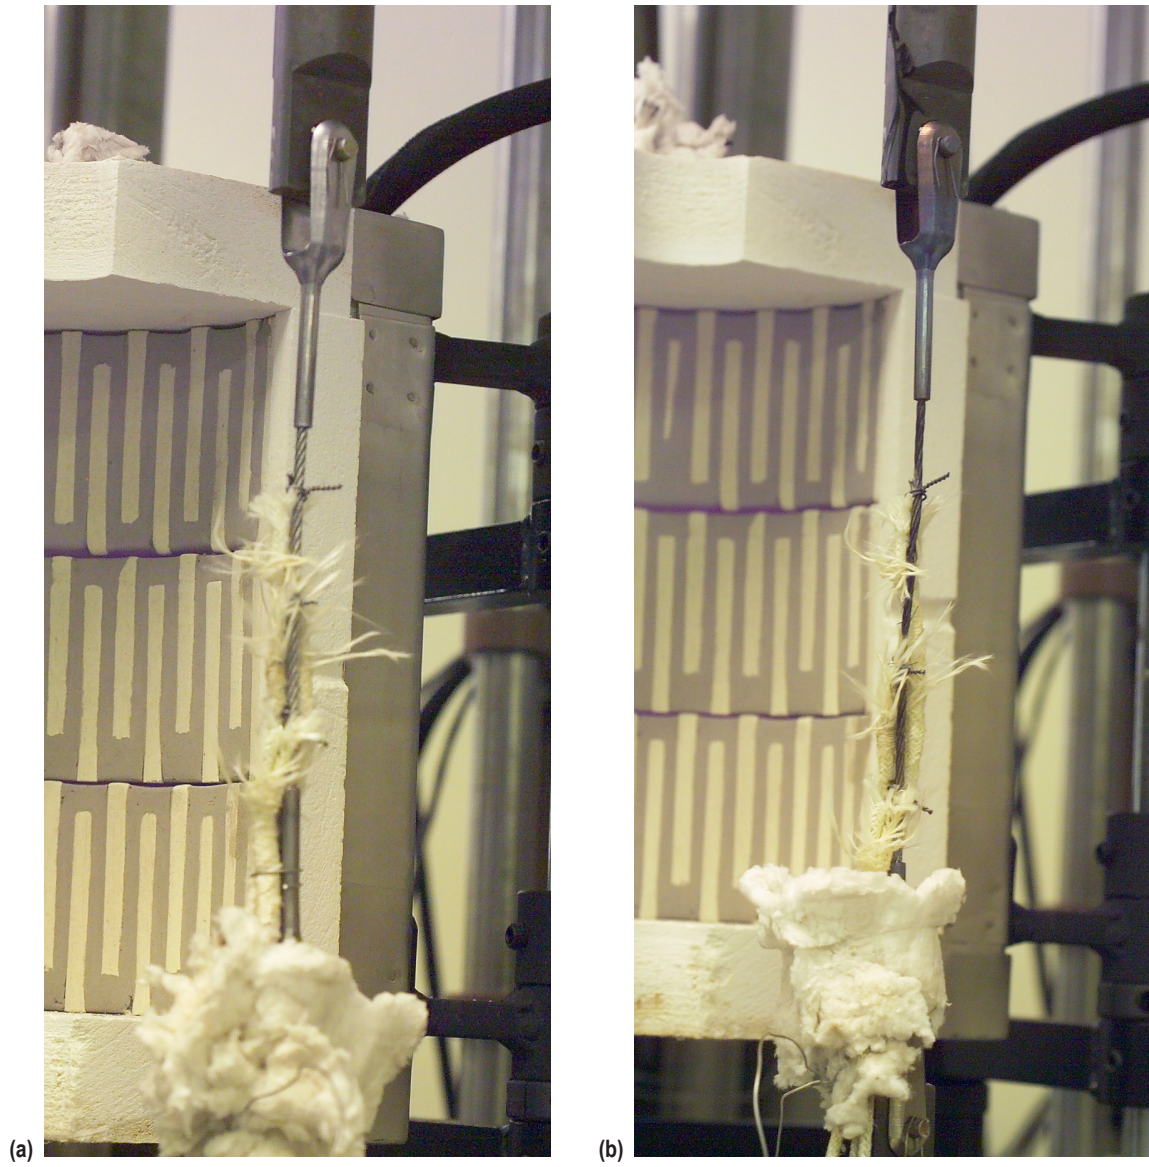
Figure 18. 104236-ELV-6 (a) before testing and (b) after testing.

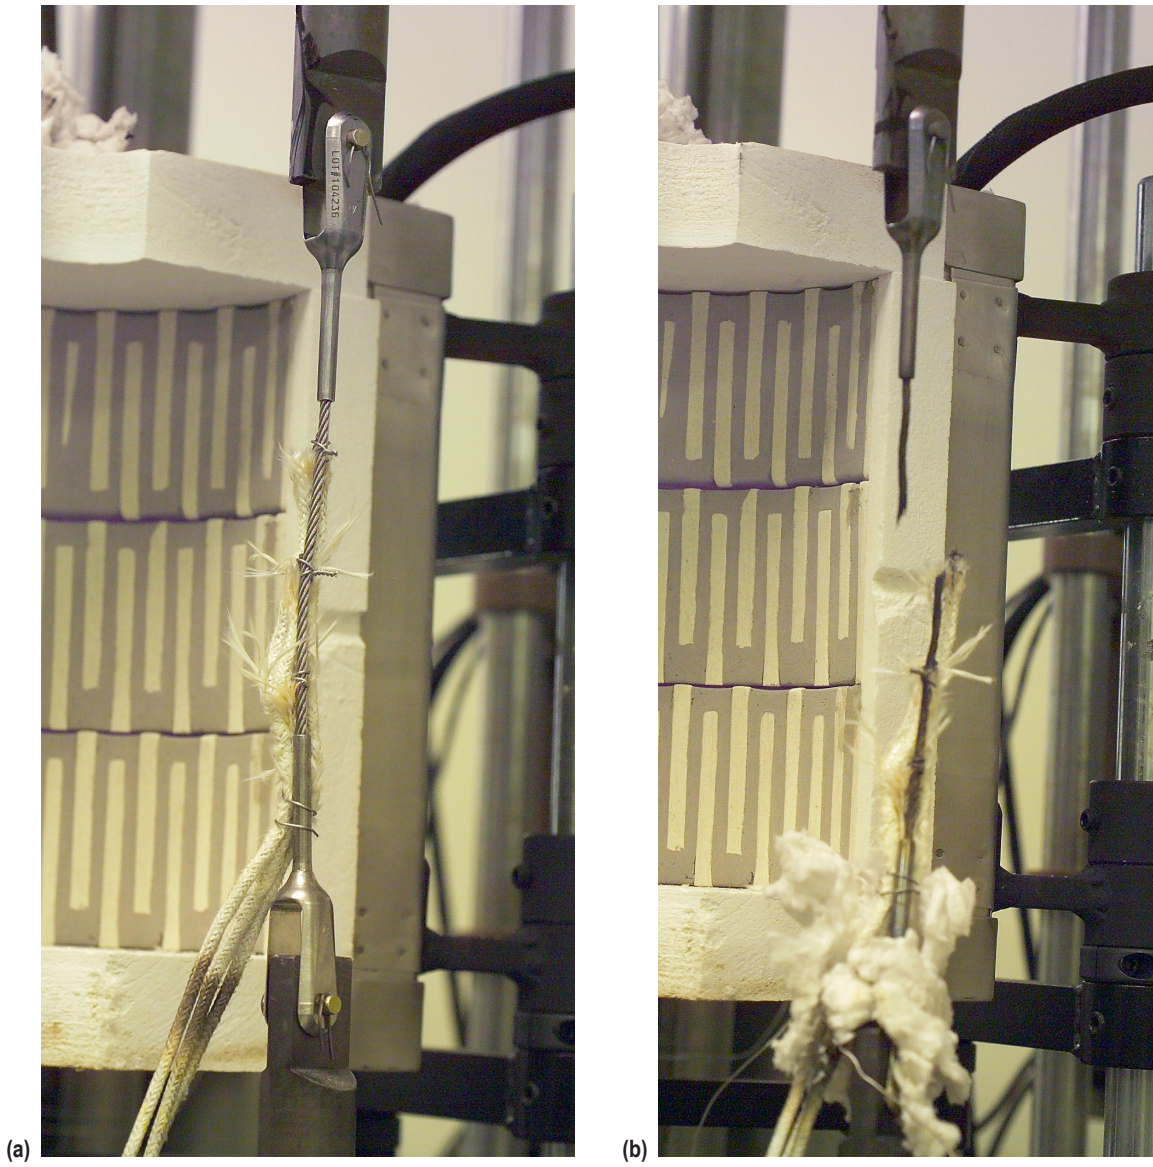
Figure 19. 104236-ELV-7 (a) before testing and (b) after testing.

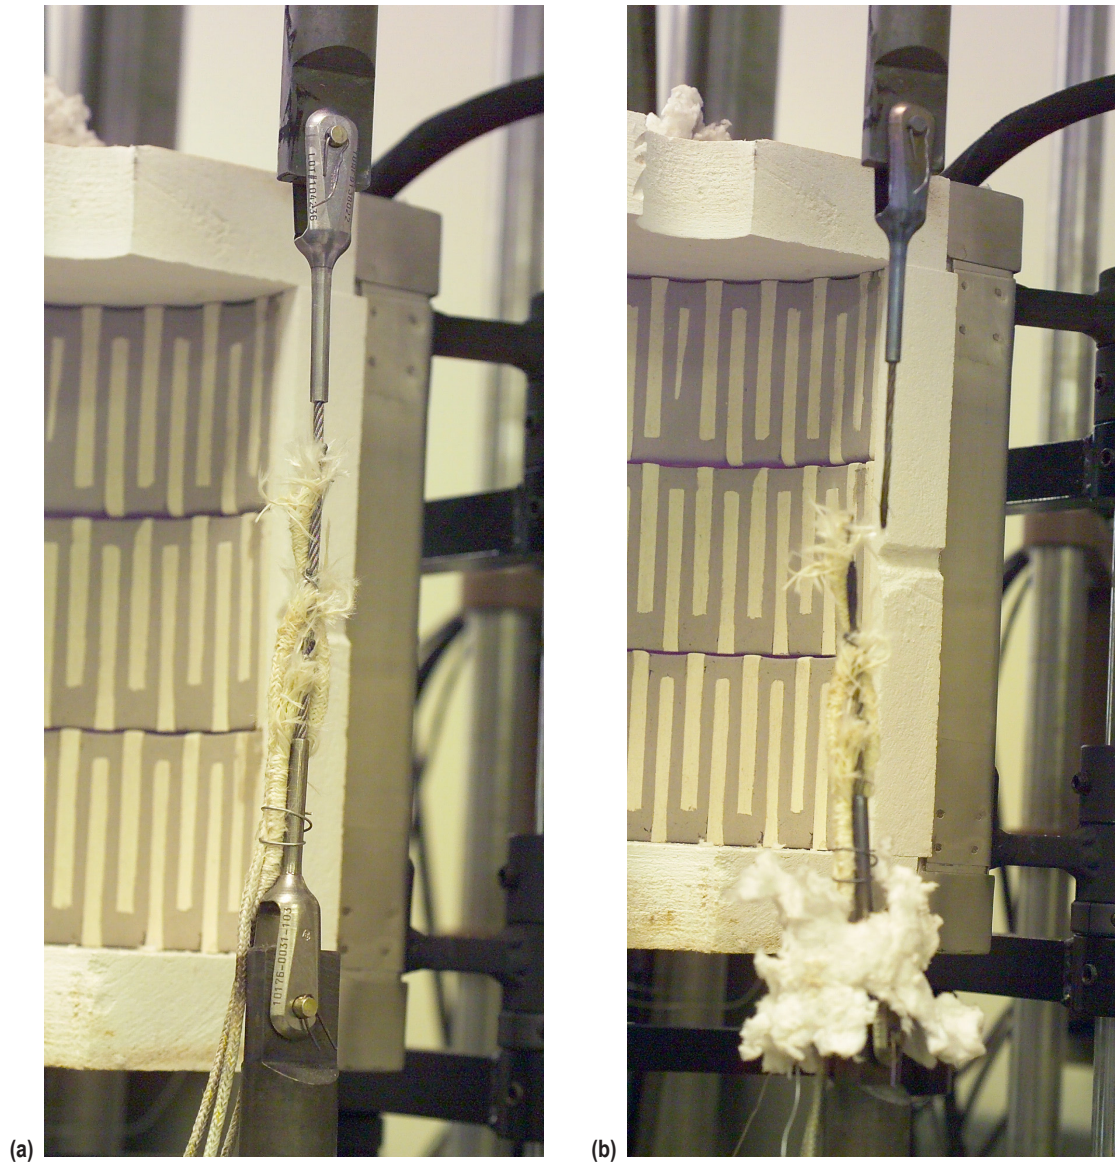
Figure 20. 104236-ELV-8 (a) before testing and (b) after testing.

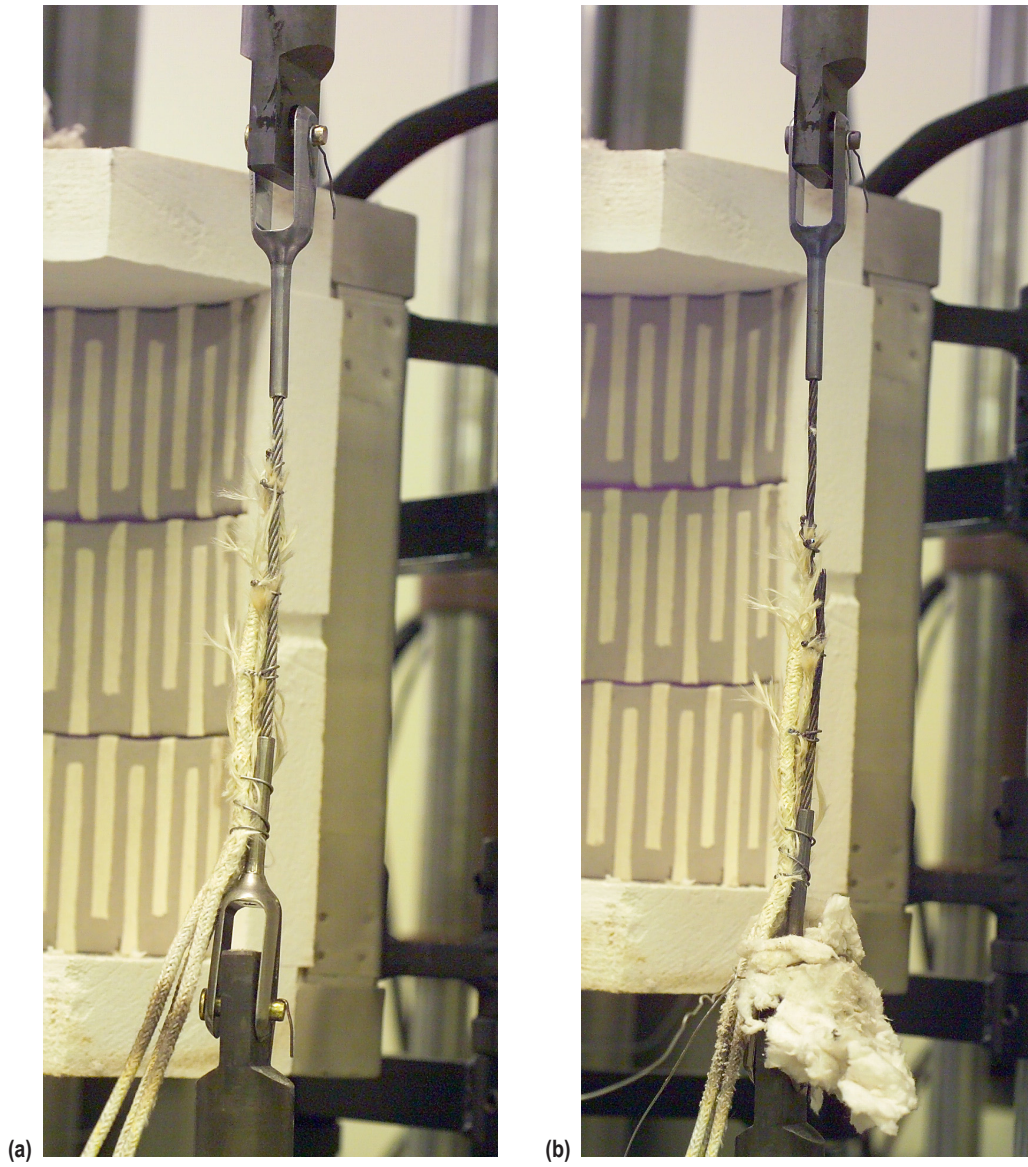
Figure 21. 104236-ELV-9 (a) before testing and (b) after testing.

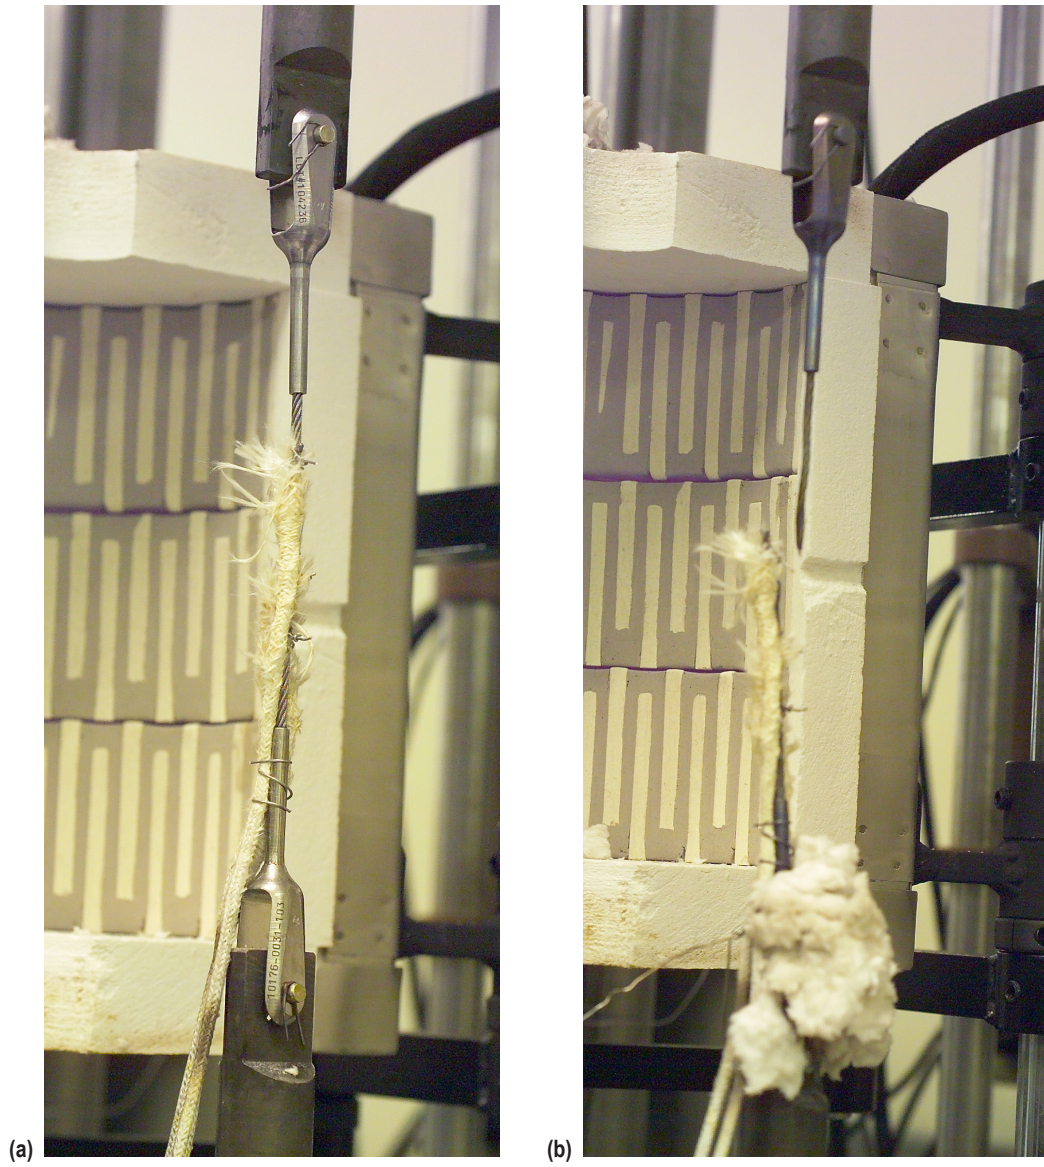
Figure 22. 104236-ELV-10 (a) before testing and (b) after testing.

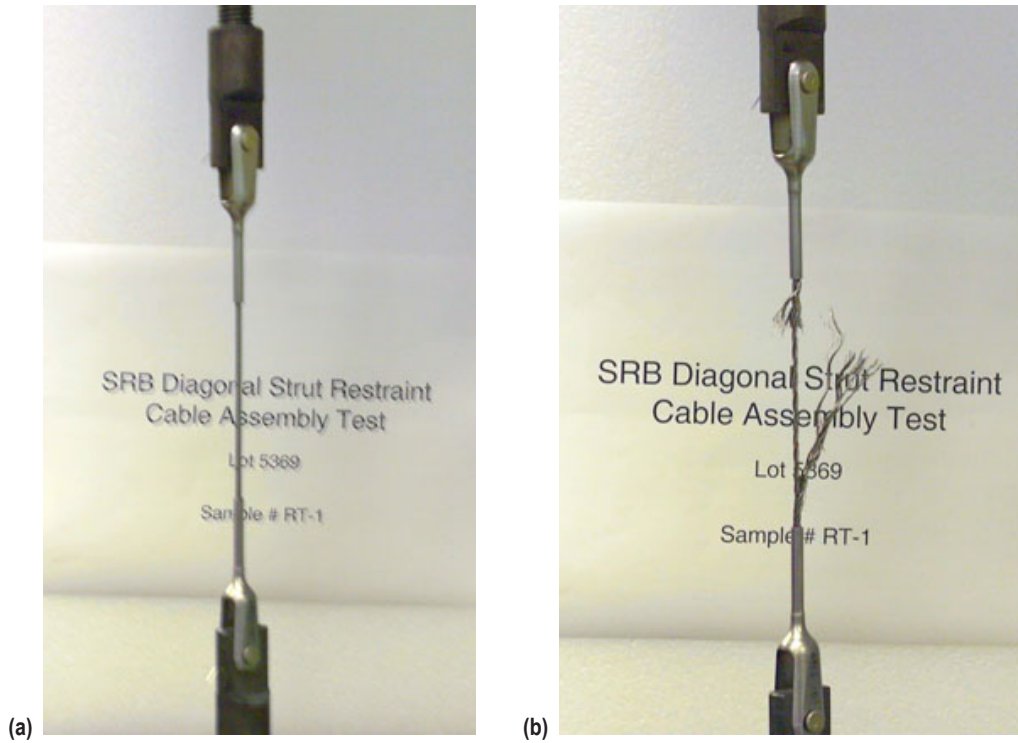
Figure 23. 5369-RT-1 (a) before testing and (b) after testing.

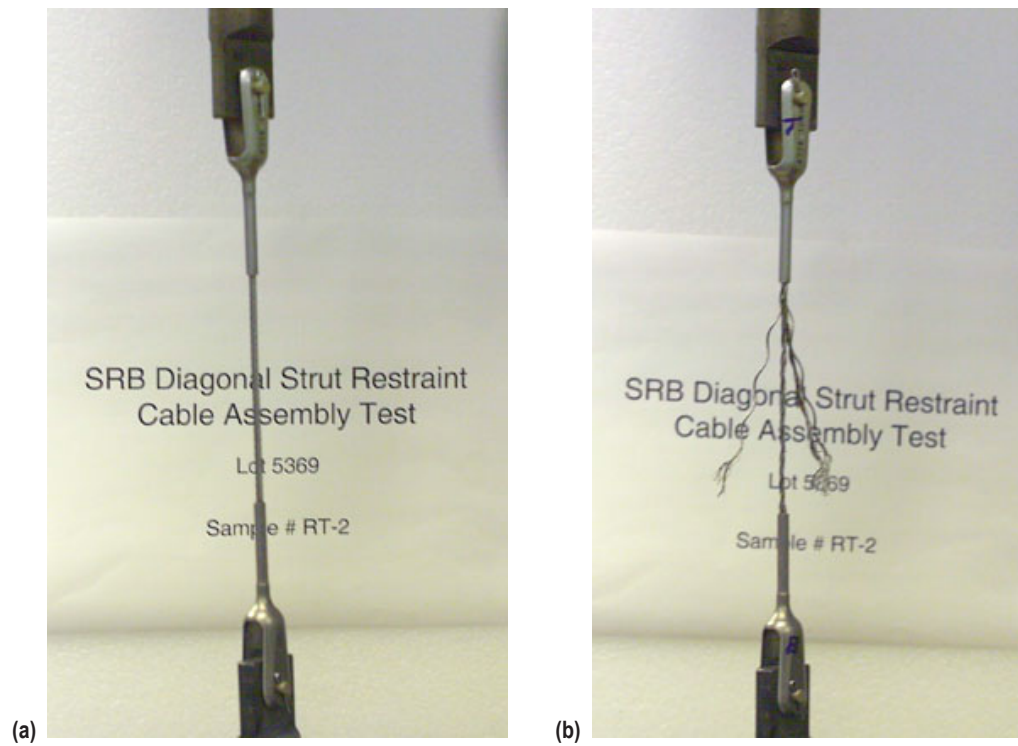
Figure 24. 5369-RT-2 (a) before testing and (b) after testing.

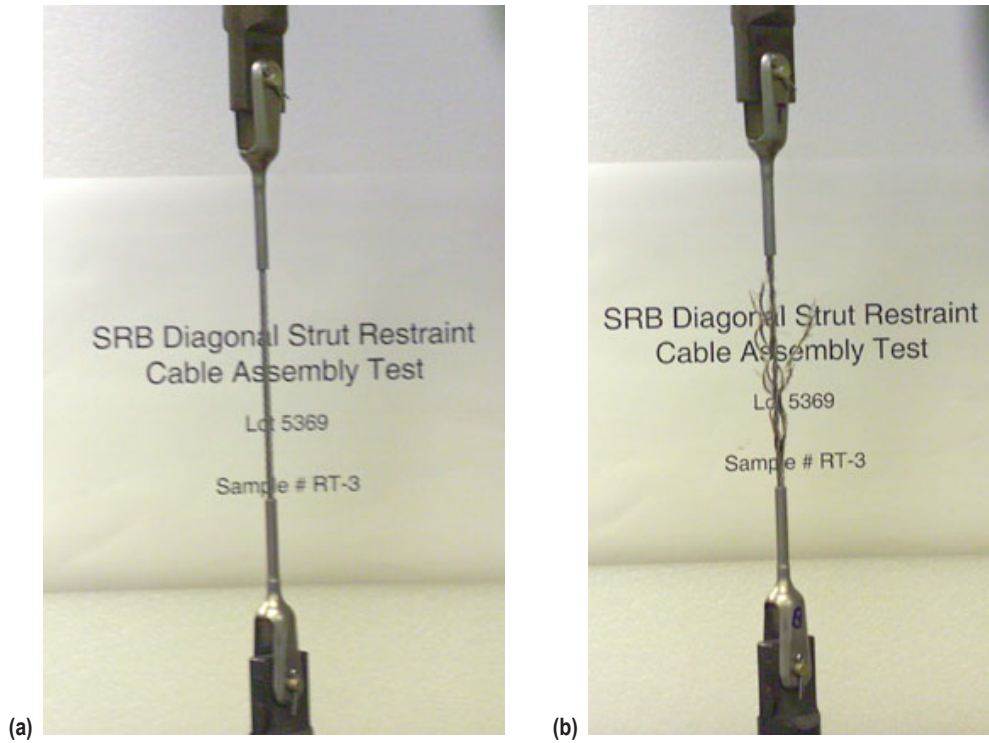
Figure 25. 5369-RT-3 (a) before testing and (b) after testing.
