NASA/TM—2006–214603

Qualification Testing of Solid Rocket Booster Diagonal Strut Restraint Cable Assembly Part Number 10176–0031–102/103

Marshall Space Flight Center, Marshall Space Flight Center, Alabama

September 2006

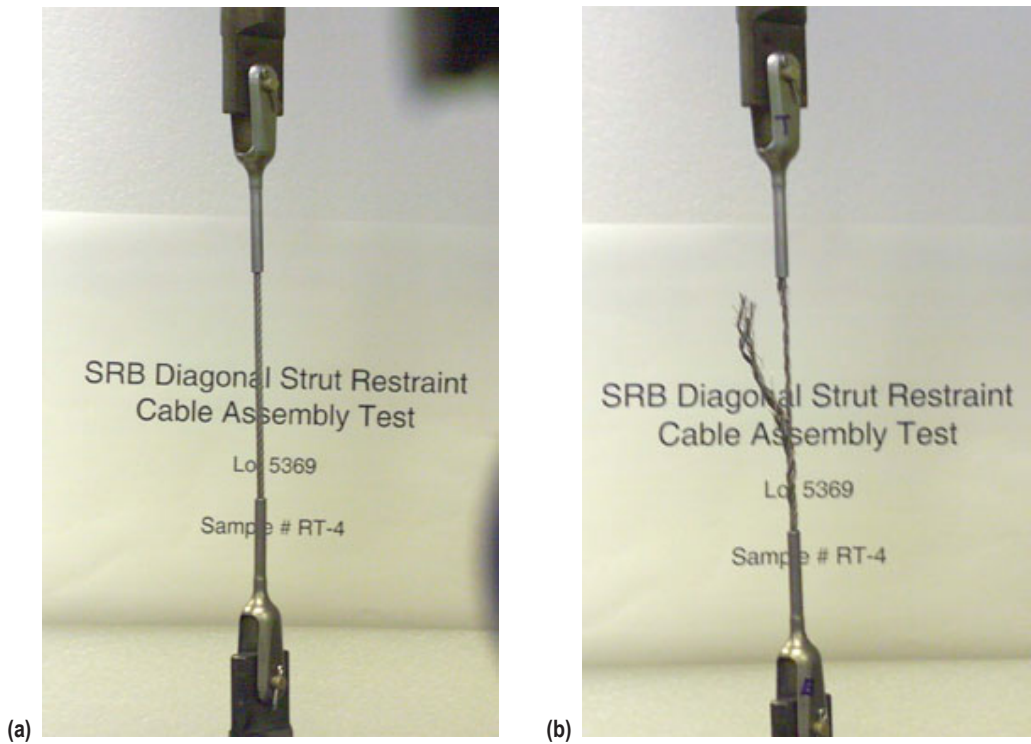
Figure 26. 5369-RT-4 (a) before testing and (b) after testing.

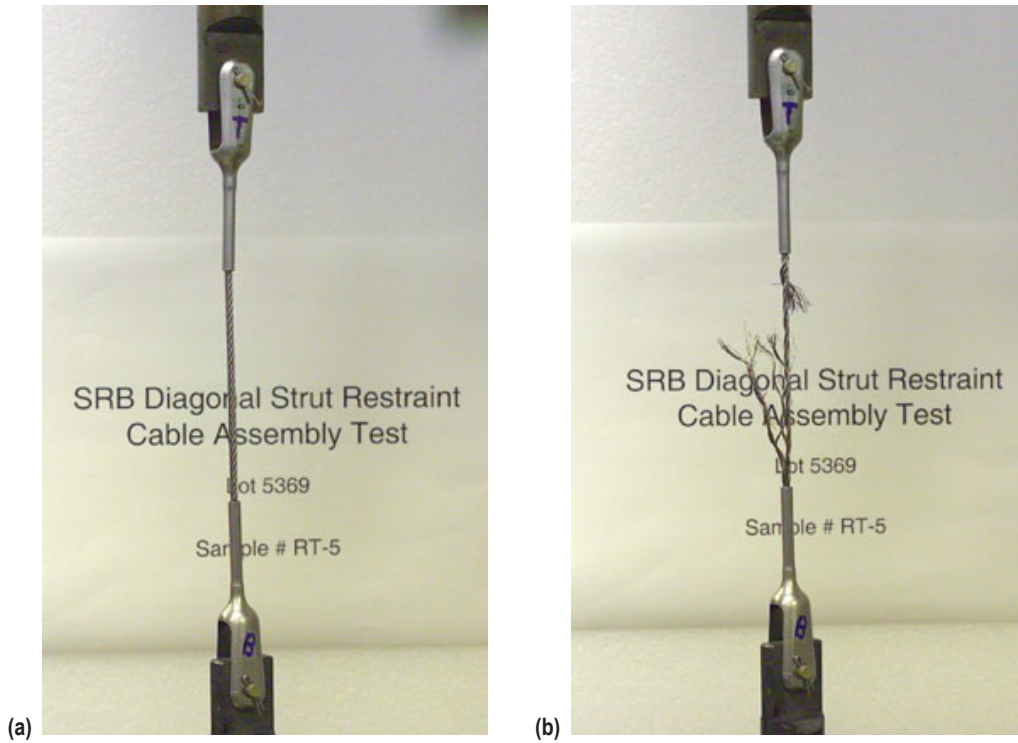
Figure 27. 5369-RT-5 (a) before testing and (b) after testing.

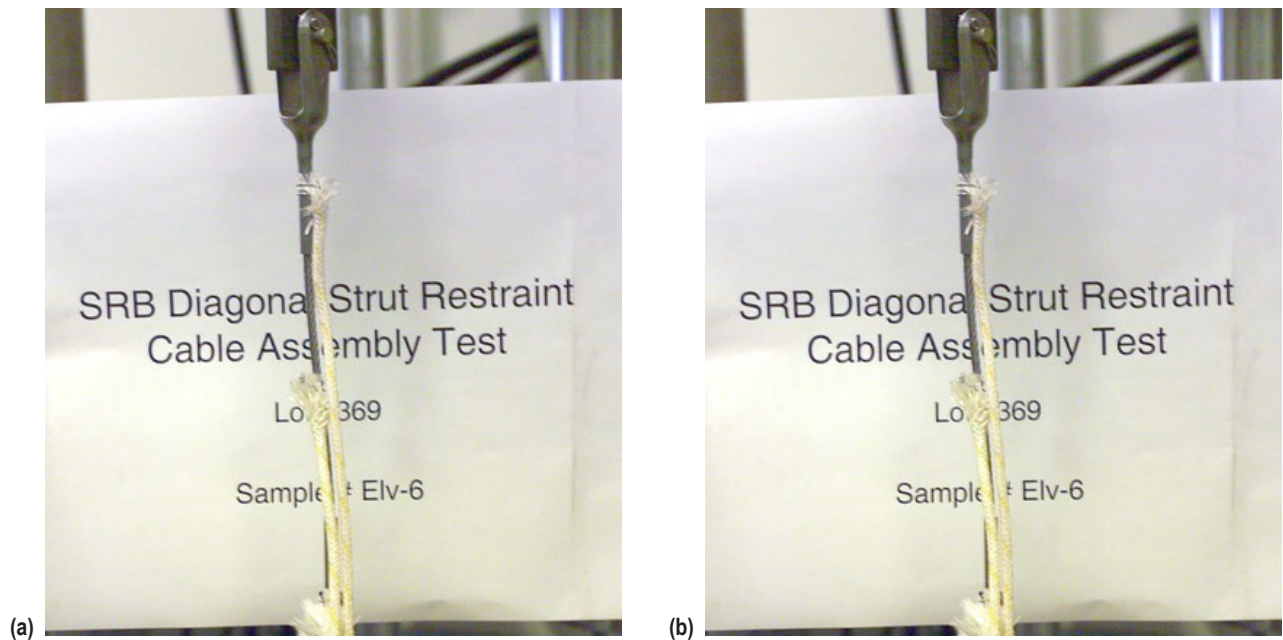
Figure 28. 5369-ELV-6 (a) before testing and (b) after testing.

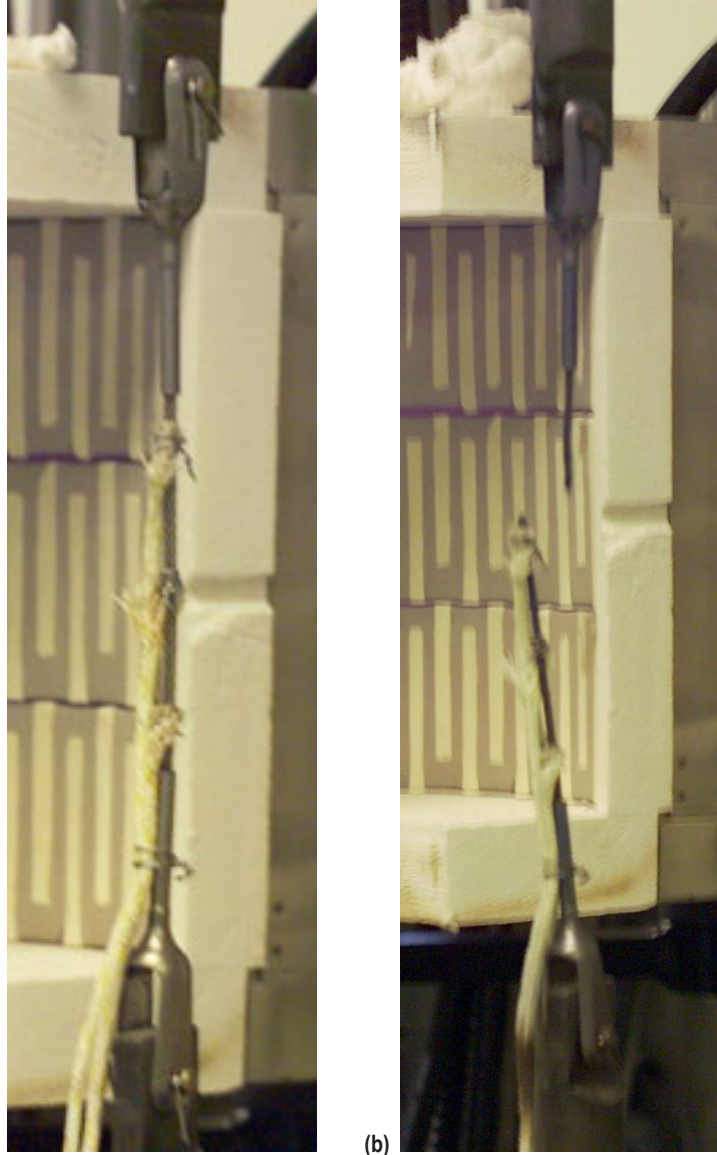
Figure 29. 5369-ELV-7 (a) before testing and (b) after testing.

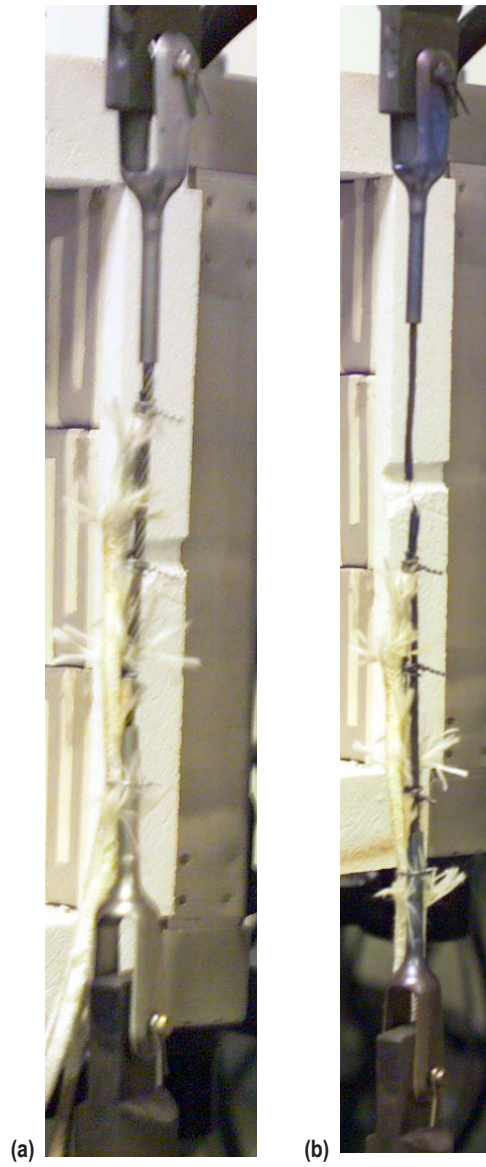
Figure 30. 5369-ELV-8 (a) before testing and (b) after testing.

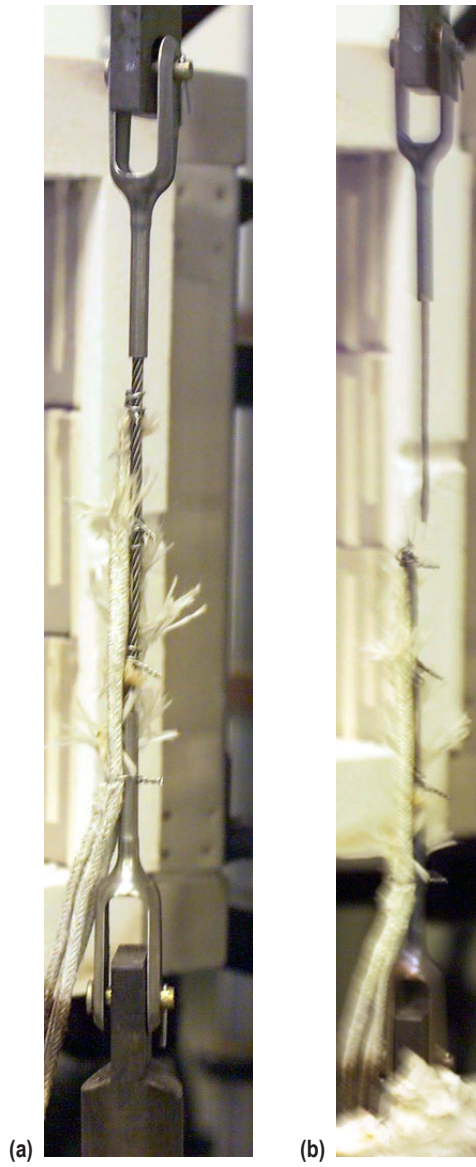
Figure 31. 5369-ELV-9 (a) before testing and (b) after testing.

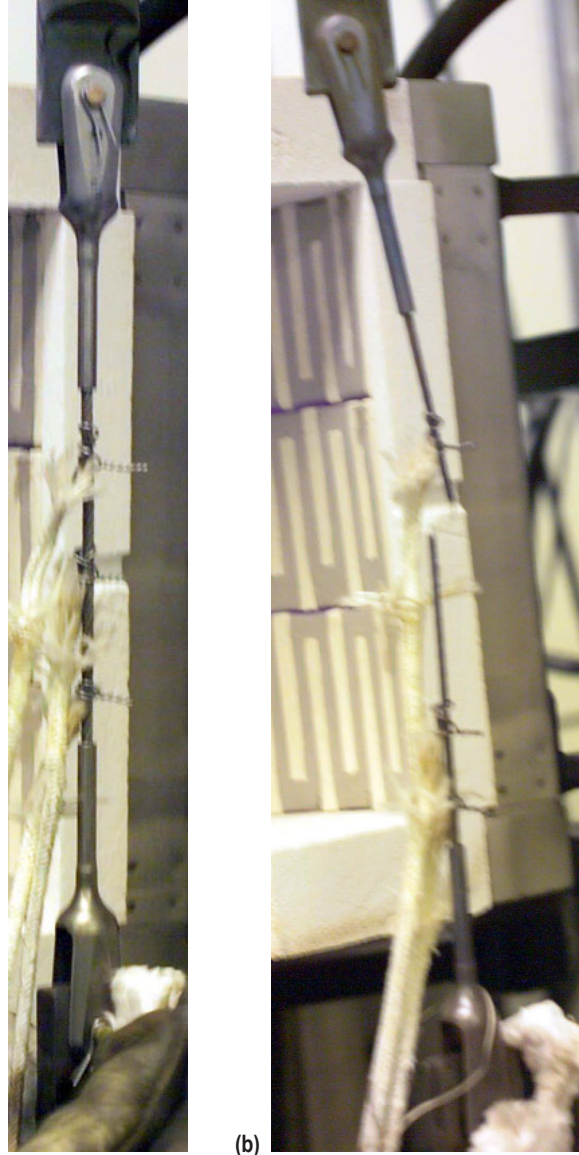
Figure 32. 5369-ELV-10 (a) before testing and (b) after testing.
