REPLICA-BASED CRACK INSPECTION

**John A. Newman, Stephen W. Smith, and R.S. Piascik
NASA Langley Research Center, Hampton, Virginia**

- **Cracks found in Space Shuttle Main Engine LH₂ feedline flowliners (2002)**
 - Ranged from 0.1 inch to 0.6 inch long
 - Weld repaired, polished, and recertified for flight
 - NDE: no cracks >0.075 inches long exist
- **Revisited in 2004**
 - Unable to show flight rationale with a crack 0.075 inches long

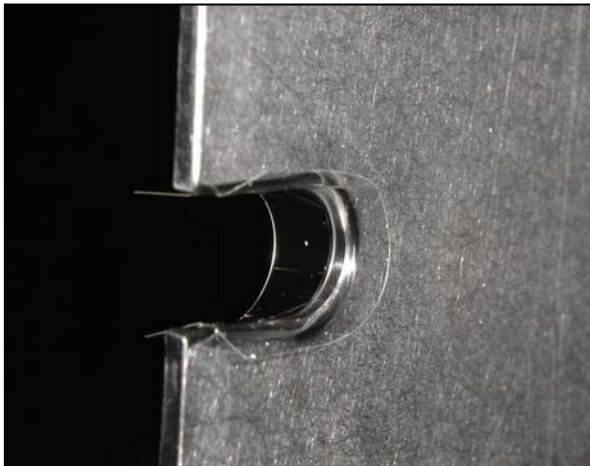
Acetate tape replica

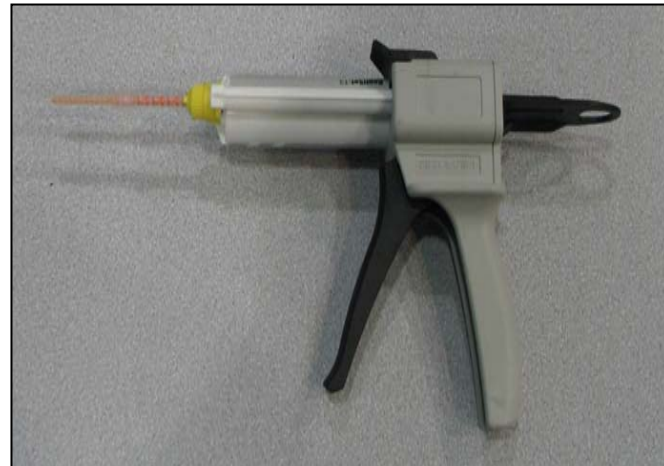
Silicone-based replica dispenser

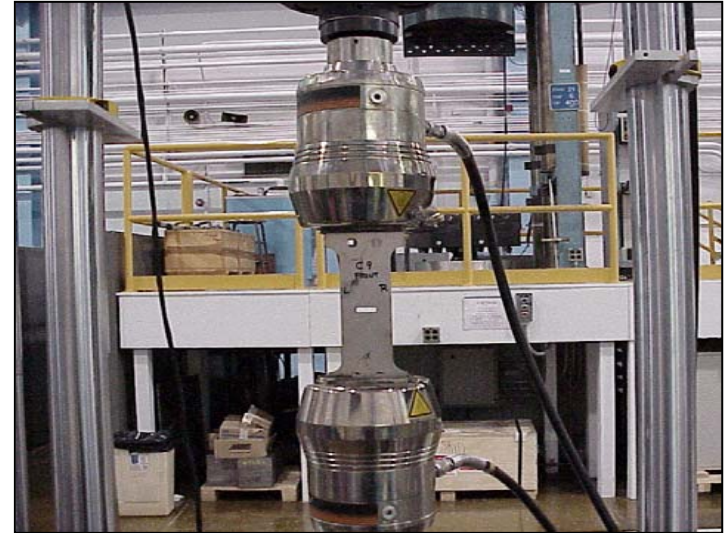
- **Specimens used to simulate flowliner slot geometry and stress state**
 - $P_{max} = 3.4$ kips, $R = 0.1$
- **Testing interrupted periodically for slot surface replication**
 - Acetate-tape replicas
 - Silicone-based replicas

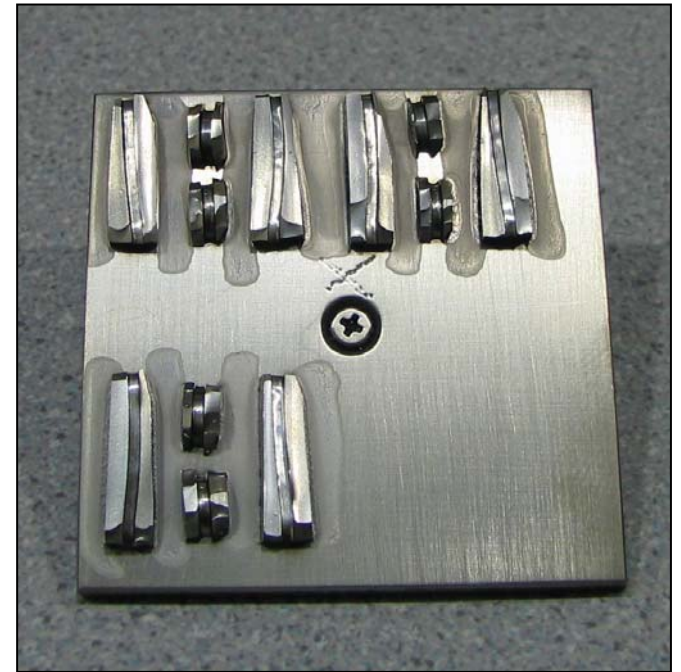
- **Replica preparation**
 - Sectioned in 4 pieces
 - Grounded on metallic slide
 - Coated with metallic material
- **Examined in an SEM**
- **Initial scan at 50-100X**
 - Surface finish, scratches, etc.
- **Crack scan at 400-700X**
