# Automated Eddy Current Inspection on Space Shuttle Hardware

John Hartman and Jeremy Felker

ATK Launch Systems Group

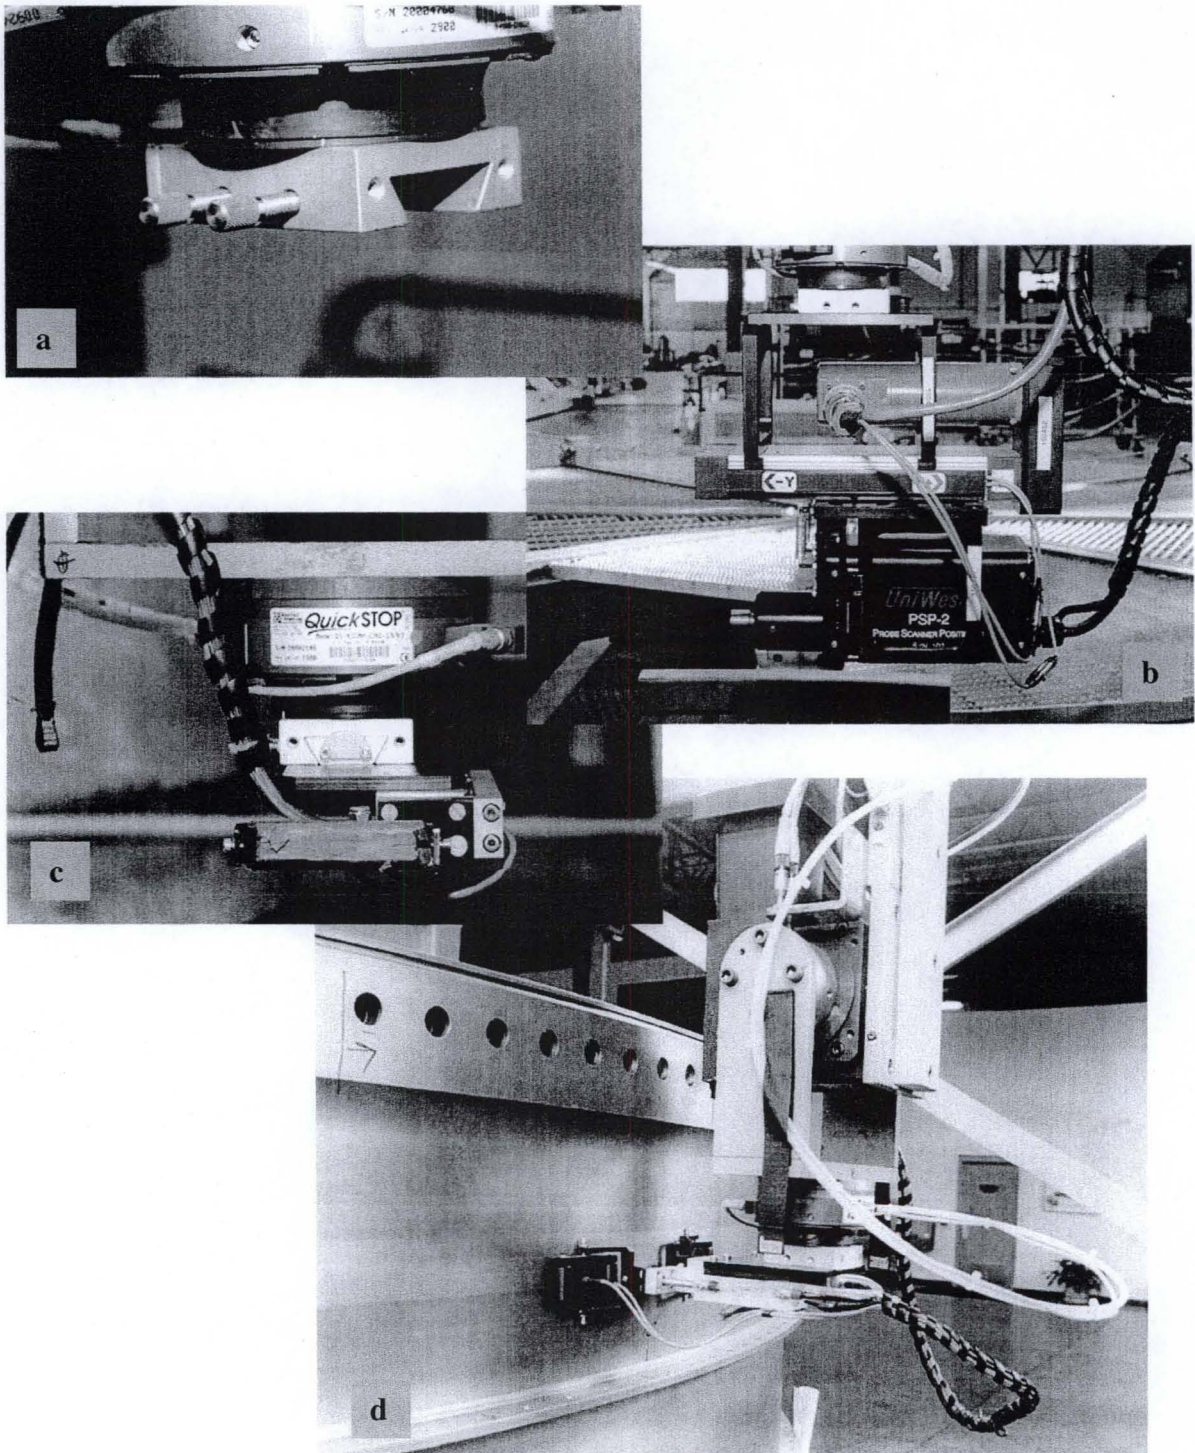
Figure 2: Various elements associated with AIIS: a) Dovetail joint to mount inspection sleds, b) mounted hole scanner, c) sled for "skiing" over holes, and d) sled for large acreages.

The AIIS is a sensor-based, robotic system and therefore has a great deal of control and repeatability, which is highly valued when working in the space program. All components and probes, some of which are shown in figure 2, are documented and controlled on tooling drawings. All RSRM parts are initially programmed and inspection coverage of required surfaces is verified. These programs and all associated software are controlled through a software configuration control procedure, assuring that all required surfaces are inspected the same way each time. The sensors are calibrated, assuring a measurable and consistent level of sensitivity and response. All calibration and detection "thresholds" are traced back to extensive Probability of Detection (POD) testing performed on actual cracks. This helps ensure that the required flaw sizes will be detected with a high level of statistical probability and confidence.

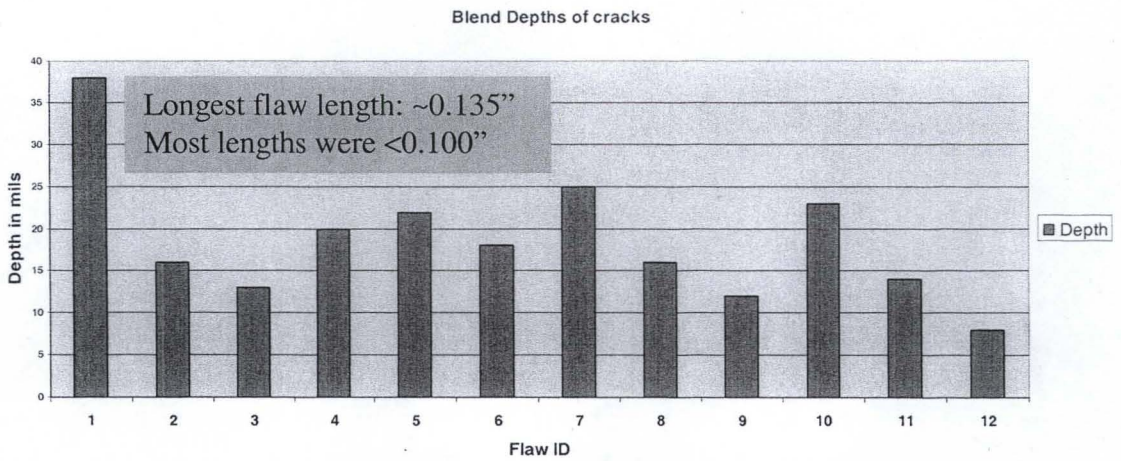
Figure 3: Summary of crack dimensions found on cylinder.

Cylinder	12 – ID membrane; circumferential & longitudinal orientations.	All very small (well below detection requirement for that area - see table 2).	All manufacturing flaws. Part was on 6 <sup>th</sup> refurbishment. Unable to visually detect.	All cracks were verified with local MT and blended out.

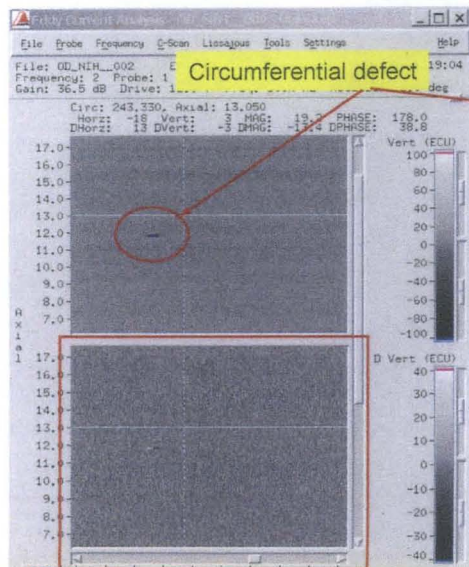
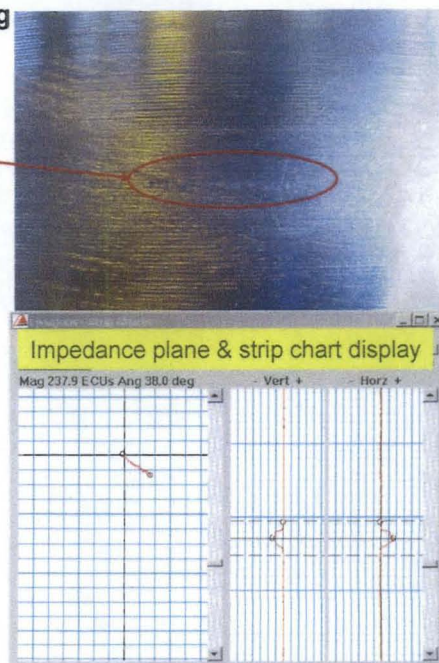
### Aluminum Components - Nose Inlet Housing

- Three separate parts were found with shallow crack-like inclusions
- The very first part (a new part) inspected with the system was found to have several cracks
  - The part surface was machined and very smooth, but all the cracks were in conjunction with pitting (~0.005" deep)
  - Flaws were blended out – deepest was around 0.020"
- Two other refurbished Nose Inlet Housings have also been found with similar defects in the same region of the part,
  - The flaws were typically "long" (still less than 1") and shallow (deepest around 0.030")
  - They correlate with pitting
  - Some of the flaws were visually verified during removal (blending)
- All flaws were manufacturing flaws

Bottom C-scan is filtered image of top C-scan

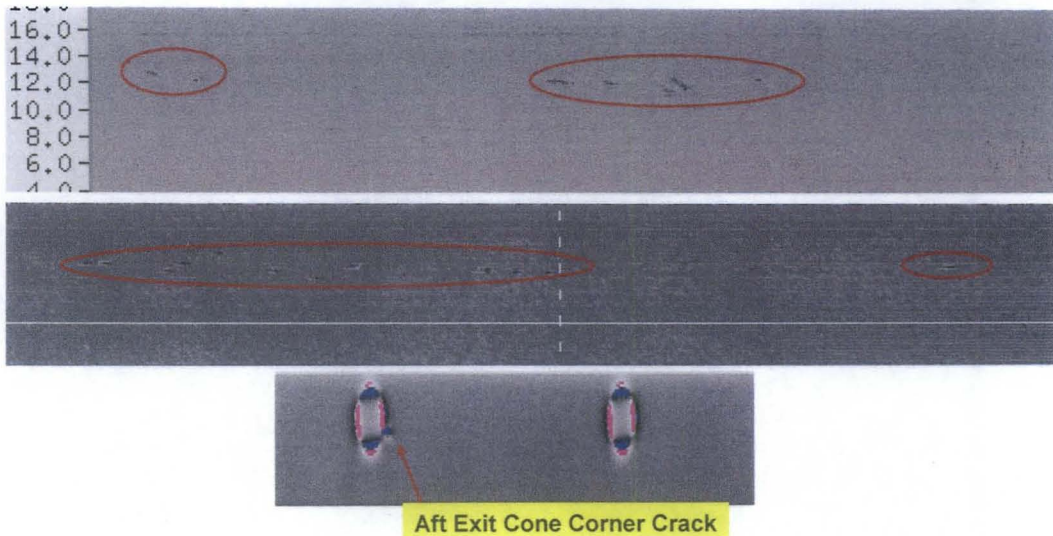
**Aluminum Components - Two other Nose Inlet Housings had similar circumferential defects in the same region (OD membrane). Also, an Aft Exit Cone was verified to have a corner crack (part was initially inspected with penetrant)**

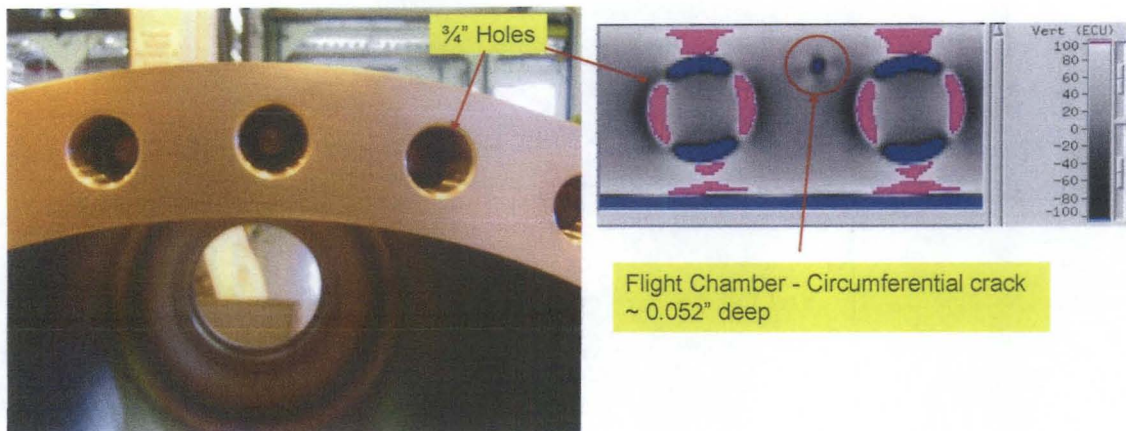
### **D6AC Steel Igniter Chamber**

- Two separate parts found with flaws in the same region
  - One chamber dedicated for flight, the other for testing

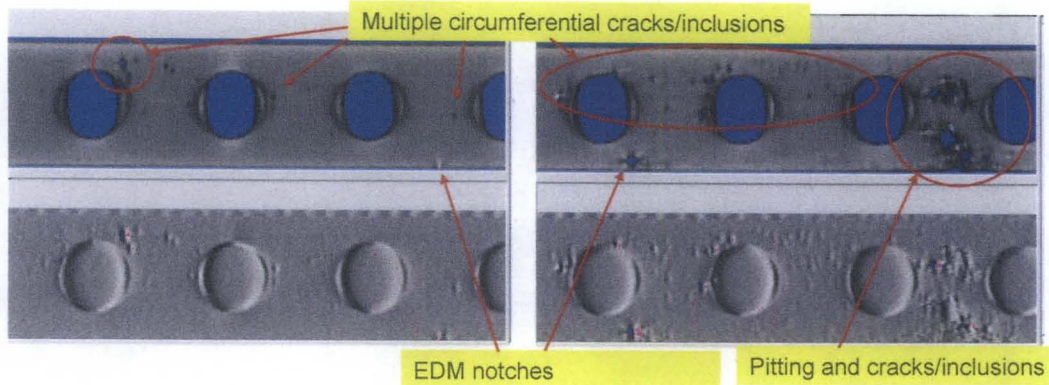
### D6AC Steel Igniter Chamber

- Test article

- Bottom images are the same as the top but they are filtered (differentially)

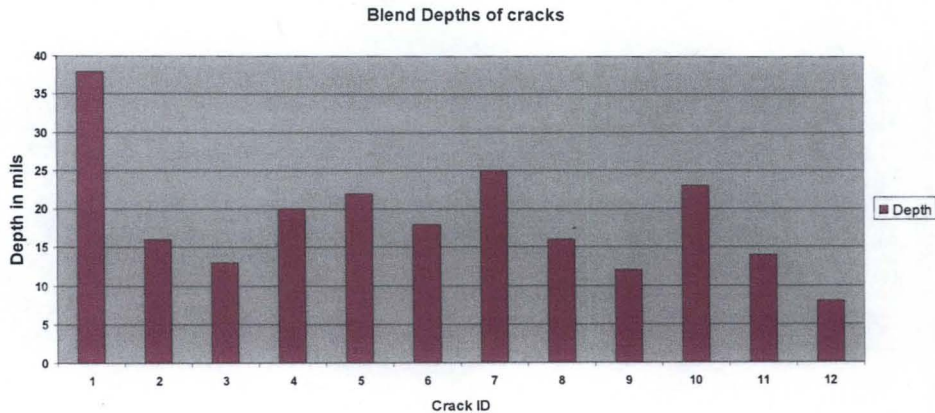
### D6AC Steel Cylinder (Case Component)

- On it's 6<sup>th</sup> refurbishment (i.e., had been inspected multiple times over the years)
- Detected 12 small cracks on the ID membrane of the cylinder
- All cracks were manufacturing flaws with different orientations
- Lengths were on average around 0.100" or smaller (required detection level was 0.250" by 0.125" deep). Depths are summarized below

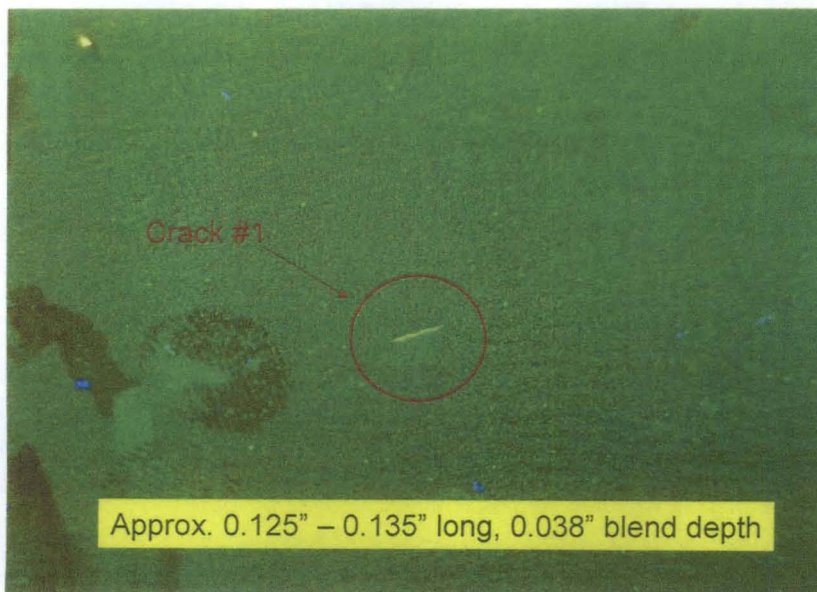
**Crack #1: Mag image of crack using portable yoke with wet fluorescent spray**

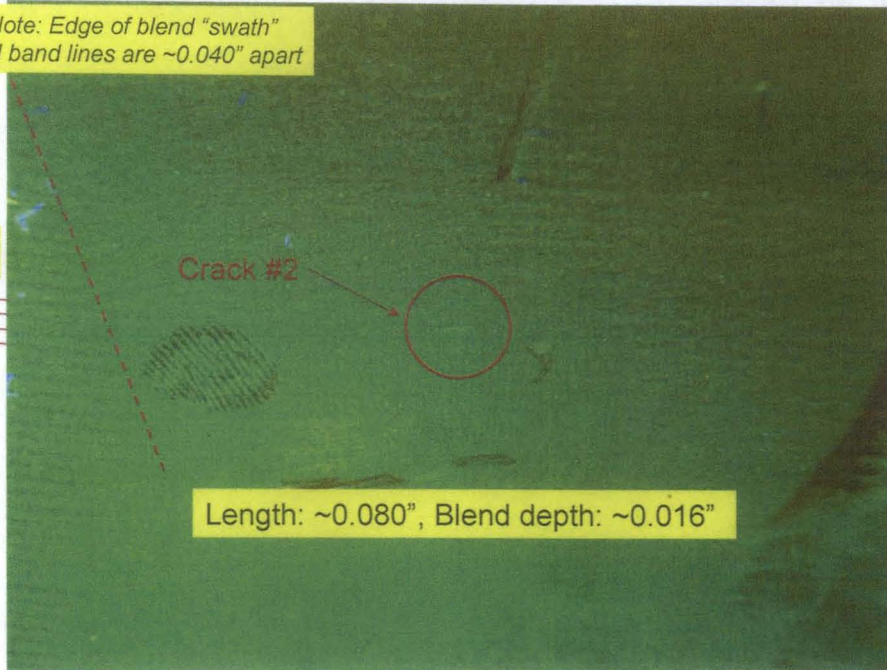
## Crack #2: Mag image of crack using portable yoke with wet fluorescent spray

Note: Edge of blend "swath"  
Roll band lines are ~0.040" apart

Roll Bands  
~0.040" apart
