Dearborn, Michigan
NOISE-CON 2008
2008 July 28-30

Vibroacoustic response of residential housing due to sonic boom exposure: a summary of two field tests

Jacob Klos¹, Ralph Buehrle and Brenda Sullivan
NASA Langley Research Center
Hampton VA, 23681

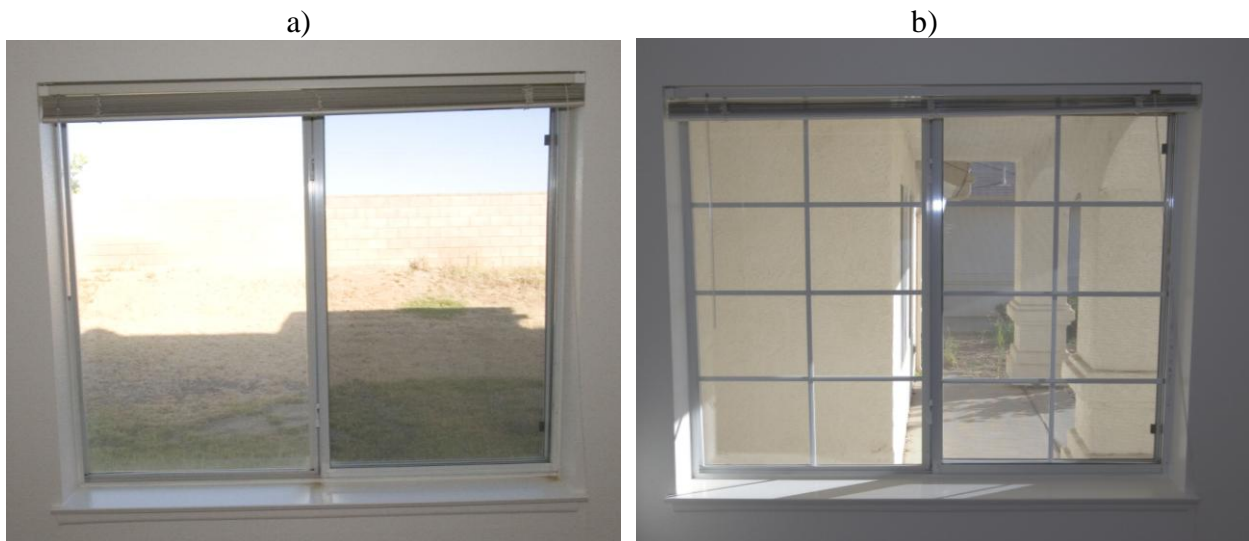
Figure 8: Photographs of the horizontal slider windows in a) the master bedroom and b) the front bedroom of the 2007 house. The right sash of the window is operable. The left is fixed.

truss framed, plywood sheathed, and finished with fiberglass shingles. This roof system formed an attic space above all of the rooms. R-38 fiberglass insulation bats were used in the attic above all of the rooms. Each bedroom had one window and the windows in these three bedrooms were horizontal slider windows, where each window consisted of two glazings (Fig. 8). Each glazing was a double pane insulated glass assembly. An aluminum sash held each glazing, and each sash was installed in a metal frame attached to the house. In between the sash and the frame was a pile type weather-stripping that significantly reduced the potential for direct metal-on-metal rattle at the sash-frame interface. The window in the bedroom by the front door differed from the windows in the other two bedrooms. This window had simulated muntin bars installed in-between the two insulated glass panes (Fig. 8b). These muntin bars were attached to the insulated glass spacer at the ends of each bar, but were not attached to either of the glass panes. Consequently, this lattice was free to vibrate in the gap in-between the two panes. Under even modest excitation of the insulated glass panes, these muntin bars would “slap” each pane as it oscillated back and forth, creating audible noise indoors.
