Dynamic Impact Tolerance of Shuttle RCC Leading Edge Panels Using LS-DYNA

This paper describes a research program conducted to enable accurate prediction of the impact tolerance of the shuttle Orbiter leading-edge wing panels using “physics-based” codes such as LS-DYNA, a nonlinear, explicit transient dynamic finite element code. The shuttle leading-edge panels are constructed of Reinforced-Carbon-Carbon (RCC) composite material, which is used because of its thermal properties to protect the shuttle during re-entry into the Earth’s atmosphere. Accurate predictions of impact damage from insulating foam and other debris strikes that occur during launch required materials characterization of expected debris, including strain-rate effects. First, analytical models of individual foam and RCC materials were validated. Next, analytical models of foam cylinders impacting 6-in. x 6-in. RCC flat plates were developed and validated. LS-DYNA pre-test models of the RCC flat plate specimens established the impact velocity of the test for three damage levels: no-detectable damage, non-destructive evaluation (NDE) detectable damage, or visible damage such as a through crack or hole. Finally, the

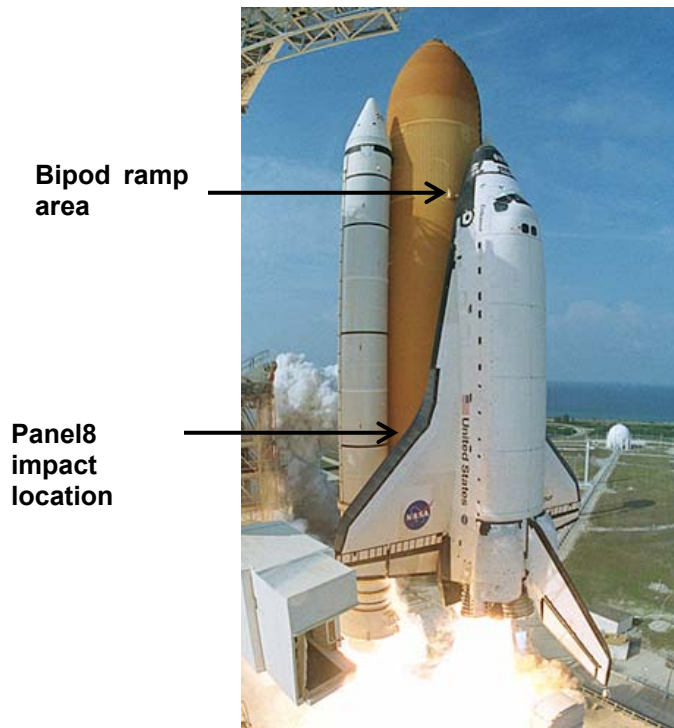
Figure 1. Picture of Columbia showing the bipod ramp area where the foam block was released and the panel 8 location on the left wing where the foam impacted.

block of External Tank (ET) insulating foam from the bipod ramp area that impacted and penetrated the lower portion of a left-wing leading edge RCC panel (see Figure 1). The location of the impact was determined to be the left-wing RCC Panel 8. Consequently, the CAIB sanctioned a foam impact test onto RCC panel 8 in July 2003 at Southwest Research Institute (SwRI) in San Antonio, Texas. In the test, a 1.67-lb. block of foam was shot from a large compressed-air gun and impacted panel 8 at a velocity of 777 ft/s at an angle of incidence of 25.1 degrees in an attempt to simulate the scenario observed approximately 82 seconds into Columbia's flight. The impact resulted in a large 16-in. x 16-in. hole in panel 8.

The foam that brought down Columbia was an abnormally large 1.67-pound wedge of hand-applied foam from the bipod ramp area where the external tank is attached to the Orbiter (see Figure 1). The normal foam debris environment consists of small pieces, each typically only a fraction of a pound. The foam wedge was estimated to impact the left wing of the Orbiter at a velocity of over 700 ft/s. Although the bipod ramp area has been redesigned to use heaters, thus eliminating the large piece of foam, smaller foam debris can still potentially cause serious damage if the impact is at a high velocity at a relatively large incidence angle. According to debris transport analysts, a small piece of foam shed from the external tank stops very quickly in the slipstream, allowing the foam to impact the Orbiter at velocities as high as 2500 ft/s.

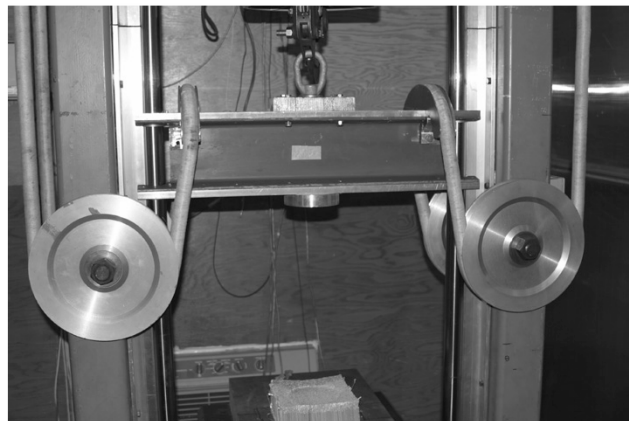
Figure 2. High-speed bungee-assisted drop tower.

These tests are required to develop the physics-based material models for LS-DYNA that include strain-rate data. Much of the high-speed crush testing of foam, ice, and ablators required to develop these LS-DYNA material models was generated using a high-speed bungee-assisted drop tower at NASA Langley, shown in Figure 2.

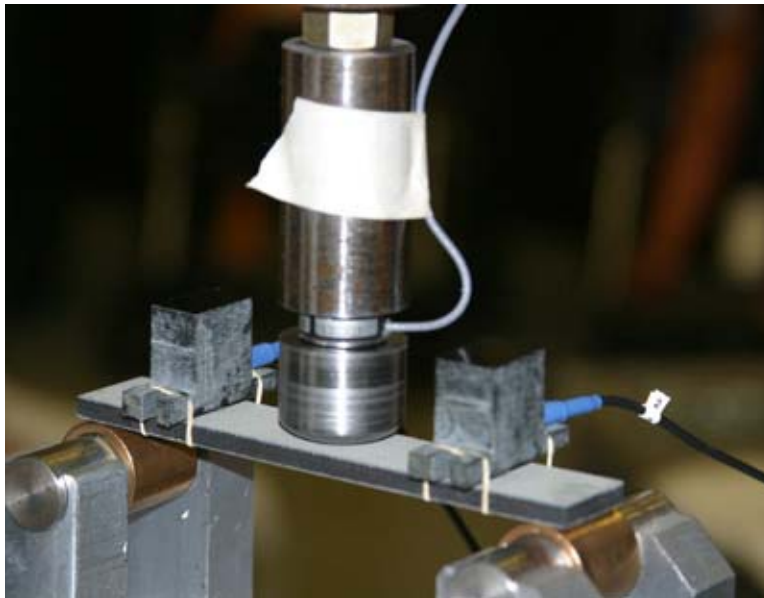
Figure 3. Level 1 three-point bend test of RCC coupon.

Southern Research Institute (SRI) cut twenty 1-in. x 5.8-in. flex coupons, a compression test coupon, a tension test coupon, and a scrap for testing coating crush strength from RCC test panel TC3-11. Static and low-rate dynamic 3-point bend tests of 19-ply RCC coupons 1.0-in. wide x 5.8-in long (5-in. gage length) were conducted with incremental loading and NDE after each load cycle to validate the LS-DYNA RCC threshold of damage predictions. The objectives of the tests were: 1) to study the damage initiation and propagation in the RCC samples under quasi-static 3-point bend loading, 2) to determine the NDE detectable damage threshold, 3) to correlate first-detectable NDE damage with LS-DYNA damage parameters, and 4) to determine if delamination can be initiated in RCC bend tests, and if so, can that delamination be correlated with LS-DYNA damage parameters. A picture of the test set-up is shown in Figure 3.

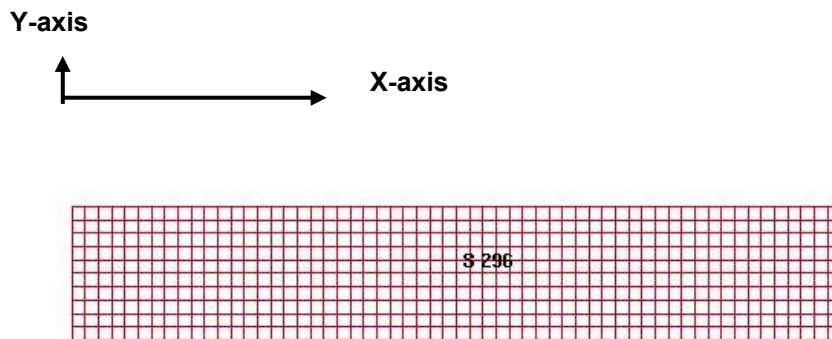
Figure 4. Simple 3-point specimen discretization.

The model discretization is shown in Figure 4. The load was spread over 9 nodes at the center and simple-support boundary conditions were applied at the ends at the positions of the two rollers (see Figure 3).

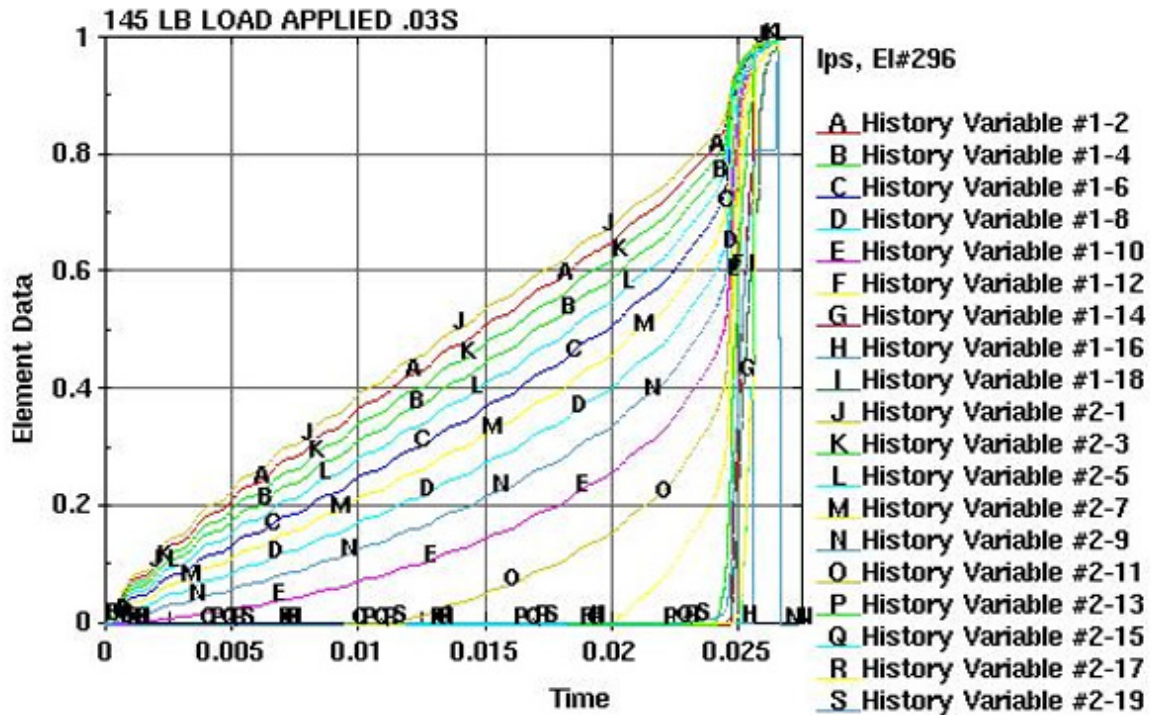
Figure 5. Damage parameter for a center element 296 versus time.

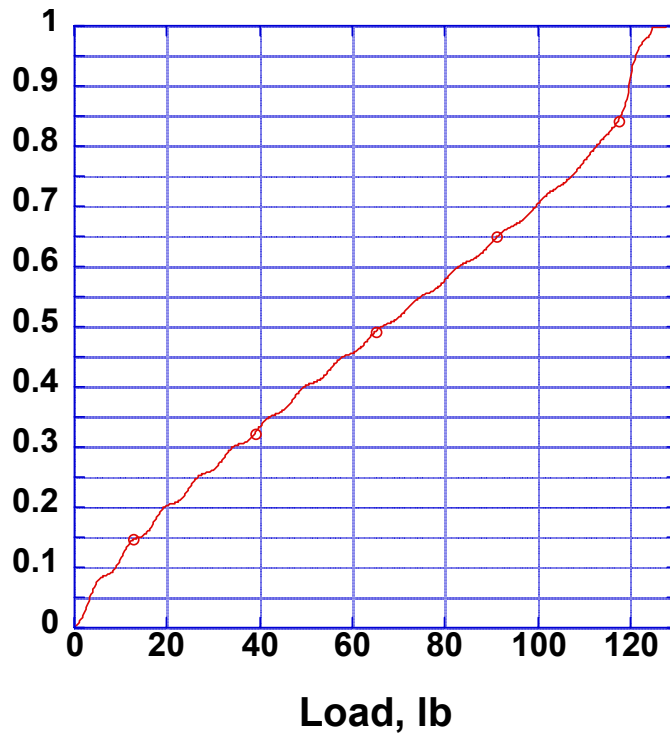
Figure 6. Maximum damage parameter versus load (bottom ply).

was well predicted as shown in Figure 6. First NDE damage was not detected until about 120 lbs, which corresponds to a damage parameter of 0.9 as shown in Figure 6. The initial failure for the bend tests was always a tension crack in the lower ply. Delamination did not occur, or if it did occur, it occurred very late in the loading sequence. For dynamic tests, where NDE damage that looks like internal delamination does occur early in the damage sequence, the maximum damage parameter for NDE-detectable damage ranged from around 0.9 to 0.98, with values 0.95 – 0.97 being typical.

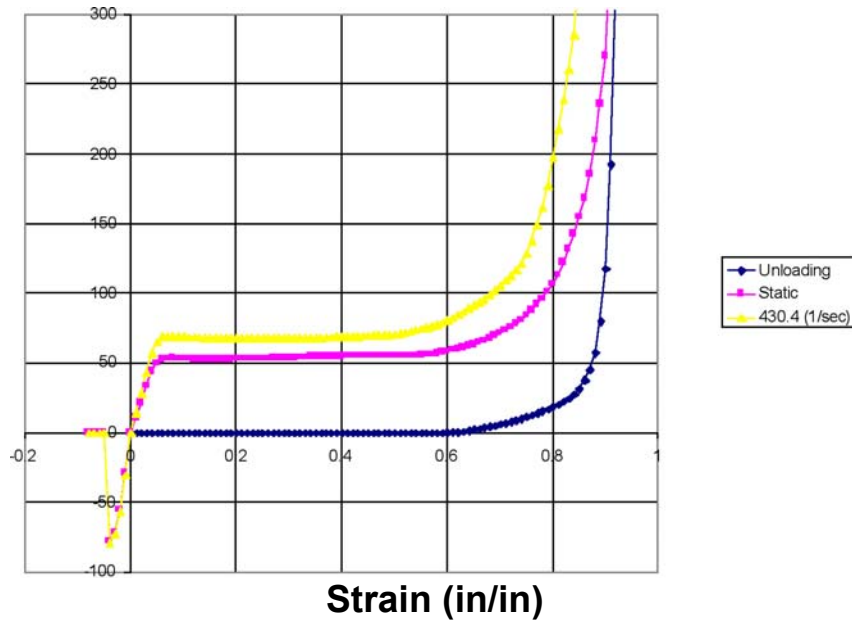
Figure 7. Foam model for BX-265 in the rise direction for room temperature. Note tension is negative.

The external tank foam material representation for the projectile used the Mat 83 MAT_FU_CHANG_FOAM model⁶. Strain rate effects were found to be important in the foam material at the velocities of interest. The external tank foam is a closed-cell polyurethane foam that is sprayed onto the tank in layers. The material strength is direction-dependent with the “rise-direction” having the greatest crush strength. High strain-rate data for the Fu-Chang model was generated in a specially configured and instrumented 14-ft. bungee-assisted drop tower at the Impact Dynamics Research Facility at NASA Langley that can achieve strain rates of over 400/s (see Figure 2). The high strain-rate data were directly input into the Fu-Chang model. Different foam models were created for different orientations and for different temperatures. A series of curves for the BX-265 room temperature foam model is shown in Figure 7.

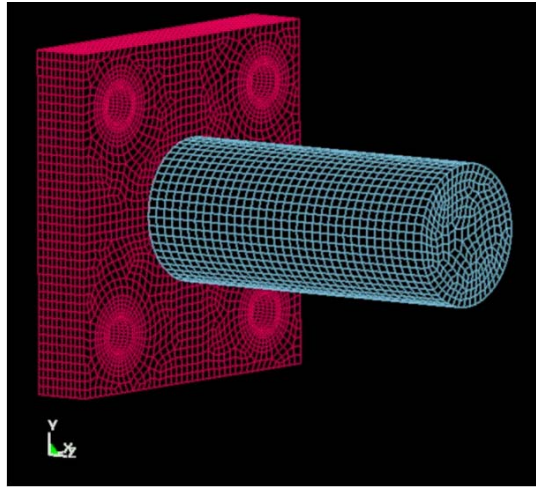
Figure 8. Typical LS-DYNA model of foam impacting an instrumented target.

A typical simulation of a test modeled in LS-DYNA is shown in Figure 8. Both the projectile and target were modeled using solid elements, and the stiffnesses of the load cells were represented as springs.

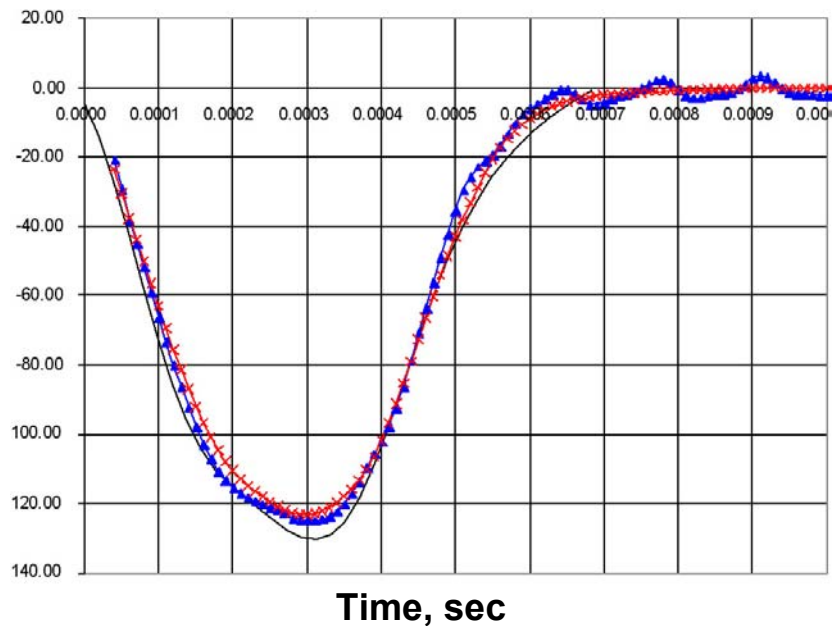
Figure 9. Comparison of test data (black line) with analysis (triangles and crosses) for a 23-degree impact at 693 ft/s.

Comparing the resulting forces of test and analysis, an example of which is shown in Figure 9, shows excellent agreement. The qualitative behavior of the foam analytical model also showed excellent agreement with high-speed video of the test.

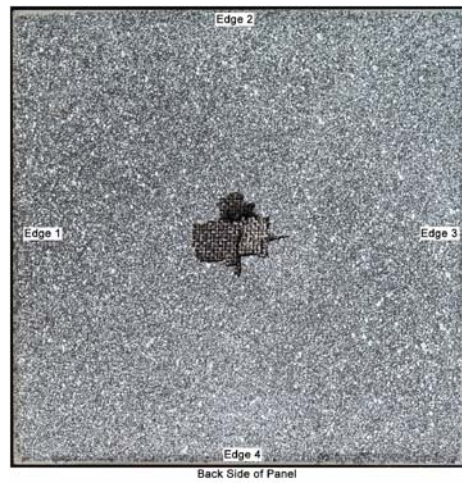
Figure 10. Post-test photograph of the backside of a 6x6-in. RCC flat panel. Coating loss is evident at the center.

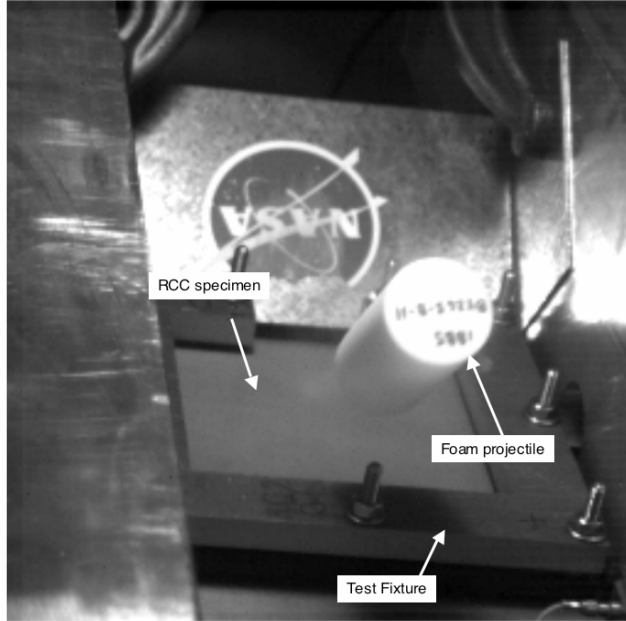
Figure 11. Photograph of 45-degree foam impact onto 6-in.square RCC plate.

The 45° test configuration including a foam projectile just prior to impact is shown in Figure 11. In each test, the RCC panel had dimensions 5.95 x 5.95-in. with a nominal thickness of 0.233-inches. The plate thicknesses have been observed to vary from 0.21 to 0.24 inches. The panels were constrained on the upper and lower surfaces with aluminum half-round rods located 0.16 inches from the four edges. The BX-265 foam projectiles were nominally 1.5 inches in diameter and 3.0 inches long with a mass of 3.0 grams. The following information was also acquired for each test: impact velocity, pre- and post-test photographs, pre- and post-test non-destructive evaluations, and dynamic displacements using the Aramis photogrammetry system.

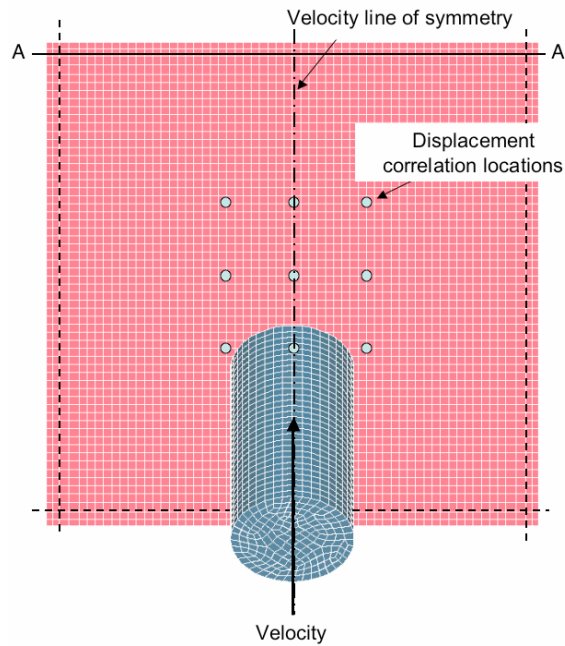
Figure 12. LS-DYNA model of foam cylinder impacting RCC panel at 45-degrees.

A typical model of an LS-DYNA simulation of the impact of a 1.25-in. diameter foam cylinder onto a 6x6-in. flat plate of 19-ply RCC material is shown in Figure 12. Various boundary conditions were simulated to bound the actual response. The flat plate was restrained at 0.1625-in. from the edges by round aluminum rods in a picture-frame configuration. Thus, the nominal dimensions of the model were 5.675-in. x 5.675-in. The units used in the LS-DYNA model for length, mass, and time were inch, pound/g, and seconds. The RCC plate was 6 x 6 in., with a shell element edge length of 0.1 in. Idealized boundary conditions were applied at the locations matching the test. Specifically, the out-of-plane displacements were constrained along three edges as represented by the dashed lines in Figure 12. The displacements, both out-of-plane and in-plane perpendicular to Line A-A, were constrained. No rotations were constrained at the boundaries. The RCC material properties and plate thickness were adjusted for

each impact to agree with test documentation. The foam projectile was modeled as room-temperature, BX-265 foam using 5250 solid elements. The foam dimensions were 1.5 inches in diameter and 3.0 inches long. The density of the projectile foam was varied to match the test-specific projectile masses. The RCC material was characterized using the LS-DYNA Mat 58 material model.

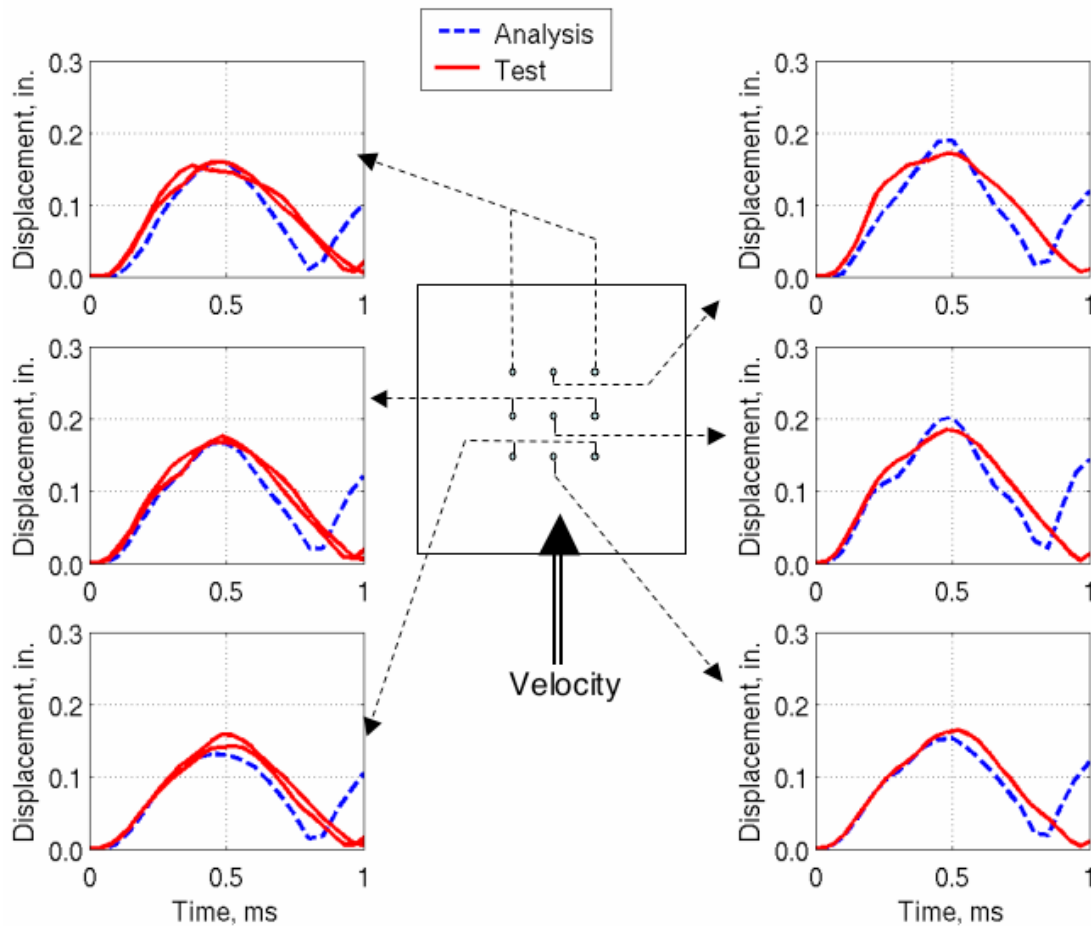
Figure 13. Sample comparison of experimental data and analytical results for test R285-10 @ 1837 ft/s.

Detailed test-analysis correlations were performed for each test. An example of correlation results is shown in Figure 13 for test R285_10, which occurred at 1837 ft/s. This particular test was selected because the damage is very close to the NDE-detectable limit. Several things should be noted. Symmetric locations are plotted on the same figure in the left-hand column. The symmetry in the simulation is nearly ideal and therefore no distinction is discernible for the analytical results. The difference in the experimental results for symmetric locations is small indicating that a nearly symmetric response was measured. The figures in the right-hand column show comparisons for the middle locations. The comparison of the time histories is very close for all locations.

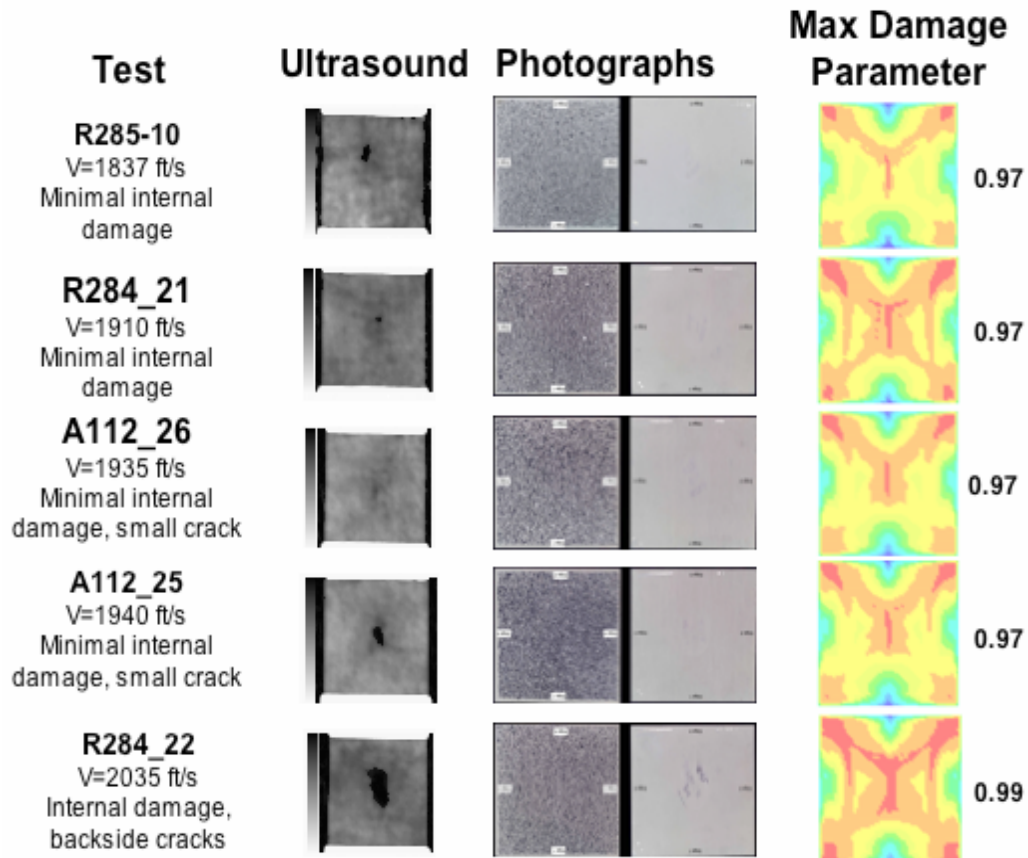
Figure 14. Comparison of measured and predicted damage for lower velocity impacts.

A qualitative comparison of measured and predicted damage is shown in Figures 14 and 15. The cases shown in these figures represent impact velocities above the NDE-detectable damage limit of RCC. Both test and analysis indicate a similar amount of NDE internal damage for impacts ranging from 1837 to 1940 ft/s (Figure 14). The maximum damage parameter of 0.97 correlated best with the threshold of NDE-detectable damage. For test R284-22, the maximum damage parameter was found to be 0.99 and backside cracks were seen in addition to the large black area of internal damage seen in the ultrasound image. At the higher velocities, both the test and analyses show significant damage to panels emanating from the center and progressing to the corners furthest from the impact site as can be seen in Figure 15. Note the damage parameter of 1.0 indicates that RCC shell elements have been deleted, which corresponds to a through crack in the test. Also, notice that the diagonal or V-shaped front-side surface damage shown in Figure 15 follows the trends of the damage parameter contour plots.

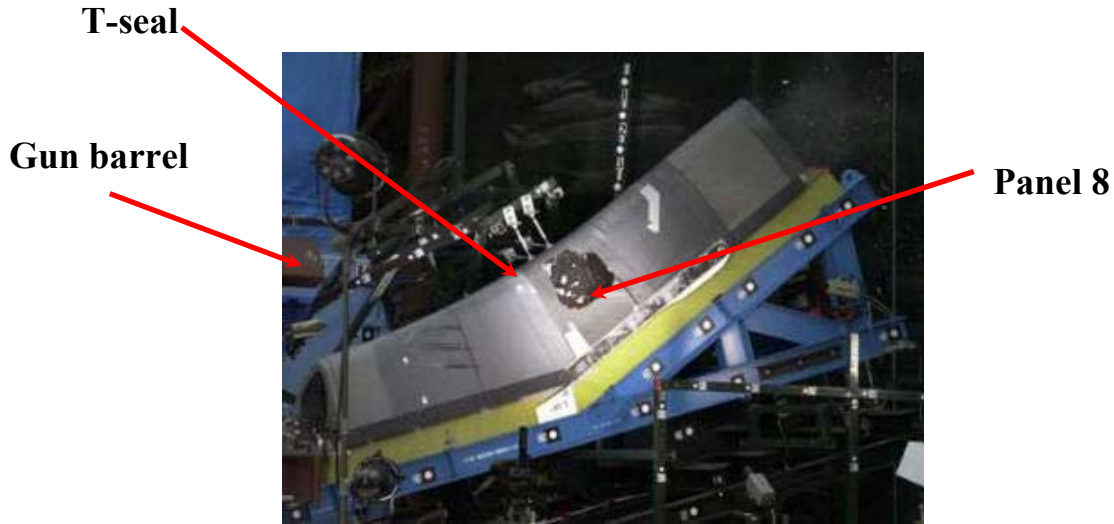
Figure 16. Post-test photo illustrating the test set-up at SwRI with panels 5 through 10 and associated T-seals on the test rig.

The setup of panels 5 through 10 with T-seals between panels is shown on the test-rig at SwRI in Figure 16. The gun barrel was rotated such that the front edge of the foam would align with the RCC panel to produce as much contact surface as possible.

The most obvious result from the test was the large 16-in x 16-in hole in panel 8 shown in Figure 16. In addition to high-speed photographic data, photogrammetric measurements were made of the panel behind the area of the foam impact. Also, strain gages, accelerometers, and load cell transducers were used on the test article to obtain time histories of the impact event.

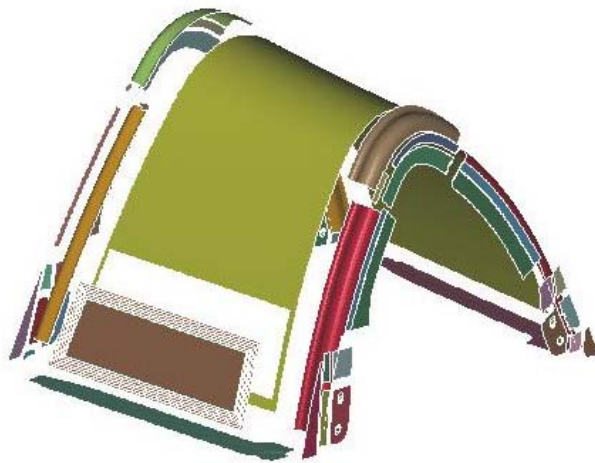
Figure 17. Exploded view of parts of the LS-DYNA 2004 model.

The 2004 post-test panel 8 model used to determine threshold of damage for return-to-flight is illustrated in Figure 17. Each LS-DYNA defined “part” is given a different color. The nominal edge length of a typical element away from the ribs is 0.2-in. The chord length of panel 8 is about 2 feet.

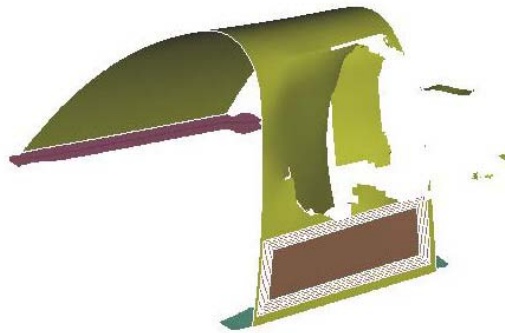
Figure 18. LS-DYNA model, with panel ribs and foam removed for clarity, at 5 ms after impact.

The damage that occurred to Panel 8 test was truly catastrophic. Consequently, the primary comparisons made of the test results with analysis are the damage pattern that occurred and photogrammetry data. The predicted damage to the panel is shown in Figures 18 and 19, and the damage that occurred in the test is shown in Figure 20.

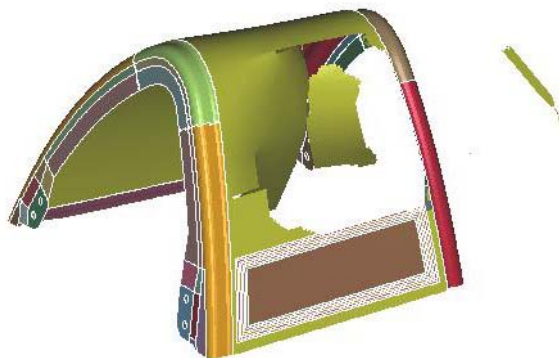
Figure 19. LS-DYNA 2004 model showing panel damage 10 ms after impact.

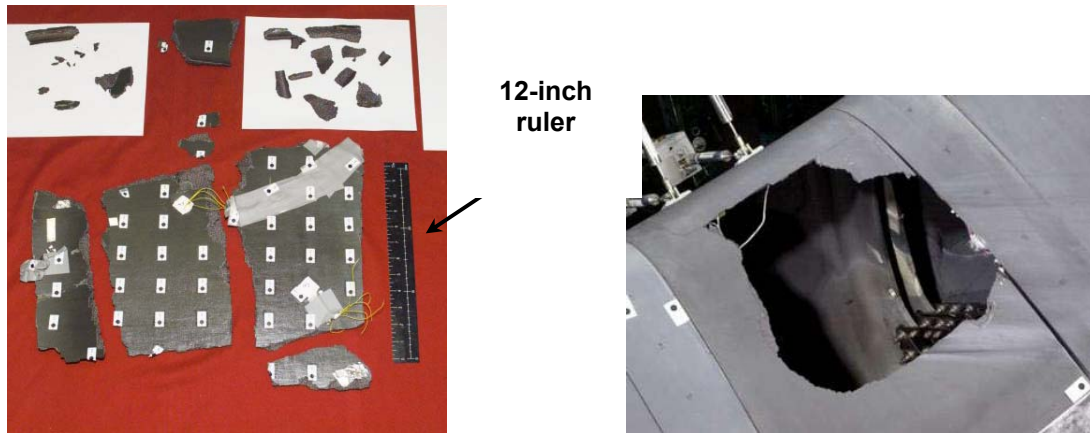
Figure 20. Panel debris showing photogrammetric targets on the back side (left) and the damage to panel 8 (right).

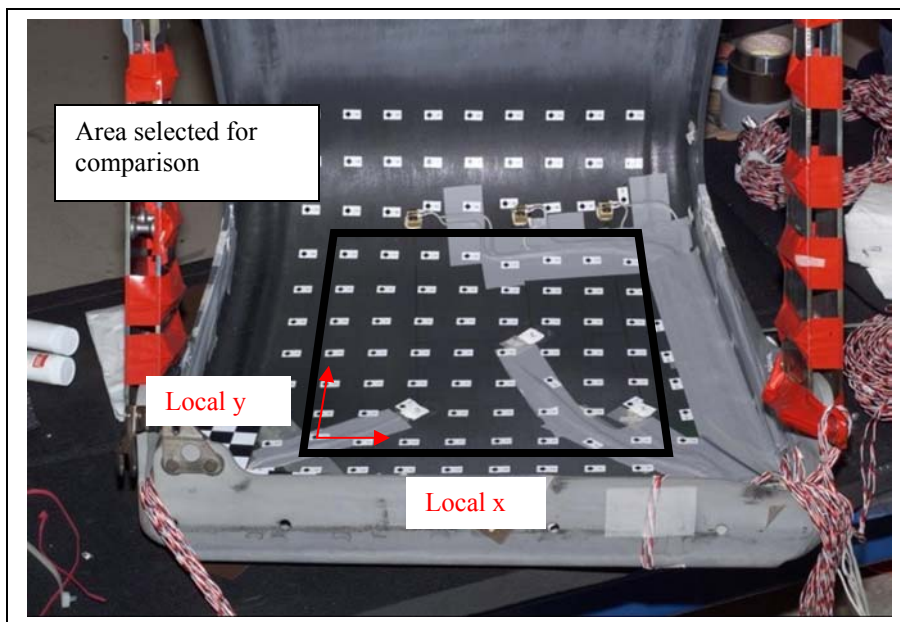
Figure 21. Location of photogrammetric targets on Panel 8 prior to impact. Box outlined in black indicates area of interest.

The three-dimensional motion of over 100 optical targets on the inside of panel 8 were tracked using photogrammetry (Figure 21). The motion was tracked semi-automatically using two Phantom 5 digital video cameras that captured 2,000 to 7,000 frames per second. The videos were analyzed by the Image Science and Analysis Group (ISAG) at the NASA Johnson Space Center (JSC). The ISAG examined the position and velocity of each point looking for discontinuities in its trajectory. Spatial continuity was then assessed by comparing the motion of each point with other points in the same row and column.

Since the local axis system shown in Figure 21 did not align with the model axes, the photogrammetric data were further processed to obtain the resultant displacement of each point versus time. Resultant displacement, a scalar quantity independent of the coordinate system, was used for the comparisons with the analysis because of the uncertainty in the coordinate transformation between the measured data and the finite-element model.

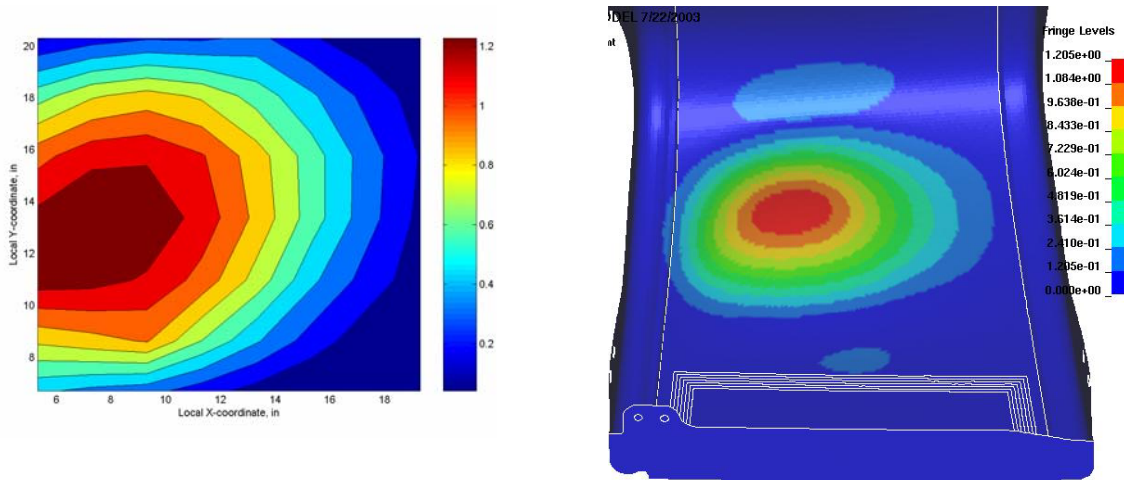
Figure 22. Comparison of measured (left) and predicted (right) deflections at 2 ms after foam impact. The maximum deflection contour for both plots is 1.2 inches.

is the last data point that existed for all of the selected points. A typical comparison of test with analysis is shown in Figure 22 at 2 ms after the foam impact.

The deflections measured using photogrammetry compare well with the analytical results and thus can be used to evaluate the simulation results up to the point where the measured data is no longer available. It is assumed that by 3 ms the panel had catastrophically failed. With the success of the Aramis photogrammetric system demonstrated in the Level 2 testing of the 6-in. x 6-in. plates, full-scale panel testing also began using the Aramis system in 2004.

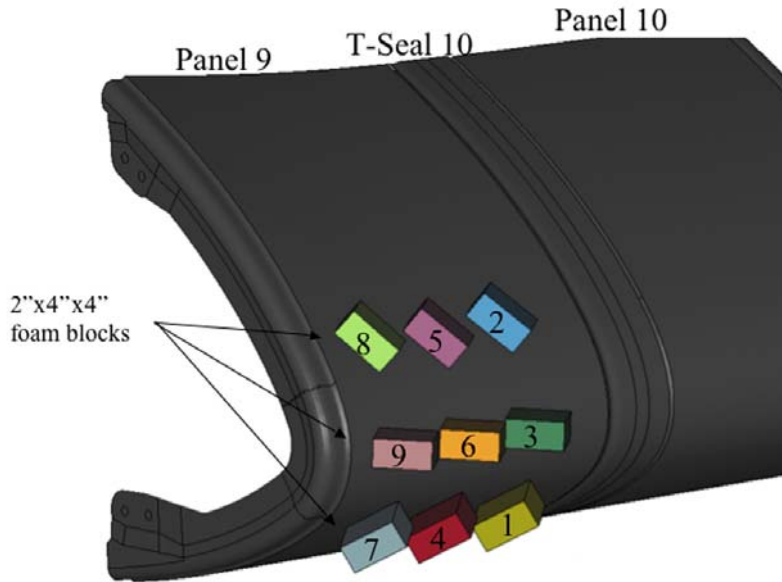
Figure 23. The location of the 9 foam impact tests onto panel 9.

For the upper and lower surface and apex, three impact velocities were defined using LS-DYNA predictions. The lowest impact velocity should produce no detectable damage, the middle impact velocity should have a 50% chance of producing damage such as delamination, and the highest impact velocity should produce severe damage such as a through crack. The projectile was a block of BX-265 foam with dimensions 2 in. x 4 in. x ~4 in. long weighing 0.044lbs. To account for foam density variations, the lengths of the blocks were adjusted so that the weight of each block was 0.044 lbs.
