# Kevlar<sup>®</sup> 49/Epoxy COPV Aging Evaluation

James K. Sutter, Jonathan L. Salem and John C. Thesken  
NASA Glenn Research Center at Lewis Field

## Abstract

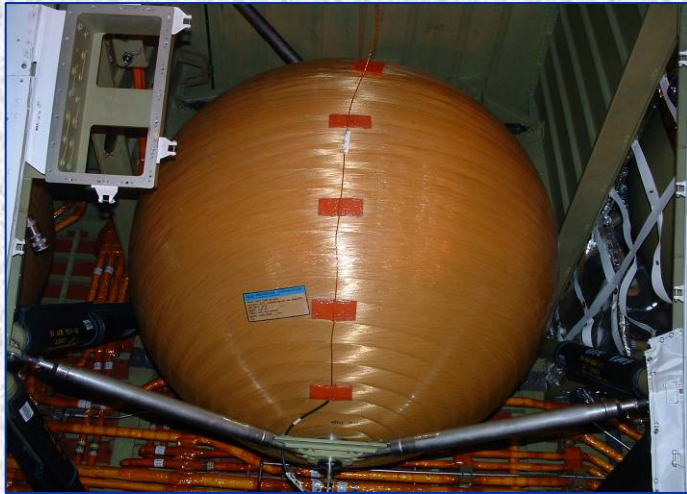
- 1. Fore/Aft RCS Helium
- 2. ECLSS Nitrogen
- 3. ECLSS Oxygen
- 4. MPS Helium
- 5. OMS Helium

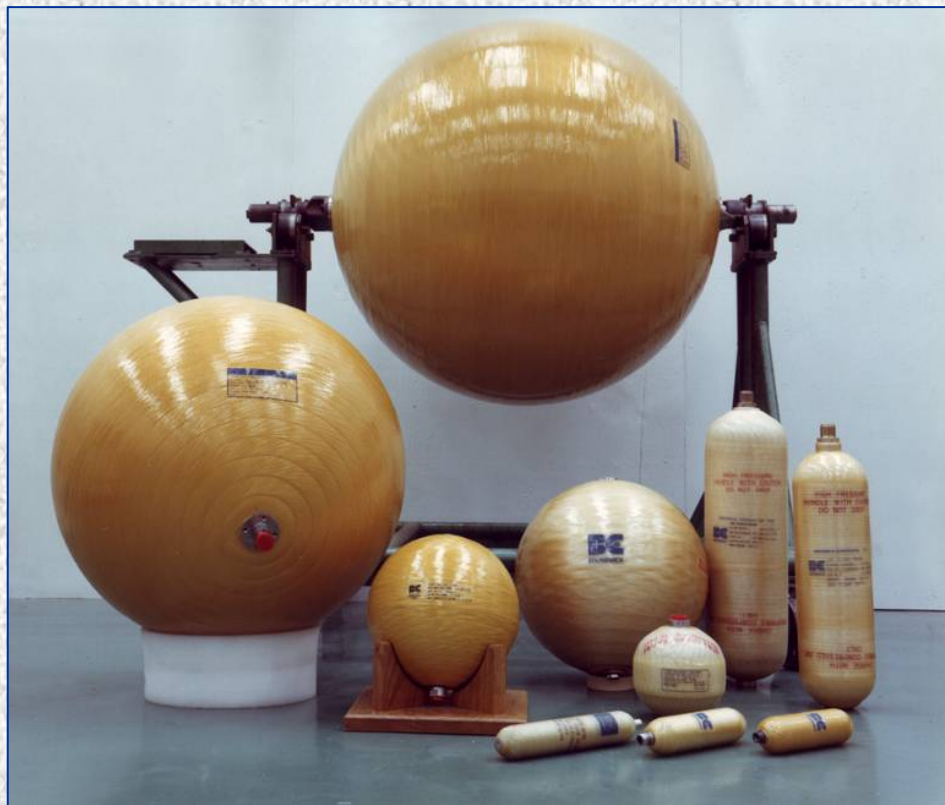
- Liner
  - Pressure-tight
  - Metal or plastic
  - Permeation barrier
  - Leak-before-burst (LBB)
  - Failure can be catastrophic

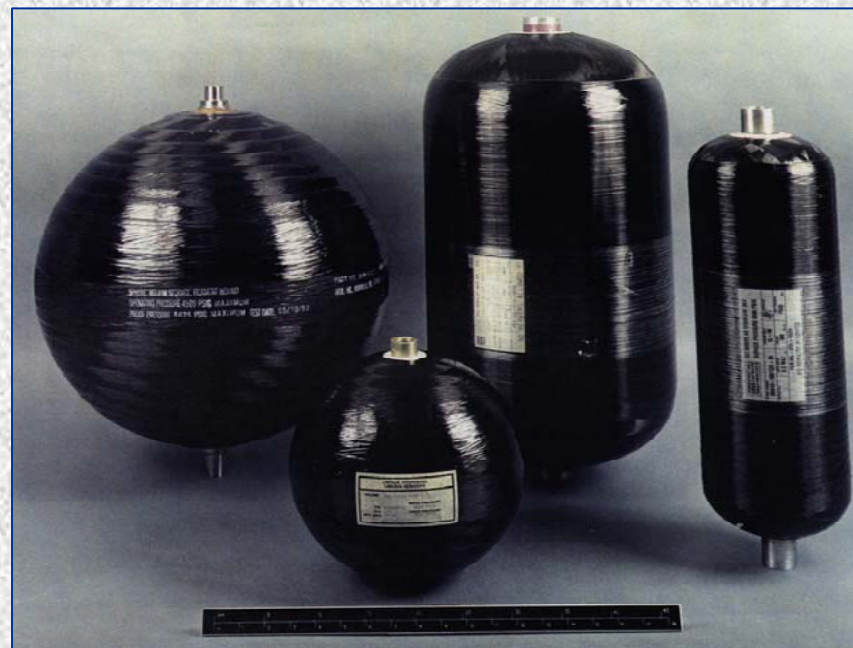
- Composite overwrap
  - Fiber & resin
  - E- or S-glass, Kevlar<sup>®</sup> 49, Carbon, Spectra
  - Epoxy matrix
  - Encapsulates liner
  - Provide strength
  - Failures result in catastrophic high energy releases

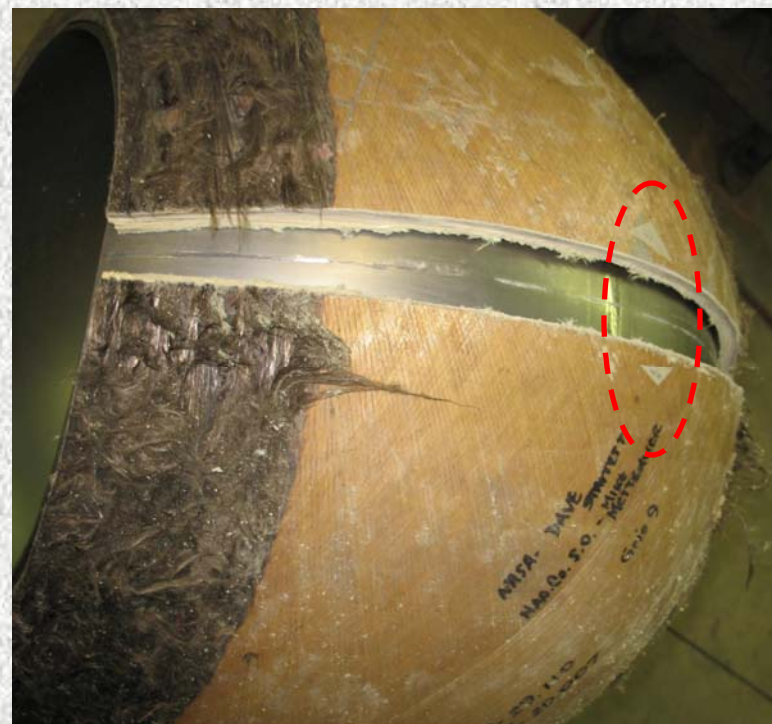
Apparent Residual Stress

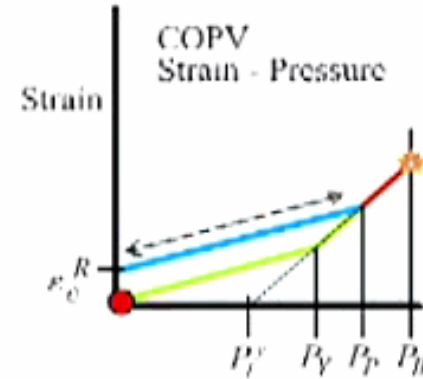
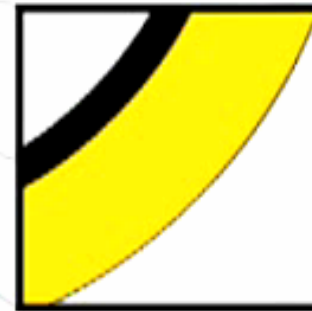
# COPV Proof Process Affects Overwrap Stress

$P_l^y$  - Liner Pressure Share Equivalent to Flow Stress of a Perfectly Plastic Liner

$P_y$  - Vessel Pressure that Initiates Plastic Flow in the Liner

$P_p$  - Vessel Proof Sizing Pressure

$P_B$  - Vessel Burst Pressure

$\epsilon_c^R$  - Residual Strain Due to Proof Sizing

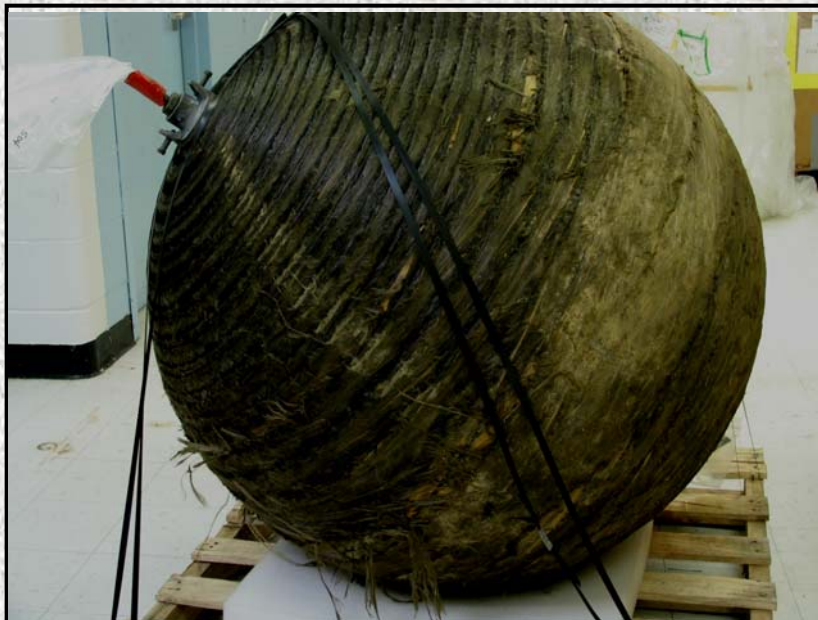
- S/N 029 Columbia OV-102 COPV ~ 25 yrs old
  - Survived reentry
  - Composite Interior Provided Good Samples
  - Manufactured by Brunswick Composites (GD)

**Columbia OV-102 COPV (40 inch)  
Model S/N 029 Damaged Outer Shell**

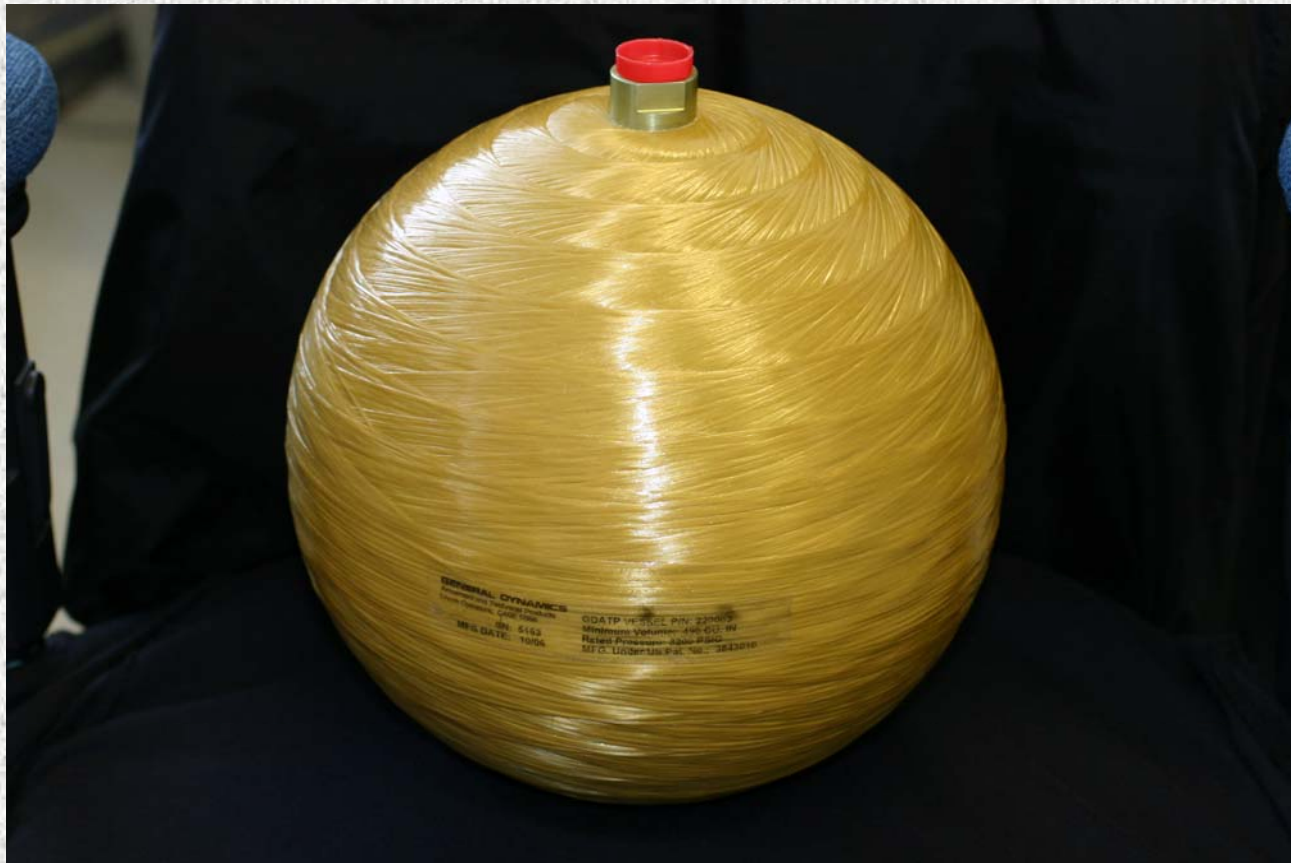
- New 10 inch Kevlar® 49/LRF-092 COPV (390 in<sup>3</sup>)
- Manufacturer is General Dynamics – Lincoln Composites
- Same fiber and epoxy as Orbiter COPV S/N 029 and 011

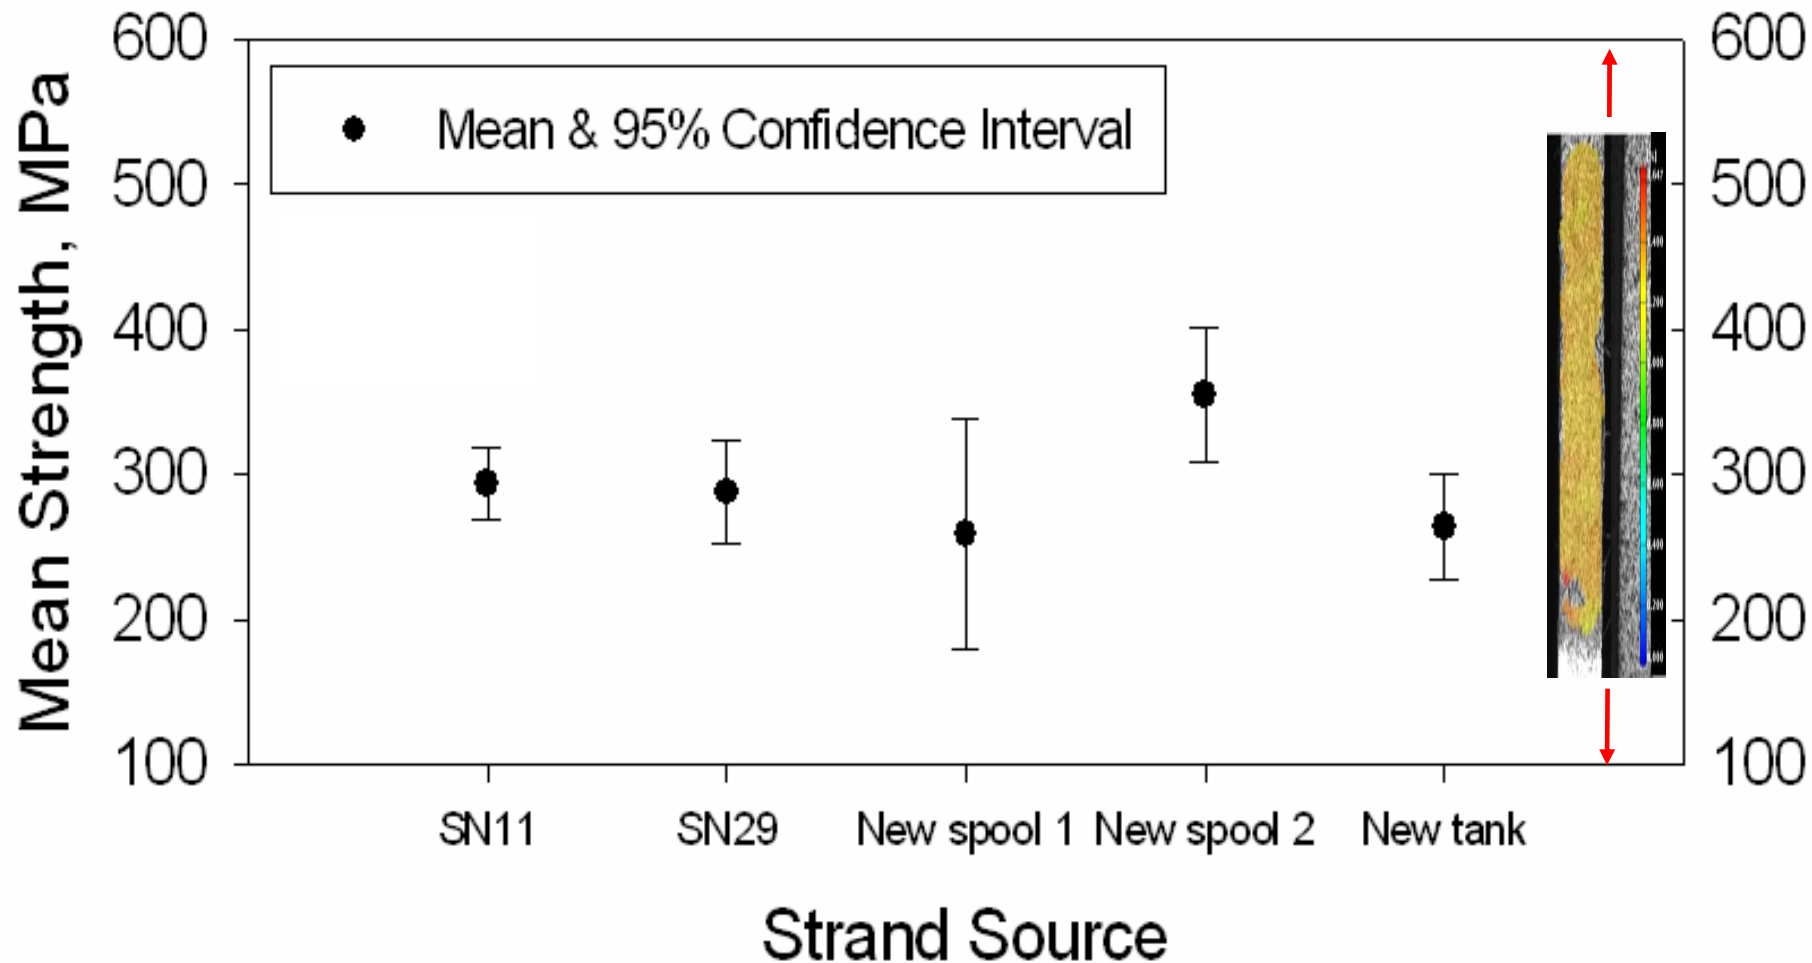
No Significant Difference in Tensile Strengths

- Tensile strengths for unaged and aged composite strands shows no significant difference
  - Differences in COPV residual volumes not detected in tensile strength tests
  - COPV manufacturing and operation environmental difference not apparent through tensile tests
- Thermal Analyses for unaged and aged composites shows no significant differences in  $T_g$ 
  - Aged Composite  $T_g$  are comparable General Dynamics reported values in 1978
- Columbia (OV-102) COPV S/N029 composite interior
  - Pristine appearance despite reentry after accident
- Future Work
  - Full-Scale COPV stress rupture underway
  - Raman Spectroscopy: useful composite overwrap strain measurements
