Testing of a Microwave Blade Tip Clearance Sensor at the NASA Glenn Research Center

Mark R. Woike¹, James W. Roeder², Christopher E. Hughes³, and Timothy J. Bencic⁴ *NASA Glenn Research Center, Cleveland, Ohio, 44135*

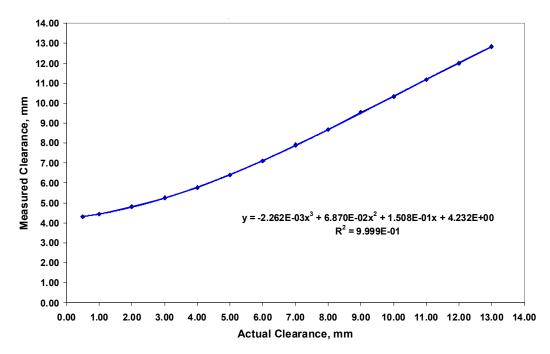
The calibration curve for a microwave probe using the thin compressor blade is shown in Fig. 5. The y-axis is the "measured" or uncorrected clearance reading that was acquired from the probe. The x-axis is the actual clearance. It represents the distance between the simulated fan casing, with sensor, and the tip of the blade. The calibration was done over a range of 0.5 to 13.0 mm. The resulting curve is a third-order polynomial and has fairly good sensitivity at clearances above 2 mm. At clearances lower than 2 mm, the response flattens out and the sensor becomes less sensitive. This effect is believed to be caused by the near field properties of the probe's antenna and its interaction with the geometry of the relatively thin blade. The curve observed in Fig. 5 was a typical response when using the probes on a thin blade when compared to the probes diameter. For this calibration the sensor's polarity was aligned to be parallel with the length of the blade tip to maximize the amount of energy reflected from the blade.

Figure 5. Calibration curve for thin blade.

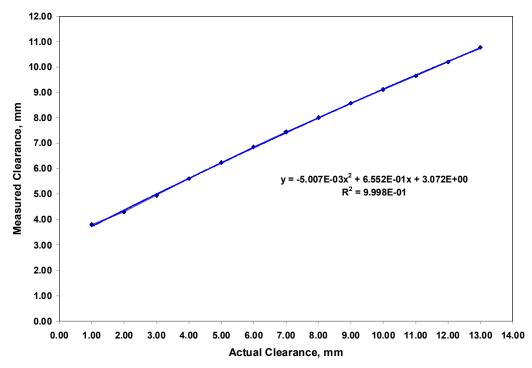
Figure 6 shows the calibration curve for the same probe against the simulated thick blade. This calibration was undertaken as a means of capturing the necessary correction data for measuring the tip clearances on a large axial vane located at the NASA Glenn Research Center. As in the previous case, the y-axis is the "measured" or uncorrected clearance reading that was acquired from the probe. The x-axis is the actual clearance distance between the simulated fan casing, with sensor, and the tip of the blade. The calibration was done over a range of 1.0 to 13.0

Figure 6. Calibration curve for simulated thick blade.

mm. The resulting curve is a second-order polynomial and has a relatively constant sensitivity over the entire range. For this calibration the sensor's polarity was aligned perpendicular to the length of the blade tip. A similar shaped curve, with slightly different values, was observed for the calibration where the probe's polarity was aligned parallel to the thick blade's tip. The curve reported in Fig. 6 was a typical response when using the probes against a blade whose thickness was of the same order of magnitude or greater than the diameter of the probe. As a means of evaluating the overall accuracy and repeatability associated with the calibrations on the thick blade, both the probe and blade were reset and the experiments were repeated across the entire range with the clearance corrections applied to the measurements. The worst case error that was observed between the actual distance and the corrected distance measured by the sensor in these verification tests was ~0.15 mm. It is believed that a portion of this error can be attributed to inaccuracies and biases associated with the calibration setup. In subsequent calibrations on a turbofan blade, improvements in the calibration setup resulted in errors that were much smaller. This calibration is presented in section V of this paper. In summary the calibrations against the thin blade and the simulated thick blade were primarily undertaken as a means to better understand the probes and develop techniques for their calibration. These objectives were achieved and the probes were successfully calibrated against two blade geometries.

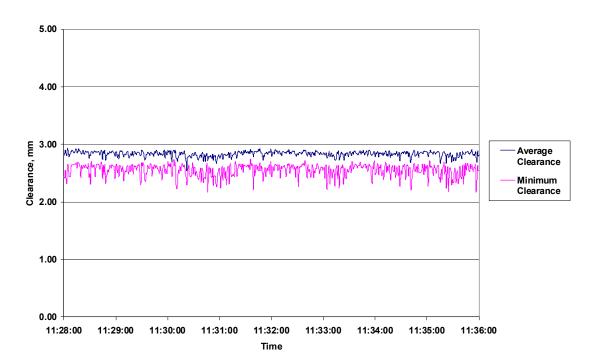
A time history of the average and minimum clearances measured for an operation of the vane fan is shown in Fig. 9. For this particular test run the probe was installed so its polarity was aligned perpendicular to the length of the blade tips. The data was acquired at a fixed sampling rate of 400 KHZ over an 8-minute period of the fan operating at a steady state condition of 1200 RPM. The average blade tip clearance for the 16 blades over this time period was 2.84 mm. The minimum clearance detected over this period was 2.17 mm with average minimum running at 2.55 mm. These measurements were consistent with the expected operation of the vane fan and are in line with the clearance measurements that were made statically. For comparison, the measurements that were made statically at this probe's location yielded a 16-blade average tip clearance of 3.33 mm and a minimum blade tip clearance of 2.87 mm. The approximate half a millimeter difference between the static and running clearance measurements was due to blades locking in their seats during fan operation. This effect is hard to duplicate when making static measurements. Other test runs were accomplished by varying the probe's polarity (parallel to the blade tips) and acquiring data using different acquisition modes (fixed sample rate vs. synchronous sample rate). The results of these runs were similar in magnitude to the results shown below. However, it was observed that for the fan's "thick" blades, a cleaner, less noisy signal was obtained with the probes polarity aligned in perpendicular to the length of the blade tip.

Figure 9. Average and minimum clearance time history for axial vane fan operation.

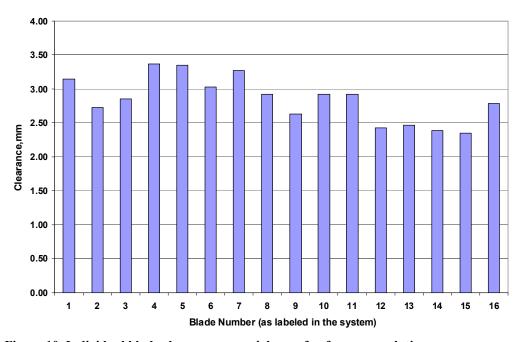
In regards to the sensors' ability to detect individual blade clearances, Fig. 10 shows the individual clearances that were measured for one revolution of the fan. The x-axis displays the blade number and the y-axis displays the measured tip clearances in millimeters. For this particular revolution the measured clearances ranged from 2.34 to 3.37 mm, with the variation in clearances between blades being on the order of tenths of millimeters. As previously indicated these clearances are in-line with the expected operation of the vane fan.

Figure 10. Individual blade clearances on axial vane fan for one revolution.

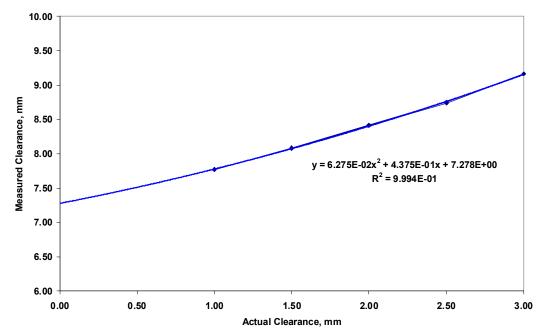
In order to make the tip clearance measurements on the turbofan a series of calibrations were carried out to map the actual clearance to the uncorrected clearance measured by the sensor. The calibration was done using the previously described calibration rig with an actual blade and the probes installed in a section of the fan casing. This setup allowed the calibration to be done in a configuration that was as close as possible to the actual use on the turbofan. It also allowed the offset due to the probe being recessed in the non-ferrous rub strip to be included in the calibration. For this application the sensor's polarity was aligned to be parallel with the length of the blade tip to maximize the amount of energy reflected from the blade. The calibrations were accomplished over a range from 1.0 to 3.0 mm between the tip of the blade and the fan casing. The calibration curve for one of the probes is shown in Fig. 12. The y-axis is the "measured" or uncorrected clearance reading that was acquired from the probe. The xaxis is the actual clearance distance between the fan casing and the tip of the blade. The resulting curve is a secondorder polynomial and shows good sensitivity over the range of calibration. One issue involved with the calibration is that the clearances on the turbofan were expected to be a little under a millimeter. Due to the particular geometry of this setup obtaining a repeatable calibration of distances under a millimeter between the fan casing and blade was not possible. However, since the probes had a second-order response in the targeted calibration range, it was determined that accurate results could be obtained in projecting the curve fit for clearances that were a little under the calibrated range. This assumption held true in previous calibrations. As a means of evaluating the calibration and its repeatability, a verification test was conducted by resetting the probe and repeating the measurements across the entire range with the clearance correction curve being applied to the measurements. The largest difference that was observed between the actual clearance and the corrected clearance in this verification was ~ 0.05 mm. This was a major improvement when compared to the errors observed in previous calibrations.

Figure 12. Calibration curve for nickel tipped composite blade.

It needs to be acknowledged that these calibrations were accomplished after the probes were used on the turbofan. This was done because the calibrations accomplished prior to the test entry were not done with the same probe alignment and system settings that were used when acquiring data from the turbofan. In addition, prior to testing, it was noticed that one of the probes was not providing a strong signal and was replaced with a spare probe that had not been calibrated for this application. The clearance data acquired from the turbofan was reprocessed using the correction curves generated during the post calibration. Normally, a pre-test calibration is sufficient if the settings and geometry used in the calibration are consistent with the actual use on the fan or engine.

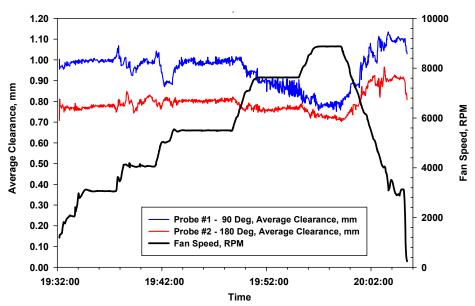
Blade tip clearance and tip timing data was acquired for several test runs of the NASA turbofan. Data was acquired at a variable sampling rate that was synchronized to the fans speed. Each measurement consisted of two revolutions of data with 10,000 samples taken per revolution. Good clearance data was acquired in this experiment. Figure 13 shows the 18-blade average tip clearance measurements and the fan speed for one of the test runs. From these charts it is observed that the average tip clearance decreases as the fan speed is increased. This result is expected and is mostly due to the growth of the composite blades as the fan operates at higher speeds. Probe #1 measured a decrease of 0.22 mm and probe #2 measured a decrease of 0.06 mm as the speed increased to 8875 RPM. The change in clearance observed in this experiment was within the range predicted for these blades. In addition, the change in tip clearances measured by the microwave sensors were very similar to previously observed values. In a previous test entry using capacitive clearance sensors, changes in tip clearances up to 0.22 mm were observed when the turbofan was operated over the same speed range.

Figure 13. Average Blade Tip Clearances and Fan Speed from the NASA Turbofan Experiment.

One anomaly that was observed in the data of Fig. 13 is the difference in the absolute clearance values measured by each of the probes. The average blade tip clearance measurement made at static conditions for probes #1 and #2 was 0.86 and 0.91 mm, respectively. Assuming that the blades do not experience much growth at low speed, the clearances measured at these speeds should be close to the values measured statically. Using this assumption, it is observed in Fig. 13 that probe #1 was reading ~0.14 mm high and probe #2 was reading ~0.13 mm low in absolute clearance values. It is believed that this zero shift in measured clearances is due to dissimilarities between the probes' installation on the turbofan and the installation used for the calibration. Any differences in probe alignment and installation depth will affect the accuracy of the measurement. Improved methods will be used in future experiments to better control these parameters so the installation used in the calibration more closely matches the installation used on the test article. It should be noted that the tip timing data acquired in this experiment is still being processed and evaluated. It is planned to present this data in future reports.

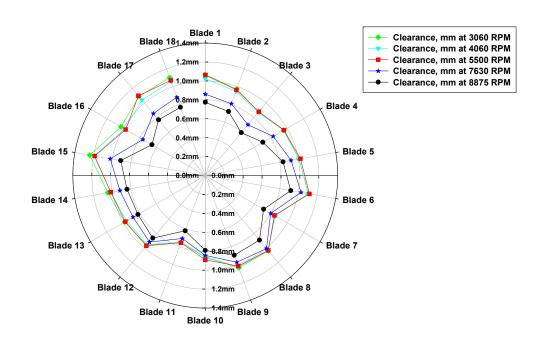
An additional means of viewing the data is shown in the polar plots of Figs. 14 and 15. These plots show the individual blade clearances measured by each of the probes for several fan speeds. As noted previously, these plots show that the individual blade tip clearances decrease as the fan speed is increased. A more noticeable change in the individual clearances can be observed in the polar plot in Fig. 14 for probe #1. This clearly shows the decrease in the individual blade tip clearances as the fan is operated at higher speeds. A less noticeable change is observed in the polar plot in Fig. 15 for probe #2. It still shows the overall trend of the tip clearance decreasing as speed is increased, but it is just not at the same magnitude as observed by the first probe. In reality, the small change in displacement observed by the probe at this location during the run is approaching the measurable limit for using this size of probe on this blade. However, even with this observation, these plots do show that the microwave clearance probes are sensitive enough and have sufficient resolution to pick up the minor variations that exist in the individual blade tip clearances.

Figure 14. Individual Blade Tip Clearances for Probe #1, 90 deg location – NASA Turbofan Experiment.

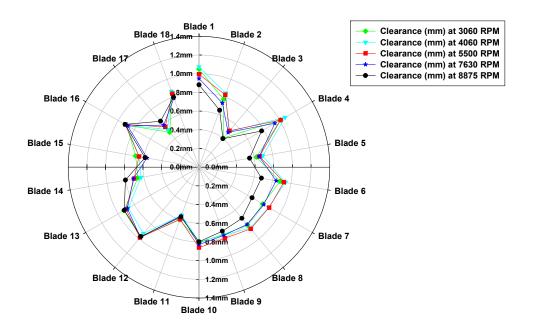
Figure 15. Individual Blade Tip Clearances for Probe #2, 180 deg location – NASA Turbofan Experiment.
