**AAS 09-013**

# Hubble Servicing Challenges Drive Innovation of Shuttle Rendezvous Techniques

John L. Goodman  
United Space Alliance, LLC

Stephen R. Walker  
NASA Johnson Space Center

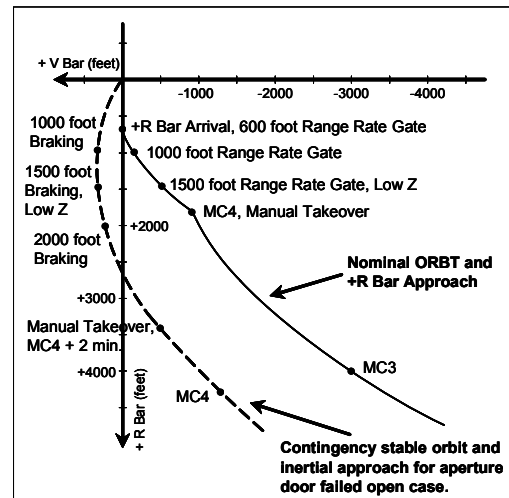
**Figure 18 Comparison of nominal and contingency approaches to HST for STS-103, STS-109, and STS-125.**

Starting with STS-103, the nominal rendezvous profile was ORBT, supporting a +R Bar approach (Figures 12, 16, and 17). However, should the aperture door fail to close before rendezvous, a +R Bar approach could expose the HST optics to RCS jet plume contamination. Like STS-82, in the event that the HST aperture door failed to close before rendezvous, the orbiter would perform an inertial approach. However, this inertial approach would be flown from a stable orbit profile (Figures 6, 17, and 18), instead of the nominal ORBT profile (Figures 16, 17, and 18).

With the proper timing, the failed open HST aperture door could be pointed away from the approaching orbiter throughout an inertial approach, to minimize risk of optics contamination. Execution of a contingency stable orbit would have required replanning of the last ground targeted maneuver by

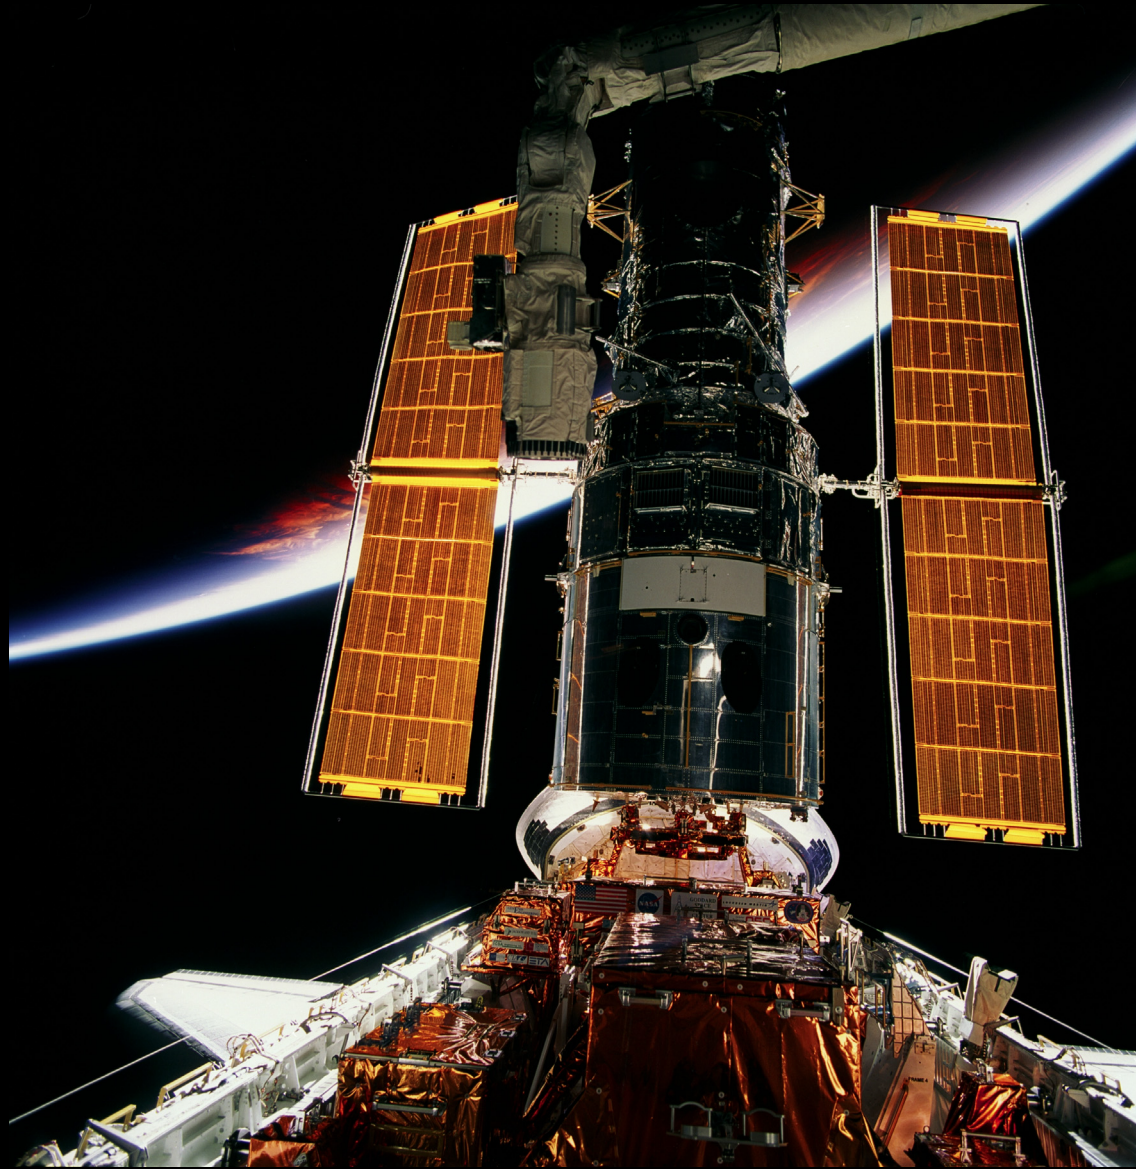
# Rendezvous and Proximity Operations

# Inertial Approach for STS-31 Contingency Rendezvous & STS-61 Rendezvous

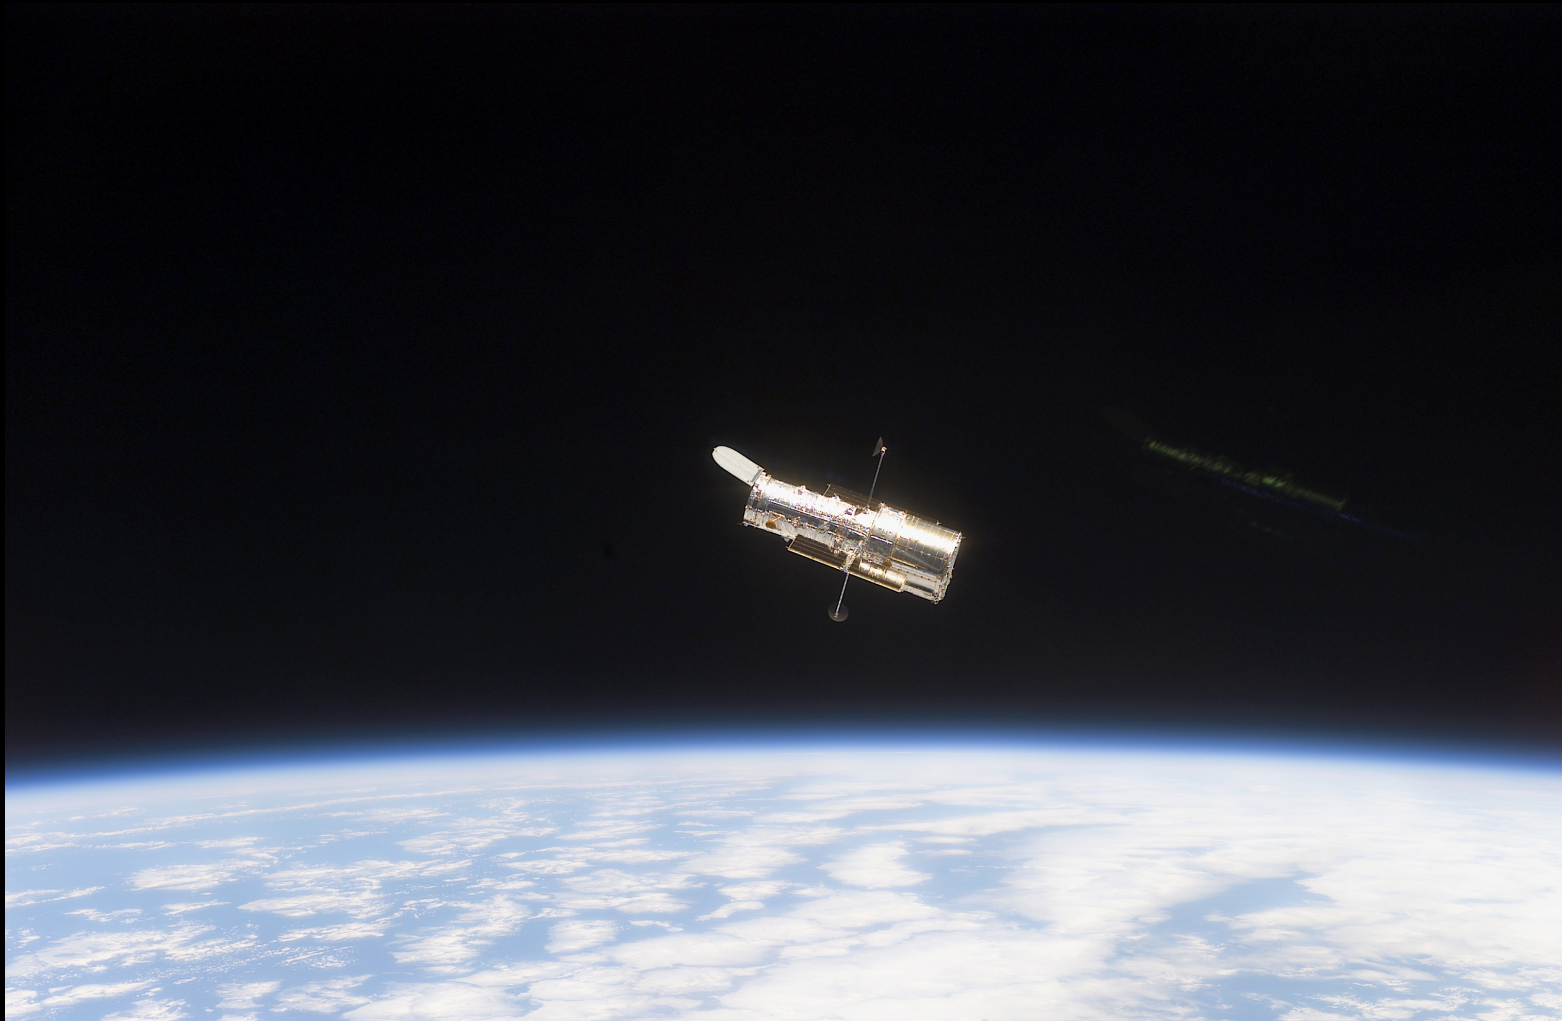
# Deploys

# HST placed on-orbit during STS-31.

Deploy attitude optimized for solar array power generation.

Simple two-burn posigrade in-plane separation

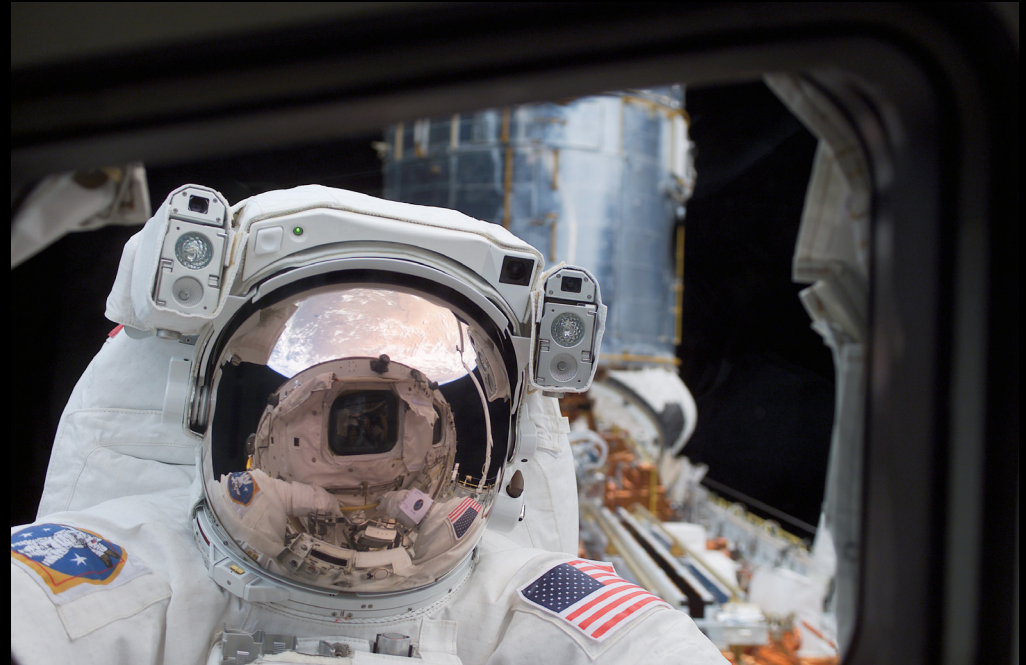
STS-103 – Moon in star tracker field of view, procedural work-around avoided impact to navigation.

STS-103 – HST gyro failures led to use of Hardware Sunpoint mode. Crew performed 90 degree yaw maneuver to align Shuttle for grapple.
