# EDDY CURRENT SYSTEM FOR DETECTION OF CRACKING BENEATH BRAIDING IN CORRUGATED METAL HOSE

**ABSTRACT.** In this paper an eddy current system for the detection of partially-through-the-thickness cracks in corrugated metal hose is presented. Design criteria based upon the geometry and conductivity of the part are developed and applied to the fabrication of a prototype inspection system. Experimental data are used to highlight the capabilities of the system and an image processing technique is presented to improve flaw detection capabilities. A case study for detection of cracking damage in a space shuttle radiator retract flex hoses is also presented.

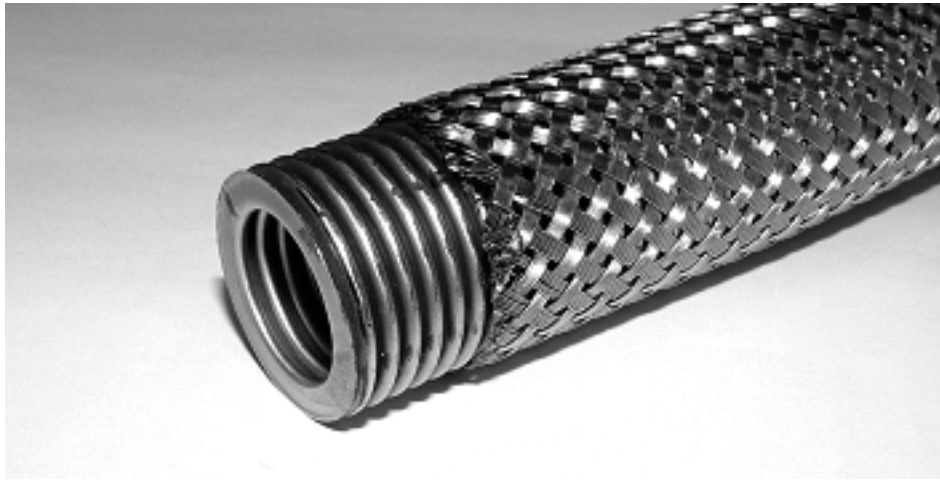
**FIGURE 1.** Typical flex hose design showing convoluted thin metal wall hose and braided metallic overwrap.

Corrugated metal hose, also known as flex hose, poses several challenges for quantitative nondestructive evaluation techniques. The complicated structure of the part is shown in Figure 1. In this image the metallic braid has been pulled back to reveal the convoluted thin wall structure of the hose. Partially-through-the-thickness cracking in the corrugated metal hose can easily be masked by the irregular geometry of the part. Inspection of the hose through the braid, as required for any in situ application, further complicates the inspection by adding an irregular metallic layer between the inspector and the critical surface. Coupling of thermal or ultrasonic energy into the part and analysis of the energy flow in the system are daunting tasks, and the large percentage of the surface area covered by the metallic braid limits the effectiveness of even a detailed visual inspection. Leak testing can be effective for through-wall cracking, but no good options have been available for detection of partially-through-the-thickness cracks in a pressurized system. In this work an eddy current technique for the detection of such damage is proposed. The probe design and inspection technique, along with experimental data for the detection of cracking in a typical flex hose component, are presented.

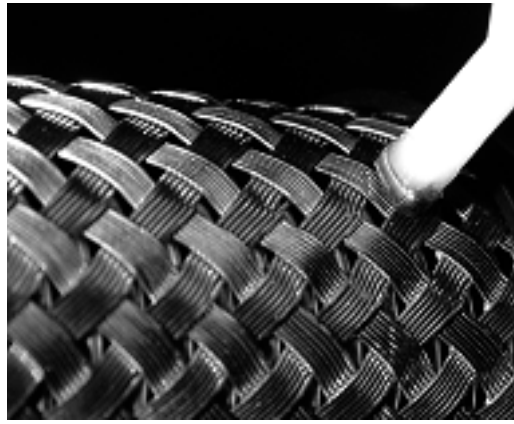
**FIGURE 2.** Probe orientation implemented to inspect for circumferential cracking in the flex hose convolute.

Optimization of the probe orientation was studied to minimize braid effects and maximize coupling to the underlying hose. As can be seen in Figure 2, high pressure flex hose is typically braided with a linear array of stainless steel wires. The resulting braid structure is highly anisotropic in conductivity. Orienting the eddy current probe such that the induced electromotive force (EMF) is always non-parallel to the high conductivity directions of the braid minimizes the shielding effects of the braid. To maximize coupling into the underlying hose, the induced EMF should also be in the plane of the hose. Targeting the detection of circumferential cracks adds a final criterion in that induced currents should be orthogonal to the crack direction for maximum eddy current response from the flaws. Optimization of the probe orientation based upon these criteria led to the

inspection geometry shown in Figure 2, with the coil axis tangent to the inspection surface and along the convolute direction.

Initial testing of the eddy current technique was performed by holding the eddy current probe stationary and scanning the hose section. A small air gap of approximately 0.010" was set between the eddy current coil and the flex hose, with the coil orientation explained above and pictured in Figure 2. The sample was initially scanned with the

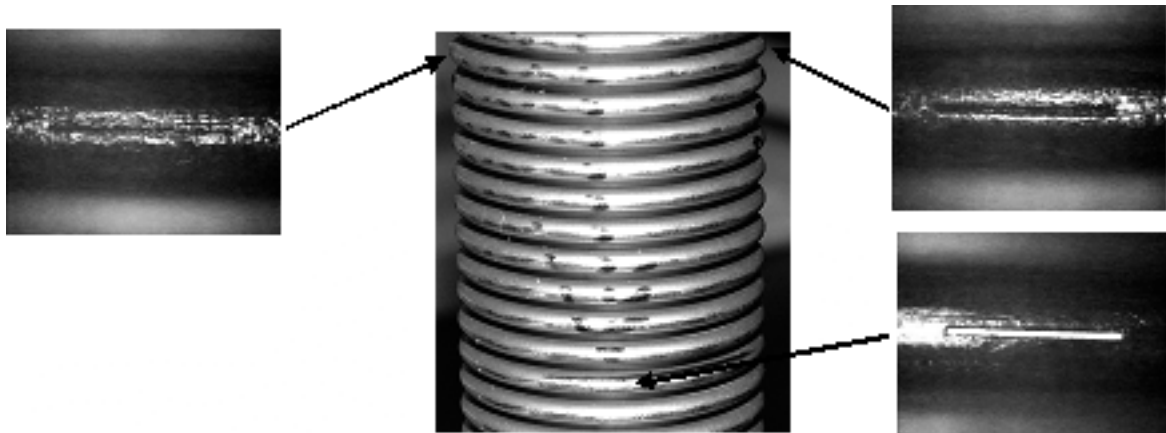
**FIGURE 3.** Radiator retractor verification sample with three laser cut notches, braid removed.

A test specimen was fabricated from a spare section of radiator retractor flex hose. After removing the flex hose braid to expose the hose convolutes, three laser cut notches were placed in the hose at the crown of the convolute. The notches were each 0.005" wide x 0.1" long. The first notch was cut completely through the thickness of the hose while the other two notches were cut to a depth approximately half way through the wall. Figure 3 shows a picture of the hose convolutes with close up views of the three notches.

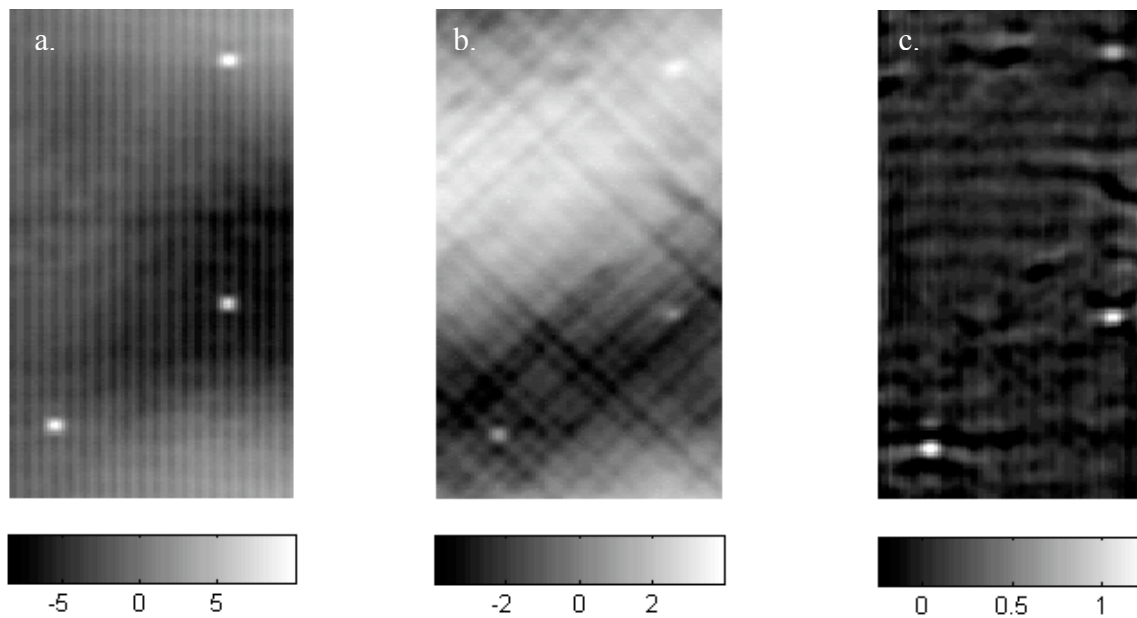
**FIGURE 4.** Vertical component eddy current C-scan data for (a) validation sample with braid removed, (b) validation sample with braided overwrap in place, and (c) two-dimensional Fourier filter results of (b).

overwrap removed. After optimizing the probe response in this configuration the braided metallic overwrap was placed over the hose and the sample rescanned. In both cases a full 360 degree scan over a 2" length along the hose axis was performed. Figure 4 displays the vertical component eddy current C-scans of the raw data, along with two-dimensional Fourier filter processed results for the scan of the braid overwrapped hose. In the figures the circumferential direction is vertical, with the annular convolutes easily identified as vertical banding in Figure 4a. The three laser cut notches are clearly identified in the data for the unwrapped hose and are also visible in Figure 4b, although background variations due to braid and lift-off effects somewhat mask the flaws. In obtaining Figure 4c, a two-dimensional Fourier transform was applied to Figure 4b. In the frequency spectrum, the regular spatial pattern of the braided overwrap produced an easily identifiable and separable signature. These components, along with high and low frequency variations, were then removed from the frequency space spectrum. Performing an inverse Fourier Transform on the filtered frequency spectrum produced Figure 4c, which displays the real component of this inverse transform. The automated filtering technique was seen to reduce braid artifacts, improving the signal to noise ratio for the three validation notches.

be compared to Figure 4b, which shows the response from the absolute probe on the same sample. Note that the flex hose orientation is consistent between Figures 4 and 7, but the starting position of the scan is rotated approximately 135 degrees between the two figures. The signal to noise ratio for the system shows great improvement with the differential coil probe. A pronounced maximum-minimum pair is observed at each of the three defects, as expected for differential coil inspection. This characteristic response is highlighted in the extracted lissajous pattern of Figure 7b. Braid effects are seen to produce a signal response very close to the horizontal axis, with amplitude of approximately  $\pm 2V$ . The calibration defect produces a strong vertical response with amplitude more than double that of the braid effect at approximately  $\pm 5V$ .

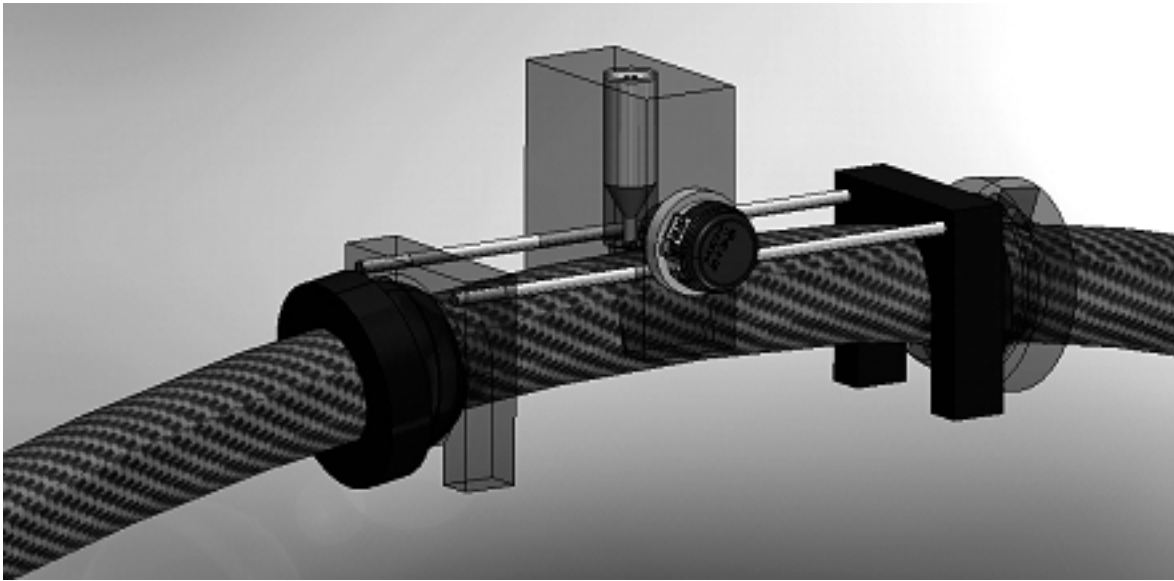
**FIGURE 5.** Flex hose scanner design for testing of pressurized, installed hoses.

Following the success of the initial testing, a scanning fixture was designed to enable eddy current C-scan data to be acquired on installed, pressurized flex hose components. The design, pictured in Figure 5, incorporated a spring loaded probe holder integrated into a manual scanner. The scanner can be coupled directly to the flex hose with a minimal pressure of approximately 1 psi. An optical encoder was used to track probe position along the axis of the hose, with the circumferential position around the hose indexed at a resolution of 2.5 degrees (approximately 0.022" for 1" diameter hose). A ball joint coupling between the probe holder and fixed ends allowed scanning of a hose with a radius of curvature of 23" or greater (hose sections with smaller radius or curvature could be inspected with a restricted scan length along the axis of the hose). This, combined with the small profile of the eddy current scanning system enabled coupling to and scanning of installed flex hose components in confined areas with limited access.

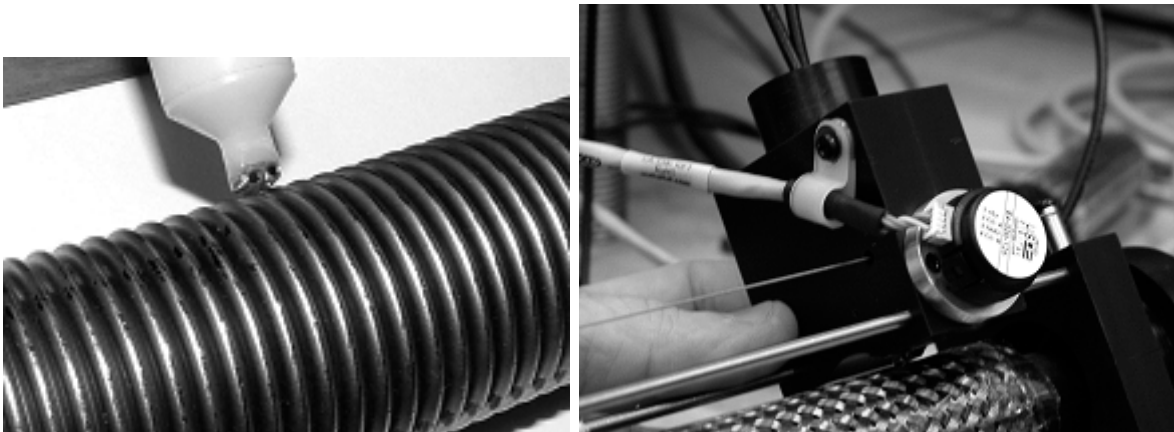
**FIGURE 6.** Differential eddy current flex hose probe and flex hose scanning system.

The flex hose scanning system was designed such that the eddy current sensor could be easily changed, without the need to uncouple the scanner from the hose. Along with enabling rapid replacement of a damaged or questionable eddy current coil, this feature allowed for the evaluation of different sensors on an indication of interest. As an example, probes with higher or lower operating frequencies could be applied to add additional information on the depth of the feature causing the indication. In this work the capabilities of a differential sensor with coil spacing equal to the pitch of the corrugation were studied and compared to that of an absolute coil sensor. It was reasoned that a relative measurement between equal areas of adjacent hose corrugations could help to increase the signal to noise by reducing the background levels. Each coil of the differential coil set was designed as described above and pictured in Figure 2. The two coils were then bonded together in a parallel axis configuration. As with the absolute probe, testing of the flex hose was performed with coil axes tangent to the inspection surface and along the convolute direction. Photographs of (a) the differential probe configuration in reference to the corrugation direction and spacing and (b) the flex scanner attached to the validation sample are displayed in Figure 6.
