NASA/TM—2009-215667

# Gear Fault Detection Effectiveness as Applied to Tooth Surface Pitting Fatigue Damage

*David G. Lewicki*  
*Glenn Research Center, Cleveland, Ohio*

*Gregory F. Heath and Perumal Shanthakumaran*  
*The Boeing Company, Mesa, Arizona*

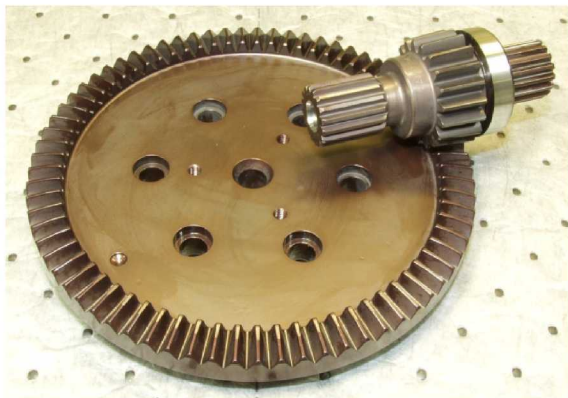
Figure 2.—Test gears.

The design parameters for the pinions and face gears used in the tests are given in Table I. A photograph of the test specimens is shown in Figure 2. The set was primarily designed to fail in surface pitting fatigue mode. The set had a reduction ratio of 3.842:1. The pinions were slightly tapered, which allows the independent setting of backlash for the multiple pinions and idlers in the split-torque transmission application (Ref. 13). The pinions and face gears were made from carburized and ground vacuum induction melting-vacuum arc remelting (VIM-VAR) Pyrowear 53 steel per AMS 6308 using standard aerospace practices. At 6000 lb per in. face gear torque, the calculated AGMA contact stress index was 250 ksi and the calculated AGMA bending stress index was 72 ksi using approximate spur gear calculations per AGMA (Ref. 14).

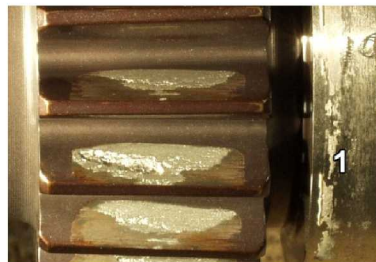
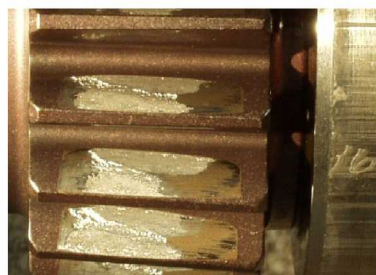
Figure 4.—Typical macro-pitting pinion tooth surface fatigue failures.

(a) Single/few teeth macro-pitting failure.

(b) Multiple teeth macro-pitting failure.

Of the 24 sets of gears tested, 17 sets resulted in spalling/macro-pitting failures. The other 7 sets were suspended with moderate to heavy wear but had no spalling. For all the 17 sets that failed, spalling occurred on the pinion. In some cases, spalling occurred on both the pinion and face gear. There were zero instances of face gear spalling with no pinion spalling. Thus, the remainder of this study will concentrate on pinion results only. The tests sets were classified into four groups: (1) pinion macro-pitting with single or few teeth pitted (this occurred for 5 sets), (2) pinion macro-pitting with multiple/all teeth pitted (this occurred for 12 sets), (3) moderate pinion wear but no macro-pitting (this occurred for 3 sets), and (4) heavy pinion wear but no macro-pitting (this occurred for 4 sets). An example of a pinion with single or few teeth pitted is given in Figure 4(a). An example of a pinion with multiple teeth pitted is given in Figure 4(b). The number of cycles tested per set ranged from 32.7 to 590.9 million pinion cycles.

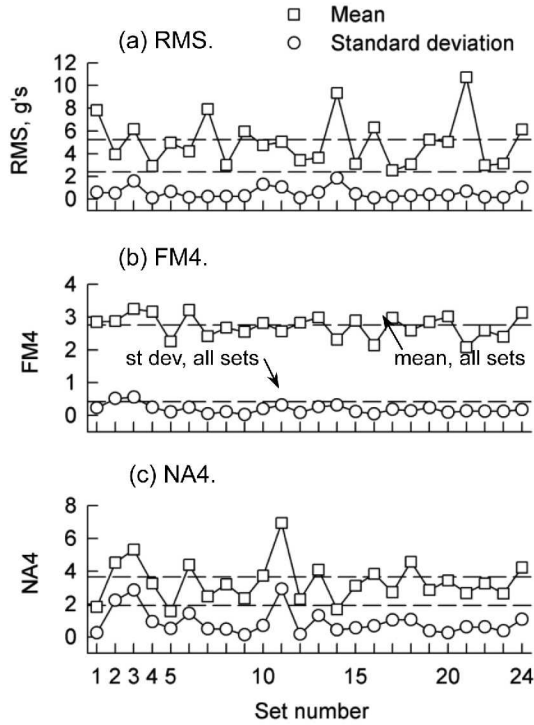
Figure 5.—Mean and standard deviation statistics for all sets, healthy state condition.

The objective of this section is to investigate the variability of the CI's for known healthy components. The data labeled "Healthy" in Appendix B were assembled and the means and standard deviations of the CI's for these data were determined. For 15 of the 24 sets, the healthy data was selected at the start of the set installation. For the remaining sets, the healthy data was offset due to the influence of the opposite side set failures on the CI results. The mean and standard deviation results are shown in Table III and Figure 5.

RMS had a large variation among sets, ranging in mean values from 2.53 to 10.73 g's. FM4 had a fairly steady value of means, with a total average of 2.75 and a relatively low standard deviation. NA4 had a slightly higher mean than FM4 and significantly larger scatter.

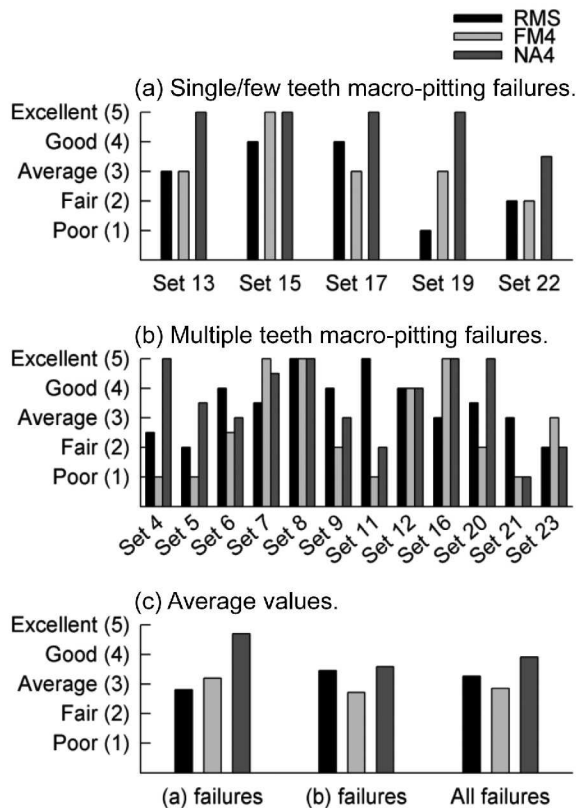
Figure 6.—Qualitative analysis of condition indicator fault detection effectiveness.

Figure 6 depicts the results of the qualitative analysis. For the single/few teeth macro-pitting failures (Fig. 6(a)), NA4 showed an excellent fault detection effectiveness. FM4 showed a slightly above average effectiveness. NA4 and FM4 were primarily developed to detect isolated gear tooth faults, which explains the excellent performance of NA4. FM4 suffered in effectiveness due to noise and the decrease in values with increased fault progression. RMS showed a slightly below average effectiveness, indicating that isolated gear faults did not significantly increase the overall vibration signature.

For the multiple teeth macro-pitting failures (Fig. 6(b)), the fault detection effectiveness of NA4 and FM4 decreased compared to the single/few teeth failure modes. Again, this is not surprising since the parameters were developed to detect isolated tooth faults. The RMS fault detection effectiveness increased due to the increased influence of the multiple teeth faults on the overall vibration signature. In general considering all failures (Fig. 6(c)), NA4 showed a good fault detection effectiveness, FM4 was slightly below average, and RMS was average.

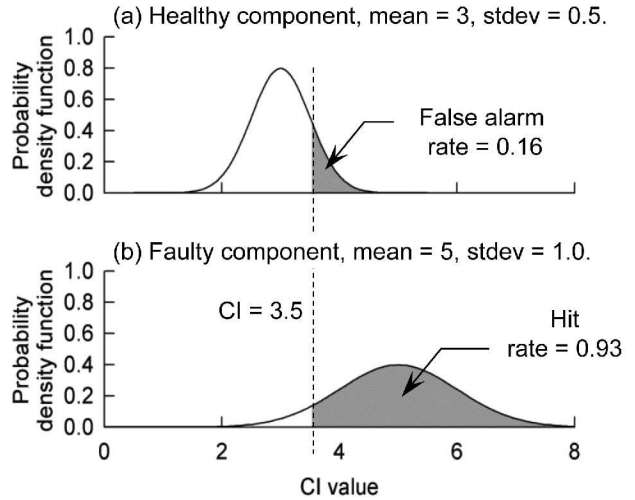
Figure 7.—Sample probability density functions.

The procedure in using ROC curves is as follows. First, CI data is extracted into healthy and faulty groups corresponding to healthy and faulty components. The means and standard deviations of the groups are then determined. Figure 7 shows probability density functions for sample data with a mean and standard deviation of 3.0 and 0.5, respectively, for the healthy set, and a mean and standard deviation of 5.0 and 1.0, respectively, for the faulty set. Note that normal distributions are used in this example and this assumption was used on all the data in this study. For a given CI value (CI = 3.5 in Figure 7 as an example), the false alarm rate and hit rate are the shaded areas in the figure and can be determined from statistics using the CI value probability distribution to calculate the area under the curve. By sweeping through a range of CI's (usually from the mean of the healthy to the mean of the faulty set), one can tabulate and plot the hit rates versus false alarm rates. This is known as the ROC curve. The ROC curve can be used to evaluate the CI fault detection effectiveness as well as to determine a threshold CI value. The threshold CI value with the best performance is the point corresponding to the upper-left most point on the ROC curve. This maximizes the hit rate while minimizing the false alarm rate. One method to determine the optimum numerical value of the threshold is to determine the CI value for the intersection of the tail edge of the healthy probability density function with the leading edge of the faulty probability density function.

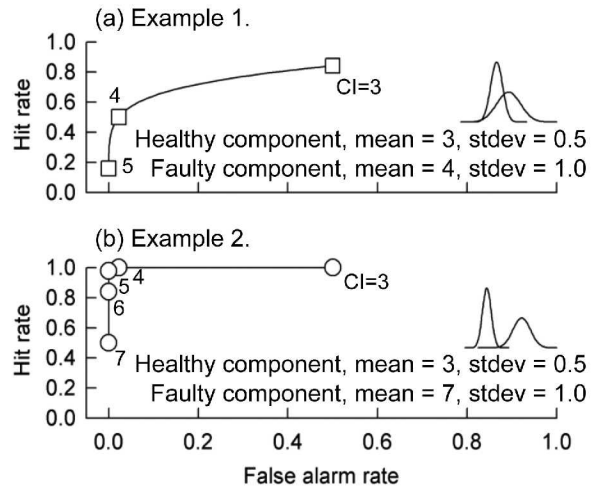
Figure 8.—Sample receiver operating characteristic (ROC) curves.

ROC curves are given in Figure 8 for two examples. The first example has considerable overlap between the healthy and faulty groups. The threshold value is 3.62 for this example. The ROC curve is fairly smooth (Fig. 8(a)) and the threshold value has less significance due to poor separation of healthy and faulty data. If actual data performed in this manner, the CI would be a poor fault detection indicator. The second example has a greater spread between the healthy and faulty groups. The ROC curve has a sharp edge (Fig. 8(b)) at the upper-left location and thus, a tangible threshold. The threshold value with the optimum performance is 4.42 for this example. If actual data performed in this manner, the CI would be a good fault detection indicator.

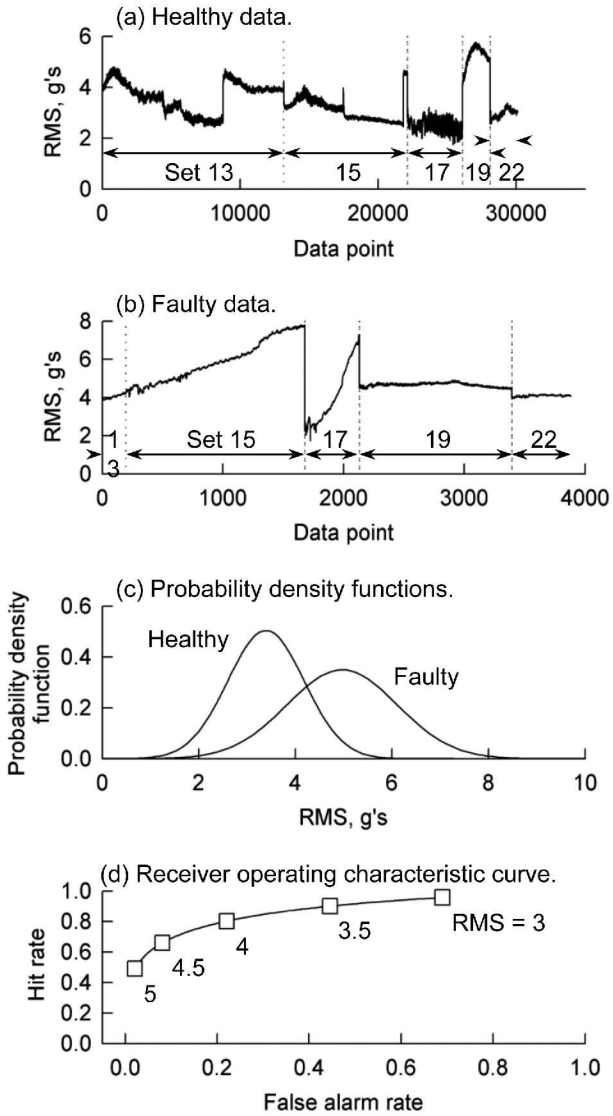
Figure 9.—Summary results for RMS condition indicator for macro-pitting, single/few teeth failures.

ROC curves for RMS, FM4, and NA4 are given in Figures 9 to 11 for the macro-pitting, single/few teeth failures (pinion condition 1). This was based on the healthy and faulty data of sets 13, 15, 17, 19, and 22. The means and standard deviations of the healthy and faulty data, along with the estimated thresholds from the ROC curve analysis, are given in Table IV. ROC curves for the macro-pitting, multiple teeth failures (pinion condition 2) are given in Figures 12 to 14. The means, standard deviations, and thresholds are given in Table V. Note that analysis for the macro-pitting, multiple teeth failures only included 9 out of the 12 total sets for this failure mode (sets 4, 5, 7, 8, 9, 12, 16, 20, and 23). This was due to difficulty in classifying the faulty data regimes for the excluded sets (sets 6, 11, and 21). The CI plots of Appendix B show the groupings of healthy and faulty data that were used for the ROC curve analysis.

Results of the analysis showed that both RMS and FM4 did not show good separation between healthy and faulty data (Figs. 9, 10, 12, and 13). For RMS, significant variation in values from set to set occurred for both healthy and fault data. This increased the standard deviation of the data and thus, caused poor separation. The RMS ROC curves were rather smooth, making the threshold less significant due to the poor separation between healthy and faulty data. For RMS from Tables IV and V, thresholds of 4.24 and 6.14 g's gave hit rates of 0.74 and 0.59 and false alarm rates of 0.14 and 0.16, indicating rather poor gear fault detection effectiveness in itself.

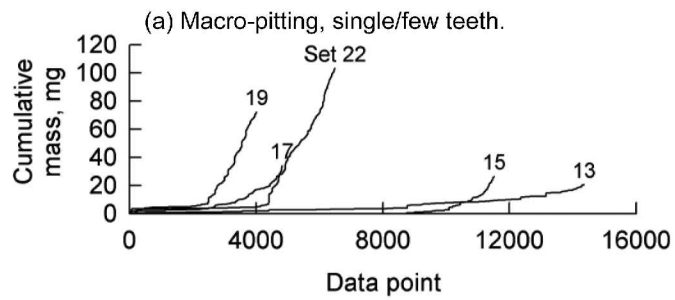
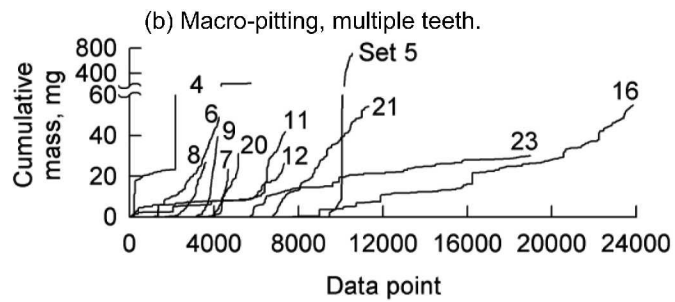
Figure 15.—Oil-debris monitor results.

The results from the oil-debris monitoring (ODM) system is given in Figure 15. Data from all 17 failed sets are included. Shown is the calculated cumulative mass per data point (one data point every minute). The ODM responded to all 17 failures. Some sets had definitive inflection points, indicating increased gear tooth pitting (Fig. 15(a), set 22, at data point

4900, as an example). Others had a steady increase in debris (Fig. 15(a), set 13). Three sets were outliers with a larger amount of debris (sets 4, 5, and to some degree, set 22). There did not appear to be significantly more tooth damage (or bearing failures) to correlate with the larger amount of debris, so its cause is unknown. Excluding the three outliers, the results were fairly consistent among sets with an average value of about 40 mg cumulative mass at the end of test.

As stated before, there were difficulties in the facility setup with the ODM. A single sensor was used for both the left and right test sides. Thus, it was not possible to separate the results per side. This posed two problems. First, the measured results included the debris from both sides. Second, the failure of the opposite side set during a test of a given set produced a significant amount of debris. Therefore, the ODM was reset to zero after each failure, thus producing an offset for some sets. Fortunately, no failures occurred at the same time for the left and right sides, leaving enough separation in the results to give meaningful data.
