# Boundary Layer Transition Flight Experiment Overview and In-Situ Measurements

In support of the Boundary Layer Transition Flight Experiment (BLT FE) Project, a manufactured protuberance tile was installed on the port wing of Space Shuttle Orbiter Discovery for the flights of STS-119 and STS-128. Additional instrumentation was also installed in order to obtain more spatially resolved measurements downstream of the protuberance. This paper provides an overview of the BLT FE Project, including the project history, organizations involved, and motivations for the flight experiment. Significant efforts were made to place the protuberance at an appropriate location on the Orbiter and to design the protuberance to withstand the expected environments. Efforts were also extended to understand the as-fabricated shape of the protuberance and the thermal protection system tile configuration surrounding the protuberance. A high-level overview of the in-situ flight data is presented, along with a summary of the comparisons between pre- and post-flight analysis predictions and flight data. Comparisons show that predictions for boundary layer transition onset time closely match the flight data,

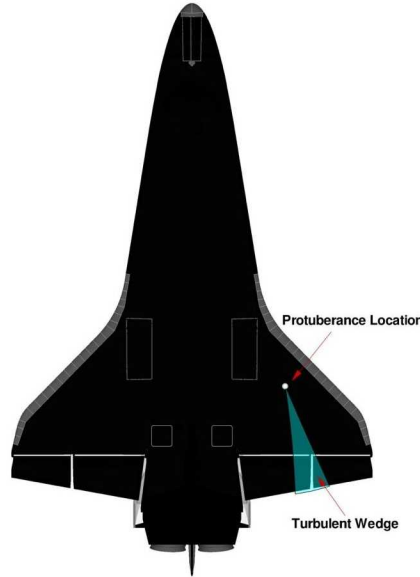
Figure 1. Selected protuberance location and predicted turbulent wedge

With all these factors in mind, the protuberance location was chosen to be on the port wing, outboard and downstream of the main landing gear door (see [Figure 1](#)). Choosing to place the protuberance on the port side avoids regions of higher-risk impact sites due to the ice frost ramps and other foam sources on the starboard side of the external tank. A Systems Engineering and Integration (SE&I) risk study was performed and found that the risk of critical damage in the turbulent wedge downstream of the protuberance was less than 1 in 10,000.

To ensure safety of the crew and vehicle, pre-flight predictions for the area downstream of the protuberance were performed for two general regions. The first region considered the area from the protuberance and aft to the end of the vehicle. A graphical representation of the area is illustrated in Figure 1, where the areas within the turbulent

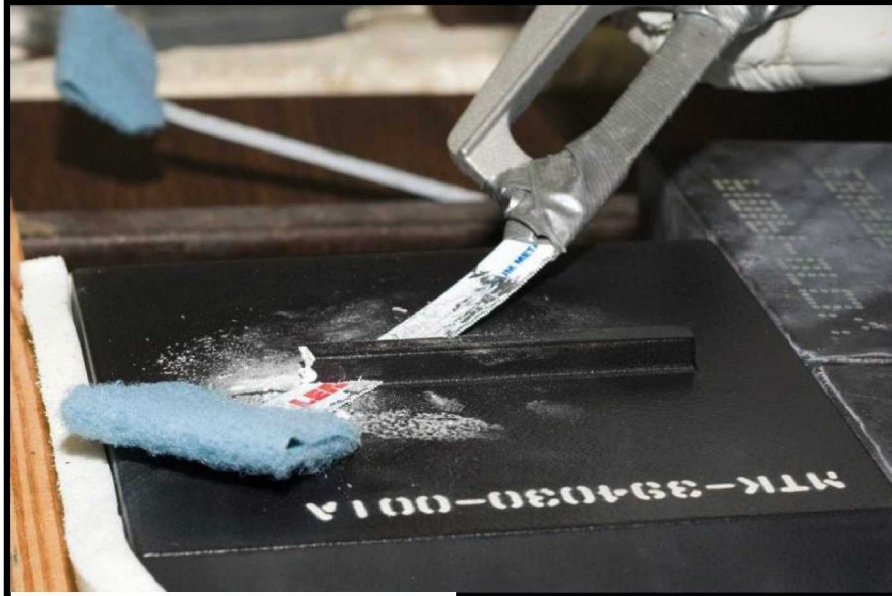
Figure 2. Tile protuberance prototype being cut by an EVA hacksaw (Ref. XX)

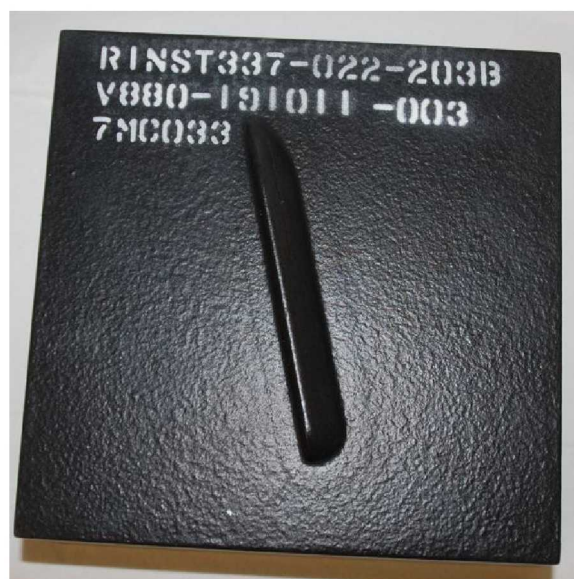
Figure 3. Final protuberance shape

One of the main requirements in the design of the protuberance was that the protuberance remain shape-stable through the entry. Based on arc jet data and previous flight experience, it is expected that as a tile reaches the material capability temperature that it begins to change shape or slump. Because of this, aeroheating and thermal analysis drove the design for the protuberance shape. Nearly 10 different design iterations were assessed and two were tested in the JSC arc jet facility. The shape was designed so that heating levels would be relatively constant along the length of the protuberance. A photograph of the final design is shown in Figure 3. The length and width of the protuberance installed on the vehicle was 4.0” and 0.376”, respectively, for both flights. The protuberance was machined into the tile such that the leading edge was oriented at an angle of  $45 \pm 3^\circ$  relative to the local flow streamline.

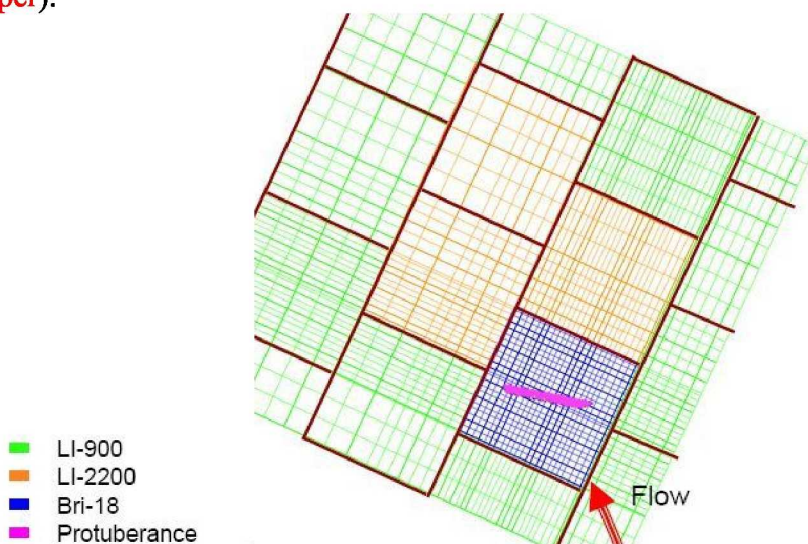
Figure 4. Tile materials used in the vicinity of the protuberance tile

The predicted tile temperatures due to vortex heating just downstream of the protuberance drove the team to replace three of the LI-900 tiles nominally found on the Orbiter acreage with LI-2200 tile, which has a higher temperature capability. A schematic showing the different tiles in the region of the protuberance is shown in Figure 4. Additional details about the changes to the TPS can be found in Reference ([Spanos paper](#)).

The second analysis region was more limited in geometrical scope and only considered the area immediately surrounding the protuberance. This area is shown pictorially in Figure 4. The intent of this analysis domain was to capture any adverse local effects due to the protuberance and associated vortex heating on the thermal and structural margins. As discussed previously, the local aeroheating analysis was carried out using a combination of XF0002 and CFD. The CFD solutions were provided using the DPLR code for select trajectory points and are discussed in Ref (Tang). Thermal and structural analyses were also performed, as discussed previously.

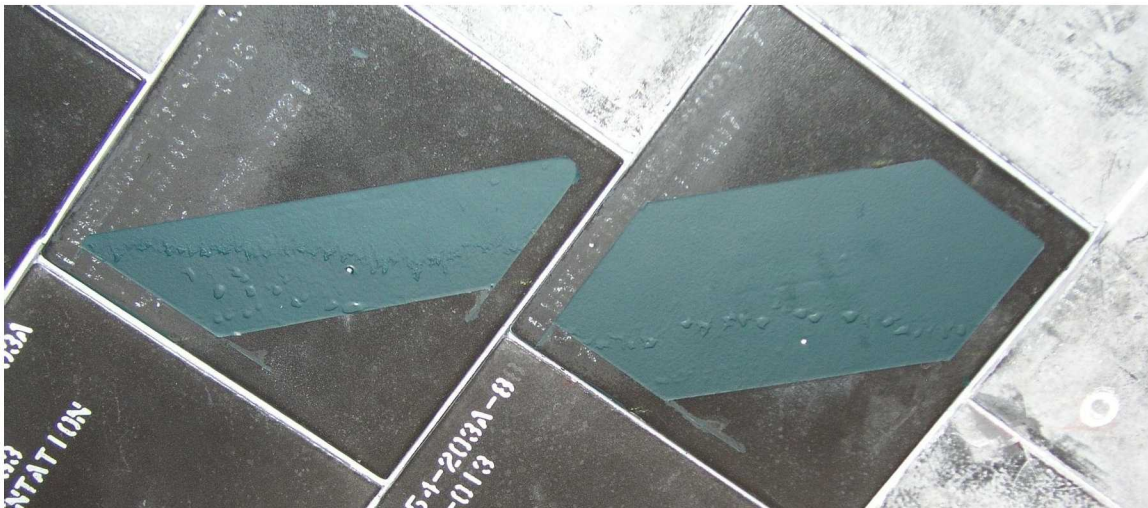
Figure 5. Catalytic Coated Tiles on STS-128.

similar material constituents as for the previous catalytic tile flight tests. The catalytic coating was then applied to two tiles placed adjacent to one another. The tiles were placed in close proximity to ensure similar environments were experienced to simplify analysis of the data following the experiment. A figure showing the coating applied to the tiles is shown in Figure 5. The apparent bumps in the figure are not as pronounced as they appear in the figure. Rather they are an artifact of the lighting in the photograph. Actual inspection of the coating showed the surface-plane deviations were minimal. Placing the coating on the tile required consideration of several constraints. These design considerations are discussed in Ref. [Spanos](#). The catalytic coating was not applied for the first flight of the flight experiment (STS-119), but was tested on the second flight (STS-128).

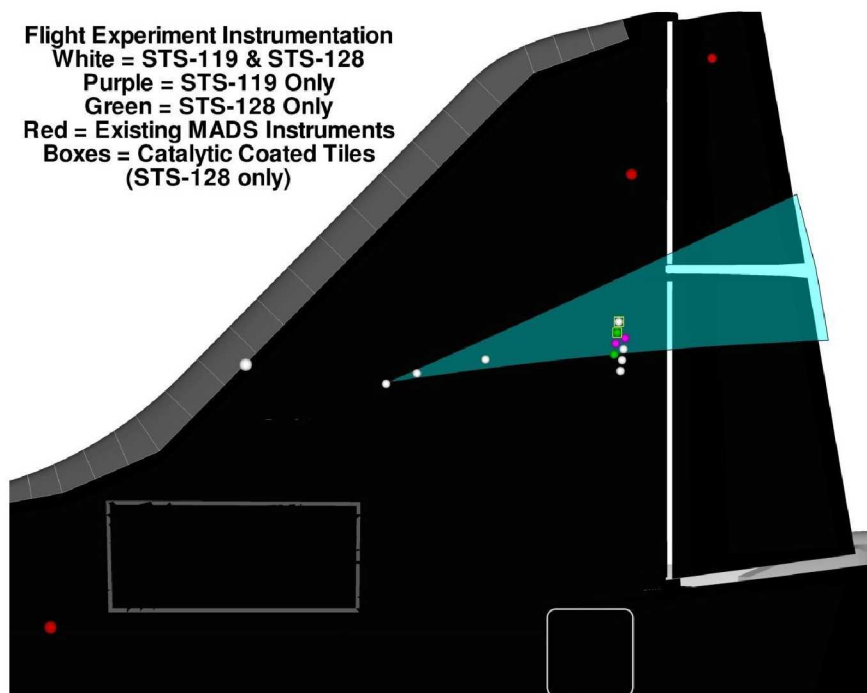
Figure 6. Instrumentation locations for STS-119 and STS-128. The turbulent wedge assumes a 7.5° half-angle.

Figure 6 shows a sketch of the location of the instrumentation for STS-119 and STS-128. White symbols represent instrument locations active for both STS-119 and STS-128. Because some of the instruments were not used for both flights, instruments that were active for STS-119 but not active for STS-128 are colored purple. Thermocouples for STS-128 that were not active on STS-119 are colored green. The catalytic coated tiles have boxes surrounding their location. It is important to note that the flight experiment team was limited to 10 additional thermocouple locations because of data acquisition system (DAS) constraints in the wing region. Three holes were drilled into the Orbiter wing structure to run thermocouple lead wires between the DAS hardware and the outer mold line (OML) of the vehicle. Additional information about the instrumentation system can be found in Reference ([Spanos paper](#)).

The differences in instrumentation layout between STS-119 and STS-128 were implemented to (1) obtain higher resolution on the turbulent wedge and (2) to take measurements in the two catalytic coated tiles during STS-128. The catalytic coated tiles were placed as near to the center of the predicted wedge as possible and were placed adjacent to one another. The thermocouples were placed in the tiles in different locations relative to the leading edge of the coating application. On one tile the thermocouple was placed as close to the leading edge as possible while the other tile included a thermocouple in the middle of the coating application. The thermocouples were placed in this manner to measure the catalytic jump due to a mismatched material (Ref. [Marichalar AIAA paper](#)) and to measure the general catalytic behavior of the coating, respectively.

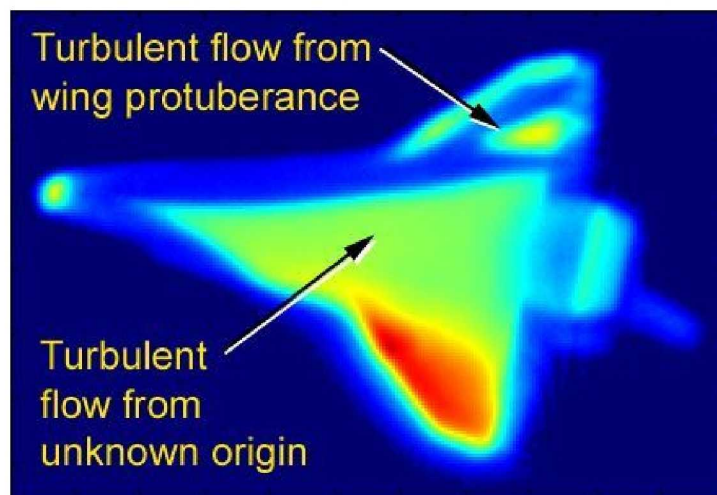
Figure 7. HYTHIRM imagery from STS-119. See Reference [Horvath](#).

A post-flight review of the thermocouple data showed a relatively early (~Mach 11.5) asymmetric BLT event on the starboard side of the Orbiter during the STS-119 re-entry. This asymmetric event was also observed in HYTHIRM imagery (Ref [Horvath](#)) as shown in Figure 7. The HYTHIRM imagery proved to be very useful and was used in conjunction with the wedge tool and the effected thermocouple locations to help isolate regions that might have caused a flow disturbance. No out-of-tolerance steps or protruding gap fillers were identified that could be attributed to the asymmetric BLT event during post-flight inspection.

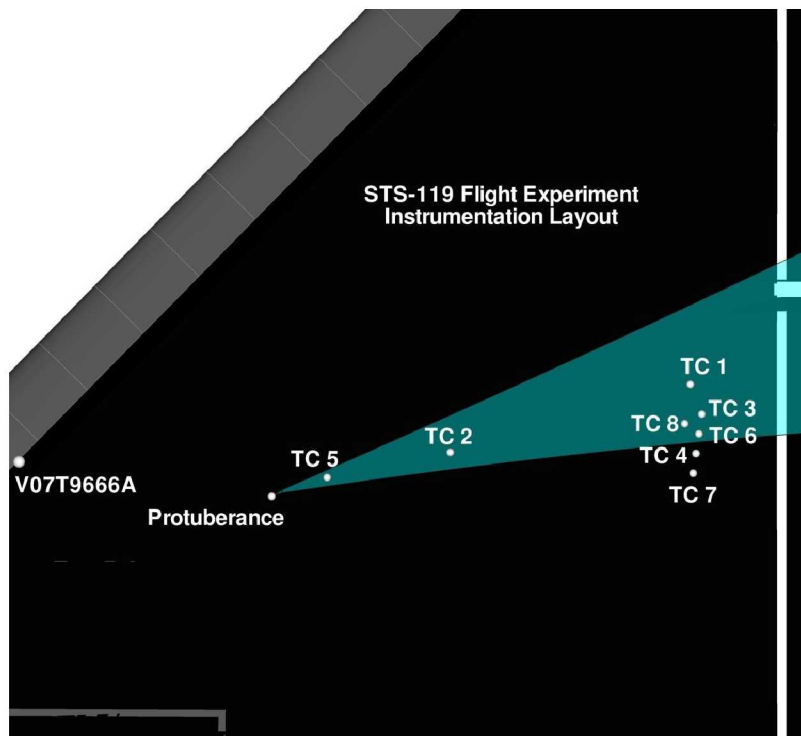
Figure 8. Thermocouple labels for STS-119.

For convenience during the discussion of the flight data, the labeled flight experiment thermocouples are shown in Figure 8. STS-119 flight data in the form of thermocouple time traces are shown in Figures 9 and 10. The thermocouple data is plotted in two different plots for the sake of clarity. Figure 9 shows the thermocouple data associated with the flight experiment thermocouples that are furthest aft, while Figure 10 shows the data for thermocouples furthest forward and on the protuberance. The data is plotted using the post-flight BET. The temperatures are plotted versus time from Entry Interface (EI). EI is defined to the time at which the Orbiter altitude is 400,000 feet. Also shown in the figures are the angle of attack and roll angle profiles for the re-entry.

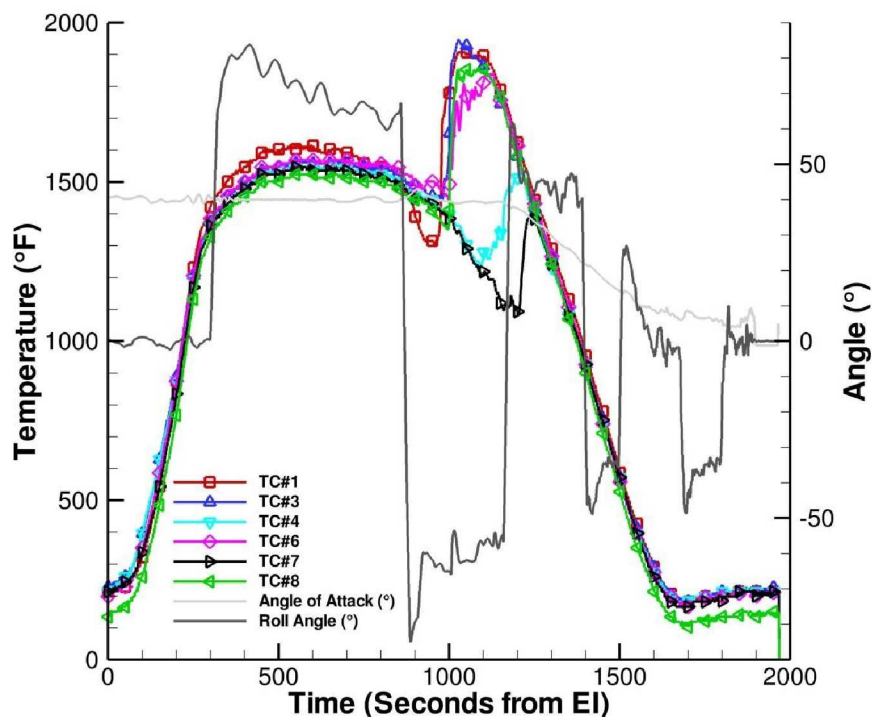
Figure 9. STS-119 data for aft thermocouples

A cursory glance at the aft thermocouple traces in Figure 9 show that temperatures did not exceed 2000°F. Peak temperatures were experienced during the turbulent portion of the entry. Temperatures during the laminar portion of the trajectory were all similar for the thermocouples shown with peak laminar temperatures between approximately 1500 and 1600°F. Thermocouple 1 (hereafter referred to as TC 1) is located at the center of the predicted wedge and shows the earliest sign of BLT between 950 and 1000 seconds. This corresponds to a Mach number of 15.6. BLT time was selected based on the earliest time that temperatures departed from laminar levels. It should be noted that the process of selecting BLT time can be somewhat subjective, depending on the data under consideration.

The thermocouple data then indicates that the turbulent wedge progresses inboard (and presumably outboard on the opposite side of the wedge), as expected, with TCs 3, 8, and 6 showing BLT very quickly following TC 1. TCs 4 and 7 show transition times much later than the other aft thermocouples. These two thermocouples appear to have been correctly placed outside the turbulent wedge. Based on these observations, the turbulent wedge half angle is  $7.0^\circ \pm 0.5^\circ$ . **This value was derived by drawing a straight line between TC5 back to TCs 6 and 4 and measuring the angle between that line and TC1.**

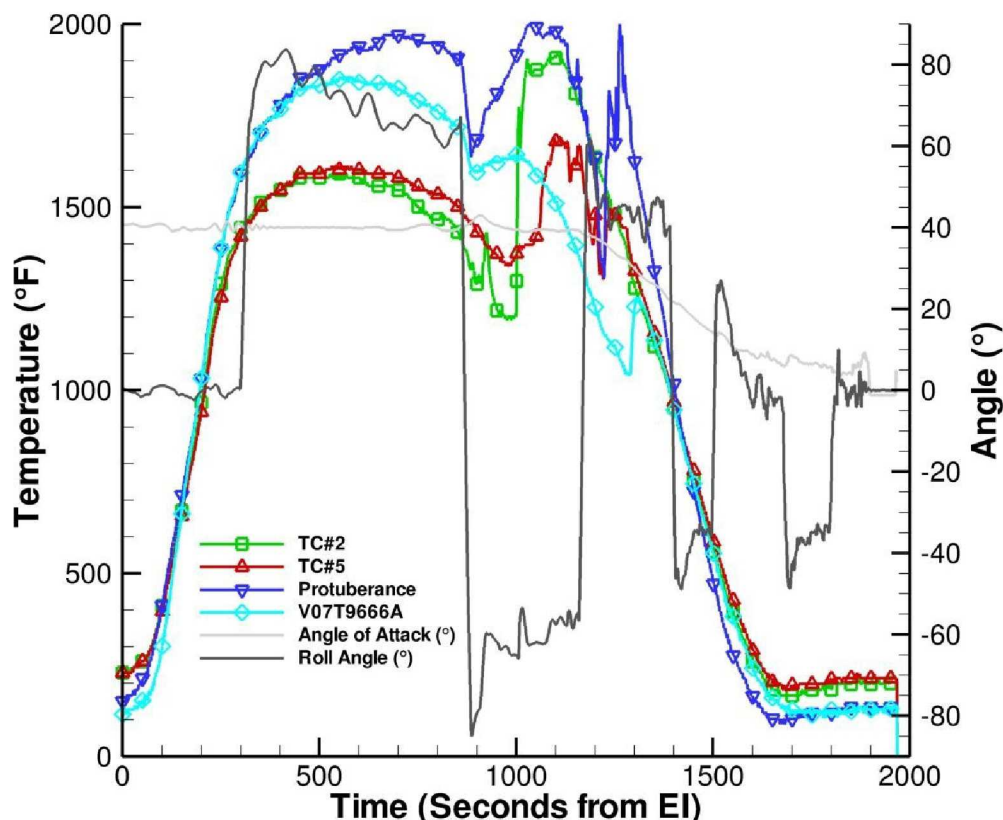
Figure 10. STS-119 data from “forward” thermocouples

Figure 10 shows the thermocouple traces for the forward and protuberance thermocouples. As can be seen, the maximum temperature was approximately 2000°F and was experienced by the protuberance. As expected, the protuberance temperature was higher than the downstream temperatures during all portions of the trajectory. In this plot, V07T9666A is located upstream of the protuberance and just downstream of the Orbiter wing leading edge. This instrument was used as a reference for interpreting the heating behavior upstream of the protuberance. Due to the location of this instrument just downstream of the wing leading edge, it is not surprising that this thermocouple registered temperatures higher than TCs 2 and 5. TCs 2 and 5 have very similar temperatures during the laminar portion of the trajectory. The time of BLT for each of the thermocouple locations is also worth noting. As expected, TC 2 experiences BLT first, followed by TC 5 and finally the protuberance. This is consistent with the turbulent front traveling upstream with time. TC 2 is the furthest aft of the measurements shown in this plot. Since TC 5 represents the measurement closest to the protuberance, it is considered to be a measure of the time for fully effective BLT due to the protuberance. Based on the BET, TC 5 experienced BLT at Mach 13.1. The protuberance itself experienced BLT at Mach 7.7. The reference thermocouple (V07T9666A) experienced BLT at approximately Mach 8.5.

An interesting signature is observed in some of the thermocouple traces shown in Figure 10. As can be seen, at approximately 850 seconds there is a sharp drop in temperature in the protuberance and reference measurements. By examining Figure 10 the angle of attack and roll data in the same figure, one can see that this time corresponds to a vehicle maneuver in the form of a roll-reversal. Close examination of the plot also reveals a

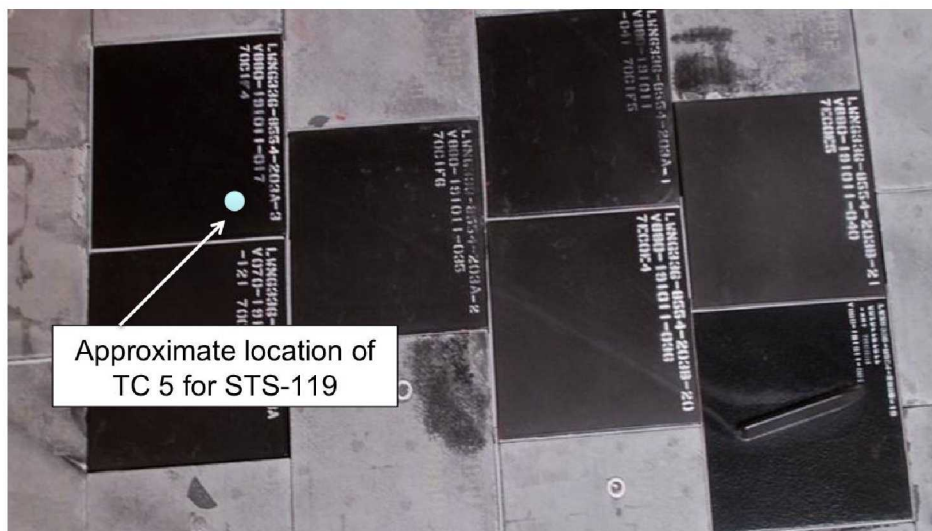
Figure 11. STS-119 post-flight photo showing streamline structure

Following the flight of STS-119, the tiles downstream of the protuberance were examined by TPS and material experts. Based on expert opinion and experience with the behavior of tile coating in arc jet facilities, it was determined none of the tiles effected by the flight experiment exceeded temperatures of 2500°F. However, some of the tiles did exhibit deposits that provided clues as to the vortex heating structure downstream of the protuberance. See Figure 11. Because of these observations, it was concluded that TC 5 was not actually located in the vortex-heating region as originally desired. Using these post-flight observations and predicted heating distributions provided by CFD, the thermocouple was relocated for STS-128.

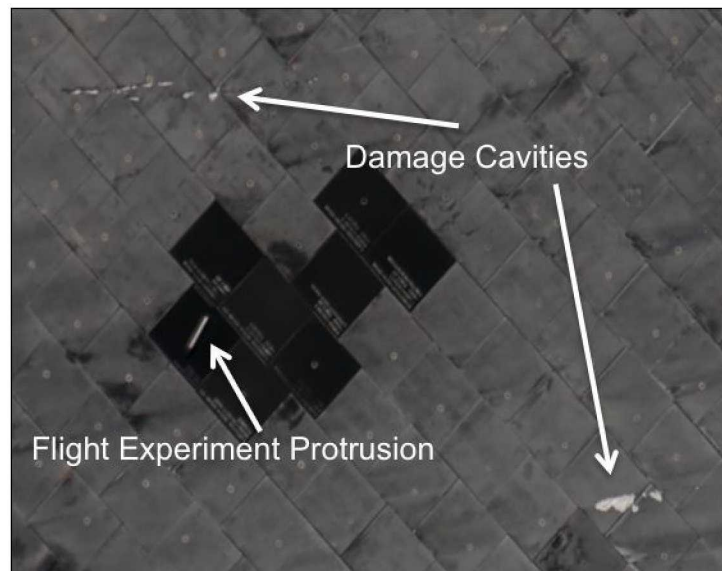
Figure 12. Damage cavities near flight experiment protrusion on STS-128.

bounding analyses. Of the 13, three were tile damage cavities assessed with depths provided by photogrammetry. Incidentally, two damages were found to have occurred on either side of the flight experiment protrusion (see Figure 12). A frayed blanket at the forward Orbiter-external tank attach point was determined to have no significant effect on BLT because the fray was expected to bend during entry. Two OMS pod gap fillers and one Felt Reusable Surface Insulation (FRSI) plug were also examined and cleared by previous analysis and experience.

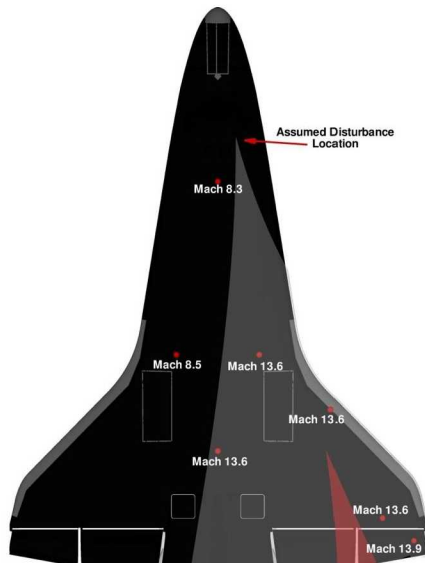
Figure 13. Post-flight reconstruction of asymmetric BLT event.

Similar to STS-119, following Discovery's landing and upon examination of the thermocouple data, it was clear that Discovery had again experienced an early asymmetric BLT event. Unfortunately for the flight experiment, this asymmetric event took place on the port wing upstream of the flight experiment protuberance and associated thermocouples. Figure 13 is a graphic showing the turbulent wedge for an assumed disturbance location in addition to the thermocouples and associated BLT Mach numbers. The asymmetric event initiated at approximately Mach 13.6. The effects of this upstream event unfortunately make it challenging to interpret the flight experiment data in some instances. HYTHIRM observations at closest approach were earlier than the measured BLT times and so observations of the asymmetric wedge similar to STS-119 are not available as shown in Figure 14. Also similar to STS-119, the exact cause of the early asymmetric BLT event is unknown notwithstanding a focused effort to inspect the vehicle for out of specification steps, gaps, and for missing gap fillers.

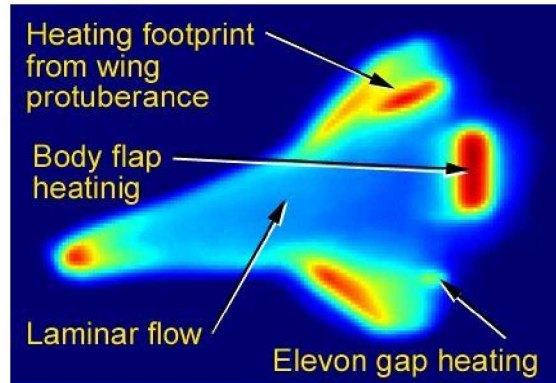
Figure 14. HYTHIRM imagery from STS-128 (Ref. Horvath)

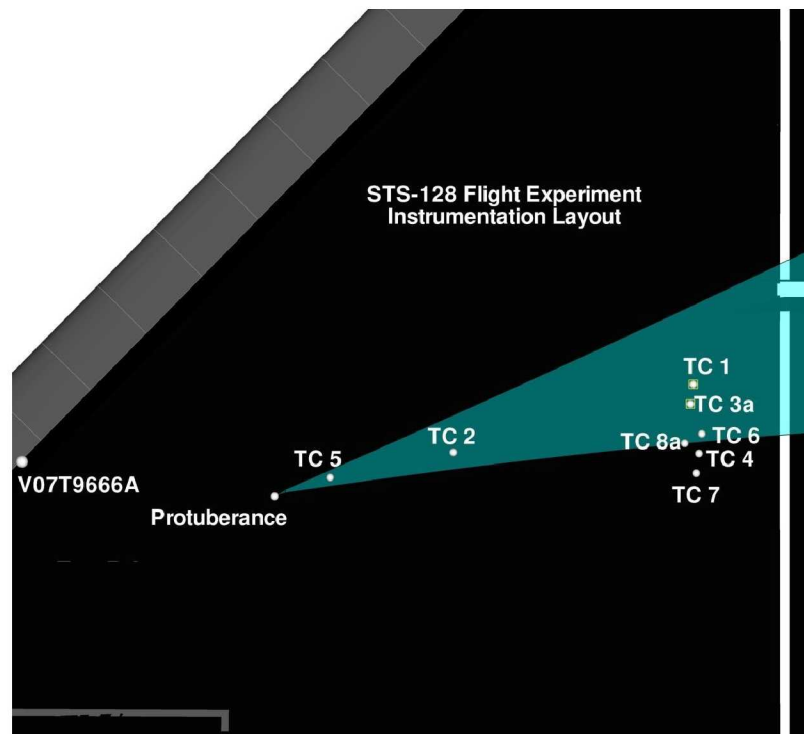
Figure 15. Thermocouple labels for STS-128.

For convenience during the discussion of the flight data, the labeled flight experiment thermocouples are shown in Figure 15. STS-128 flight data in the form of thermocouple time traces are shown in Figures 16 and 17. The thermocouple data is plotted in two different plots for the sake of clarity. Figure 16 shows the thermocouple data associated with the flight experiment thermocouples that are furthest aft, while Figure 17 shows the data for thermocouples further forward and on the protuberance. The data is plotted using the post-flight BET. The temperatures are plotted versus time from Entry Interface (EI).

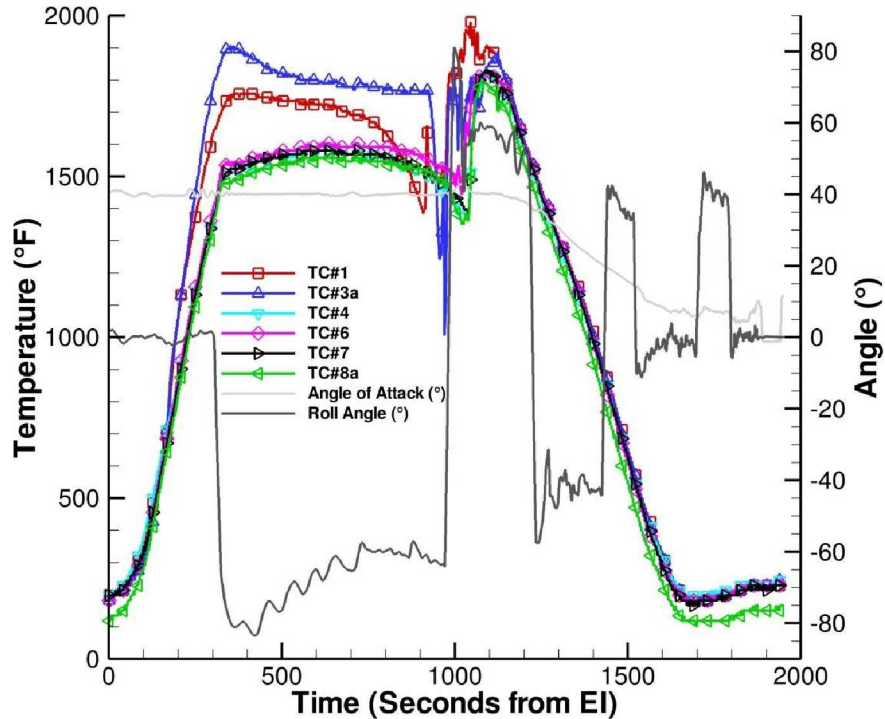
Figure 16. STS-128 data for aft thermocouples

A cursory glance at the aft thermocouple traces in Figure 16 show that temperatures did not exceed 2000°F. Peak temperatures were experienced during the turbulent portion of the entry. With the exception of TC 1 and TC 3a, temperatures during the laminar portion of the trajectory were all similar with peak laminar temperatures between approximately 1500 and 1600°F. In fact, the traces for TC 4, TC 6, TC 7, and TC 8a lie nearly on top of each other through the entire re-entry. It should be noted again that both TC 1 and TC 3a had catalytic coating applied to the surface. As such, the elevated temperatures in relation to the other aft thermocouples is not unexpected. It is also worthwhile to note that because of the placement of the thermocouple at the leading edge of the catalytic coating, it was also expected that TC 3a would exhibit a higher temperature than TC 1. The magnitude of the temperature levels and the trends with time for TC 1 and TC 3a, however, are somewhat troubling. While a physics-based explanation for the drop in temperature during the laminar portion of the trajectory is possible due to the reduction in non-equilibrium heating potential as the altitude and Mach number are reduced, the behavior of TC 1 and TC 3a during the turbulent portion of the re-entry is not understood. As can be seen, the traces appear to be very noisy. Additional, more detailed assessments of the heating in Stanton number space (not shown) also cast some doubt on the measurement validity, especially in the turbulent regime. This was a disappointment to the flight test team since obtaining coupled turbulent-catalytic heating behavior at high Mach numbers was one of the prime objectives of the STS-128 BLT FE.

Consistent with STS-119, TC 1 is located at the center of the predicted wedge and shows the earliest sign of non-laminar behavior at 913 seconds. This corresponds to a Mach number of 17.5 based on the BET. The thermocouple data then indicates that the turbulent wedge progresses inboard, as expected, with TC 3a showing the next sign of non-laminar behavior. However, there appears to be a delay in BLT of approximately 60 seconds between TC 3a and TCs 6, 8a, 4, and 7. Based on this information, it appears that the turbulent wedge was initially very narrow before widening later in the trajectory. It is important to note, however, that the upstream asymmetric BLT event most certainly effected wedge observations. This is evidenced by the fact that during STS-119, TCs 4 and 7 showed transition times much later than the other aft thermocouples, indicating that they were outside the turbulent wedge. In this case, TC 4 and TC 7 appear to have experienced transition due to the asymmetric event although it is hard to draw conclusions as to whether or not BLT at these locations was first caused by the BLT FE protuberance or by the unknown upstream disturbance. Based on these observations, the turbulent wedge half angle was not formally assessed.

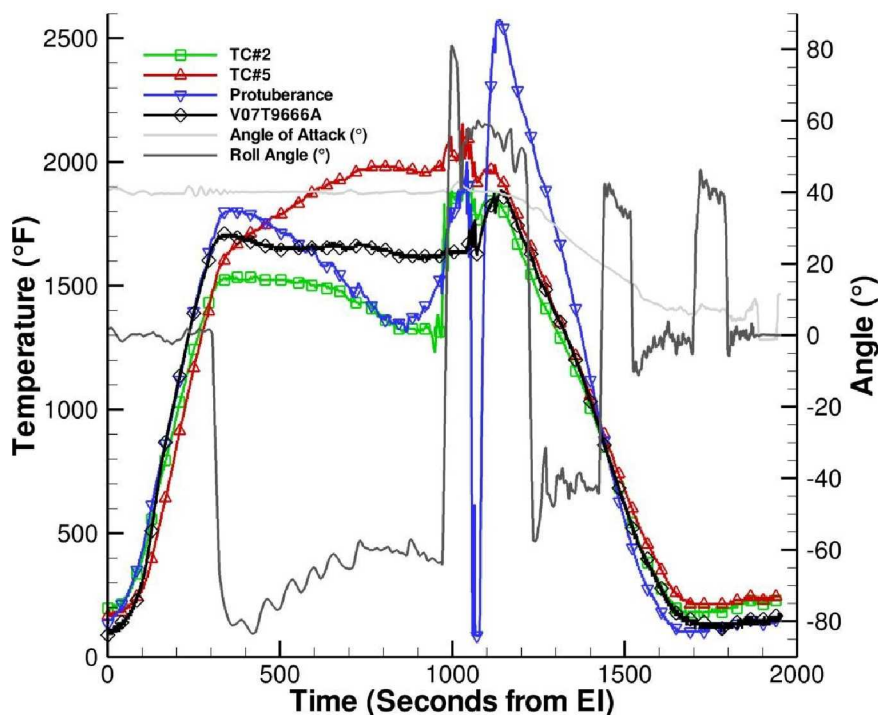
Figure 17. STS-128 data for forward thermocouples

TC 5, located just aft of the protuberance, experiences a continual rise in temperature over the course of the early portion of the trajectory. This behavior is attributed to the relocation of the measurement into the vortex-scrubbing region. Presumably, this vortex heating interaction to the surface masks any clear interpretation of the BLT time, although it was estimated at 1021 seconds, or Mach 14.2. The small spike immediately prior to 1021 seconds is attributed to a vehicle maneuver.

TC 2 exhibits similar behavior to the protuberance thermocouple. It reaches a laminar peak relatively early in the trajectory and then steadily decreases before a rapid rise in temperature. The rapid rise in temperature is assumed to have been caused by transition as a result of the BLT FE protuberance. The reference thermocouple, V07T9666A, seems to exhibit relatively nominal behavior in contrast to the discontinuous behavior exhibited on STS-119.

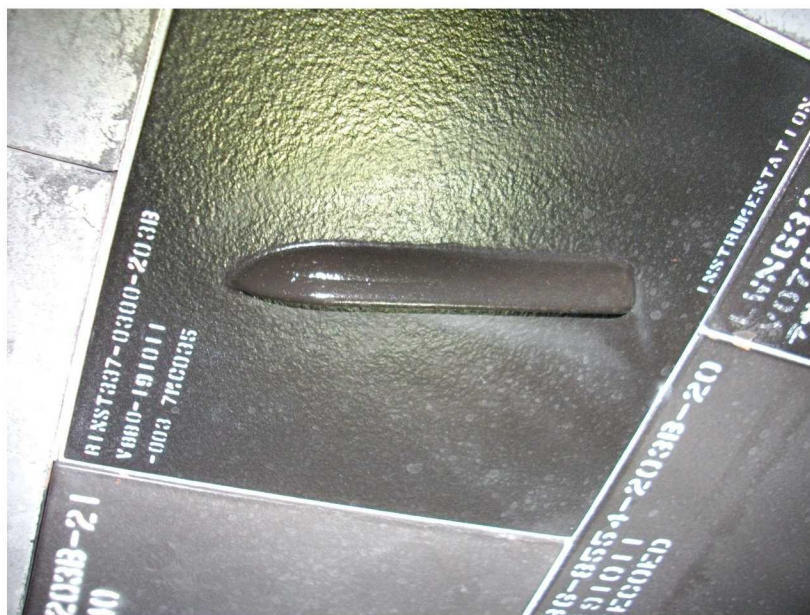
Figure 18. Post-flight runway photograph of STS-128 (0.35-inch) protuberance.

Following the flight of STS-128, the tiles downstream of the protuberance were examined by TPS and material experts. Based on expert opinion and experience with the behavior of tile coating in arc jet facilities, it was determined none of the downstream tiles exceeded temperatures of 2500°F. This information has proven useful in post-flight reconstruction activities. A close-up runway photograph of the protuberance is shown in Figure 18.

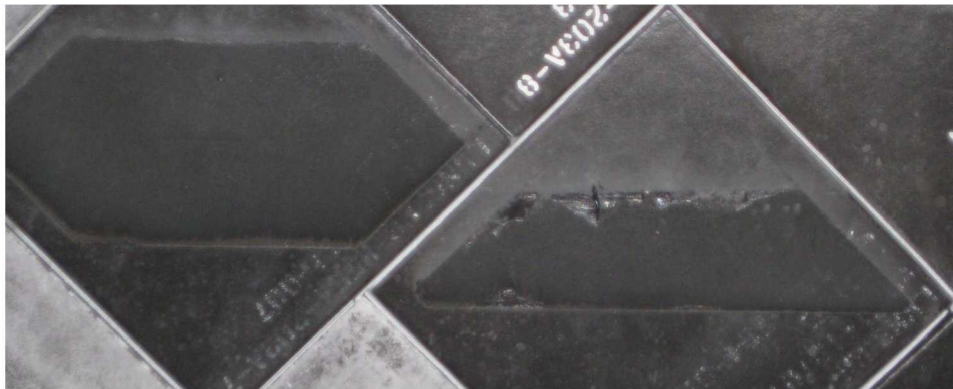
Figure 19. Post-flight runway photograph of catalytic coating following STS-128.

the vehicle and have been replaced with new LI-900 tiles. The catalytic coating did exhibit some coating flaking and RCG coating imperfections on the aft portion of the coating footprint (see Figure 19).
