The International Space Station Solar Alpha Rotary Joint Anomaly Investigation

Proceedings of the 40th Aerospace Mechanisms Symposium, NASA Kennedy Space Center, May 7-9, 2010

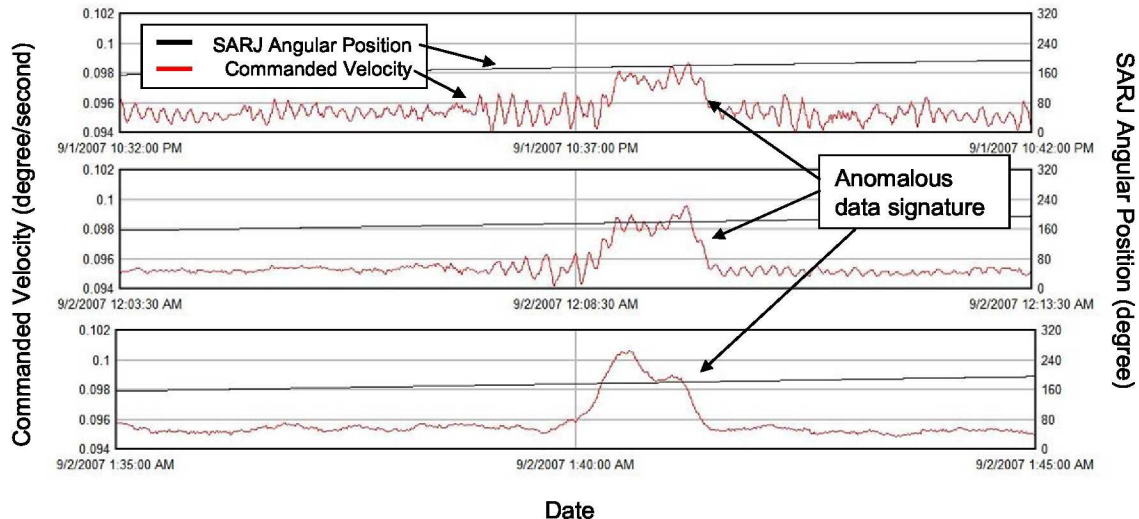
The SARJ software provides continuous status on most of the system's performance parameters. These parameters include, but are not limited to, position, speed, motor current draw, target tracking accuracy, and hardware temperatures. This telemetry is reviewed continuously to ensure the health and effective operation of the mechanism. The first indication of anomalous behavior came from unexpected changes in the Starboard SARJ telemetry. In early September, 2007 the ISS operations team raised a concern that the difference between the commanded and actual velocity of the SARJ was increasing. The SARJ controller software uses the difference between commanded and actual velocity to determine how much current to provide to the mechanism's drive motor. The change in velocity profile prompted a detailed review of the SARJ operational data. From this review engineers determined that subtle changes in SARJ performance could be noted starting on September 1st. Figure 4 below shows the onset of the anomalous data signature. There are two pieces of telemetry shown. The first is the joint position and the second is the commanded velocity of the mechanism. The three plots depict ten minutes periods of time from three

consecutive orbits. Two observations can be made from these data: (1) the irregular data signature initially occurred at a specific angular position of the joint, and (2) the magnitude of the irregularity is increasing with time. The frequency of the data spikes increased with time such that after a few days the commanded velocity at all SARJ angles was off nominal.

Figure 4. Anomalous Data Signature from the SARJ Controller

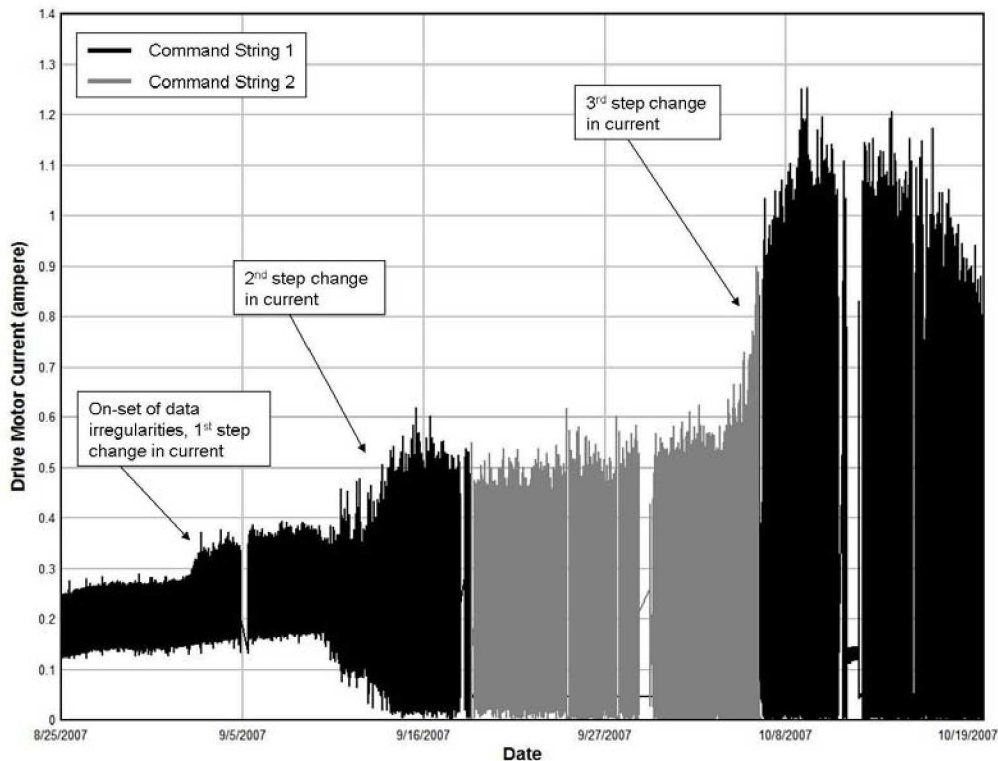
Prior to the anomaly peak motor currents of .25 amperes were nominal. This corresponds to joint drag of approximately 790 N·m (590 ft·lbf). During the initial investigation the peak currents increased to levels as high as .60 amperes, or 1,910 N·m (1410 ft·lbf) of joint drag. The system capacity is 1.4 amperes. While the increase in drag was over 100% of the nominal value, it was still well within system capacity with a torque margin of 1.33. The drive current readings remained steady for two weeks at the increased level. The system experienced another drastic increase in drive motor current in the first week of October. The multiple changes in drive motor current throughout the course of the investigation are shown in Figure 5 below. After the 3rd step change drive motor currents were over 1.2 amperes, or 3810 N·m (2810 ft·lbf) of joint drag. In a one week period the torque margin for the mechanism had decreased from 1.33 to .17. There was a risk that with another step change in required current there would be an unrecoverable stall of the mechanism.

Figure 5. Starboard SARJ Drive Motor Current Changes During the Course of the Anomaly Investigation

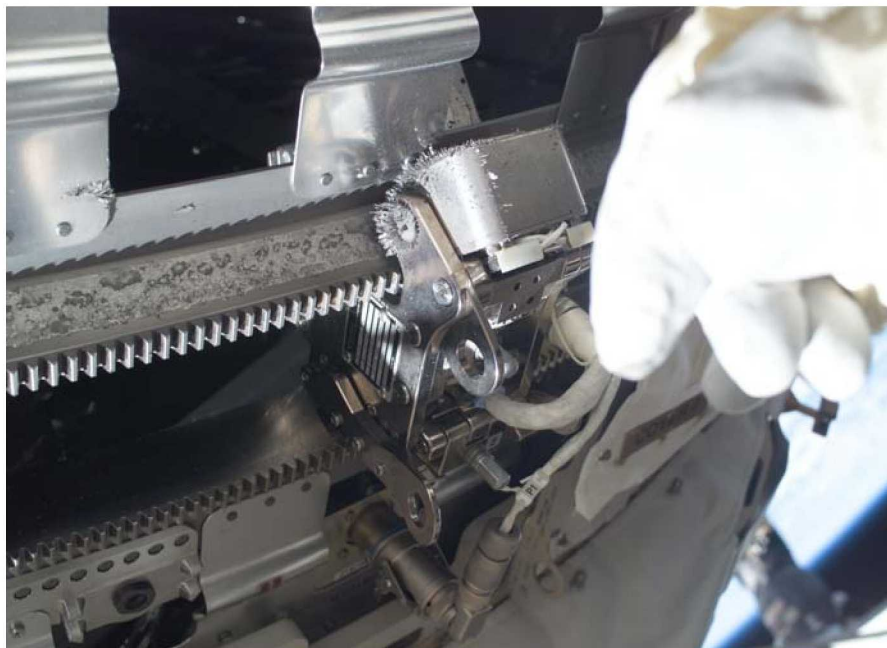
Nothing off nominal was noted during the external survey. The crew had sufficient time to remove a MLI cover for additional inspection. Upon removing the cover the astronaut immediately noticed that there were fine metal shavings across the outboard bearing race surface. Additionally the astronaut noted that the TBA roller housing was acting as a magnet and collecting metal shavings. Samples of the debris collecting around the TBA housing were gathered and returned to ground for analysis (results discussed below). A characteristic picture of the condition of the mechanism can be seen in Figure 6 below. The outboard race ring, and specifically the outer canted surface, appeared discolored and mottled and there was debris on much of the surrounding hardware.

Figure 6. Astronaut Inspecting the Starboard SARJ During an Extra Vehicular Activity

The root cause of the damaged bearing race was not immediately known. It was clear however that the mechanism was mechanically damaged and operating in a significantly degraded condition. There was concern that continued operation could exacerbate the problem. Also, the vibrations caused by rotating the joint had become severe enough that accelerated hardware fatigue was a concern. The anomaly investigation team recommended that operation of the Starboard SARJ be halted immediately until the root cause of the anomaly was known.

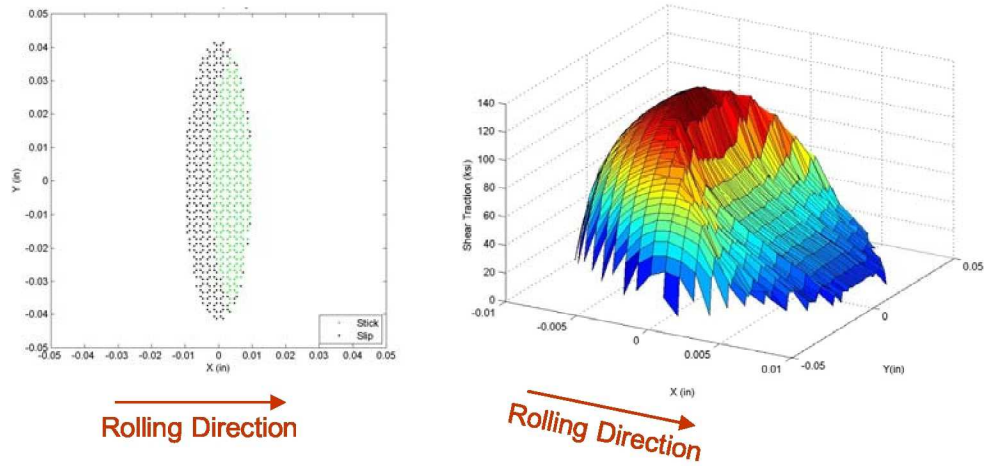
Figure 11 below shows the transverse shear traction distribution on the GRC test rollers for a representative misalignment case. The plot on the left shows that the contact area is divided into regions of stick and slip. The stick region, shown in green, is located at the leading edge of the contact. As the unstressed material of the test rollers enters into the contact patch, the shear deflections and tractions between the two rollers build until the shear tractions reach the limiting value of friction defined by the coefficient of sliding friction, μ , times the normal pressure. As material moves through the trailing end of

the contact, slipping occurs between contacting points on the rollers, and the shear tractions remain at the limiting value of friction.

Figure 11. Shear Traction Distribution for GRC Test Rollers, $Q/P = 0.4$

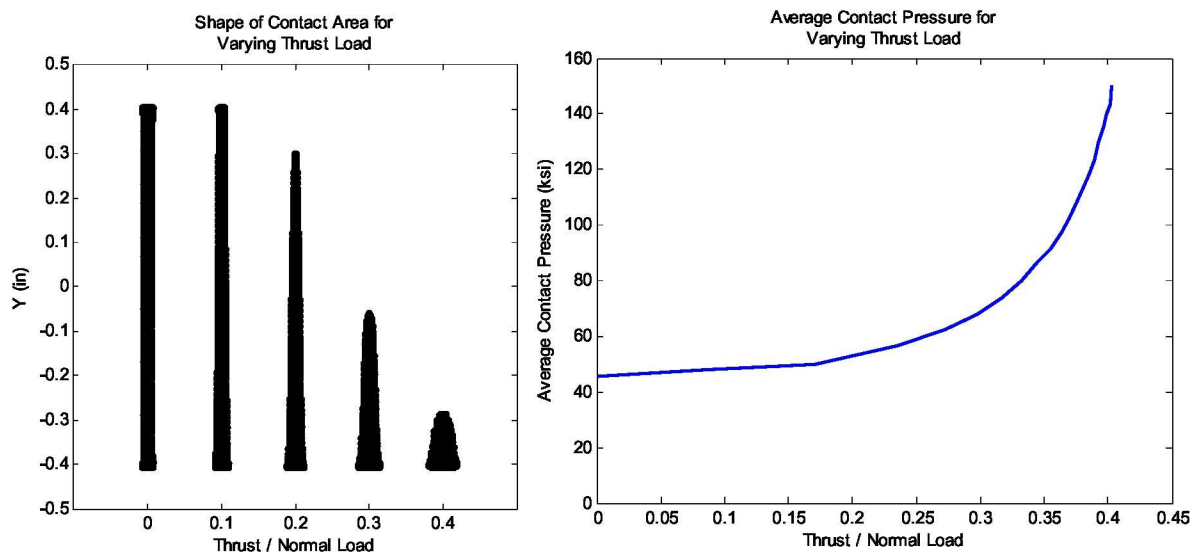
The tractive phenomena in the flight TBA rollers are analogous to those in the GRC test rollers, with the exception that the TBA rollers have an additional camber degree of freedom. The flight TBA rollers also have a flat profile that transitions to a 0.060 inch blend radius at the edges of the contact. As a result, the size and shape of the contact patch for a TBA roller vary dramatically depending on the thrust loading and camber angle of the roller. The contact patch dimensions are plotted in the left portion of Figure 12 below for increasing values of thrust load. This plot shows that as the TBA roller tilts on edge due to the thrust loads, the area in contact with the race ring is reduced. The right portion of Figure 12 shows that the average normal contact pressure increases dramatically as a result of the reduced contact area.

Figure 12. Contact Patch Dimensions and Average Contact Pressure for TBA Roller

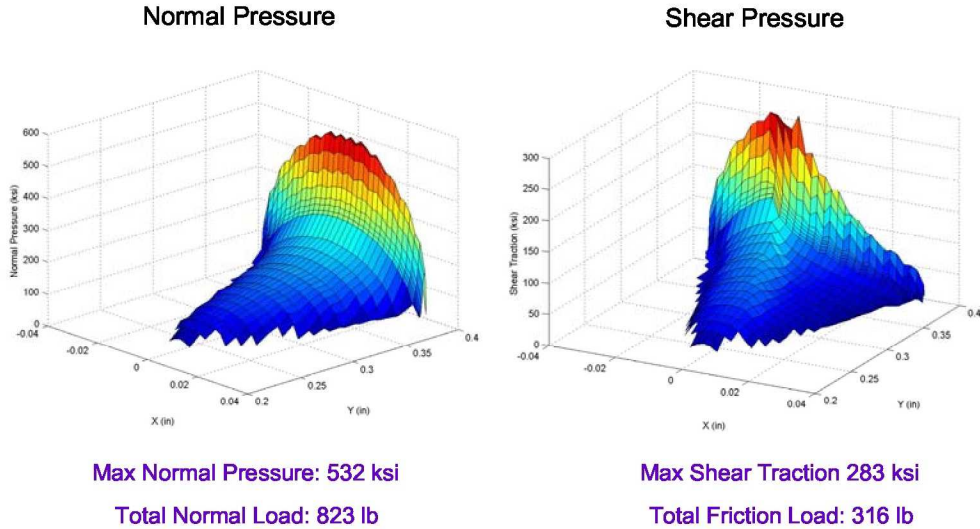
Detailed measurements and tolerance analysis of the Starboard SARJ TBAs identified an approximate worst case mistrack angle of 0.36° . The normal and shear pressure distributions at the contact are shown in Figure 14 below for that mistrack case. As a result of camber tilting, only about one quarter of the width of the roller is in contact with the race ring surface. The resulting stresses at the interface between the race ring case material and the parent material were found to exceed the yield strength of the parent material.

Figure 14. Distribution of Normal and Shear Pressure for 0.36° Mistracking, TBA Outer Canted Roller

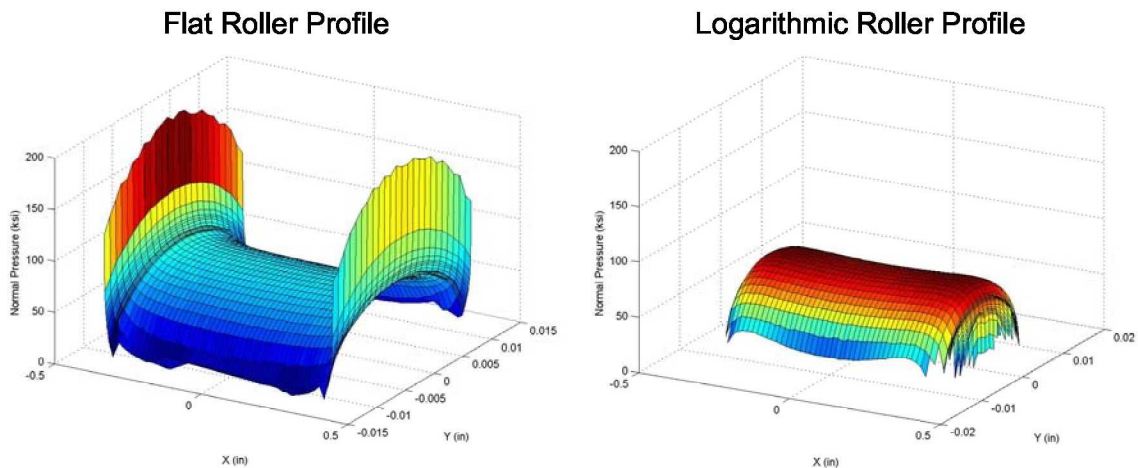
The root cause team further found that the bearing edge stresses were exacerbated by the flat, uncrowned profile of the TBA rollers. The roller geometry made the system sensitive to non-Hertzian effects, which gave rise to high pressure points at the edges of the rollers during the initial run-in period of the mechanism. These high pressure points are visible in the contact stress profile of the TBA rollers shown in the left side of Figure 15 below. Part of the recurrence control plan for the SARJ is to modify the rollers on any spare TBAs to include logarithmically crowned rollers. The logarithmic roller profile is a shape that has been mathematically optimized to eliminate the high pressure points that ordinarily occur at the edges of cylindrical roller bearings.

Figure 15. Normal Contact Stress Distribution for TBA Roller, P = 980 lb

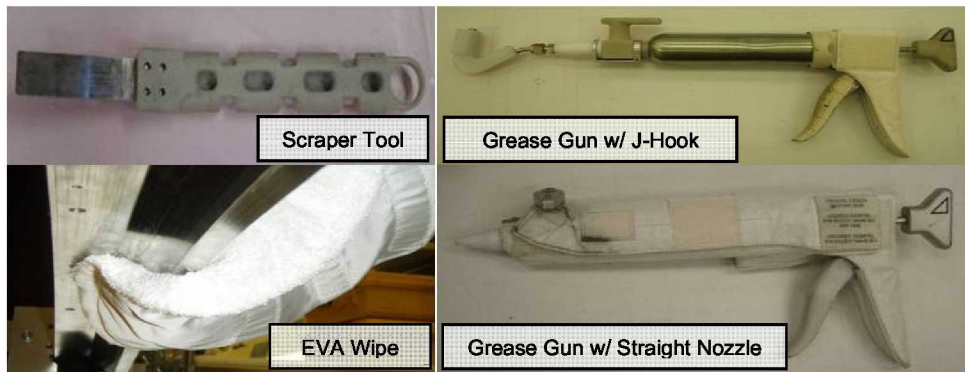
The cleaning and lubrication trials showed that the best method to clean the SARJ was to wet the surface with an EVA wipe pre lubricated with Braycote 602EF[®] and then scrape the surface with a scraper tool. Lubricating the surface prior to scraping proved to be the best method to contain the loose debris particles and prevent them from being liberated and dispersed throughout the rest of the mechanism while scraping. The final application of lubricant to the surfaces after cleaning was done using a grease gun. The inner race ring surface is not visible to the crew so a unique lubrication tool, called the J-Hook

nozzle, was developed by the JSC EVA tool team to allow the crew to lubricate that surface. Photos of the tools used are shown in Figure 16 below.

Figure 16. Tools used in SARJ Clean and Lube Operations

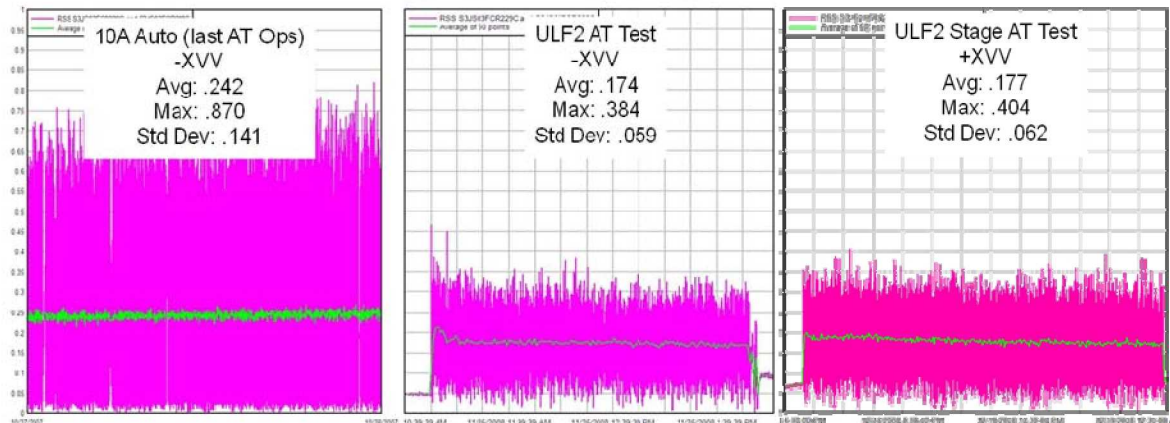
Following the successful cleaning and lubrication of the starboard SARJ, the joint was rotated and the motor drive current was monitored. The motor current decreased immediately from a pre-cleaning and lubrication average of 0.242 amperes to 0.174 amperes. The more critical benefit was the significant reduction in the maximum current levels. The large swing in motor drive current observed prior to the clean and lube operations was mitigated significantly, resulting in a reduction in the maximum current from 0.870 amperes to 0.384 amperes. These results demonstrate that the clean and lube operations were successful in increasing the stall margin in the SARJ which, in turn, maintains operational flexibility of the ISS. These post lube data also compare well with the performance of the starboard SARJ telemetry prior to the anomaly when the SARJ had an average motor current of 0.153 amperes and a maximum of 0.221 amperes. Data plots showing the motor current prior to the clean and lube operations (data taken during the 10A mission), during ULF2 just after the clean and lube operations, and data taken during ULF2 stage operations is shown in Figure 18 below.

Figure 18. Starboard SARJ Motor Drive Current Comparison Pre and Post Clean & Lubrication

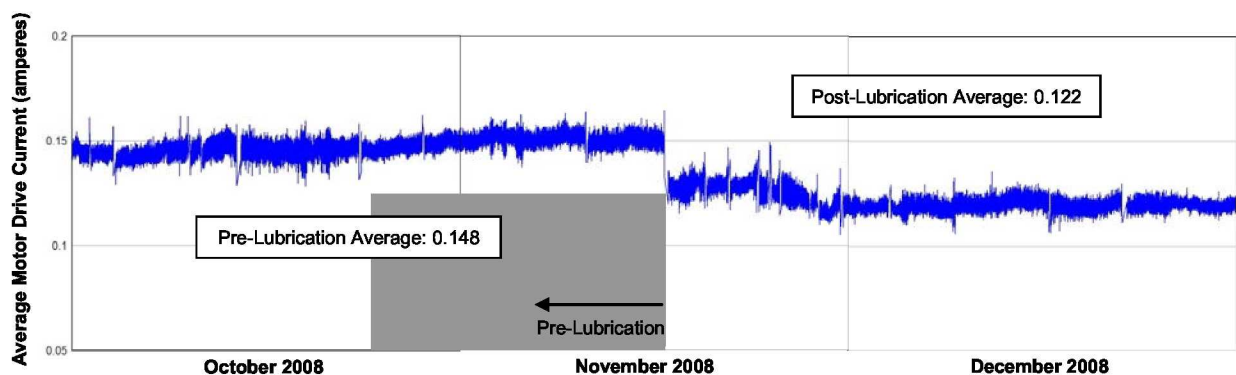
The port SARJ was also lubricated with Braycote 602EF[®] during Flight ULF2 using the same procedures and tools as were developed for the starboard SARJ. The lubricant was intended to protect the mechanism against damage by the same mechanism as was experienced by the starboard SARJ. Pre and post lubrication data for the port SARJ shows a 20% decrease in average drive motor current, shown in Figure 19 below. This drop is significant as it indicates that the mechanism pre lubrication was operating in a regime of higher roller/race friction than post lubrication and was therefore more susceptible to damage initiation prior to the application of the grease lubricant.

Figure 19. Port SARJ Average Motor Drive Current Comparison Pre and Post Clean & Lubrication

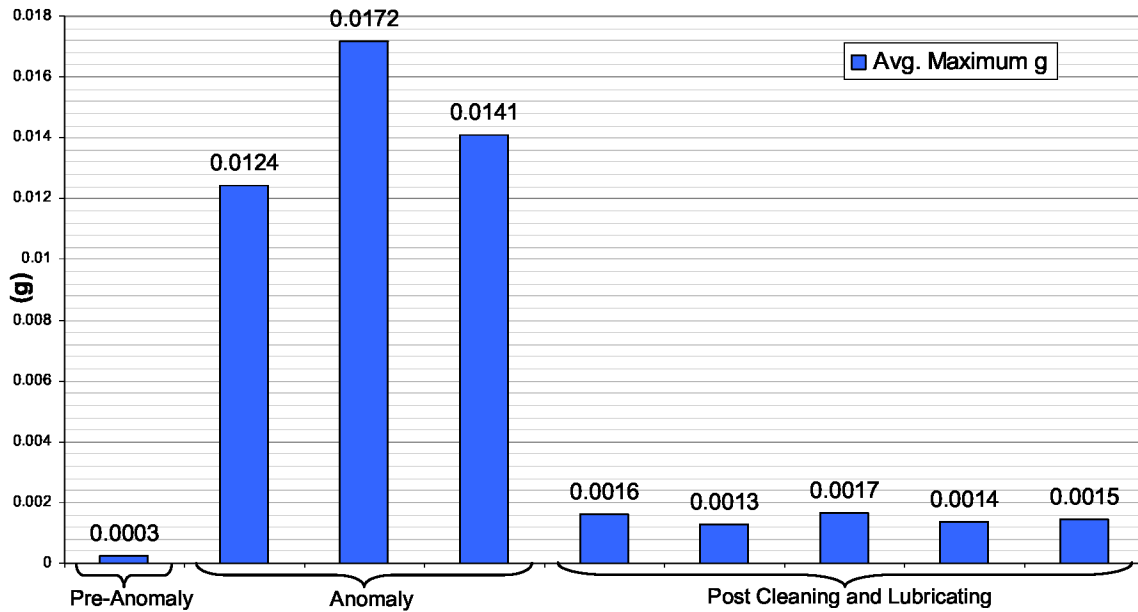
data after ULF2 showed that the peak accelerations had been reduced significantly. Data plots showing pre and post ULF2 accelerometer data are displayed in Figure 20 below and show the dramatic decrease in vibrations to the ISS due to SARJ rotation.

Figure 20. ISS Acceleration Data Pre and Post ULF2 [9]
