## White Sands Test Facility

**Task:** Develop Critical Profilometers to Meet Current and Future Composite Overwrapped Pressure Vessel (COPV) Interior Inspection Needs

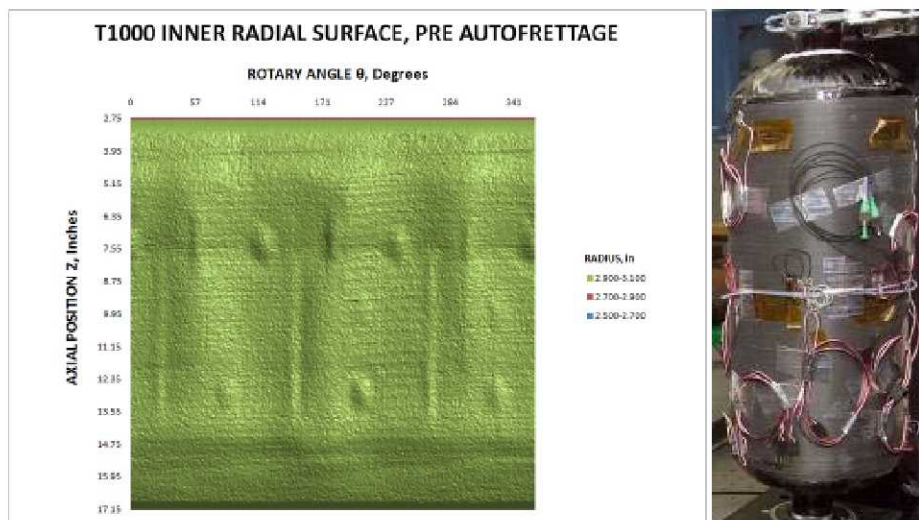
**Figure 1**

360-degree scan of COPV liner prior to autofrettage (at left), and associated vessels shown with external instrumentation

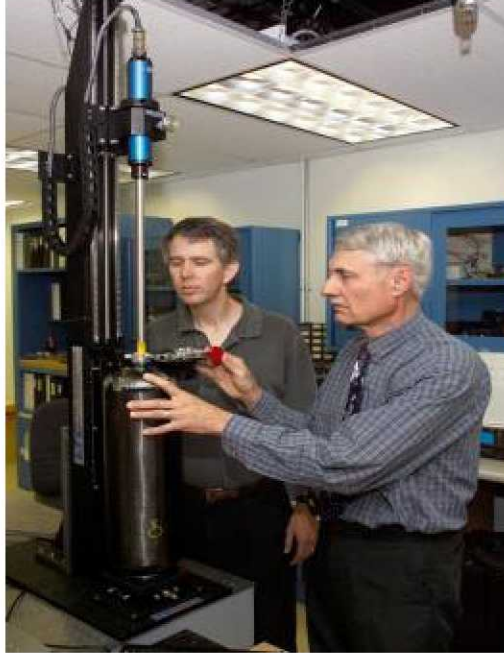
**Figure 3**

WSTF and Laser Techniques Company personnel evaluate a COPV for the NESL Plastically Responding Liner Project

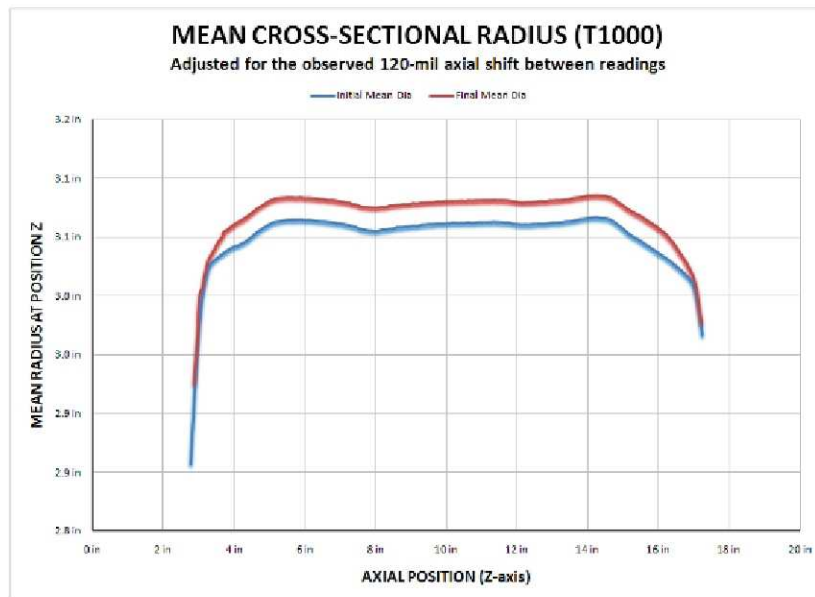
**Figure 4**

Plot of average diameter changes in an NESL T1000 autofrettage carbon vessel before and after autofrettage

A new laboratory profilometer was developed which added an axis of translation to permit examination of cylindrical vessels to the existing spherical vessel inspection device. The new profilometer was been developed for vessels with diameters of 5.9 to 6.5 in. Since development, the unit has been successfully used on dozens of COPVs manufactured for the NNWG stress rupture test project (40 have been tested), the NESC autofrettage test project, and the NESC plastically responding liner testing (Fig. 3). Fig. 4 depicts how changes in vessels before and after autofrettage can be evaluated. Fig. 5 is a 3-D view of displacements before and after autofrettage to help visualize changes in the vessel. Fig. 6 demonstrates the ability of this profilometer to image and measure pits in the inner surface.

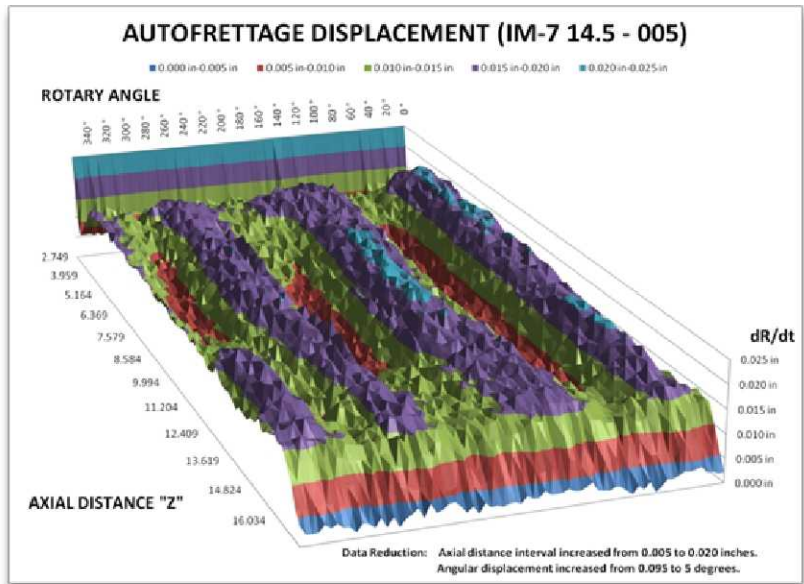
**Figure 5**  
3-D view of displacement, before and after autofrettage

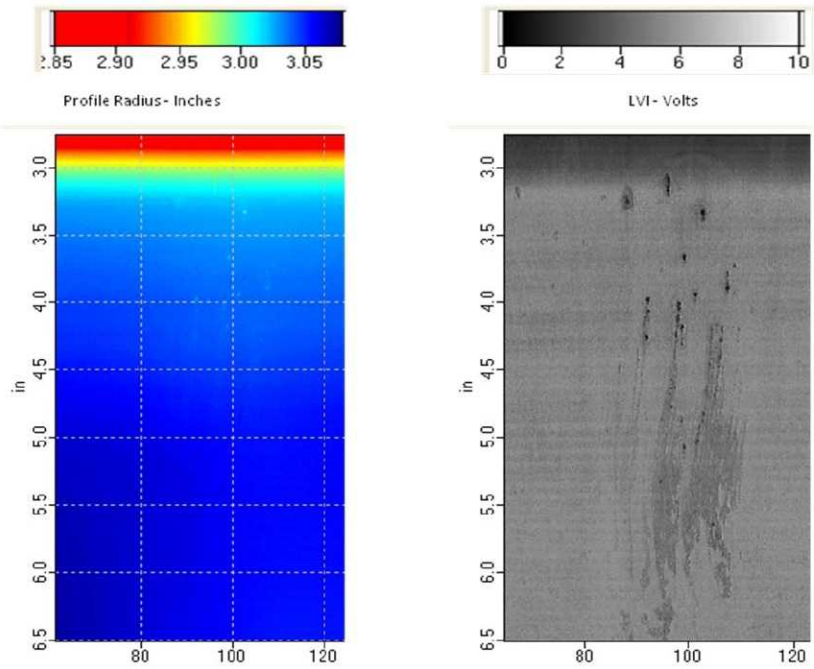
**Figure 6**  
Scan Parameters: Close-ups of pits measured at a depth of 0.005 inches
