NASA/TM-2010-216694
NESC-RP-07-035

Distributed Impact Detector System (DIDS) Health Monitoring System Evaluation

| | NASA Engineering and Safety Center Technical Assessment Report | Document #: NESC-RP- 07-035 | Version: 1.0 |

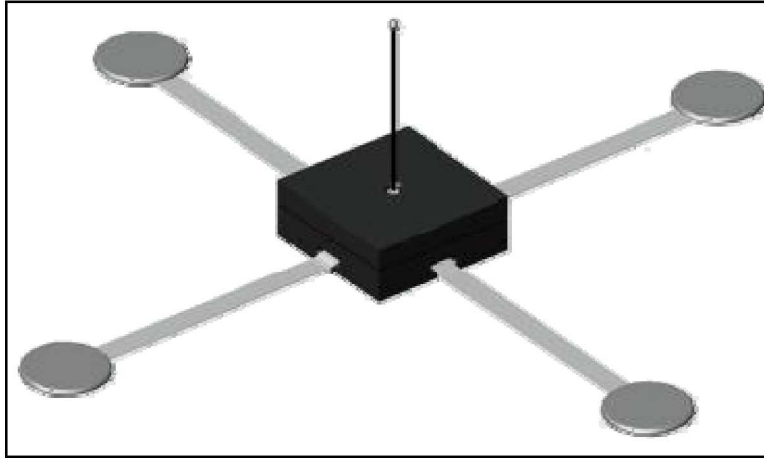
Figure 6.0-1. Conceptualization of a Wireless DIDS Module with Four Sensors

In 2005, LaRC selected an SBIR Phase II development proposal by Invocon, Inc. entitled “Distributed Impact Detection System” to develop a small, low power, multichannel, high-speed digitizing circuit that, in principle, could be used for continuous monitoring of spacecraft structures for accelerations or high-rate strains caused by impacts throughout all mission stages. The system would be able to provide general purpose circuits designed for integrated structural health monitoring. The goal was to allow for passive monitoring of a structure, including modal, frequency-based sensing, active damage detection, and structural monitoring. It was to have a modular architecture with a variety of triggering, power, and data interfaces and could support a variety of sensor options (Piezoelectric accelerometers, AE sensors, polyvinylidene fluoride (PVDF) piezoelectric patches, macro-fiber composite (MFC) patches, and microphones). Most importantly, it was to be decoupled from large amplifier modules, working wirelessly with a base station to simplify system installation, integration, and repair/replacement. Figure 6.0-1 represents a conceptualization of a DIDS module.

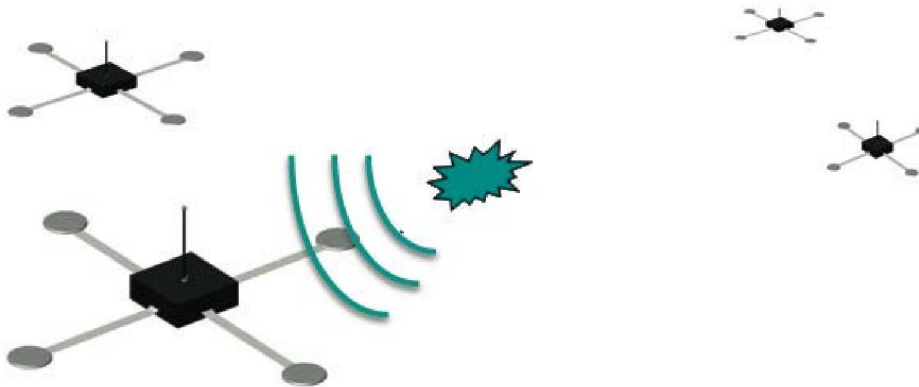
Figure 6.0-2. Schematic of the System Concept

The system concept was to deploy an array of modules throughout the spacecraft that could detect a significant impact event, see Figure 6.0-2 [refs. 1 and 2]. These units would be placed in a low-power, quiescent state where they would be “asleep” except for periodic radio telemetry checks and threshold sensing of an impact signal. The sensing of an impact event would wake a unit from the low-power mode and initiate data acquisition and storage on all four channels within a few microseconds.

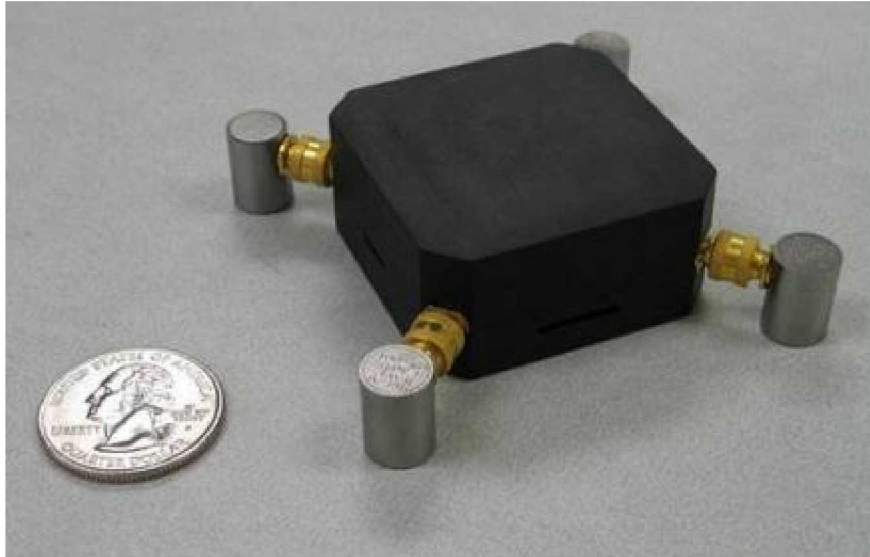
Figure 7.1-1. First Prototype DIDS Module Directly Connected to Four 0.375 inch AE Sensors

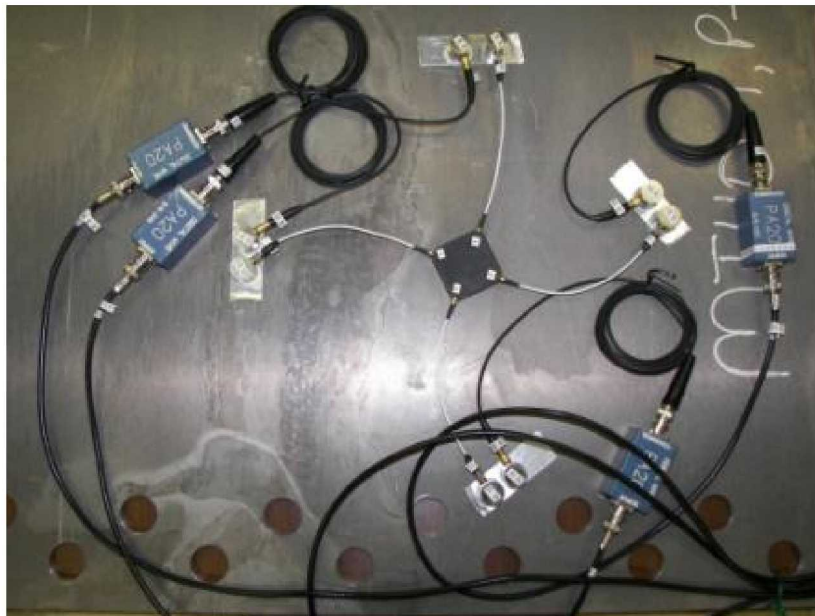
Figure 7.1-2. Close up of a DIDS Module Attached to an Aluminum Plate in Parallel to a Conventional AE System

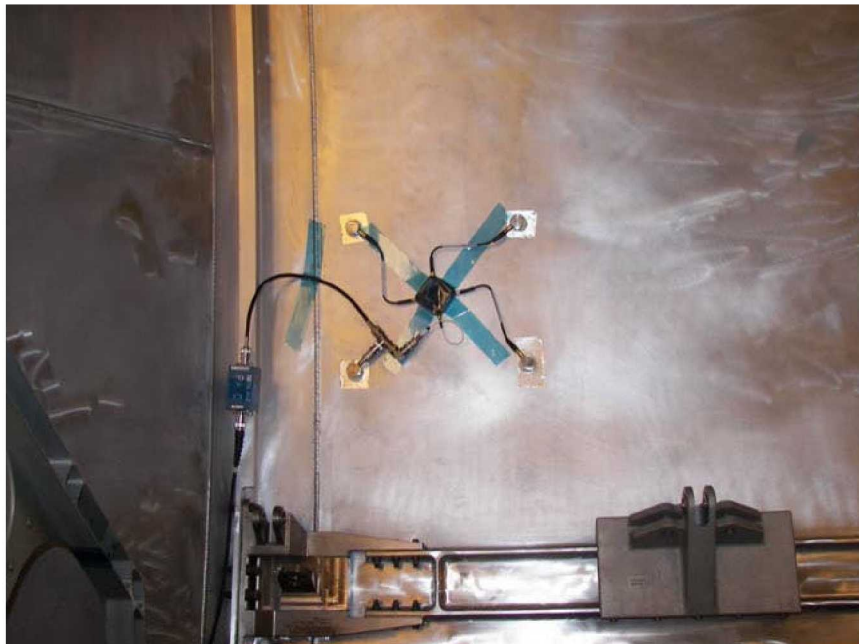
***Figure 7.2-1. DIDS Module with Four AE Sensors Attached to the Node 1 STA Module Wall
(The Third Sensor (Channel 3) was also connected to a Conventional AE System)***

Five DIDS units were attached to the STA walls as shown in Figures 7.2-1 and 7.2-2. From each DIDS, the channel 3 sensor signal was split for connection to a parallel AE data acquisition system for simultaneous recording. To simulate a leak due to a MMOD penetration in the module wall, a small hole was drilled in the forward cone wall, see Figure 7.2-3. A vacuum system was attached to the external module wall to simulate an atmosphere to space leak. The DIDS sensors under a forced trigger command then recorded the signals generated by the leak. The locations of the DIDS systems are shown in the schematic in Figure 7.2-4. They were distributed from the aft to forward end of the module to cover a range of detection distances. In addition to the actual leak source, a signal similar to a leak signature was injected at various points on the Node 1 STA wall by means of a piezoelectric transmitting transducer.

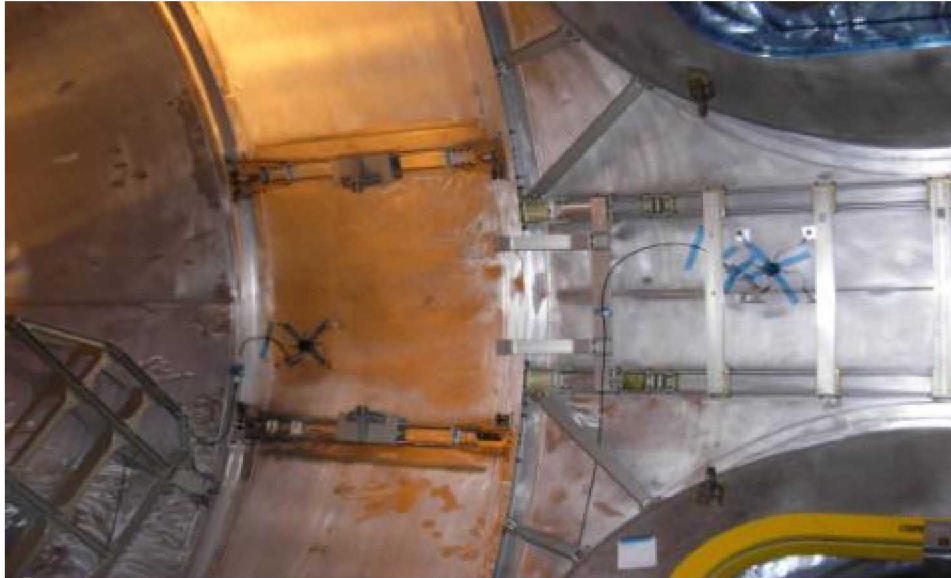
Figure 7.2-2. Photograph of Two DIDS Modules Attached to the Node 1 STA Module Wall

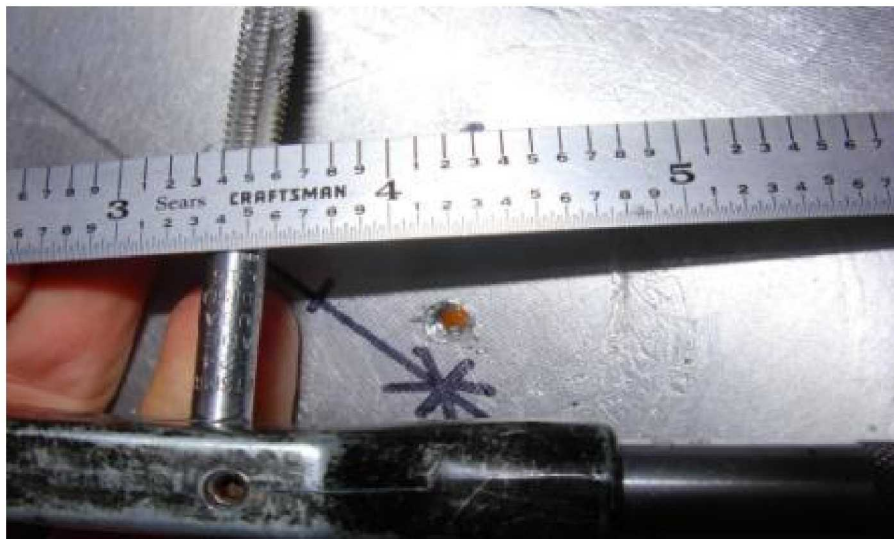
Figure 7.2-3. Example of a Hole that was drilled into the Module Wall for Purposes of Creating a Leak Signature (A tap was used to roughen the hole's edge)

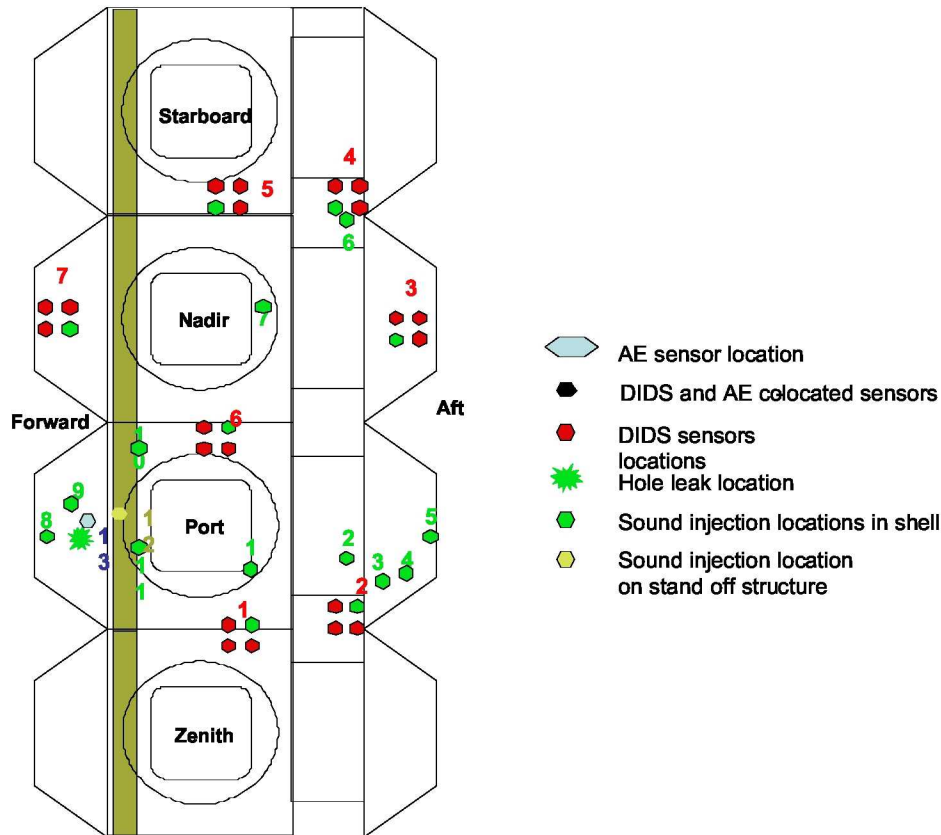
Figure 7.2-4. DIDS Module Locations (shown as red symbols) on a Schematic Layout of the Node 1 STA Wall

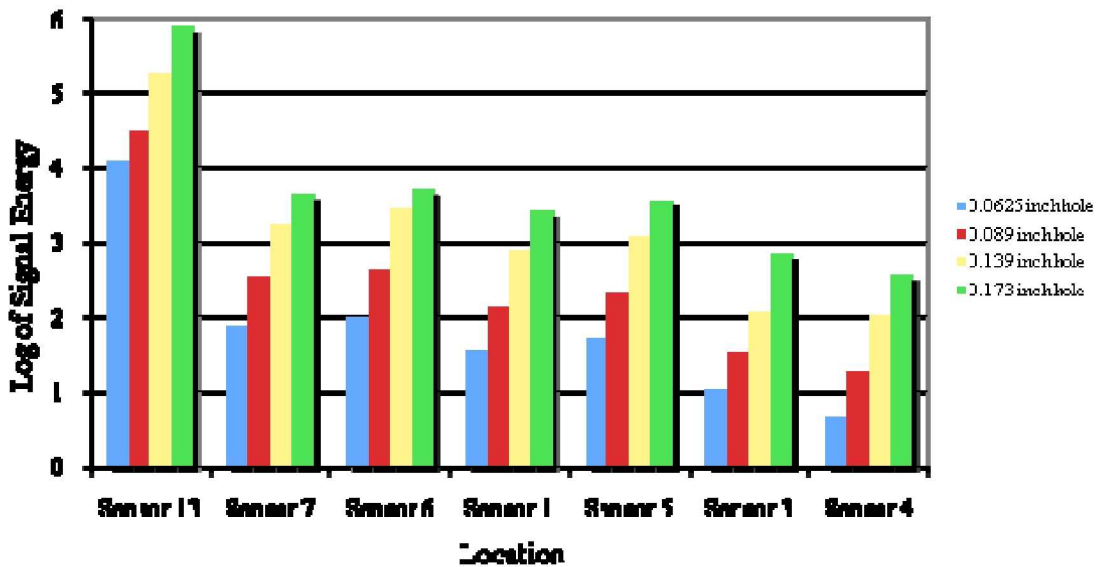
Figure 7.2-6. Measurements of the Sound Intensities from a Noise Signal Generated from Air Escaping through Holes Drilled in the Wall

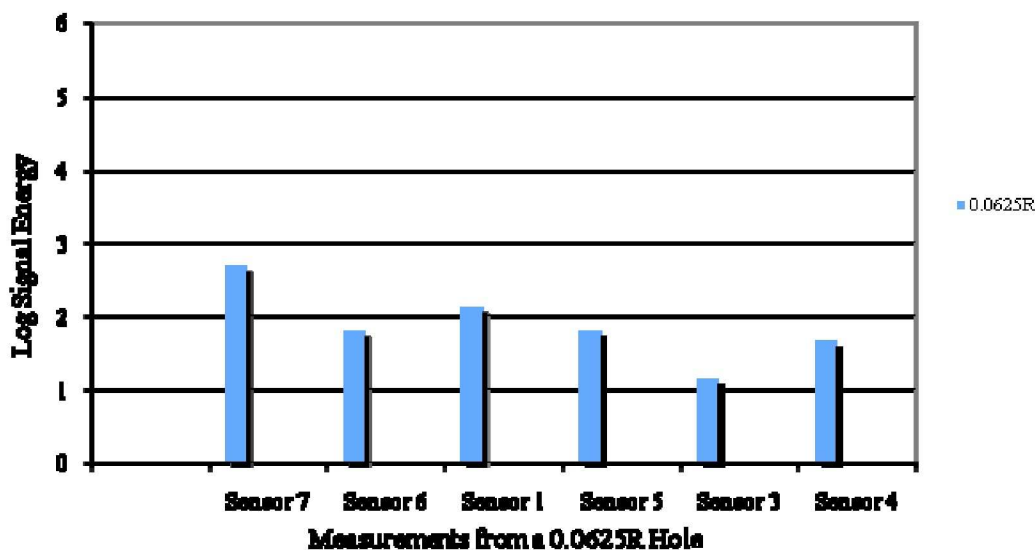
Figure 7.2-7. DIDS Measurements of the Sound Intensities from a Noise Signal Generated from Air Escaping Through a 0.0625 Inch Hole Drilled in the Wall

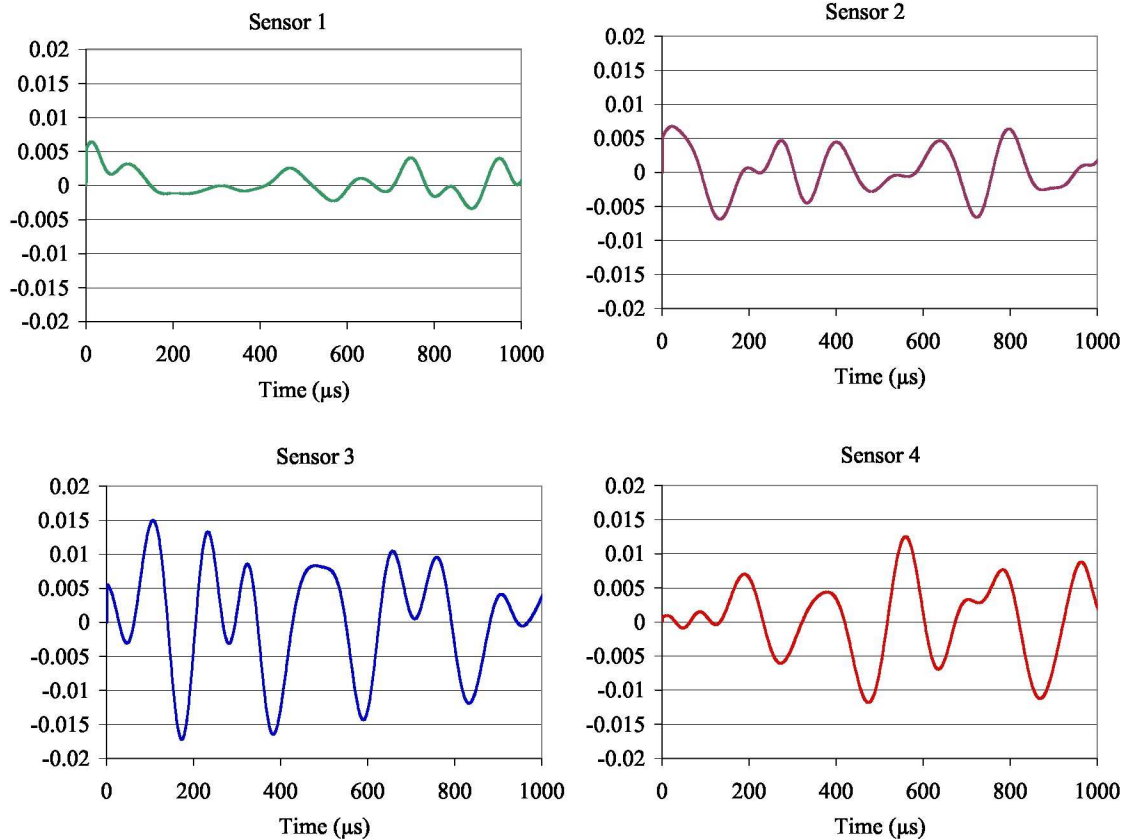
Figure 7.3-1. Signals Recorded from an Impact on a Thick Large Composite Cylinder (Vertical scale is in volts)

Another characteristic of AE signals in composites is the lack of a relatively sharp event arrival onset, which allows the DIDS unit to trigger on one sensor and be able to record the signal arrival on the other three channels. In Figure 7.3-1, all the sensors are recording signals at the outset because the ultrasound wave has already arrived at all the sensors. This makes the identification of the signal first arrival time difficult. At these low frequencies, the signals have a slow, low level amplitude onset with time, which causes the signals to slowly build up in amplitude until it is strong enough to pass the triggering threshold. At that point, the signal’s first arrival will have passed all the sensors by the time the module is triggered.

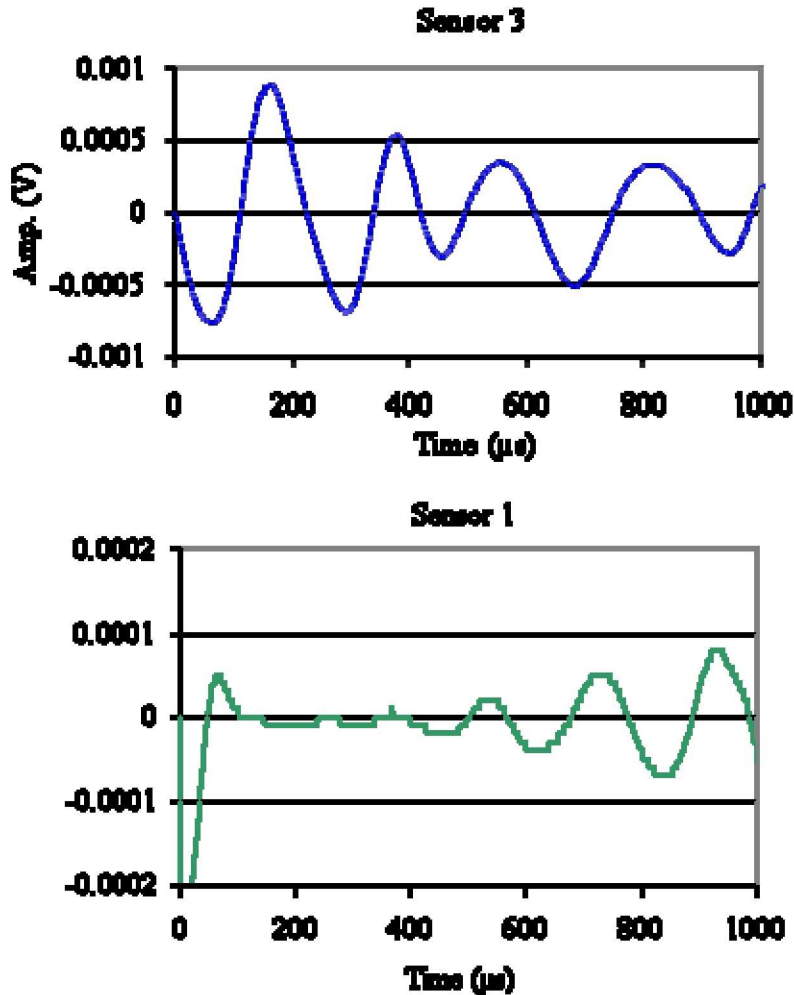
Figure 7.3-2. Signals from Sensors Spaced 60 to 70 inches Apart to Help Capture the First Arrival of the Ultrasound Wave at Sensor 1. (Vertical scale in both panels is in volts)

To counter this effect and to better record the signal's first arrival, the sensors should be placed further apart. This was done at ATK. The DIDS sensors were separated 60 to 70 inches apart on the solid rocket motor case. The results of a low level impact 15 feet away can be seen in Figure 7.3-2. In this test, the DIDS unit was triggered by sensor 3. Sensor 1 shows a signal arriving at about 250 μ s later and at a reduced signal level. Note the vertical sensitivity is different because these were two different sensors with different sensitivities.

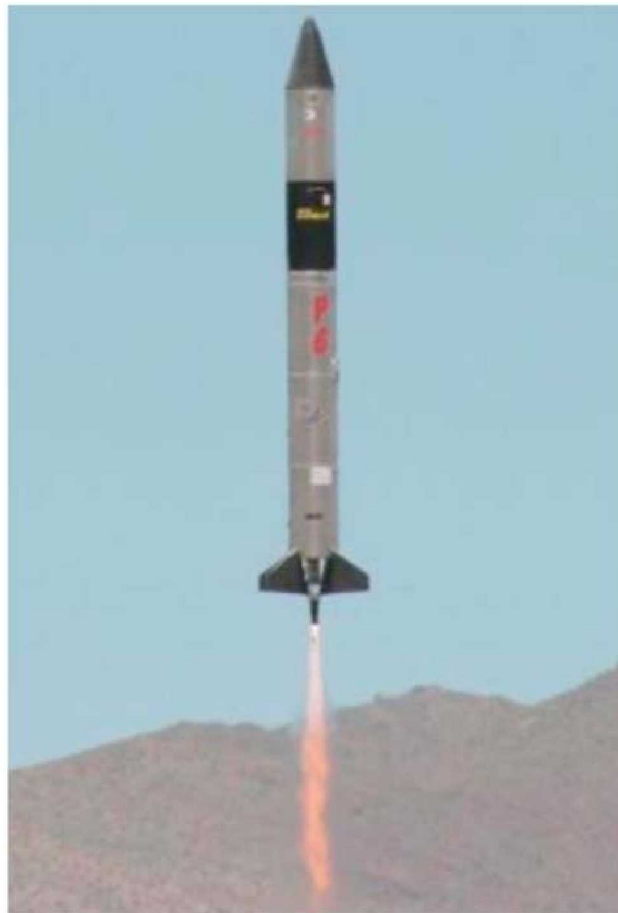
Figure 7.3-3. Full-Scale Prototype Nanosat Launch Vehicle (P-6) in Flight. Rocket is Similar to the P-9. (Photo credit: by Joe Mullin, May 2005)

Under a United States Air Force SBIR contract, Garvey Aerospace developed a series of rockets designed for multiple flight use, see Figure 7.3-3. The P-9 rocket uses all-composite tank technology, including the cryogenic LOX tank. One of the unique attributes of this rocket is that it is designed to land on its nose cone via a parachute assisted descent. The nose cone is designed to collapse in a controlled manner so that the remainder of the rocket remains viable for additional flights.

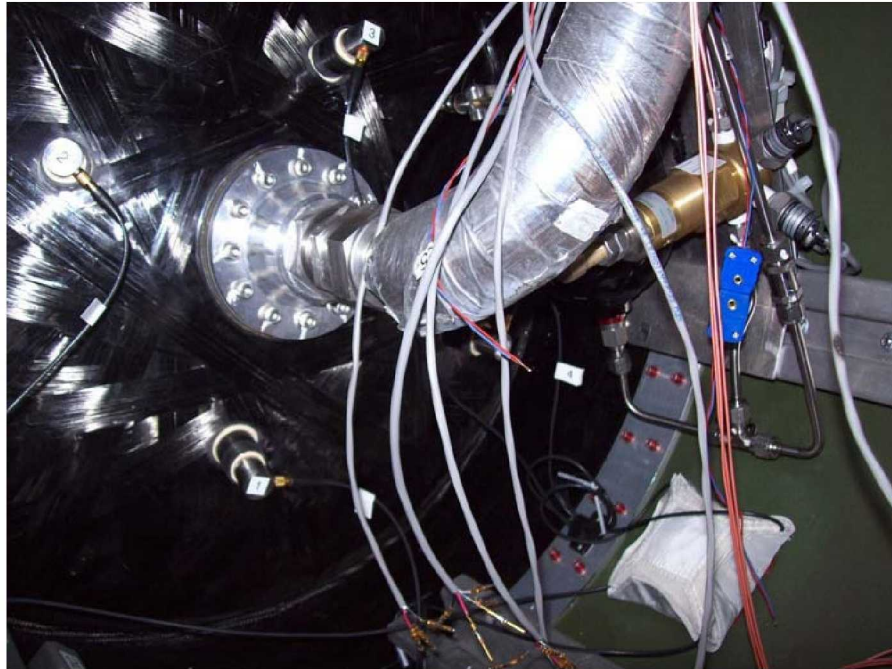
Figure 7.3-4. P-9 LOX Tank Showing the AE Sensors

was attached to the rocket in the region of the LOX tank with four sensors attached to the tank. Figure 7.3-4 shows the LOX tank with the four sensors attached to the aft end of the tank, and the DIDS module attached to the rocket body inside a thermal blanket for insulation. The thermal blanket was used because the DIDS modules have not been tested for low temperature operation. Each of the AE sensors was attached to a plastic delay line to provide some thermal isolation.

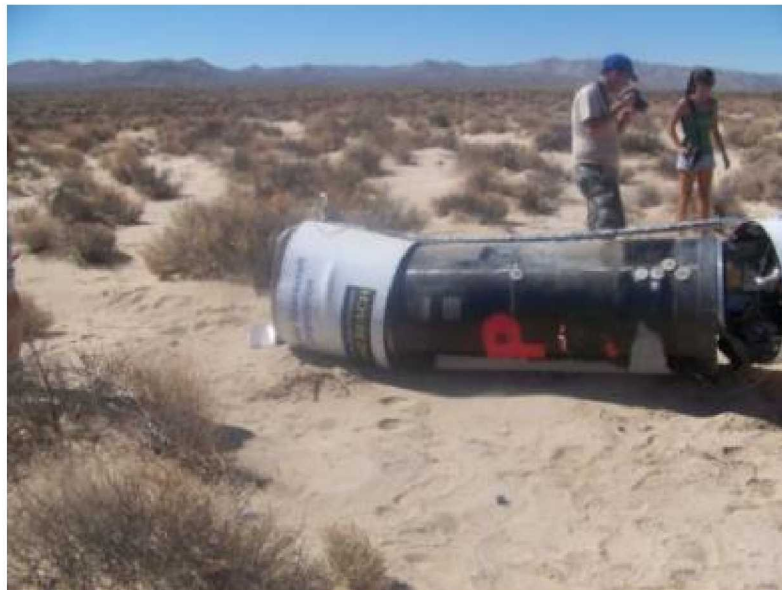
Figure 7.3-5. P-9 Rocket Crash Site Showing Vehicle Forward Section

Figure 7.3-5 shows the rocket forward end at the crash site. The black section is the linerless composite LOX tank. Figure 7.3-6 shows a closer view to the LOX tank with a longitudinal crack that ran the length of the tank. Figure 7.3-7 is an image of the crash area showing the

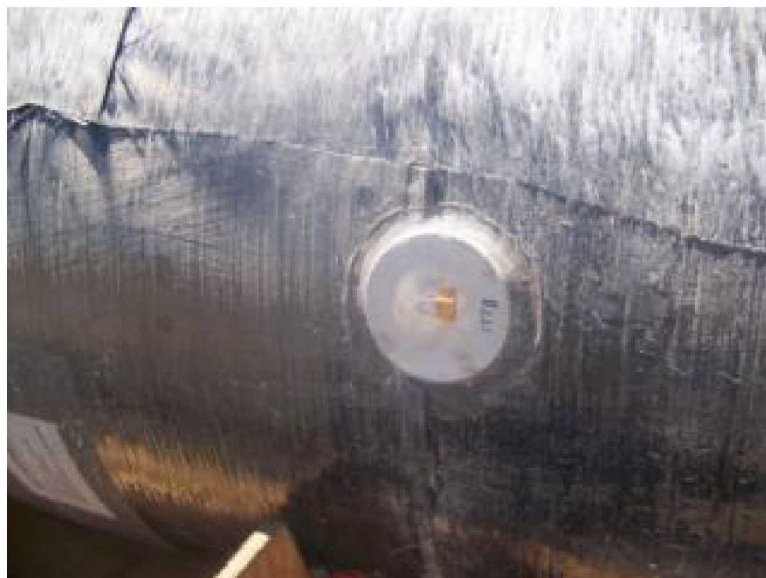
Figure 7.3-6. P-9 Rocket LOX Tank Showing Longitudinal Crack

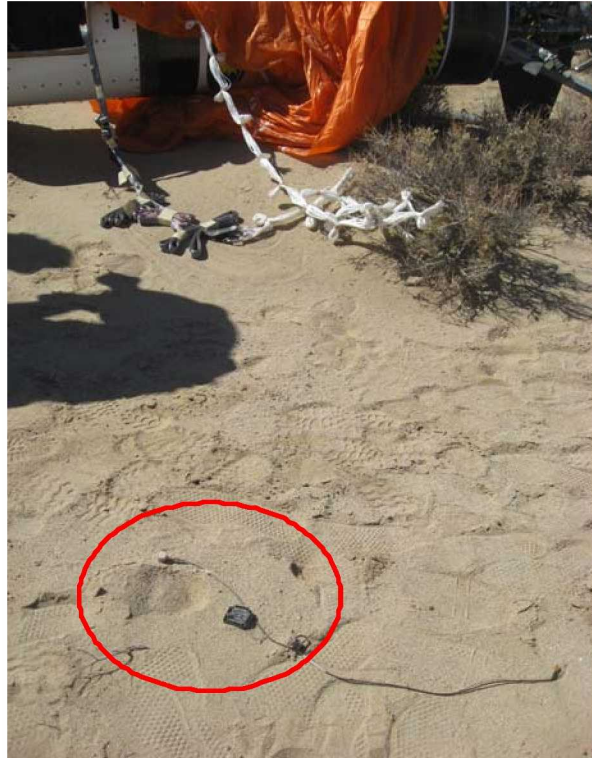
Figure 7.3-7. P-9 Crash Site with Ejected DIDS, Sensor and Cable

DIDS module and one of the sensors and cables lying near the vehicle body after it was ejected from the rocket.

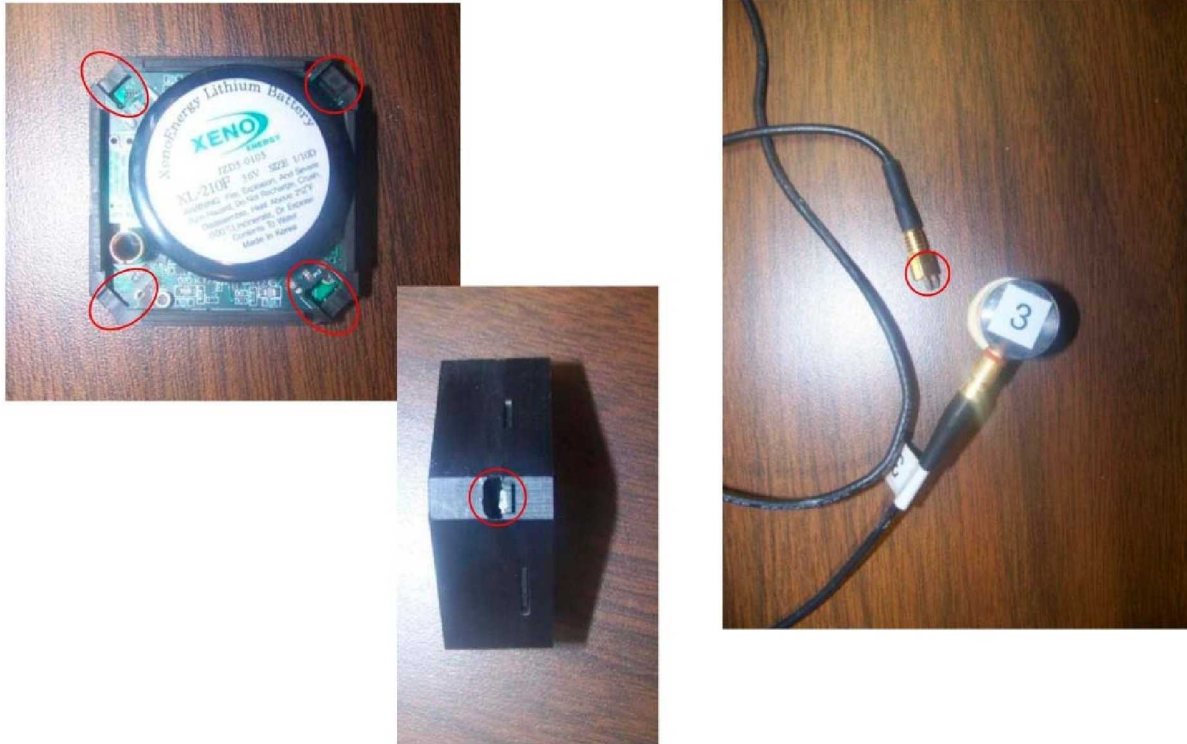
Figure 7.3-8. a) DIDS Body Showing a Missing Jack (circled in red). b) DIDS Showing Four Missing Jacks (circled in red). c) Cable with AE Sensor and DIDS Jack (circled in red).

The DIDS, battery, sensors, and cables were recovered, and the system was inspected. Figure 7.3-8 shows the damage that the DIDS sustained. The extent of the damage appeared to be that the jacks at the four corners of the module were displaced from the module's case by the sensors that came free prior to the final impact. After the battery was reinserted into DIDS, the module initialized and the complete data set was downloaded. The data set included all 275 recorded events corresponding to the flight preparation, loading and transportation to the Mojave Desert, propellant loading and, finally the launch and crash. No DIDS faults or failures occurred during this test and the system successfully collected data during the truncated flight.

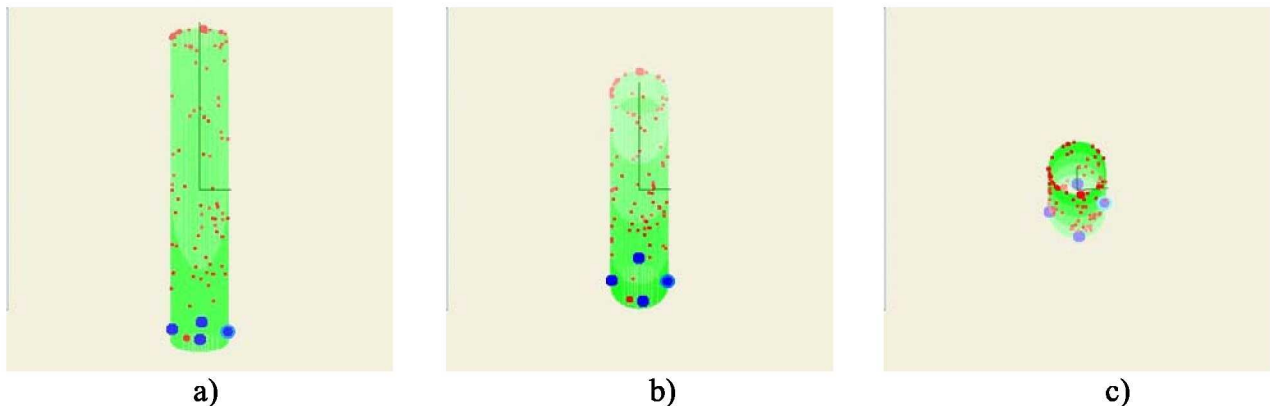
Figure 7.3-10. Estimated Event Locations Shown on a Cylindrical Shape used to Represent the LOX Tank. (The three views show the cylinder tilted at different angles)

Because the signal arrival times are discernable, it is possible to triangulate the signal’s source location. This is shown in Figure 7.3-10, which is an example of a triangulation algorithm applied to a cylindrical shape. Three views of the cylinder are shown with different aspect ratios. The four blue dots are the sensor locations while the red dots are the estimated event locations. There are some distortions in the data in Figure 7.3-10 as the tank does not have open ends and the composite material is anisotropic. This treatment of the tank as an open cylinder tended to push the event locations away from the transducers. The estimated locations were obtained for numerous events, and many were at the LOX fill port at the top of the cylinder, which should be expected.

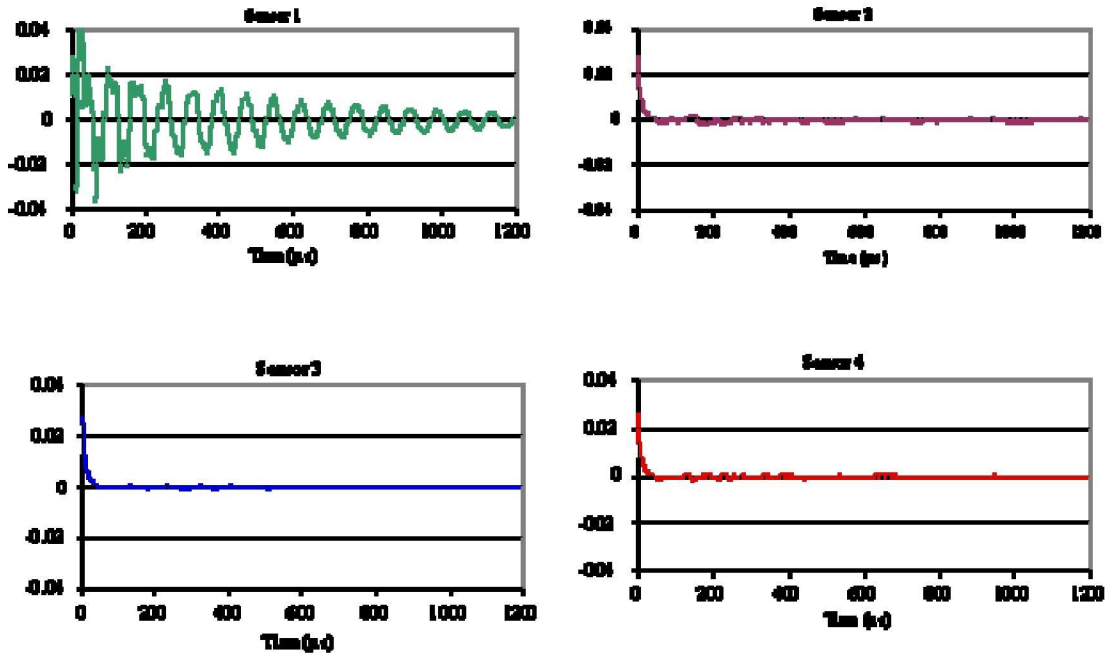
Figure 7.3-11. DIDS Response when Sensor Detached During LOX Tank fill
(Vertical Scales in Volts)

Another interesting event occurred during the LOX fill when the attachment for sensor 1 failed, see Figure 7.3-11. It was subsequently determined that the incorrect adhesive was used to attach the sensors. Sensors 2 and 3 failed during flight when the nose cone failed and only sensor 4 stayed attached until the rocket crashed, see Figure 7.3-12).

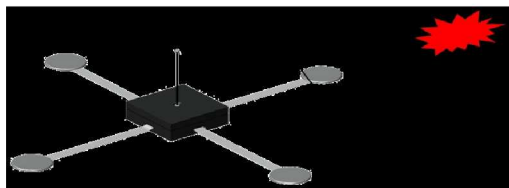
Figure 1. DIDS Operating Concept

Invocon completed the Distributed Impact Detection System (DIDS) as a Phase 2 SBIR contract from the NASA Langley Research Center. Impact detection and characterization on manned spacecraft has been an elusive goal due to the transitory nature of the detectable high-frequency signals. The approach for this effort is to use large numbers of wireless, self-powered, miniaturized, "stick on" piezoelectric sensory nodes. Each node will continuously monitor an accelerometer, acoustic emission sensor, or PZT element for an impact event, such as the foam impact that caused the Columbia tragedy or a micro-meteor impact. The figure below depicts the operating concept for DIDS.
