# Infrared On-orbit RCC Inspection with the EVA IR Camera: Development of Flight Hardware from a COTS System

*Michael Gazarik, Dave Johnson, Ed Kist, Frank Novak, Charles Antill, David Haakenson, Patricia Howell, Rusty Jenkins  
NASA Langley Research Center*

## ABSTRACT

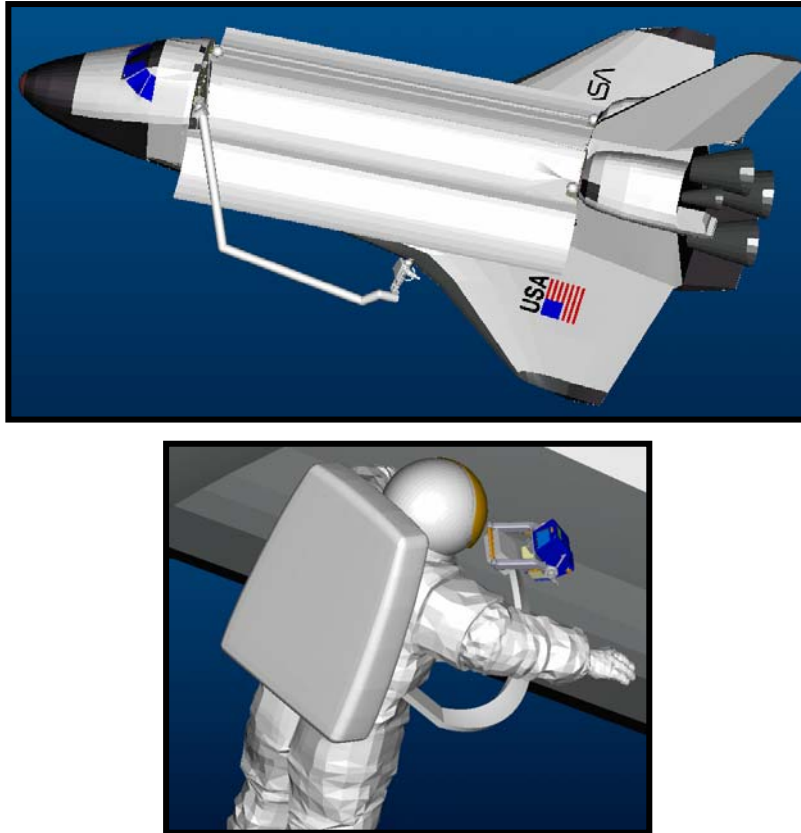
*Figure 1. Imaging the wing-leading edge of the Orbiter during an EVA*

As shown in Figure 1, a crew member will be attached to the end of the Orbiter (or International Space Station (ISS)) arm and image the wing-leading edge of the Orbiter using the camera system from a nominal stand-off distance of 1.5m. Nominal operation procedures called for an astronaut to translate out to the site of interest, record a series of short movies of the target area, transfer the acquired data to a removable storage device, and then translate back inside the Orbiter. Data would be transferred to an Orbiter Payload and General Support Computer (PGSC) for subsequent downlink to the ground where the data would be processed and analyzed. Analysis and testing of damaged RCC material showed that the ability to detect sub-surface damage was improved when imagery was acquired during heating and cooling conditions. If it is not possible for the astronaut to shadow the target area during image acquisition, then the inspection time must be coordinated with sunset, or rely on shadowing from components of the ISS or the Orbiter itself.

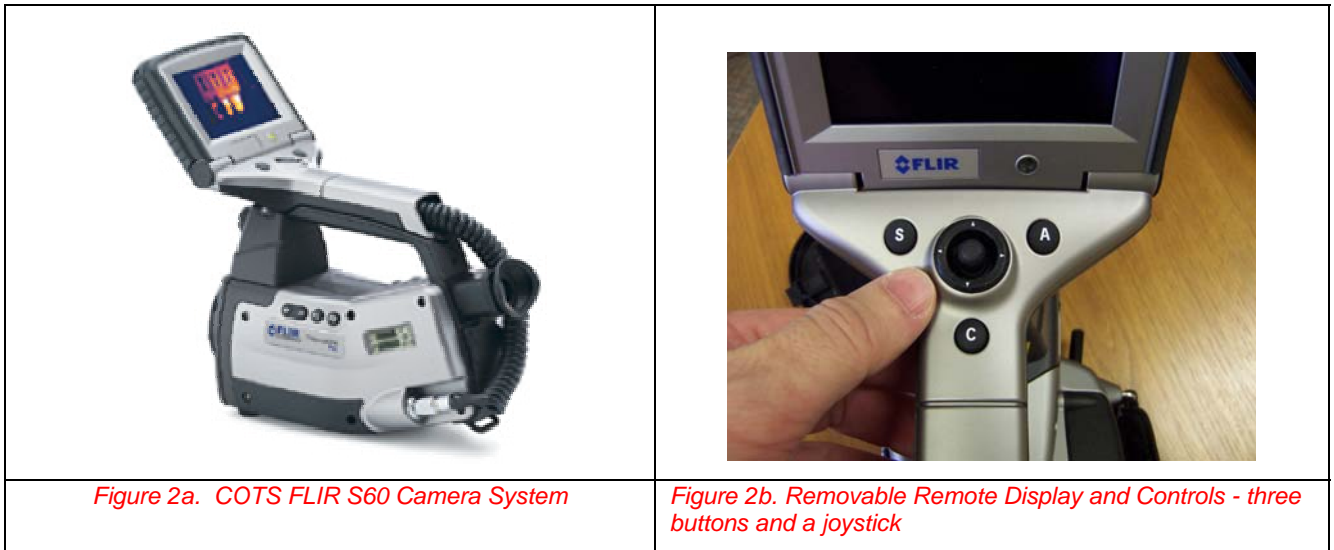
As shown in Figure 3, the S60 was mounted on the MMWS and evaluated by crew members in a 1-g suited configuration. The remote control and display unit is mounted in front of the astronaut on the T-bar away from the camera base. The evaluation found that the FLIR S60 was largely usable "as-is." An extended joystick was recommended to allow easier use with the bulky EVA gloves and a sun-shade for the display unit (shown in Figure 3). The evaluation also determined that the camera base should allow attachment to the swing arm via a standard MMWS bayonet, and allow attachment to the body restraint tether (BRT). The BRT is a flexible arm that allows easy movement and is shown in the bottom right corner of Figure 3. While the COTS S60 controls were found acceptable, subsequent evaluations led to the replacement of the joystick with a 3x3 matrix of EVA-glove compatible buttons. Furthermore, the firmware of the camera was modified to allow one-button operation of key actions such as recording and data transfer.

*Figure 3. Crew Evaluation of the FLIR S60 by NASA Astronaut Michael Gernhardt*

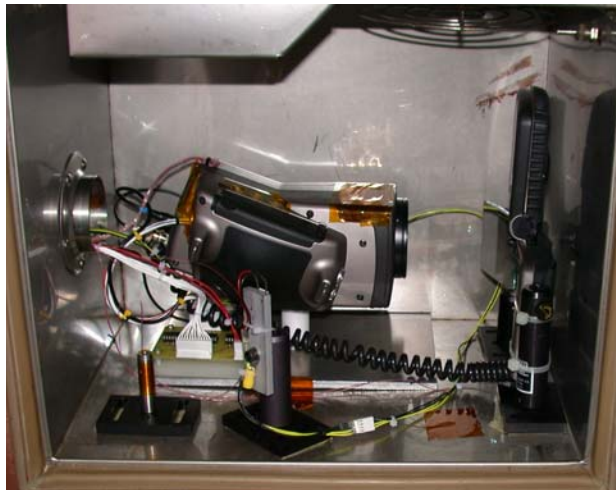
*Figure 4. Tenney Oven Evaluation of the FLIR S60*

As shown in Figure 4, the S60 was placed in a Tenney oven to determine the temperature range of the internal electronics over the -15°C to 50°C operational range of the commercial unit. The temperature extremes on the camera housing ranged from -12°C to 50°C, while the temperature extremes on the LCD varied between -10°C and +53°C. The hottest internal component ran 30°C over the camera housing temperature.

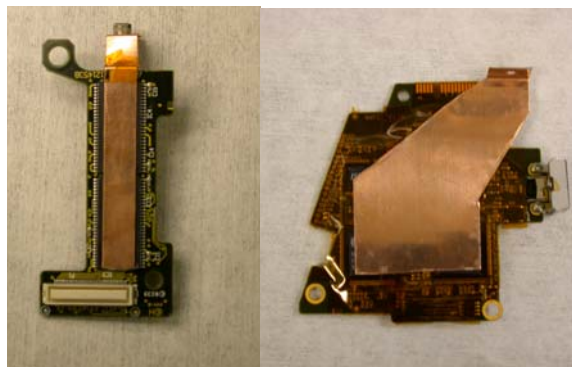
*Figure 5. Example of Copper Thermal Straps*

The temperature data from the thirteen thermocouples installed in the S60 during the Tenney oven evaluation was used to design the thermal-vacuum test. The objective of the thermal vacuum test was twofold. The first objective was to assess the performance of the camera and liquid crystal display (LCD) in a vacuum environment. The second objective was to evaluate the thermal performance of the camera in a vacuum. The S60 was designed to take advantage of natural convection to cool the internal electronic components. However, in a vacuum environment, the system must rely on radiation and conduction to cool the electronics. In order to ensure that the camera would not overheat during the test, a conductive path was created from each of the high-powered electronic chips to the camera housing. Figure 5 shows a representative copper plate that was used to create a conductive path necessary to cool the electronic components.

The addition of the conductive paths lowered the chip-to-case thermal resistance by approximately 63%. As was the case with the Tenney oven test, the camera was instrumented with 13 thermocouples in order to monitor the temperature throughout the test. The thermal vacuum shroud was set to maintain a temperature

of  $-75^{\circ}\text{C}$  for the cold case and  $+20^{\circ}\text{C}$  for the hot case at an ambient pressure of 0.04 Torr. The FLIR S60 operated successfully with the addition of the thermal “straps” and pads that were added to create a conductive path from the electronic components to the camera housing. The LCD operated at a temperature of  $-22^{\circ}\text{C}$  with no noticeable degradation in the performance of the unit. In a  $-15^{\circ}\text{C}$  ambient environment (manufacturer’s minimum temperature limit) with the presence of air, the LCD reached a temperature of  $-10^{\circ}\text{C}$  during the Tenney oven test. However, during the thermal vacuum test, the LCD operated approximately  $12^{\circ}\text{C}$  colder than the published limit. At the conclusion of the final test, the thermal vacuum portion of the assessment was terminated because the LCD high-voltage electronics appeared to begin arcing because of corona discharge. The chamber pressure was very near the corona area where the breakdown voltage of air is small. The high-voltage LCD backlight driver was replaced with a light emitting diode (LED)-based design in the flight unit.

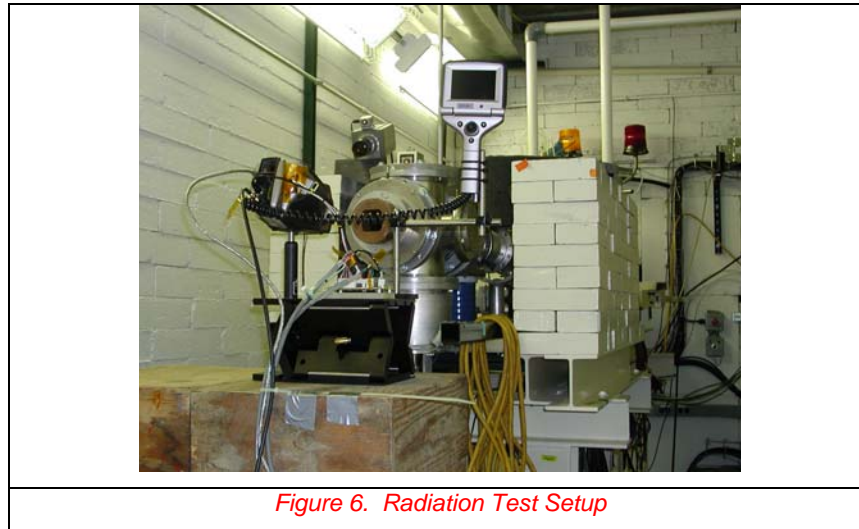
*Figure 6. Radiation Test Setup*

The fourth, and final, test performed in the COTS assessment portion of this project was a radiation test. This test was performed at the Indiana University Cyclotron Facility (IUCF) to assess the susceptibility to high-energy ionizing radiation for several elements of the S60 IR camera. It is imperative that hardware elements be able to operate in the environment for the duration of their missions. The two major elements of the ionizing radiation environment are the deposition of energy from Total Ionizing Dose (TID) and Single Event Effects (SEE) produced by high energy particles like protons and atomically heavier ions. The goal of the radiation testing was to establish estimates of the Mean Time Between Failures (MTBF) for each type of SEE detected for a given test article or electronic component. All of the testing was completed with a proton beam energy of 200 Mega-electron Volts (MeV). The test setup can be seen in Figure 6.

The normal beam diameter of approximately 6 cm was passed through various copper vignettes to adjust the size of the final beam allowed to radiate the test article. Nineteen beam positions were tested. Each position of the hardware tested (except positions 1, 7, 14, 15, 18, and 19) received a minimum TID of 590 Rads(Si) with no degradation in performance or single event effects. The other beam positions resulted in either single-event events or functional interrupts. Power latch-up events were observed and monitored by test support equipment. The accumulated on-orbit MTBF for the functional interrupt errors was 29.7 days which is sufficient for EVA use. The observation of latch-up events indicated that latch-up protection circuitry would be required to be installed in the flight camera system.

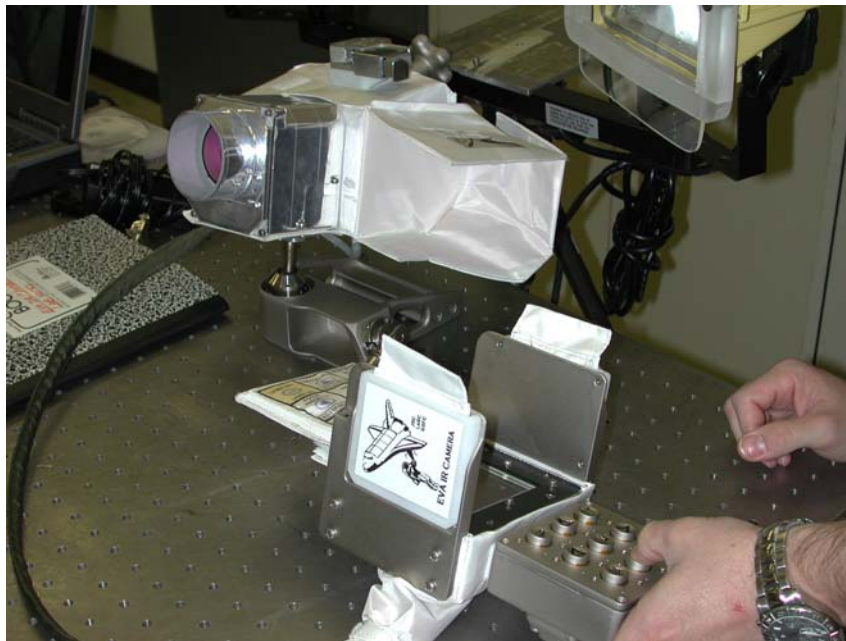
*Figure 7a. Engineering Unit*

Figure 7 shows the engineering unit, built from a COTS S65 system, and the flight unit, built from a FLIR modified S65 unit. Major modifications included removal of un-needed functionality: Bluetooth interface, Firewire interface, high-temperature iris, visible imager, battery display, viewfinder, camera base controls, and camera housing. The retained components included the electro-optical assembly (microbolometer, focus motor, and lens) and four electronic boards. The COTS laser pointer was replaced with a ruggedized version that was better equipped for space-flight operation.

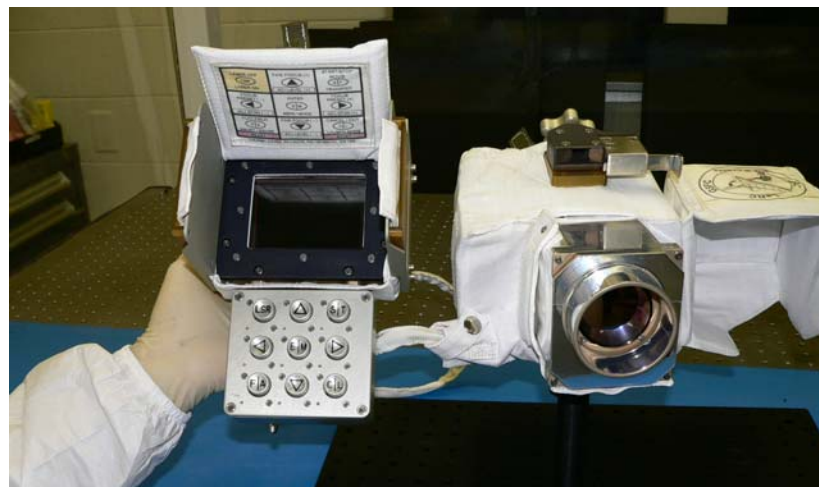
*Figure 7b. Flight Unit*

Further testing at JSC's Neutral Buoyancy Lab (NBL) with rapid-prototype mockups of the camera system refined the mechanical interfaces and mechanical package. The internal electronics and optics were enclosed in an aluminum housing that offered better structural protection against kickloads, and better thermal performance. The new housing mounted to a interface bracket through a ball joint. The ball joint allowed the crew member to orient the camera base in all three axes. The interface bracket contained both a interface to the BRT and a clockable bayonet that allows attachment to the MMWS and swing arm. The housing also provided the mechanical interface to the EHIP battery, and a slidelock on top of the camera base that allows attachment of the remote control unit (RCU) via a bayonet interface.

As shown in Figure 7, the remote control of the unit consists of nine buttons that meet EVA glove interface requirements. Working with FLIR, a modified version of the S65 was manufactured for NASA that contained firmware modifications to allow one-touch activation of certain key events such as movie recording and data transfer. Figure 8 shows the button-function mapping. Simulations of the EVA operation with the crew showed that it was important to activate movie recording with a single button activation.

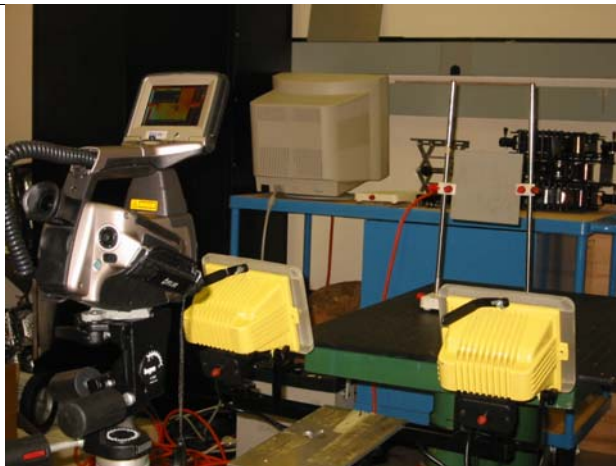
*Figure 9. Imaging Damaged RCC Under Simulated Solar Conditions*

The feasibility of detecting sub-surface damage under on-orbit solar conditions was explored by imaging damaged RCC samples using quartz lamps to simulate the expected solar flux. The maximum expected absorbed solar flux on-orbit is approximately 1100W/m<sup>2</sup>. A pair of quartz lamps were used in a laboratory environment (ambient temperature and pressure) to simulate expected solar flux. By measuring the temperature profile in RCC and knowing the material properties of RCC (thermal conductivity), the lamp power settings were calibrated to solar flux levels. In addition, the measured temperature profiles were compared to a model simulation of RCC and found to be in good agreement. Figure 9 shows the test setup.

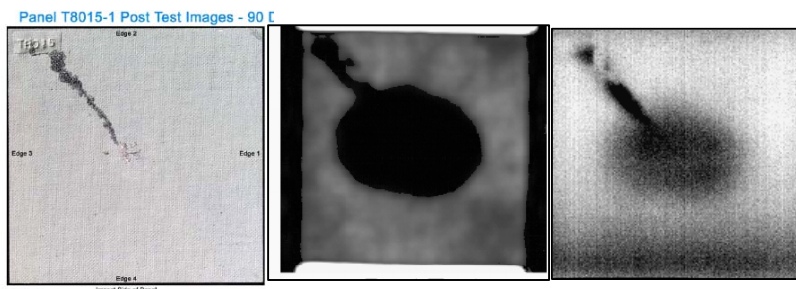
*Figure 10a. Damaged RCC specimen: visible image, ultrasound image, processed IR image at  $1100\text{W}/\text{m}^2$*

Figure 10a shows three images of a damaged RCC sample. The sample was subjected to a foam impact at Southwest Research Institute. A visual image of the sample, leftmost picture, shows SiC loss in a downward diagonal line in the upper left corner. An ultrasound image of the same sample, middle picture, reveals a  $\sim 9\text{in}^2$  delamination in the center of the sample. A processed IR image, rightmost picture, acquired by a COTS S60, shows a delamination area similar to the ultrasound image. A 30Hz rate movie was acquired by the S60 for 20 seconds. Data was recorded during the heating and cooling cycle (lamps turned off). The movie was then processed using the Principal Component Analysis (PCA) time-series technique. PCA has shown to be effective to improve detection capability of sub-surface defects. The PCA window was centered at frame number 150 where the quartz lamps were extinguished. Acquiring the image movie during the cooling cycle, or while the sample is shadowed, helps distinguish damage from non-uniform heating and minimizes effects from reflections. PCA takes advantage of the difference in cooling rates of the nominal RCC and damaged area.

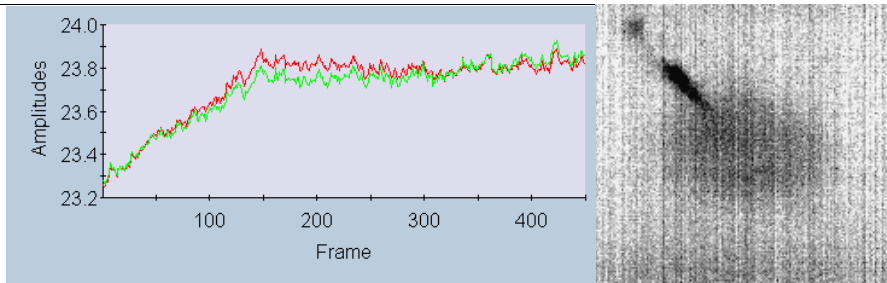
*Figure 10b. Signal level per frame and processed IR image at 225 W/m<sup>2</sup>*

Figure 10b shows the average signal levels per frame, and the processed IR image at a simulated flux level of  $225\text{W}/\text{m}^2$ . The red line is an average from pixels in the damaged area and the green line is a average from an area of corresponding size outside the damaged area. Though the signal to noise level is reduced, the damaged area is still detectable.

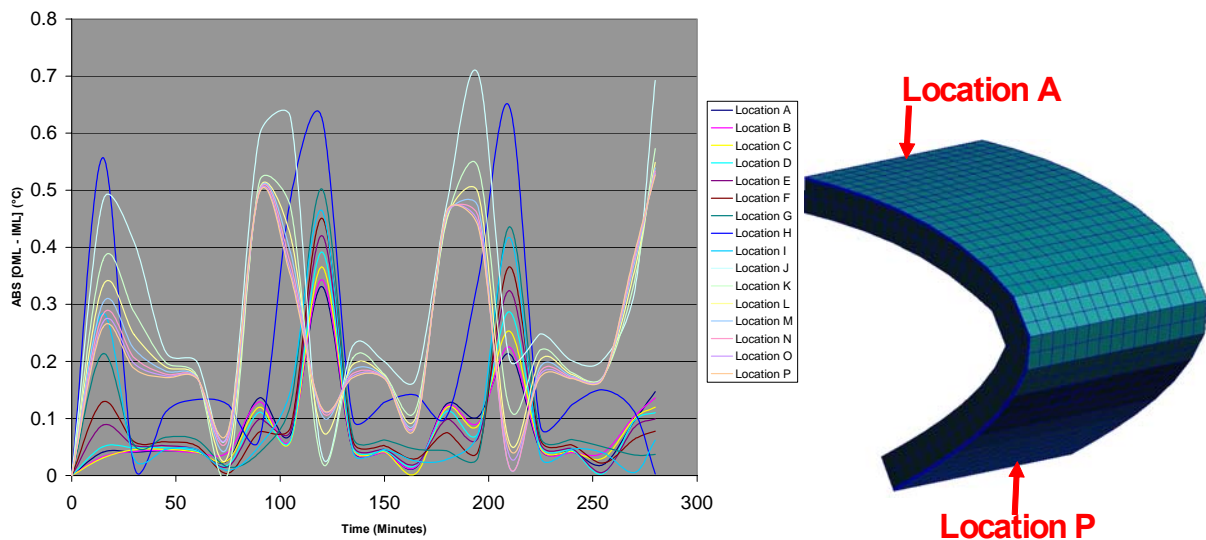
*Figure 11. Expected On-orbit Through Temperature Gradient for RCC Panel 9*

Figure 11 shows a prediction of the on-orbit temperature gradient through RCC panel 9. Certain periods during the 90 minute orbit contain higher through-gradients than others and indicate the presence of larger heating and cooling rates. These periods are desirable times to perform damage inspection.
