Use of Modal Acoustic Emission to Monitor Damage Progression in Carbon Fiber/Epoxy Tows and Implications for Composite Structures

NASA Johnson Space Center (JSC) White Sands Test Facility (WSTF)

QNDE Conference

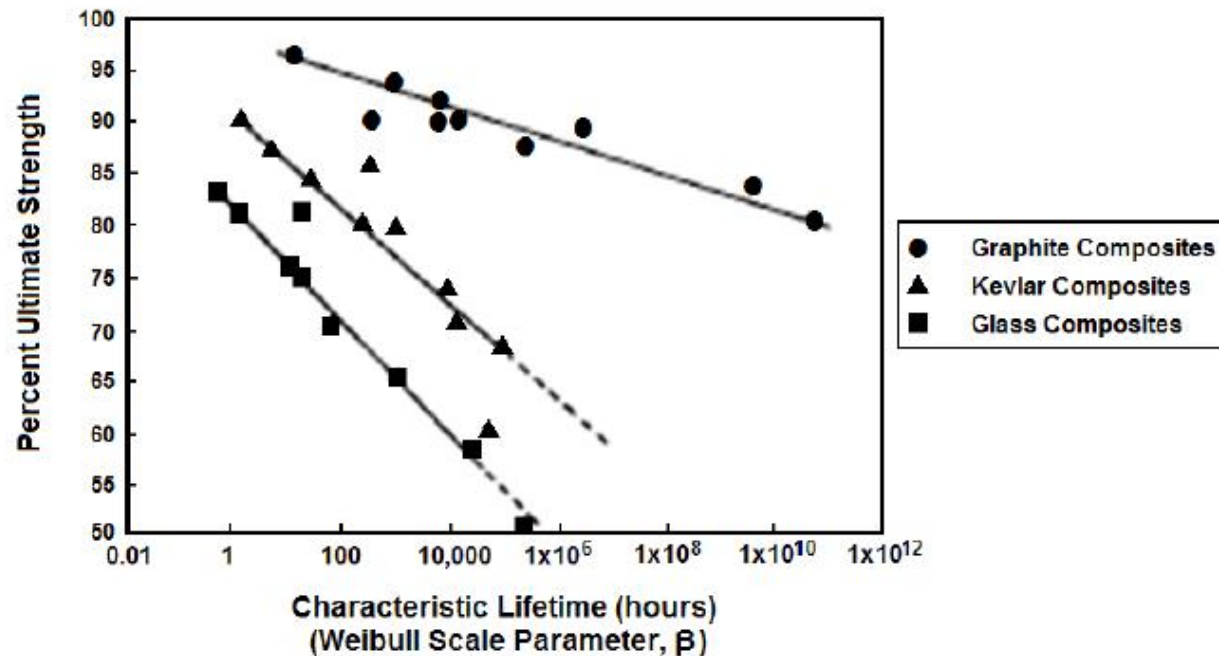
Characteristic lifetimes of graphite, Kevlar[®] and glass-reinforced composites at different percentages of the ultimate strength. Each symbol represents the median life (50%) under sustained loads as percentage of the ultimate strength of the material.[§]

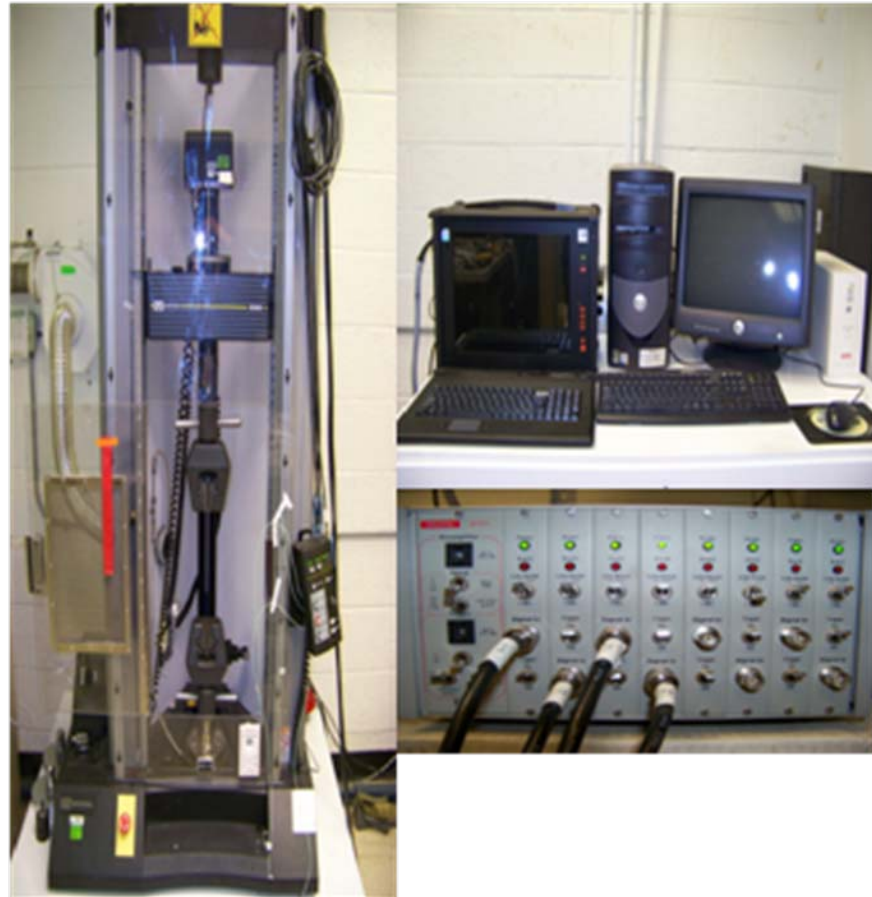
Load control and AE data acquisition system consisting of:

- Instron® 5569 Series Electromechanical Test Instrument (left)
- DigitalWave Corp. FM-1 8-channel DACS (lower right)
- AE and tensile test CPU controllers (upper right)

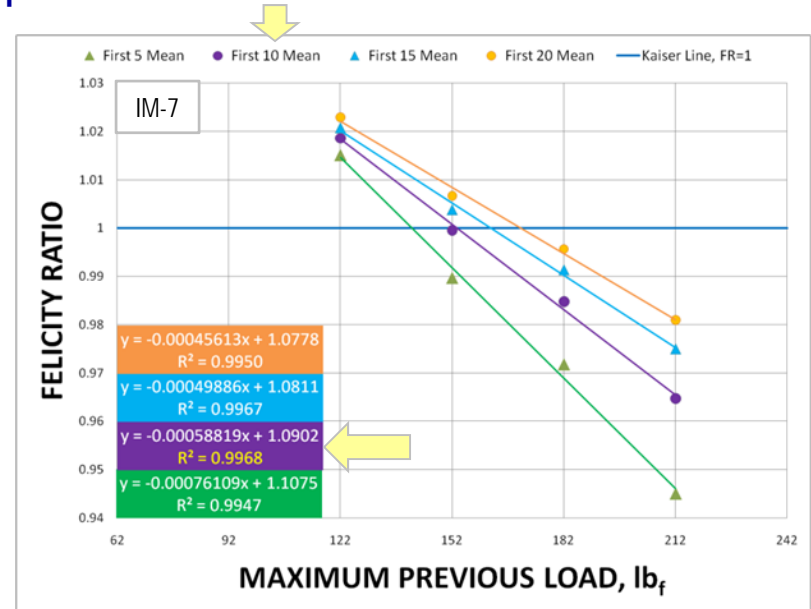
- Linear decrease in FR with load noted for T1000 and IM-7 C/Ep, similar to the behavior noted for Kevlar 49-epoxy K/Ep

- For a given material and averaging method, the slope of least squares fit is indicative of damage tolerance
 - Flatter slopes correspond to good damage tolerance (in-character behavior)
 - Steep slopes correspond to low damage tolerance (out-of-character behavior)
- Kaiser effect violated at $FR < 1 \Rightarrow$ onset of severe accumulated damage
- C/Ep produced more AE than K/Ep

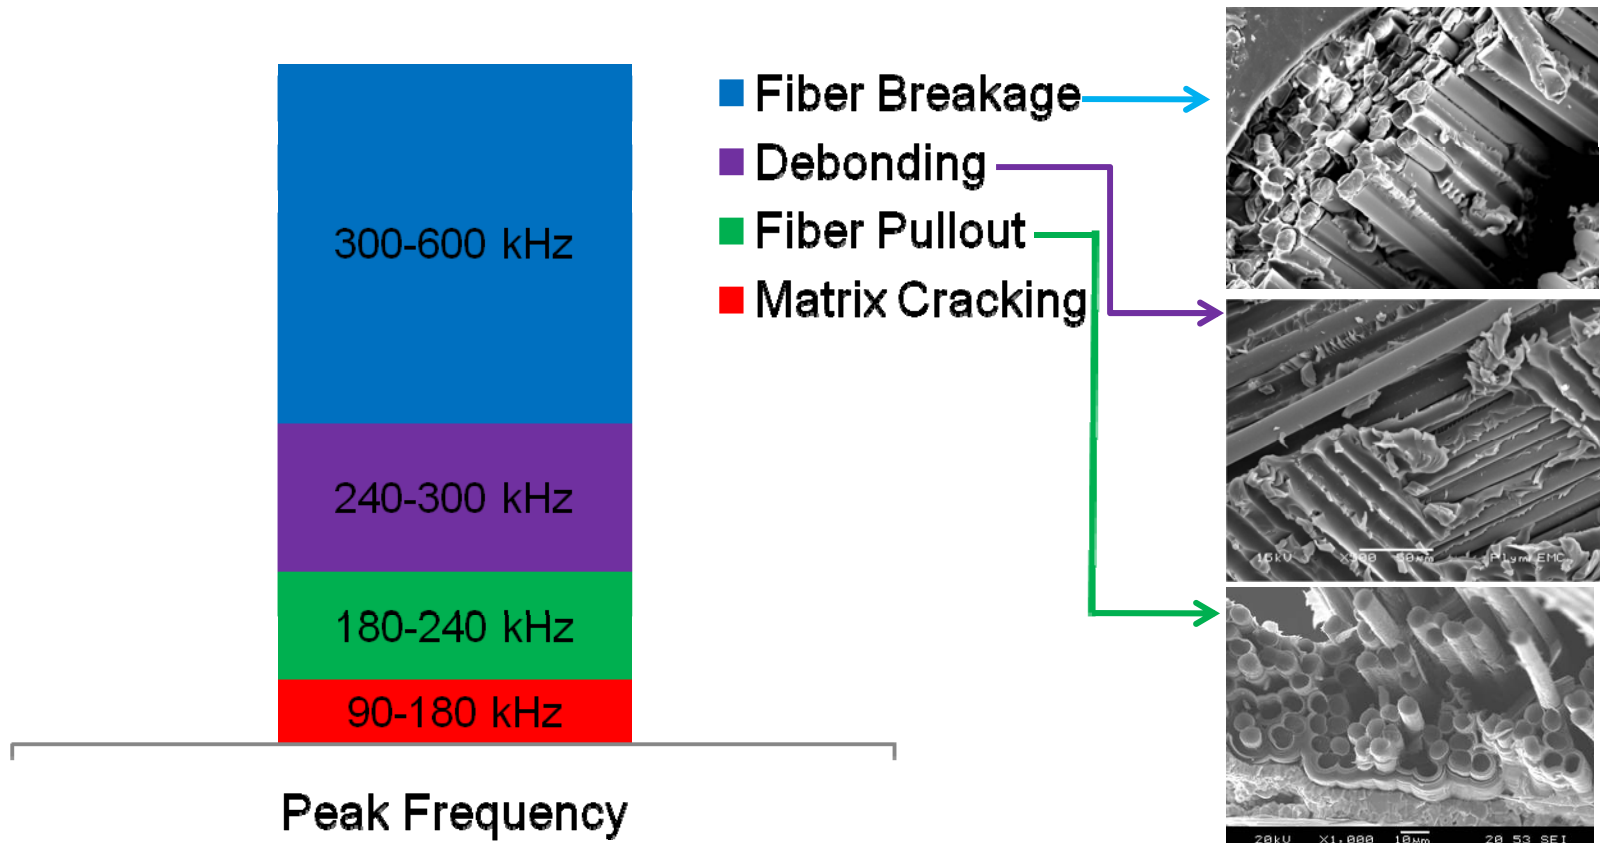
- AE frequency ranges have been correlated with micromechanical damage mechanisms in C/Ep^s

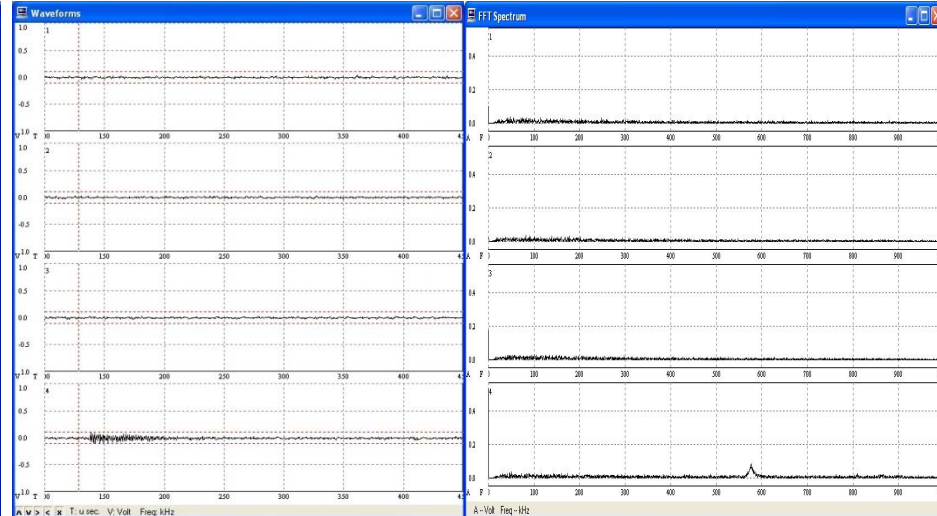
2. Fiber Breakage

waveform

FFT

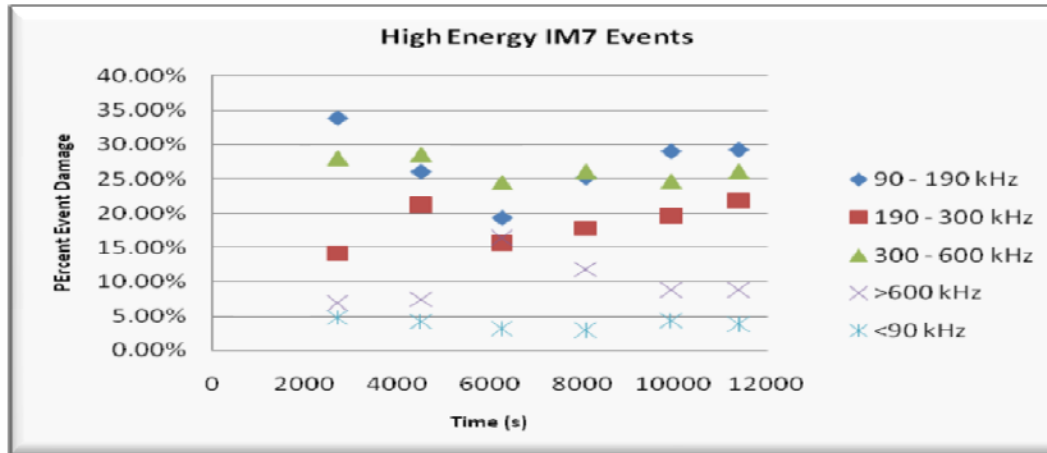
High
Energy

$E > 2 V^2\text{-}\mu\text{sec}$

- Low energy events behave in an ordered fashion, while high energy events appear more random

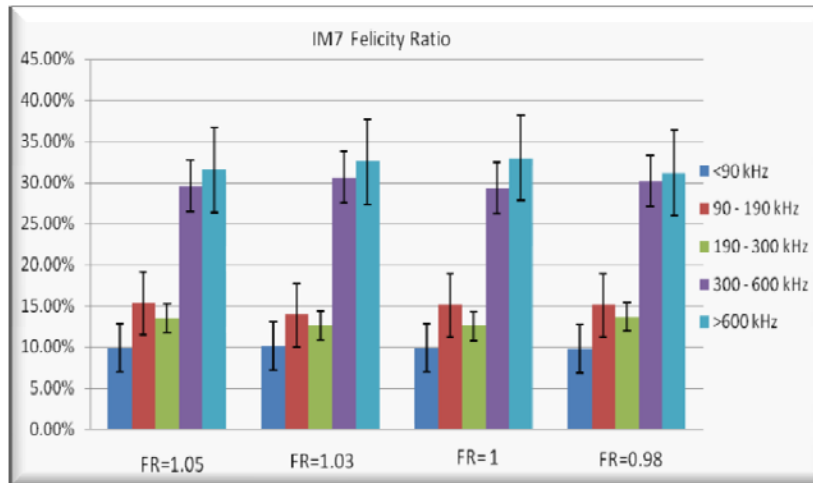
- IM-7 (2 specimens) and T1000 (1 specimen) Felicity ratio events (first ten events, FR_{10} method) were then compared to see if they had a characteristic frequency distribution or energy

- Fiber breakage dominates the FR, otherwise FR events reflect a concerted failure mode for both types of C/Ep
- Other minor differences between IM-7 and T1000 noted, but same overall trend:

300-1000 kHz > 90-190 kHz > 190-300 kHz
(*fiber breakage > matrix cracking > debonding/pull-out*)

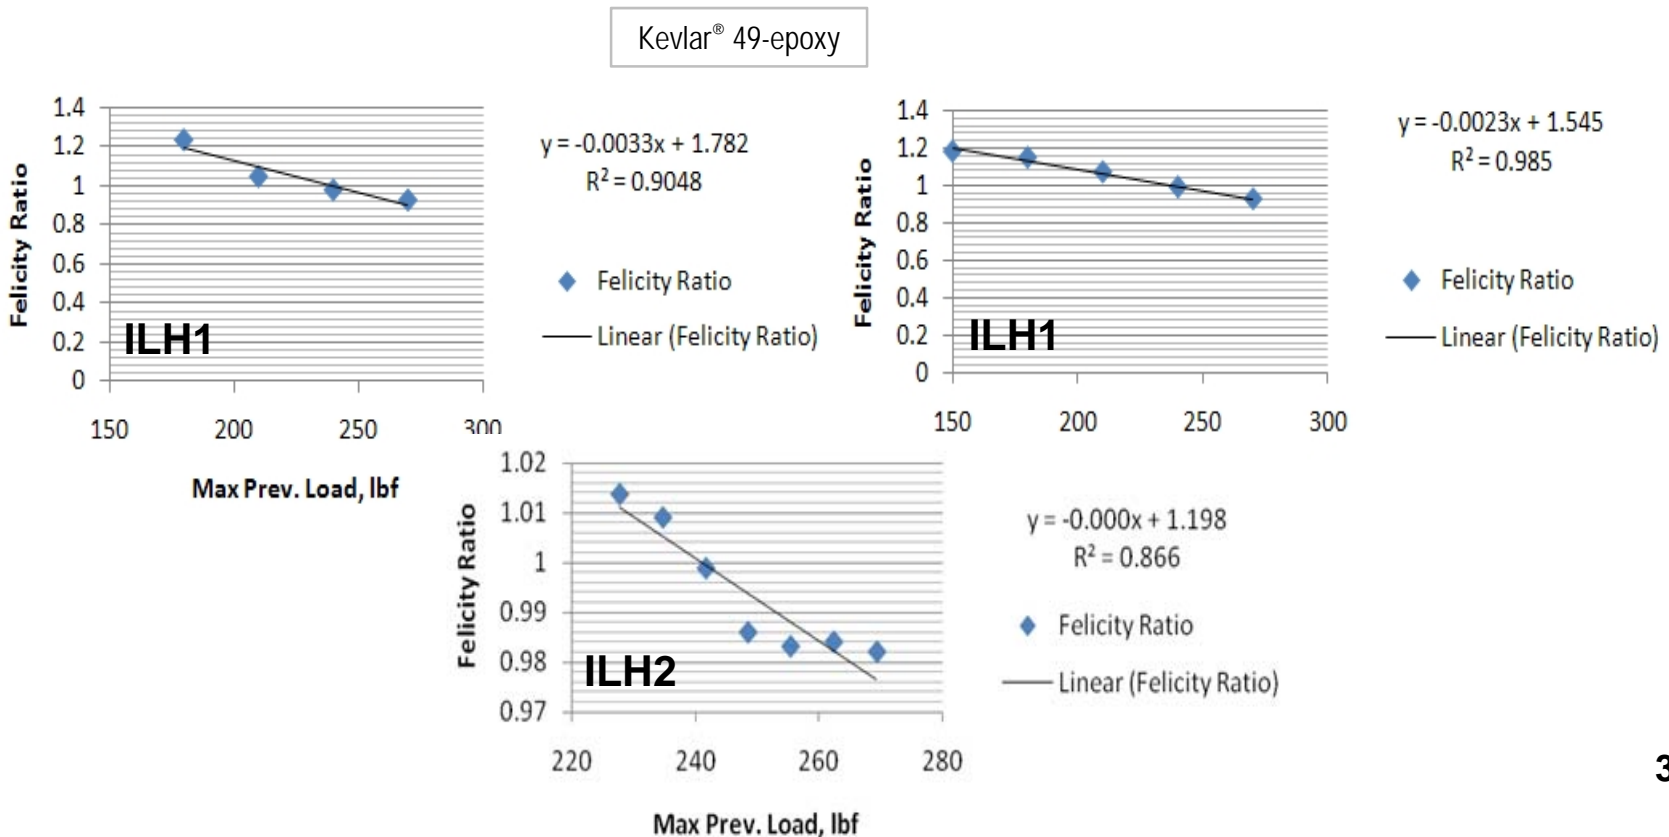
- For Kevlar-epoxy 4650 denier tow, correlation coefficients for ILH 1 & 2 methods indicated good ($R^2 = 0.866$) to excellent ($R^2 = 0.985$) agreement:

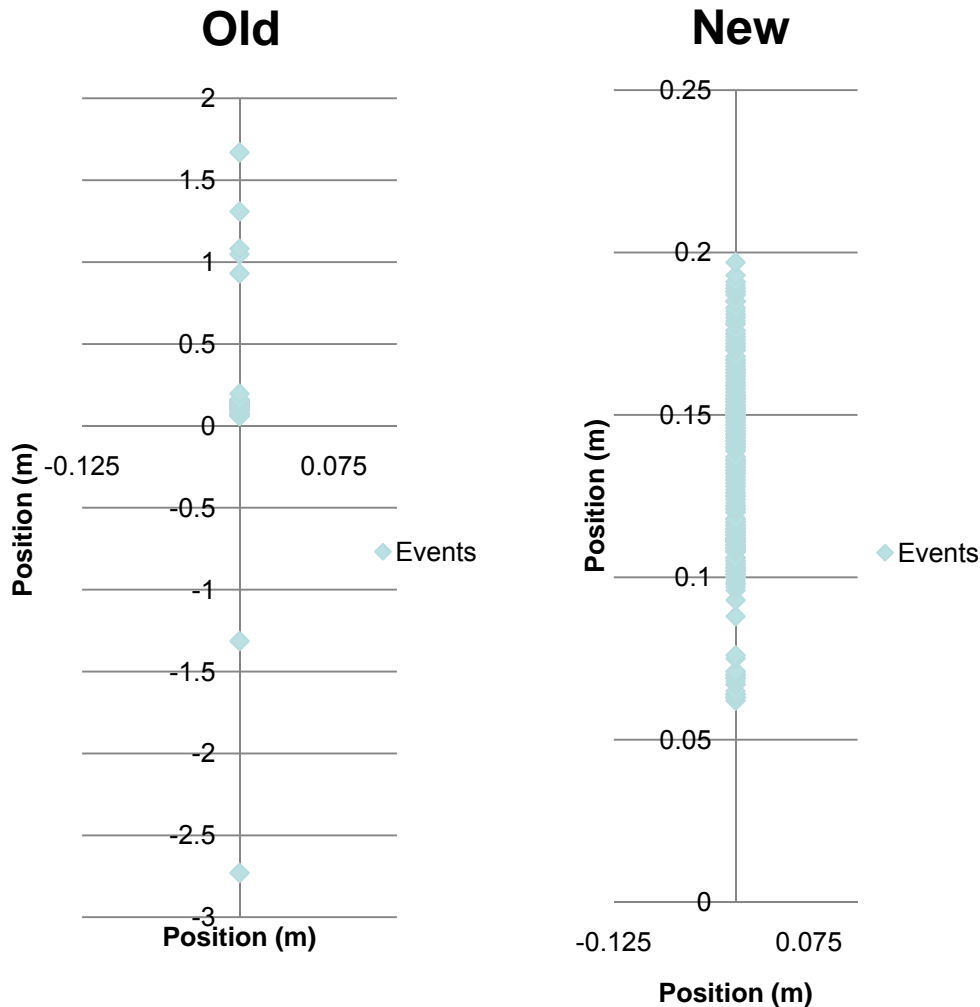
AE source location method improved

- For 2D or 3D specimens, arrival times from at least 3 sensors are needed for accurate source location
 - for a 1D tow specimen, by splitting 4-channel*.wave files into 2-channel*.wave files, it was possible to reduce this number to 2 sensors
- Arrival times not always accurate
 - Manual correction was done
- Erroneous events were eliminated or located more accurately
- > 300% more events were located
