Photogrammetric Measurements of an EH-60L Brownout Cloud

Abstract

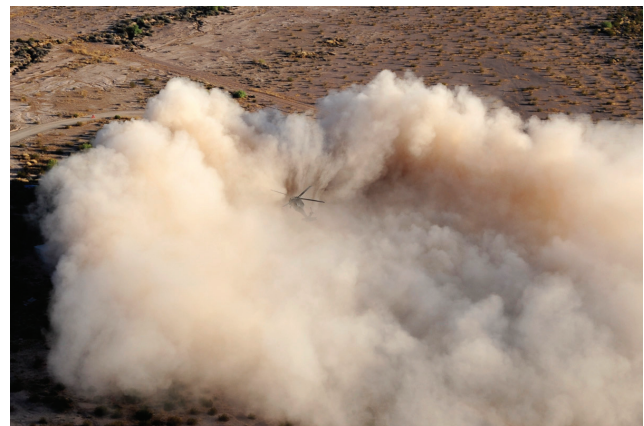
Figure 1. View of an EH-60L entering a brownout cloud

The shape of the brownout cloud also seems to be highly influenced by the flight path characteristics of the helicopter as the dust cloud is forming³. An example of brownout is shown in Figure 1. In this image, the EH-60L used for this testing is entering into a brownout cloud.

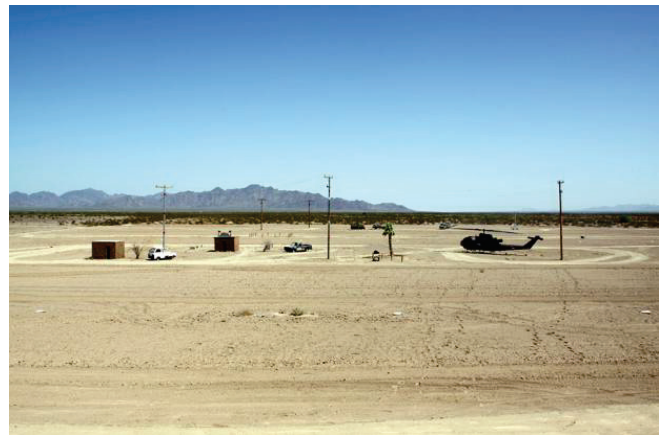
Figure 2. View of Oasis LZ, looking north from the ground test complex

The flight testing occurred at the Oasis Landing Zone (LZ), which is located in a remote section in the northern-most part of the US Army Yuma Proving Ground (YPG). A view of the LZ from the roof of the ground test complex looking north can be seen in Figure 2, with Lane 1 in the foreground and the various obstacles in the LZ clearly visible.

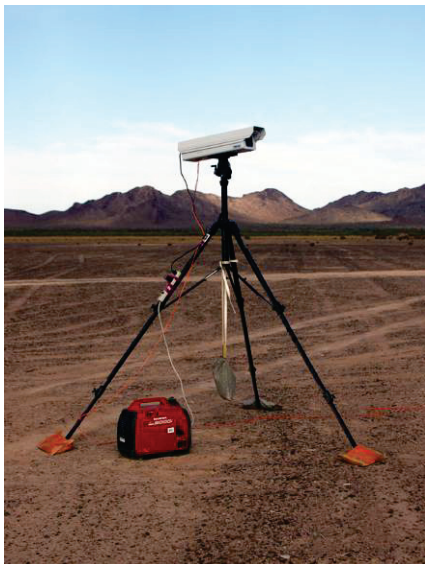
Figure 4. Camera setup, round one

The photogrammetry equipment consisted of two 2.0 megapixel machine-vision cameras powered by a small gasoline generator. Each camera was sealed in an environmental housing with protective sunshade, mounted on a heavy duty tripod and gearhead, and secured by 50 lb shot bags. Each camera was also fitted with a 20mm lens, resulting in a 32.9° field of view. The setup is shown in Figure 4. The cameras were connected via military-grade optical fiber to a workstation located in the ground test complex just outside the perimeter of the LZ. The workstation was used to control image capture and time-stamp each image with its appropriate GPS time. The cameras were triggered at 15 Hz.

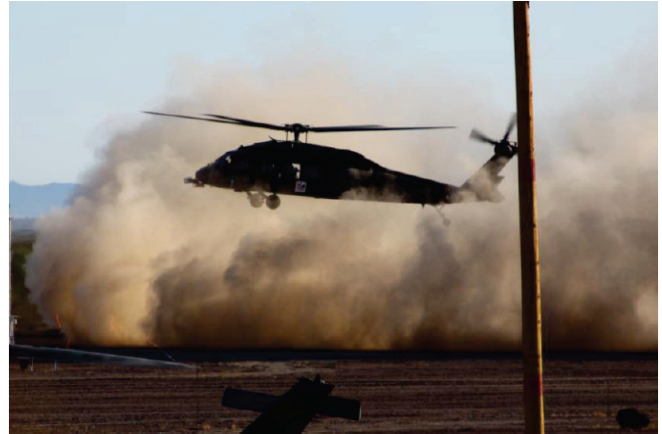
Figure 5. EH-60L approach to touchdown in Lane 7

The flight testing occurred for about 1.5 hours, with a total of six events through Lane 7. There was sufficient time between events to allow the brownout cloud to clear before the next pass. The majority of events were an approach to touchdown and takeoff. An image from a typical event, during approach before the aircraft is completely engulfed in the brownout cloud, is shown in Figure 5, while Figure 6 shows the aircraft exiting the cloud.

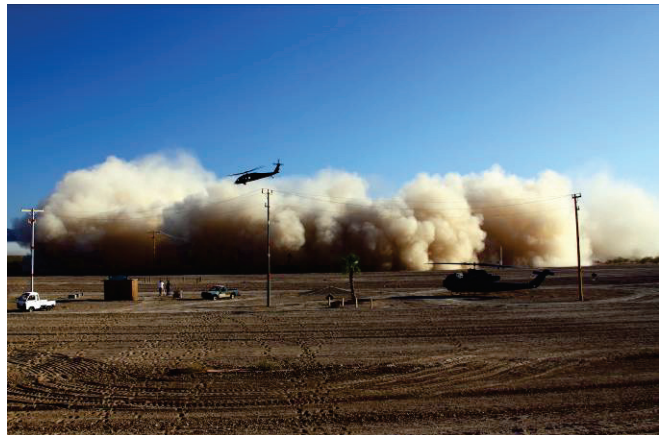
Figure 6. EH-60L takeoff after touchdown in Lane 7

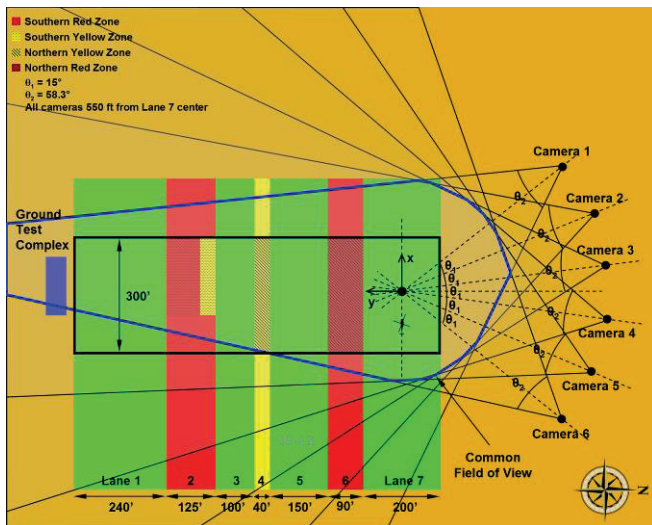
Figure 7. Schematic of Oasis LZ, round two

A second round of flight tests was conducted at Oasis LZ in late September 2009 after the previous round showed promising results. A similar test plan as before was followed. Experience gained during the first round of testing was used to develop a new photogrammetry system which was a significant improvement over the system used during the first round of tests in August. The new system consisted of six 15.1 megapixel digital SLR cameras placed evenly about an arc of 75° approximately 550 ft north of the landing zone, as shown in Figure 7. This increase, both in the number and resolution of the cameras, was done to capture more detail of the brownout cloud and to enable easier identification of common features within the cloud.

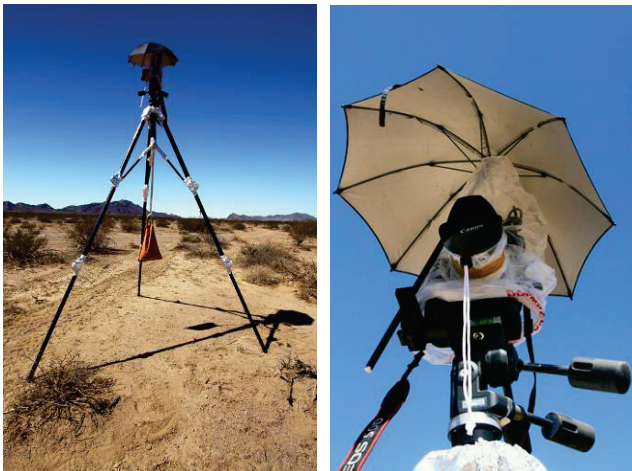
Figure 8. Camera setup, round two

Each camera was fitted with a 20mm lens, resulting in a 58.3° field of view. The cameras captured the images onto on-board memory. All of the cameras were simultaneously triggered at 3Hz, and each image was stamped with GPS time. For protection from the dust and sun, each camera was wrapped in a plastic rain sleeve and placed under a repositionable umbrella, as shown in Figure 8.

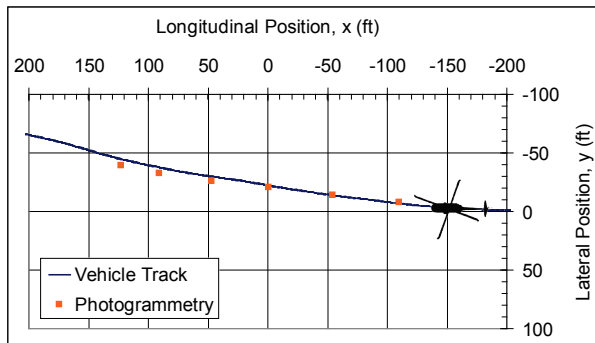
Figure 10. Longitudinal versus lateral position

The second validation involved comparison of the vehicle position from photogrammetric measurements and on-board vehicle position measurements during a taxi pass of the Oasis LZ. For this pass, the aircraft was traveling approximately 20 kts. Figure 10 displays the longitudinal position versus the lateral position of the aircraft during the taxi pass through Lane 7 is shown in Figure 10. The longitudinal position versus the altitude of the aircraft for the same pass is shown in Figure 11. Comparison of the photogrammetry data and the measured vehicle track shows good correlation. A direct comparison of the two data sets at the same time stamp was not possible due to a GPS timing offset. The offset was found to be induced during the initial GPS startup process and was rectified for the second round of flight tests.

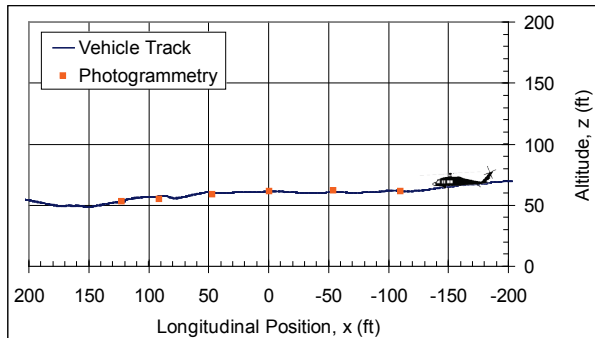
Figure 11. Longitudinal position versus altitude

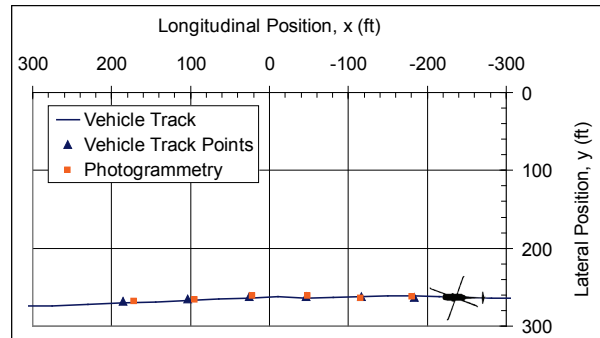
Figure 12. Longitudinal versus lateral position

The second method of validation also indicated good agreement between the photogrammetry data and the actual flight track data. Figure 12 shows the longitudinal versus lateral position of the aircraft during the taxi event through Lane 5, with the aircraft traveling approximately 25 kts. The photogrammetry points all fall on the vehicle track. When compared to the vehicle data from the same instant in time, the correlation is also very good. The longitudinal position versus altitude of the aircraft is shown in Figure 13. There is very good agreement between the photogrammetry and the vehicle track near the origin. Variability in the comparison increases slightly toward either extreme.

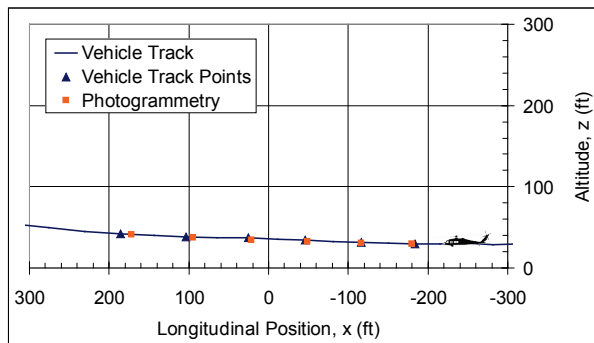
Figure 13. Longitudinal position versus altitude

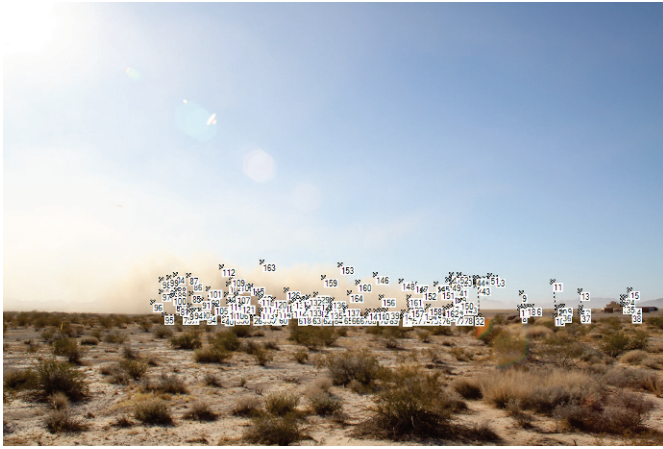
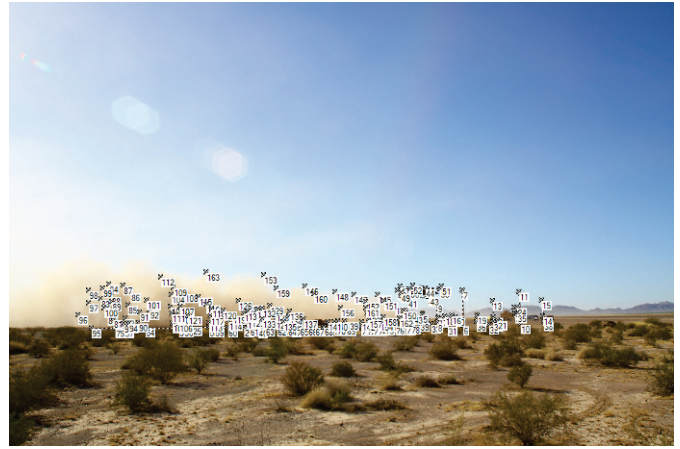
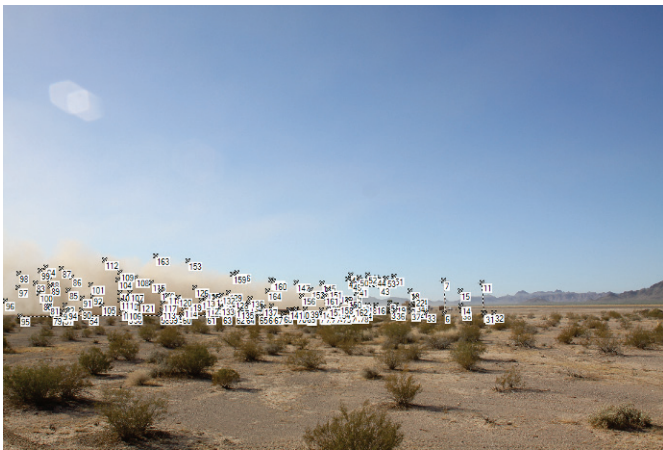
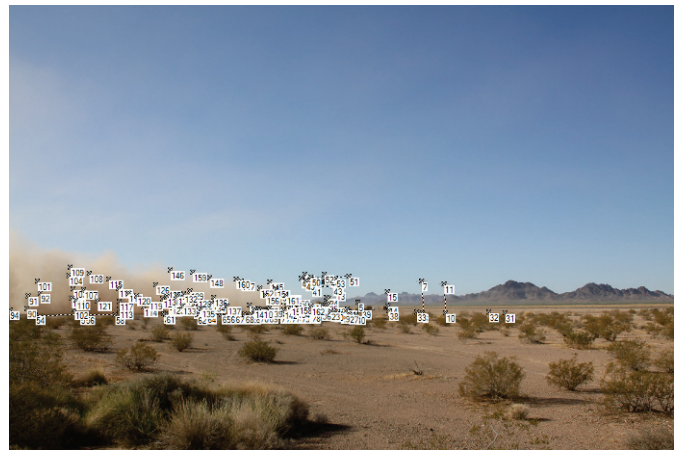
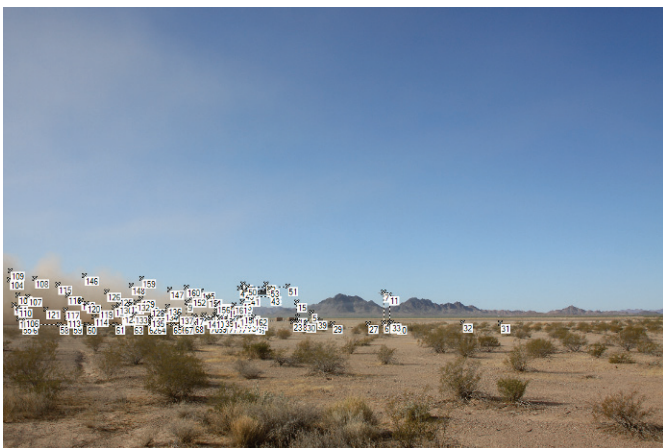
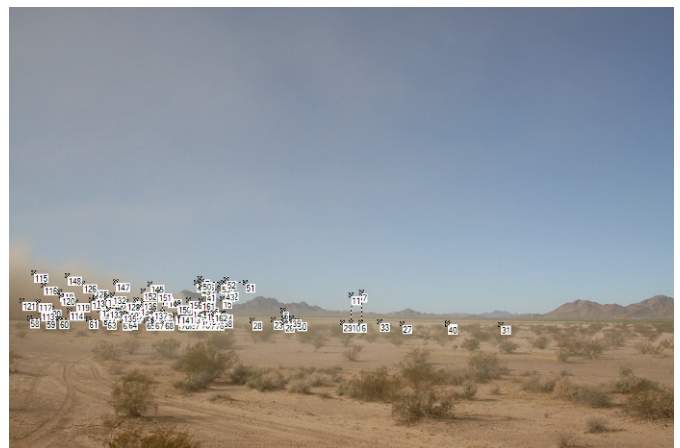
Figure 15. Brownout cloud analysis from second round of testing, Lane 5 taxi pass images, frame 127, time $t = 6.00$ s

During the taxi pass used for validation, the vehicle was low enough that it generated a brownout cloud. This is the same event that was used to obtain the aircraft position plots in Figure 12 and Figure 13. Due to printed space limitations, only one set of six images from this pass is shown (Figure 15). The 3D view resulting from photogrammetry from six different times is shown in Figure 16. As before, the yellow dots represent points on the perimeter of the brownout cloud and the blue dots represent the aircraft.

With the improved setup utilized in round two, significantly greater volumes of data were collected. Increased points of view, image quantity, and resolution provided the ability to characterize the brownout cloud in much more detail. Utilizing this technique, the high three-dimensionality of the brownout cloud is no longer an obstacle to distinguishing features in the cloud. Whereas previously, only five or six points could be accurately identified for each frame, the improved setup raised the number of identifiable points from approximately 50 to over 100.

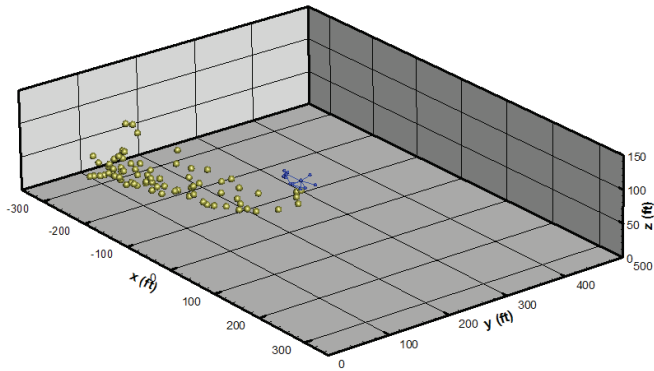
Figure 16. Brownout cloud analysis from second round of testing, Lane 5 taxi pass 3D views

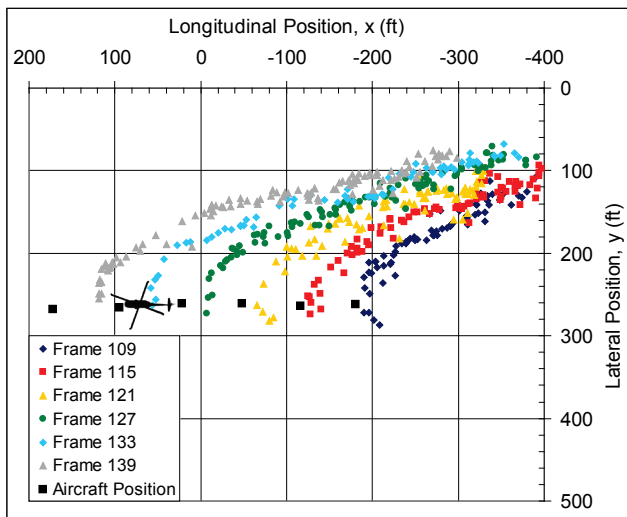
Figure 17. Top-down view of dust cloud progression from Lane 5 taxi

A top-down view of the LZ and the brownout cloud data is presented in Figure 17. A side view of the same data is shown in Figure 18. In both figures, the aircraft is marked as the spot in the center of the fuselage between the main landing gear wheels. The highly parabolic overall shape of the brownout cloud can be observed in both figures, with the shape of the cloud forming a somewhat tighter parabola as the aircraft progresses through the LZ. The distance at which the aircraft leads the front of the brownout cloud is particularly notable. Initially, this point on the aircraft is about 10 ft ahead of the cloud. As the aircraft travels through Lane 5, that distance increases to around 50 ft with 10 ft of additional altitude gain.

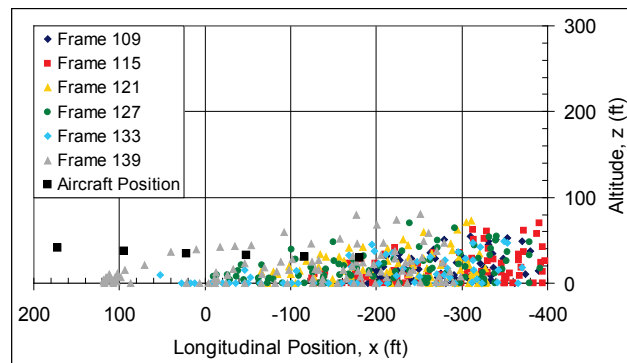
Figure 18. Side view, looking north, of dust cloud progression from Lane 5 taxi

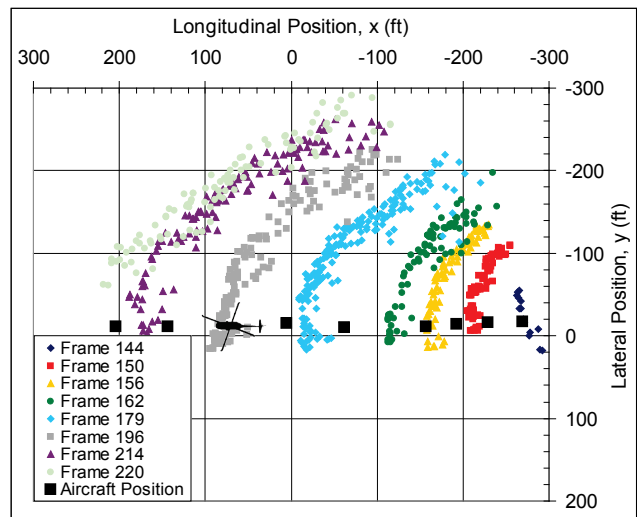
Figure 19. Top-down view of dust cloud progression from Lane 7 approach to touchdown

Top-down and side views of the brownout cloud data are shown in Figure 19 and Figure 20, respectively. In both figures, the image of the aircraft is positioned at approximately the point of touchdown. In the first four frames, the aircraft is visible and its position was determined from photogrammetry. This was also done for the final two frames. In frames 179 and 196, the aircraft is fully engulfed in the brownout cloud. Aircraft position while fully engulfed was determined using onboard data. Comparing the vehicle position to the front of the brownout cloud, it can be seen that the cloud quickly passes ahead of the vehicle. By the third frame, 156, most of the aircraft is surrounded by the cloud. Aside from its expected outward growth, the overall shape of the cloud does not appear to change significantly as time progresses. By the time the aircraft touches down, the cloud has grown to a size between the

gray and purple points in the figures. In the final frame, approximately five seconds after takeoff from touchdown, the aircraft has fully exited the cloud.

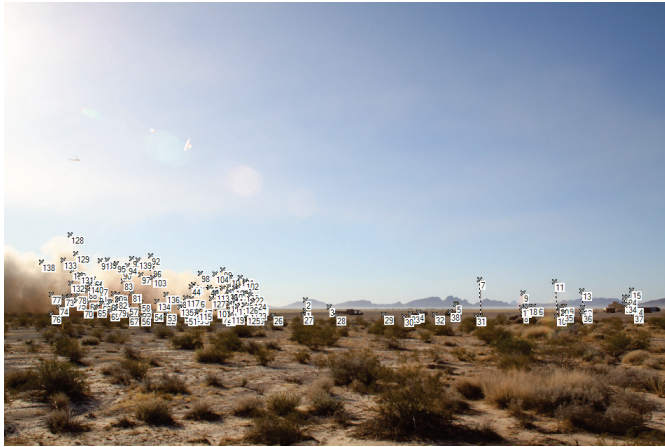
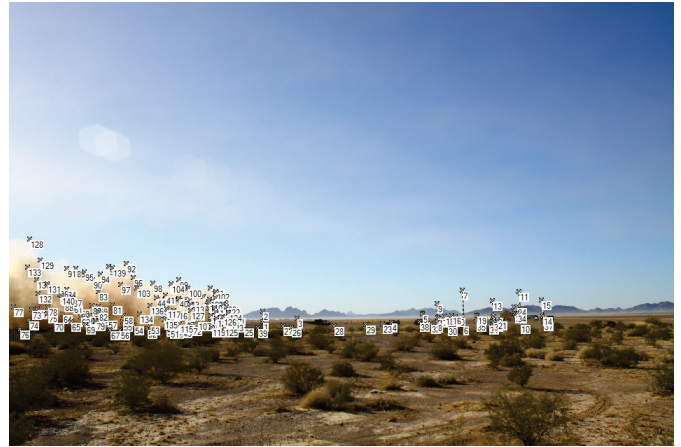
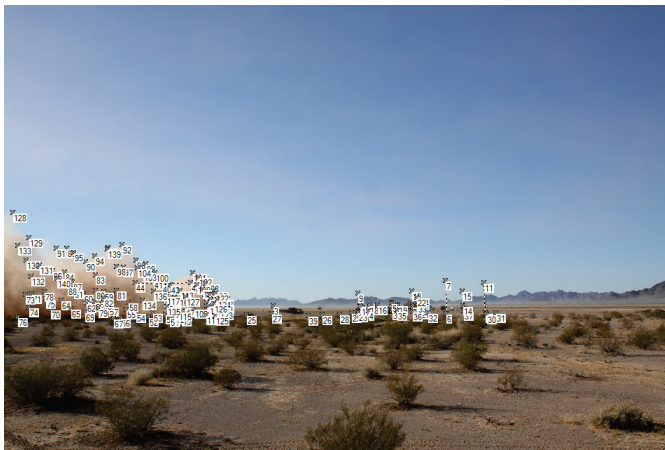
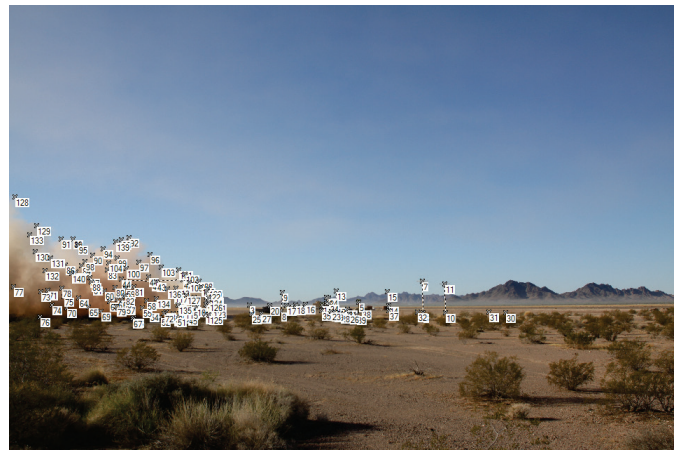
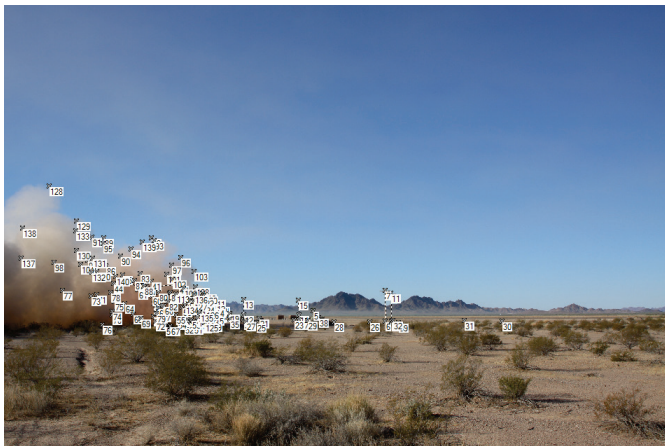
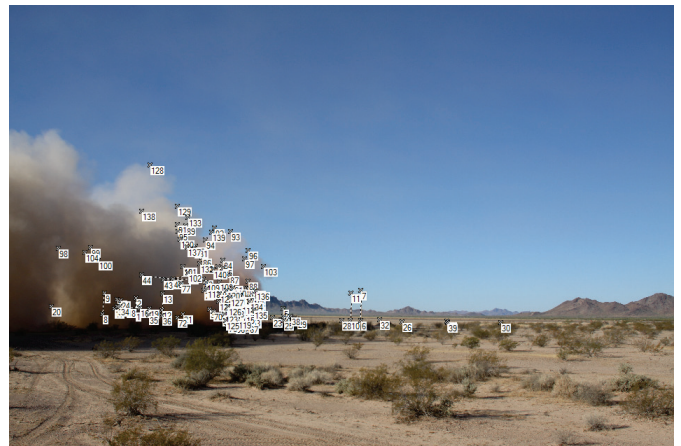
Figure 21. Brownout cloud analysis from second round of testing, Lane 7 approach to touchdown images, frame162, time $t = 6.00$ s

The next progression of the analysis was to look at a full brownout approach to touchdown. For illustration, one set of images from one of the eight frames examined of an approach to touchdown event in Lane 7 is shown in Figure 21 on the next page. The resulting 3D views for all eight frames are shown on the page following that in Figure 22.

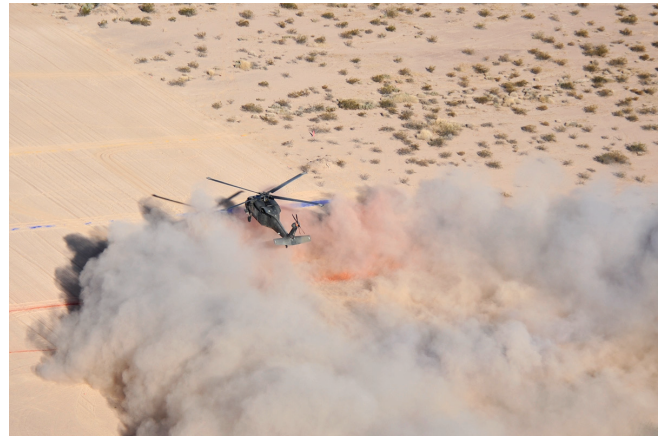
Figure 26. View from chase aircraft of EH-60L approach to touchdown in Lane 7

For the following day's test, the chalk was mixed with sand from the LZ to more closely approximate the properties of the LZ sand, and was spread across Lane 7 in wider lines, as shown in Figure 23. Chalk entrainment was greatly improved. Red and blue chalk was observed in the brownout cloud, as shown in Figure 24, Figure 25, and Figure 26.

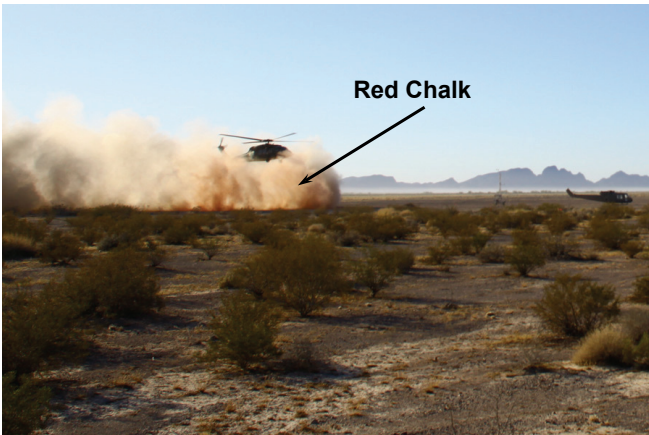
Figure 24. View from Camera 2 of Lane 7 approach to touchdown event with red chalk pickup visible

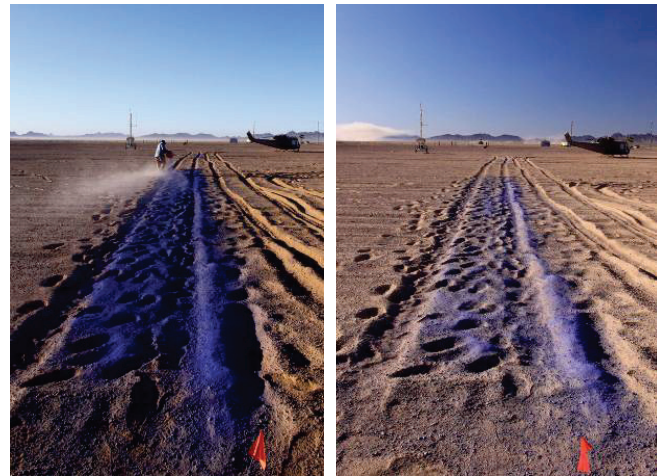
Figure 27. Blue chalk line 200 ft east of centerline, before and after day two of round two

Before and after photographs of the blue chalk line are shown in Figure 27. Prior to inspecting the chalk lines, the research team had hypothesized that all of the chalk would be removed from the surface within one to two landings. Notably, inspection of the chalk lines after testing revealed that this did not happen. While chalk was clearly visible in the brownout cloud, a significant portion of the chalk/sand mixture was in its original position on the ground. This implies that the pickup forces for the cloud are very low. Only the uppermost layer of chalk/sand was removed from the surface during cloud formation.
