X-RAY COMPUTED TOMOGRAPHY INSPECTION OF THE STARDUST HEAT SHIELD (IPPW-7)

Karen M. McNamara⁽¹⁾, Daniel J. Schneberk⁽²⁾, Daniel M. Empey^{(3)*}, Ajay Koshti⁽¹⁾, D. Elizabeth Pugel⁽⁴⁾, Ioana Cozmuta⁽⁵⁾, Mairead Stackpoole⁽⁵⁾, Norman P. Ruffino⁽⁶⁾, Eddie C. Pompa⁽⁶⁾, Ovidio Oliveras⁽⁶⁾ and Dean A. Kontinos⁽⁷⁾

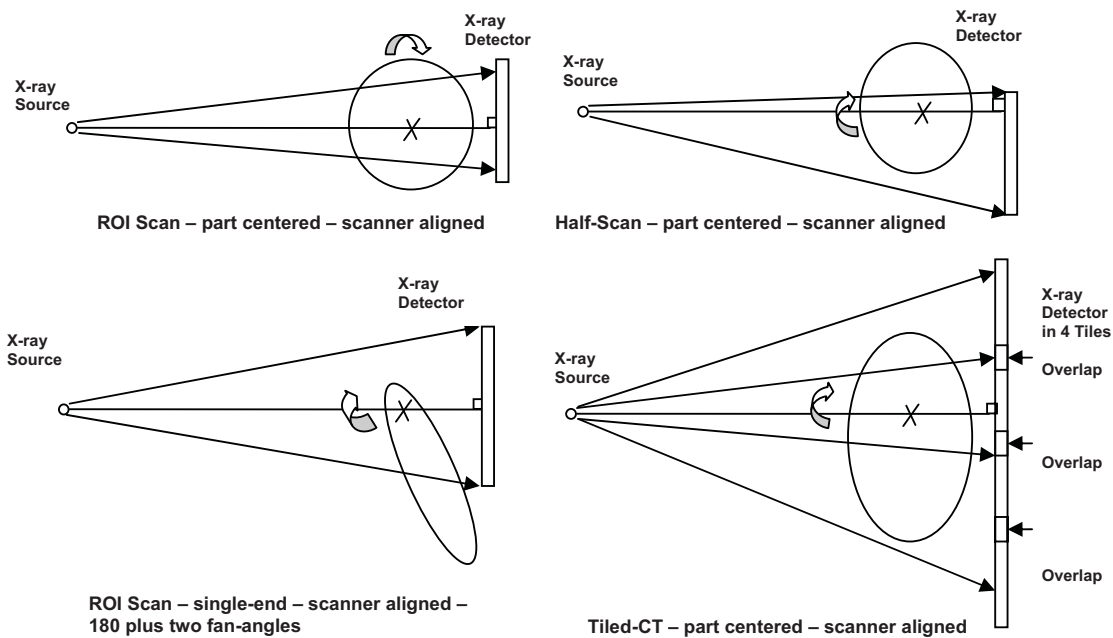
The 450 kVp scanning system at JSC includes motion can accommodate 4 different scanning modes. Figure 2 contains the different alternatives. Given the large size of the Stardust shield as compared to the 40 by 30 cm (approximately 16 by 12 in.) size of the Flashscan 33 detector, we elected to implement a ‘‘tiled-scan’’ strategy. The impact of this choice is rather long scan times; the total scan time equals the time for a single scan multiplied by the number of tiles. Secondly, there is the added complexity of positioning the detector with sufficient precision to construct a ‘‘joined’’ scan that does not include artifacts from the ‘‘joining’’ operation. The source-detector geometry for the JSC 450 kVp room is cone-beam, requiring the detector be moved to cover the entire projected size of the Stardust shield at the detector plane. To reduce the number of tiles we elected to scan with ‘‘half-scan’’ or ‘‘offset-scan’’ techniques where we reconstruct the entire object from a field of view that covers just over half of the

Fig. 2 - Alternative scanning modes at JSC.

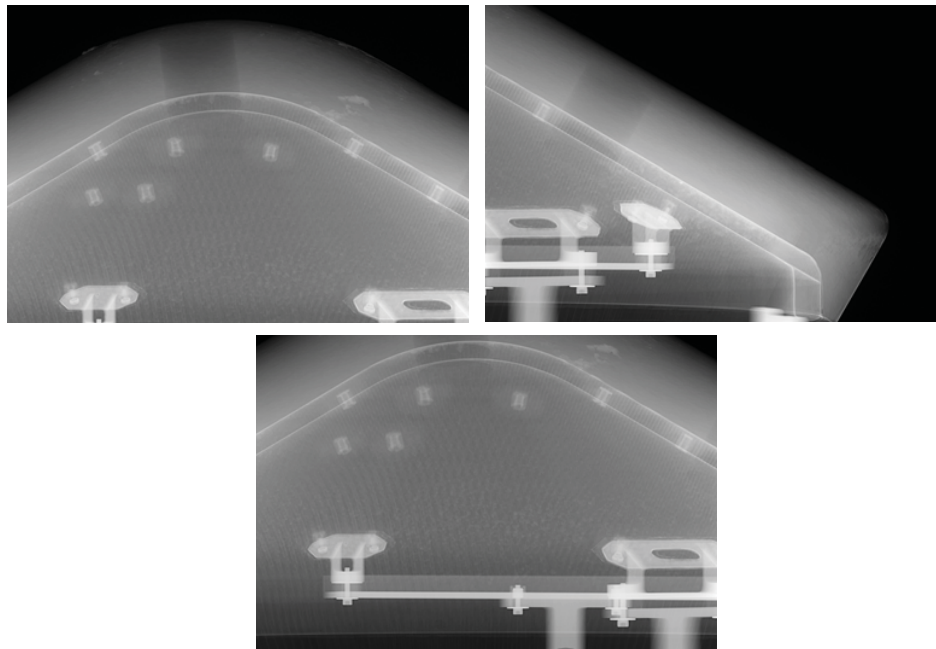
Fig. 3 - First images from the three acquired scans.

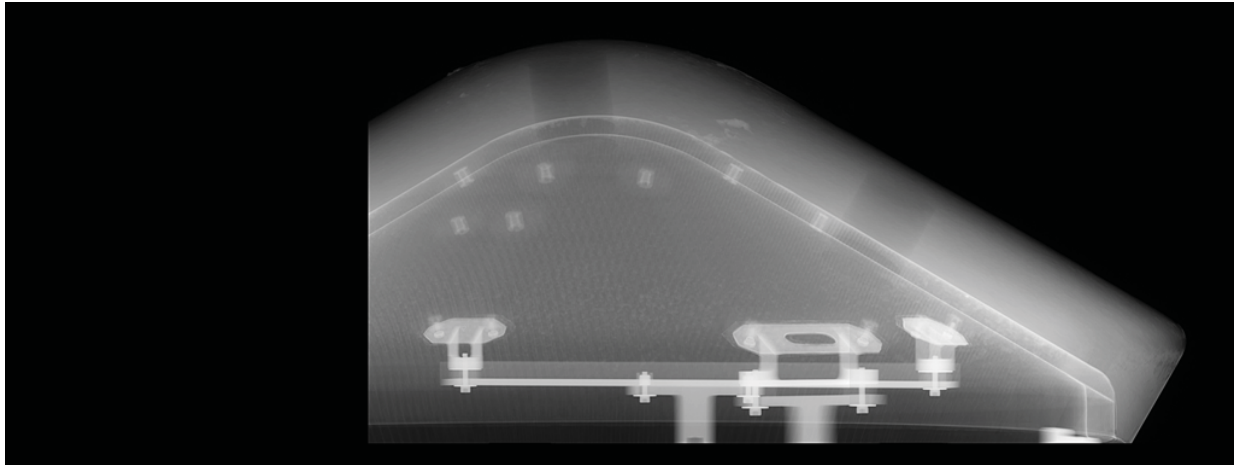
All 900 radiographs in the three tiles were joined into a radiograph as displayed in Fig. 4. Those 900 radiographs acquired over 360 degrees were then processed and reconstructed with a modified Feldkamp reconstruction algorithm for the “offset-scan” geometry illustrated by the radiograph in Fig. 5. In the course of processing the data we resampled the projection data to support a reconstruction into 0.324 mm cubic voxels (the 0.162 mm pixel radiographs were resampled 2x2). The result is a 2640 by 2640 by 1000 volume of voxel elements.

Fig. 4 - Joined digital radiograph from three tiled scans.

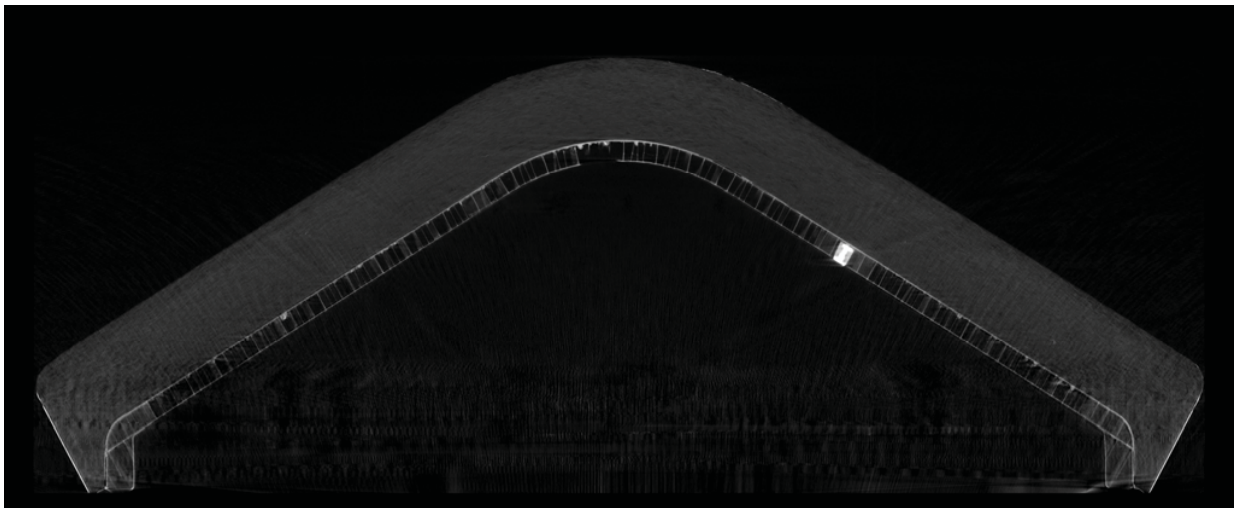
Fig. 5 - Vertical slice from tiled offset-scan.

The vertical slice shown in Fig. 5 shows two of the main components of the stardust shield, the PICA and the aluminum honeycomb underneath. Also, notice some structured noise or artifacts in the lower part of the vertical slice in Fig. 5 which are a combination of “streak” artifacts (from the long chords in the Aluminum and the inadequate number of views for a radiographic area of this size). Fig. 6 contains a close-up view of the center-top of the vertical slice from the reconstructed volume showing the type of detail imaged by the CT scanning in the JSC system. Using the different Aluminum pieces, and the drilled holes in the Stardust Shield as reference standards, the volume appears to include accurate dimensions of the internals of the Stardust shield.

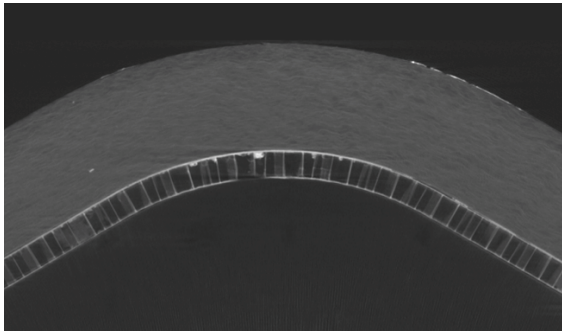
The 3D CT data can be viewed and unpacked in a number of different ways from a number of different orientations. Fig. 7 contains a cross-sectional or (transverse) slice through the Stardust reconstructed volume. In both Fig. 6 and Fig. 7, notice the texture in the slices through the PICA, we consider this texture in the images to be an accurate measure of the variation of the fibers in the make-up of the PICA. Also, there appears to be higher attenuating material sparsely interspersed within PICA material. Preliminary analysis of these higher-attenuating chunks indicate a close resemblance to the same features found in scans of recently fabricated PICA [1]. Second, notice the

small change in attenuation in the cross-sectional slices towards the outside boundary of the PICA, we consider this change in attenuation to be the char layer, a feature we will examine subsequently. Third, for the slices showing the state of the Aluminum honeycomb, notice a variation in the attenuation in the interstitial layer between the honeycomb and the PICA. It appears there are gaps in the fill between the PICA and the Aluminum honeycomb. Fourth, there appears to be higher attenuating material on the outside of the PICA. From a visual inspection of the outside of the shield, this is “dirt” accumulated on the shield from the landing. As expected the “dirt” is higher in x-ray attenuation than the PICA. Lastly, notice the hole cut

Fig. 6 - Extracted region from verticle CT slice.

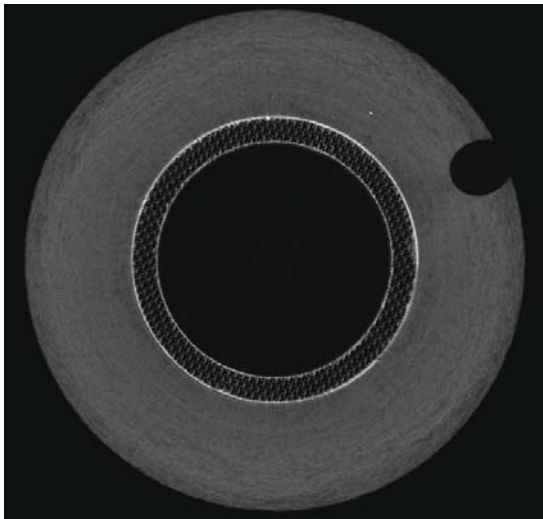
Fig. 7 - Transverse CT slice.

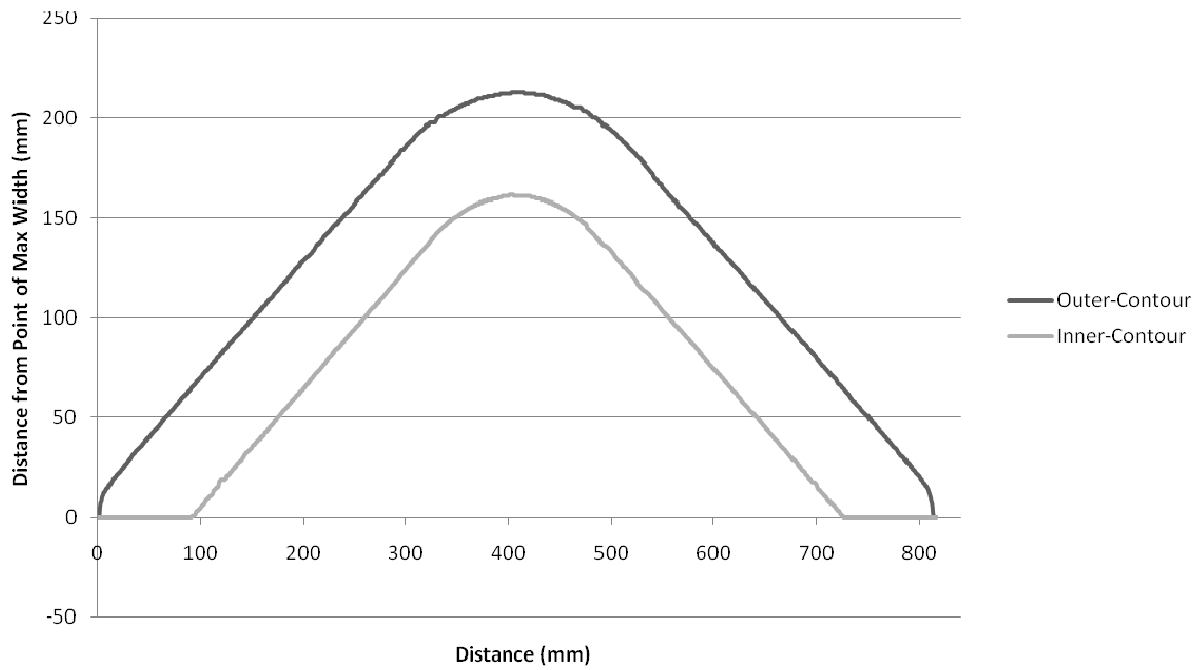
The measurement procedure for a center vertical slice involves three steps; 1) measure the coordinates of the boundary of the outer PICA layer from the center vertical slice, 2) for the same vertical slice, measure the boundary of the inner PICA layer (the inner boundary is bounded by the aluminum honeycomb layer), and 3) measure the distance from outer to inner boundary on the line perpendicular to the surface of the outer boundary. Fig. 8 shows plots of the outer and inner boundary contours of the PICA layer from the scan of the Stardust shield obtained from “shrink-wrap” operations applied to the volume. Fig. 9 shows the PICA thickness measured from the boundaries in Fig. 8 compared with the “as-built” thickness. Fig. 10 shows the estimated material loss based on Figs. 8 and 9.

Fig. 8 – Plot of inner and outer boundaries of PICA.

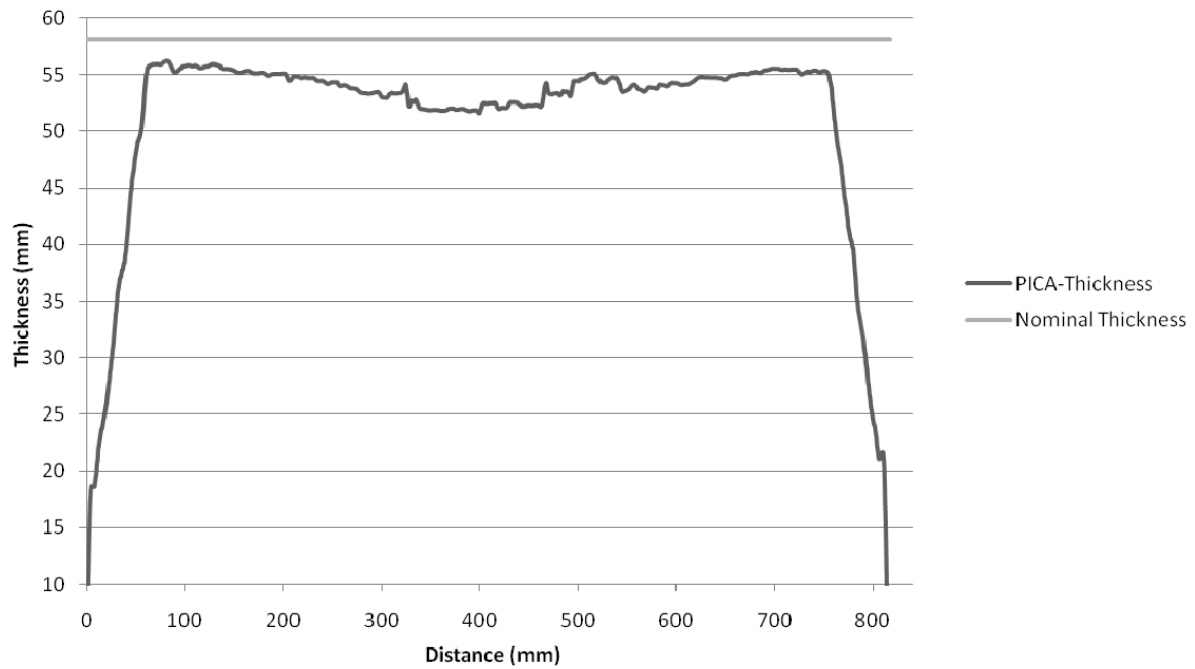
Fig. 9 – PICA thickness measurements.

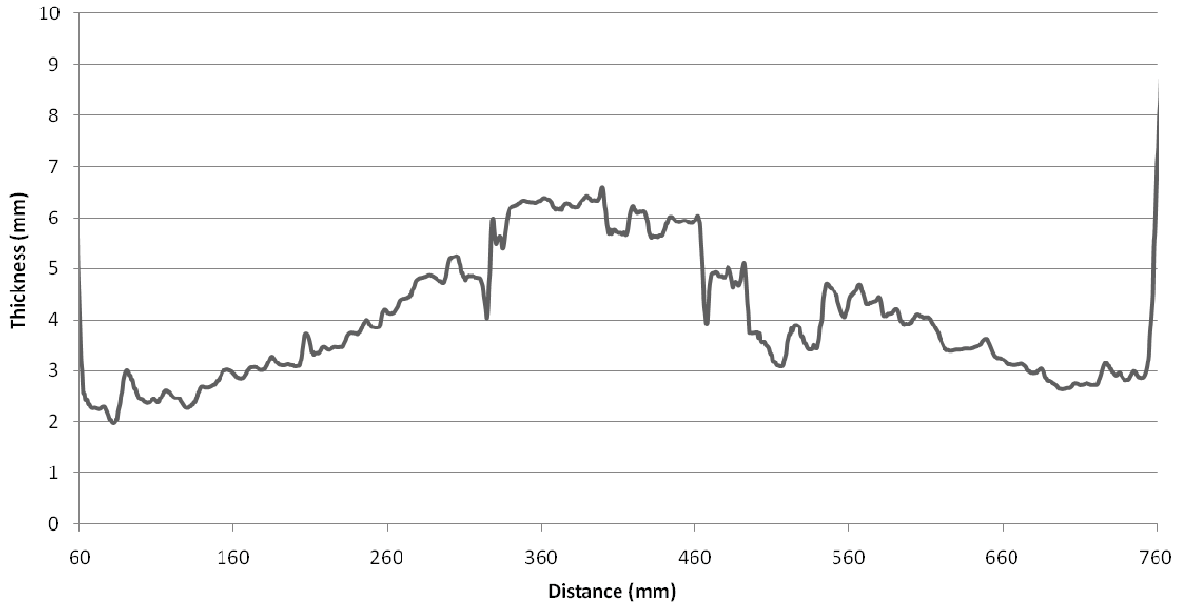
A few trends in the material loss in the PICA are apparent from the data. First the loss of material (compared to the assumed build with a constant thickness) is greater at the top of shield than towards the outer ends. The maximum loss is around 6.3 mm ($\frac{1}{4}$ inch) in thickness. But as can be seen from the outside of the shield there is substantial variation in the outer texture with “chunks” of the shield missing, possible due to the impact at landing. However, independent of the chunks missing from the shield, there appears to be a near-linear decrease in the loss of the PICA material proceeding from the top of the Shield to the outside edges.

Fig. 10 - PICA thickness loss from nominal thickness of 58 mm.

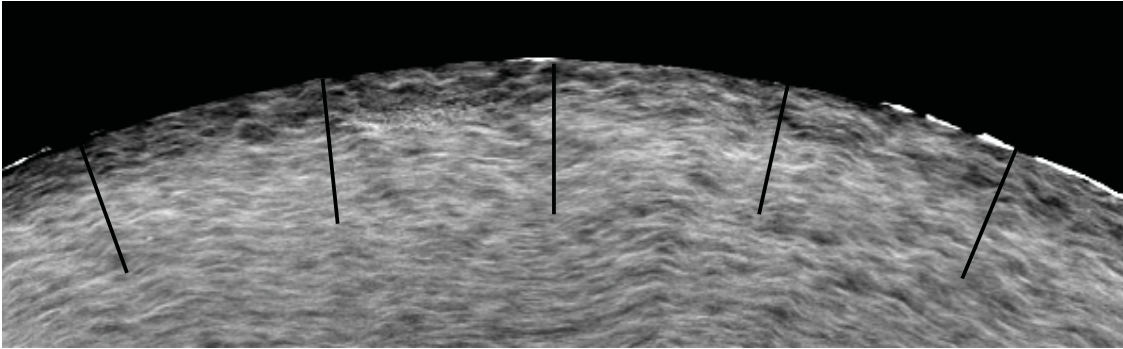
The “char” layer is a lower attenuating band of PICA material at the outer boundary of the shield. Fig. 11 includes an image extracted from the top of the dome, with the grey-level-window set to just span the attenuation of the PICA (the “dirt” on the outside layer are all at the maximum gray level). Notice the subtle differences in density characteristic of this layer. To

Fig. 11 - Extracted section of top dome showing approximate positions of line-outs.

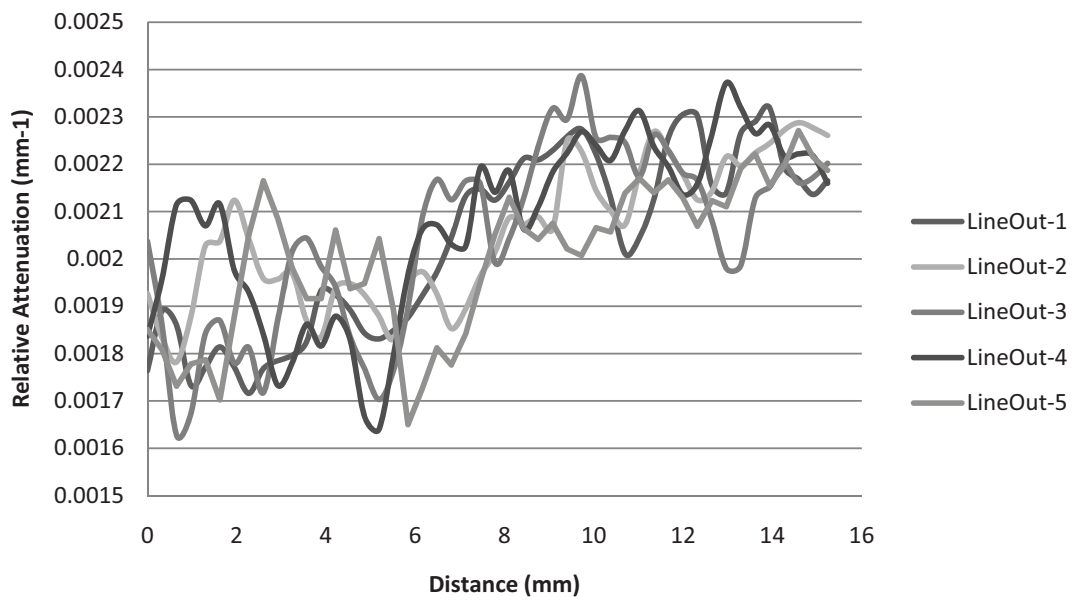
obtain a quantitative measure of the density differences in the charred PICA line-outs were acquired at different positions indicated on the image. Fig. 12 is a comparison of the relative attenuation along the line outs. Since the char layer occupies the region close to the outside boundary, we obtained “shell-extractions” from the reconstructed volume. This process involves finding the outer boundary, then shrinking the outer boundary to intersect a layer at a uniform distance from the edge, thereby generating an image of the internals of the Stardust shield in exclusively in the char layer. Fig. 13 is an image of the shell extraction of the entire char layer, Fig. 14 is a extract of the char layer shell, and Fig. 15 is an extract of a layer deeper into the PICA.

Fig. 12 - A comparison of the relative attenuation from the line-outs indicated in Fig. 11.

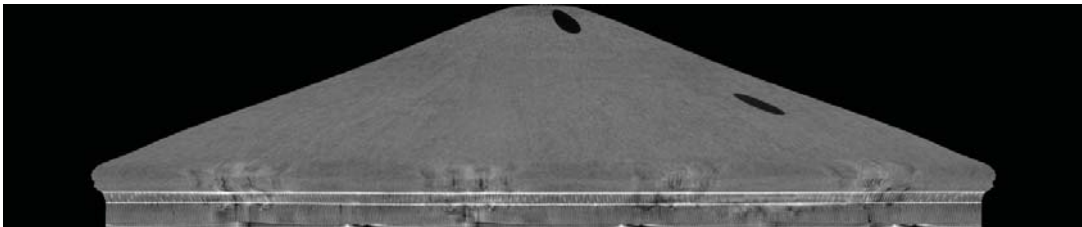
Fig. 13 - Shell extraction for the entire volume in the outer char layer.

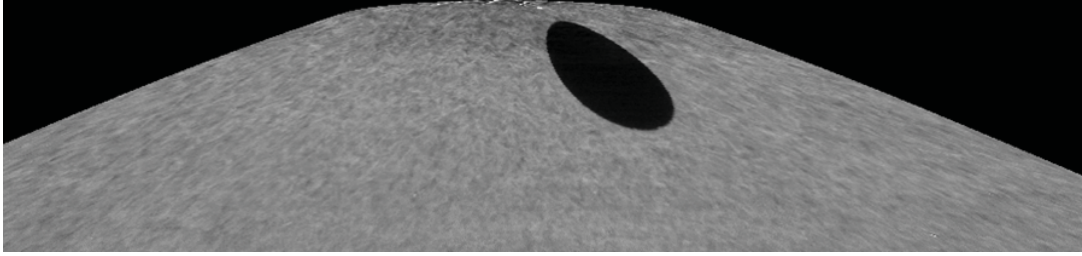
The variation in the attenuation values in the above images and displayed in the, images, line-outs, and histograms shows the difficulty in accurately dimensioning the char layer. First, there is variation in the fibers themselves that is close to the change in density in the char layer (0.000109 for a mean value of 0.00214 – approx 1 part in 20). Second, comparing average values from a shell extraction in the char layer and from a layer inside the char (the “no-char” region), the “char layer is lower in attenuation by about 12%. However, referring to Fig. 17, notice the substantial overlap between the histograms of voxels from the char and no-char layer. This can also be observed in the images; some of the fibers in the char layer retain their original density.

Fig. 14 – Extracted region from the shell of the outer char layer.

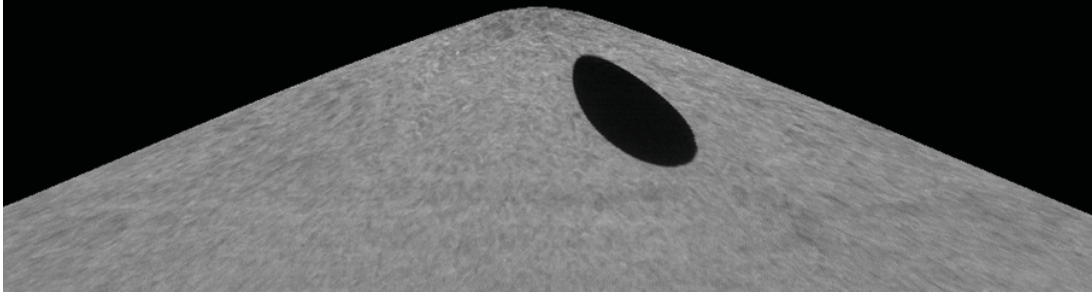
Fig. 15 - Extracted region from the shell of the inner layers of PICA well inside the char layer.

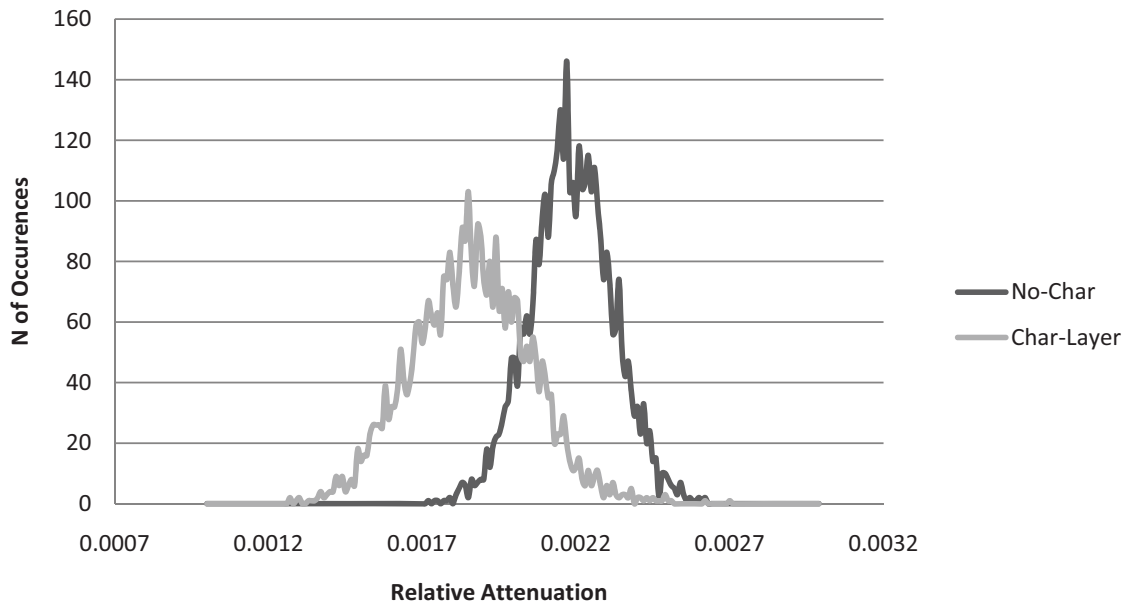
Fig. 16 - Histograms from extracted regions of the same size from the shell extraction data.

Third, and as expected, the loss in density in the char layer results in a material that is less uniform than the “no-char” region as shown in the width of the histogram for the “Char-Layer” voxels.

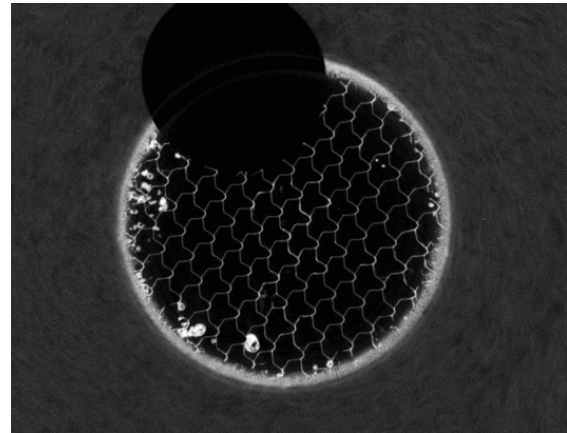
The “bond-layer” referred to here is the layer of material in-between the PICA and the Aluminum honeycomb. From the cross-sectional slices presented above and below the layer is higher in attenuation than the PICA, and is close in attenuation to the Aluminum. Figure Figs. 17 and 18 contain extracted regions from cross-sectional slices through the PICA, the section at the top of the honeycomb and containing the bond-layer. Notice the small porosity at about 4 o’clock in the bond-layer in Fig. 17. Also, notice the excess metal in the honeycomb.

Fig. 17 - Cross-sectional slice showing PICA, bond-layer and Honeycomb.

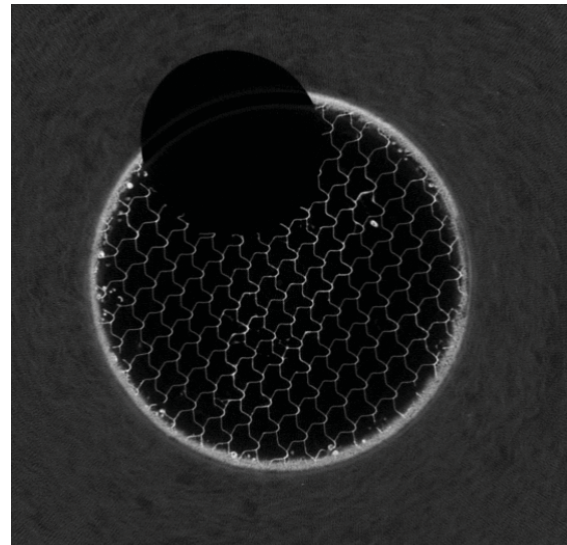
The cross-sectional slice in Figure 18 shows a gap in the bond-layer at a radial position of 3 o’clock. This void-space in the “bond-layer” extends a length of approximately 20 mm at this particular position.

Fig. 18 - Cross-sectional slice showing a gap in the bond-layer.

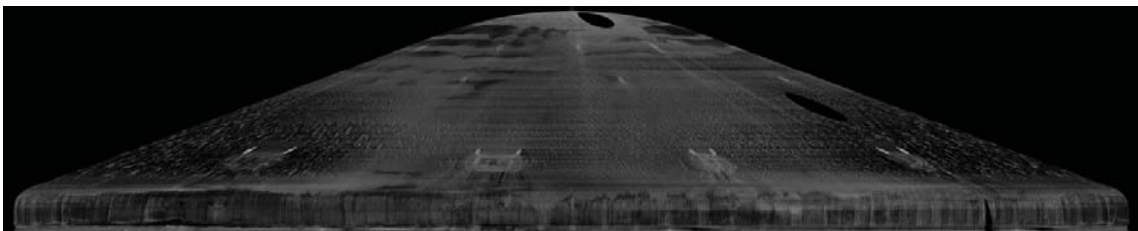
Fig. 19 - Shell extraction of the bond-layer.

“Shell extractions” utilized above to examine the char layer can be used to evaluate the bond-layer in the Stardust heat shield. Using the exterior of the aluminum honeycomb as a boundary we can position a shell with this contour in the geometric position of the “bond-layer”. Consequently, we obtain an image of the entire “bond-layer” in one image. Figs. 19 and 20 show this.

The “shell-extraction” images show a number of gaps in the “bond-layer” in the Stardust heat shield. In general the bond-line is better filled at the top of the shield than down the length towards the ends of the shield. In particular for the section at the top shown in Fig. 20 the bond-layer is only 62% filled, that is 38% of the space in the bond layer contains substantial voids. At this point in time these results have not been compared to the as-built data so it is not clear if the void-fraction developed over time in service, or the void-fraction is as-built

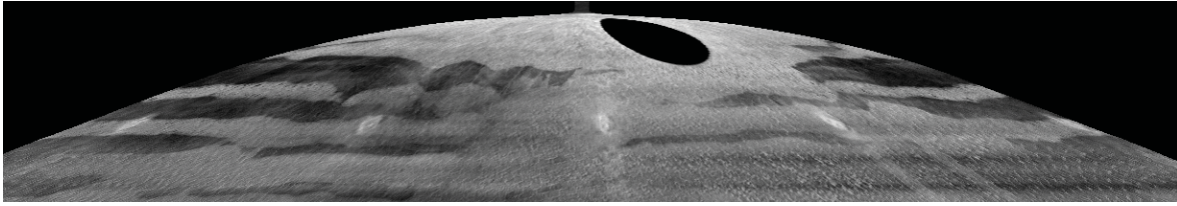
Fig. 20 - Close-up of the top of the image in Fig. 19.

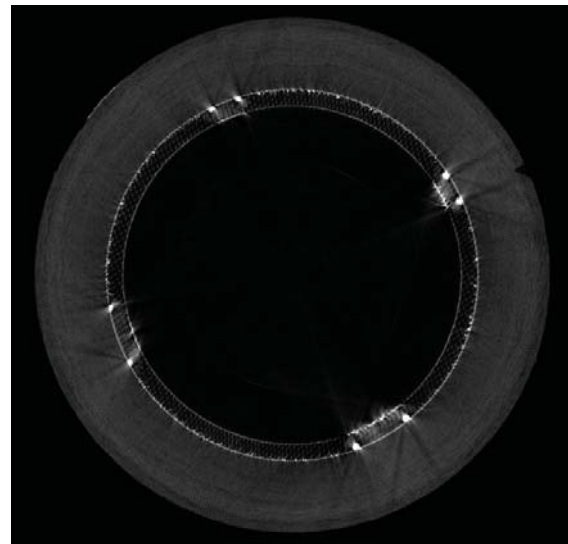
From the evaluation of the entire 3D CT volume two different types of artifacts can be identified which hamper the evaluation of certain features in the data. First, the sections of PICA and aluminum honeycomb in close proximity to the Aluminum support structure are inundated with troublesome “streak” artifacts. Fig. 21 contains a cross-sectional slice displaying these effects in the reconstructed volume. These artifacts are the result of a “lack of penetration” of the longer sections of Aluminum in the support structure combined with the proportion of “Background Scatter” [3] characteristic of this technique. In many cases these effects can be remediated by a thicker x-ray beam filter, thereby increasing the average energy used in the scanning. This should be considered in subsequent scanning.

Fig. 21 - Cross-sectional slice showing streak artifacts.
