Experimental Techniques for Evaluating the Effects of Aging on Impact and High Strain Rate Properties of Triaxial Braided Composite Materials

*J. Michael Pereira, Gary D. Roberts, and Charles R. Ruggeri
Glenn Research Center, Cleveland, Ohio*

Prepared for the
2010 Aircraft Airworthiness and Sustainment (AA&S) Conference
cosponsored by the DoD, NASA, and FAA
Austin, Texas, May 10–13, 2010

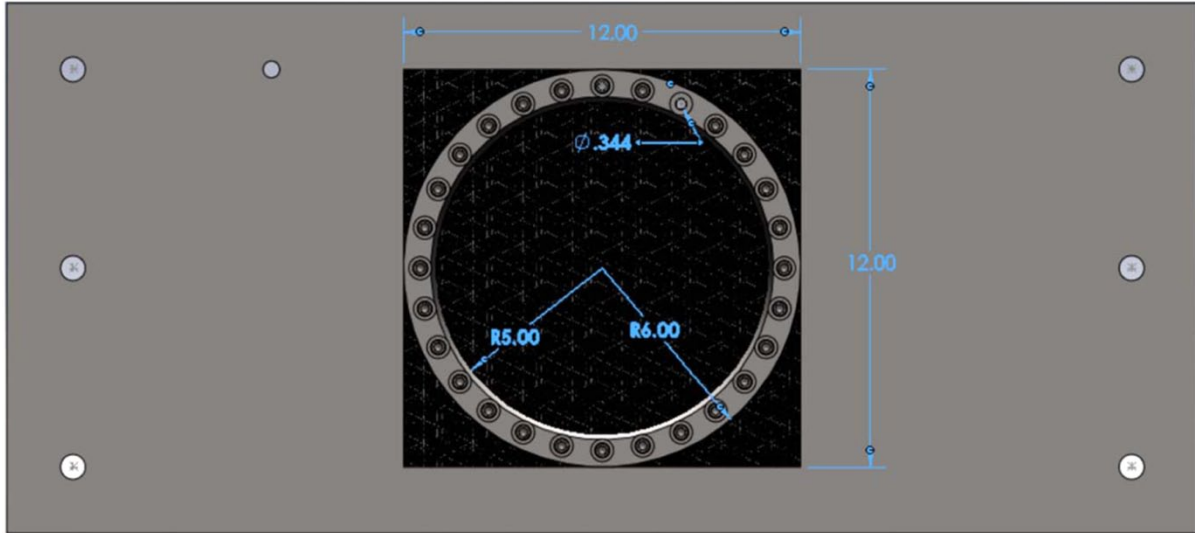
Figure 4.—Impact test fixture for 12 in. square specimens. Dimensions are in inches.

The ballistic impact response of the composite specimens is being measured by impacting projectiles into flat plates at a normal incidence using a single stage gas gun with a 2 in. bore and a length of 12 ft. The composite test specimens measure 12- by 12-in. and are clamped in a circular fixture with an aperture of 1 in. (Fig. 4). To eliminate slipping at the boundary, 28 bolts extend through the fixture front clamp, the specimen and the rear fixture plate. The projectile is a thin walled hollow AL 2024 cylinder with a nominal mass of 50 gm and a front face with a compound radius (Fig. 5). This projectile was designed based on a number of considerations. One is that AL 2024 is a well characterized material and its properties are independent of strain rate at least to rates up to 5000/sec. This significantly simplifies computational modeling of the impact test compared to the use of a soft body projectile. The radius of the front face of the projectile was designed such that the deformation profile and failure mode were similar to those observed in the composite plate tests described in Reference 3. The projectile underwent a design modification after the initial stages of the test program. Originally the overall length of the projectile was 1.243 in., with a length of 0.75 in. for the straight cylindrical section. However, due to some problems related to velocity repeatability and impact orientation, the overall length of the projectile was increased to 1.947 in. and the wall thickness reduced to 0.030 in. All other characteristics of the projectile, including the front face profile and overall mass remained the same. The projectiles have a diameter of 1.995 (+0/-.006) in., such that they fit inside the gun barrel with just enough clearance so that they would slide easily.

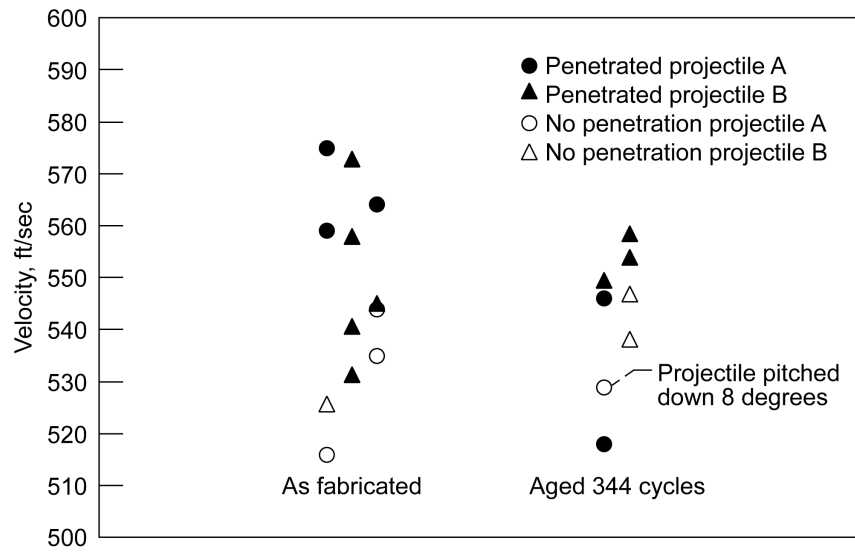
Figure 9.—Impact velocity and penetration results for composite panels.

The results indicate that there is some variation in penetration velocity between panels. An example of this variation can be seen in the second and third columns of the as-fabricated panel tests, where the penetration velocity for one set of panels is below 530 ft/sec, and in the other set above 540 ft/sec. While this variation may be considered small, it appears to be greater than any changes due to the 344 aging cycles.

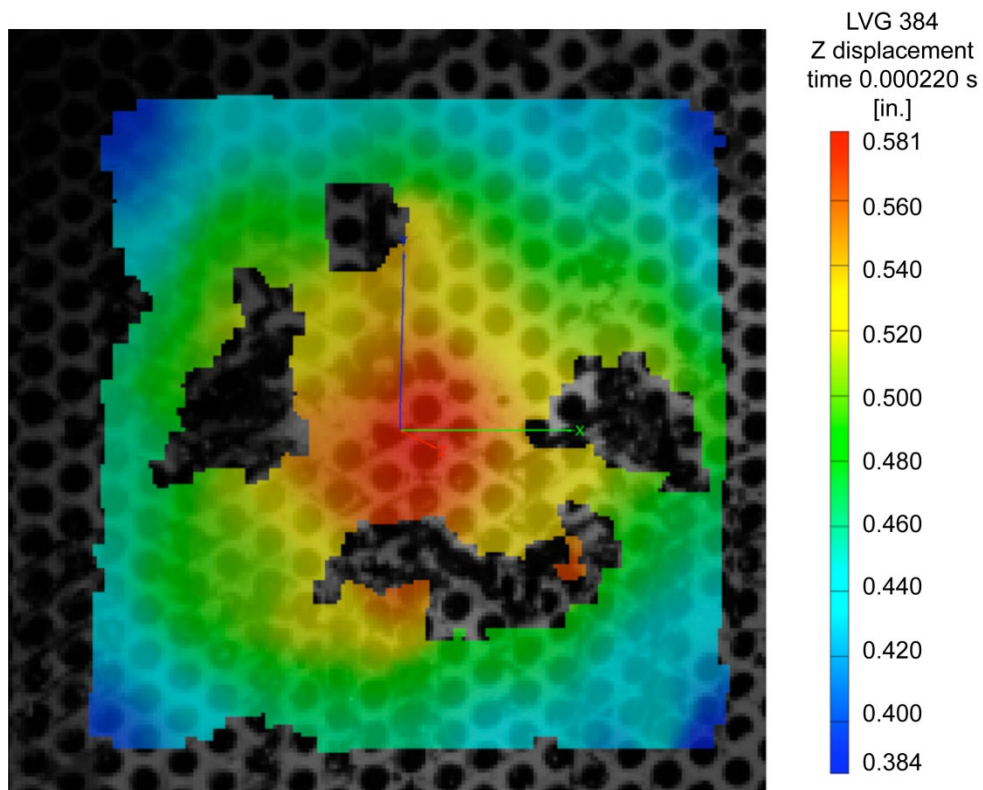
Figure 10.—Out of plane deformation pattern in composite panel at an impact speed just below the penetration threshold. Note missing areas of data due to paint pattern loss.

Figure 10 shows the deformation profile on the back side of a panel from a typical impact test at a velocity just below the penetration velocity (544 ft/sec). The deformation is relatively localized at the center of the panel, with a maximum of 0.58 in., and is similar to the profiles observed in an actual fan case blade-out test on a composite case (Ref. 1) and to those seen in larger panel tests with a soft gelatin projectile (Ref. 3). The damage induced by the projectile is diffuse, as opposed to a cutting or shearing failure, as can be seen in Figure 11 which shows a panel in which the projectile penetrated at a velocity of 554 ft/sec.

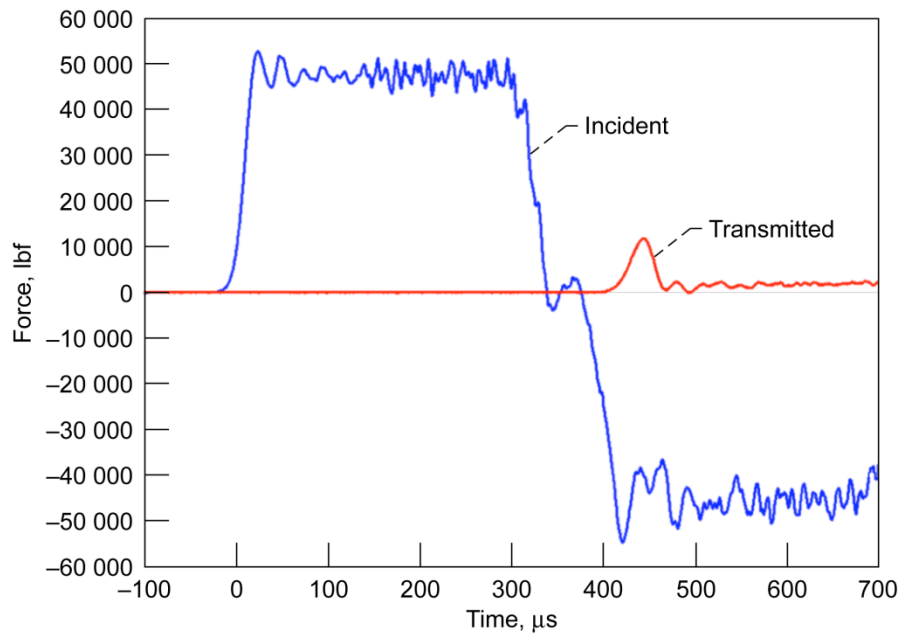
Figure 12.—Incident, transmitted and reflected waves in SHB experiment.

Results from the first pilot test conducted with the new Split Hopkinson Bar apparatus are shown in Figures 12 to 15. Figure 12 shows the waves recorded in the incident and transmitted bars. Note that the amplitude of the incident wave is over 40,000 lb. The wave in the transmitter bar is actually the force transmitted through the specimen. The record shows a signal with a force that reaches 10,000 lb. The stress in the specimen is shown in Figure 13. The strain measured in the specimen (middle point) during the test with DIC system is shown in Figure 14. The average strain rate during the test (the slope of the strain versus time curve) is approximately 150 s^{-1} . The stress-strain curve is shown in Figure 15. The overall stress level appears to be significantly higher than the stress that was measured in quasi-static compression tests of specimens with the same configuration.
