“Image Science and Analysis Group Spacecraft Damage Detection/Characterization”

NASA Lyndon B. Johnson Space Center, Houston, TX
Astromaterials Research and Exploration Sciences (ARES)

Ira M. Wheaton Jr.
MUST Program
Mentor: Tracy Calhoun
June 1, 2010 – August 6, 2010

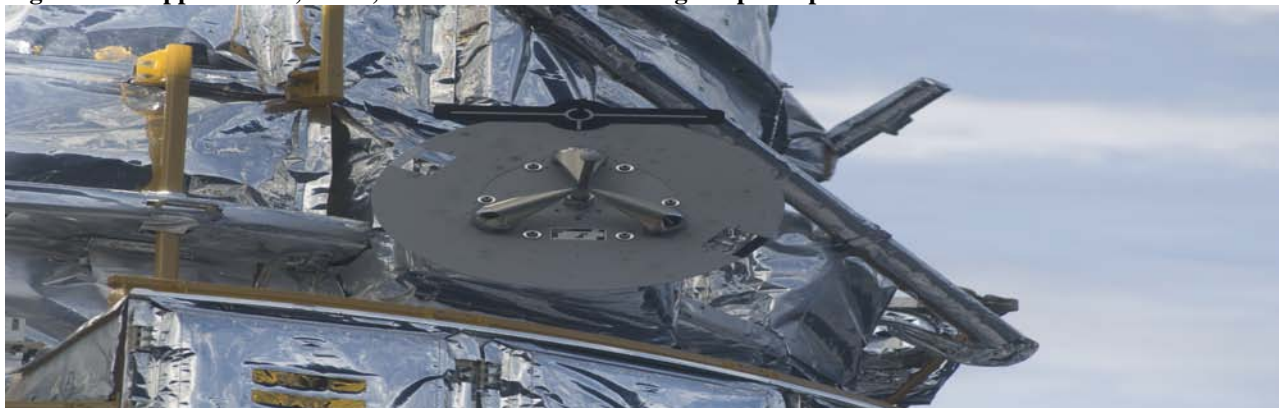
Figure 2: Grapple fixture, ID 87, which was measured using the pixels per inch calculations in Table 1.

Table 1: Shows (x,y,z) coordinates for Shuttle Windows and ID points. Also, shows the magnification calculations in pixels per inch, based on the distances and vectors from the windows and ID points, unit vectors above ID points, & angles between the vectors.

182.1493625	(Pixels per mm)		
36429.8725	(Focal Length in Pixels)		
Window	X	Y	Z
Window 9	576	15.82	483.13
Window 10	576	-15.82	483.13
ID	X	Y	Z
128	1065.59	8.57	500
120	1067.68	-21.81	598.84
87	1083.72	-45.95	754.59
Magnification for 200mm lens in parallel plane (pixels per inch)			
Mag(W9, ID128)	74.35666249		
Mag(W9, ID120)	71.92307043		
Mag(W9, ID87)	62.91441456		
Mag(W10, ID128)	74.27280796		
Mag(W10, ID120)	72.11731015		
Mag(W10, ID87)	63.18900994		
Magnification for 200mm lens in z-direction plane (pixels per inch)			
Mag(W9, ID128)	74.31256912		
Mag(W9, ID120)	70.02119747		
Mag(W9, ID87)	55.57218804		
Mag(W10, ID128)	74.22886363		
Mag(W10, ID120)	70.19984576		
Mag(W10, ID87)	55.74592179
