Influence Of Impact Damage On Carbon-Epoxy Stiffener Crippling

Dawn Jegley

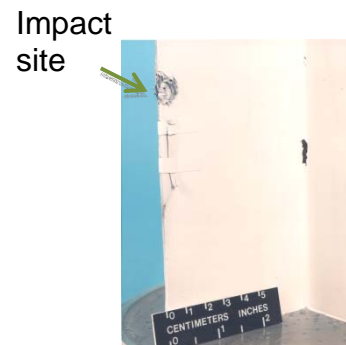
Figure 9. Impact damage site for blade-stiffened specimens.

Impacts to PRSEUS stiffeners resulted in no visible damage for either the side or top impact, as shown in figure 8. Impacts to the blade-stiffened specimens resulted in obvious impacts as shown in figure 9. Even though the energy level is the same for the blade-stiffened specimens and the PRSEUS specimens, the smaller, lighter impactor inflicts damage over a smaller area and leaves more-visible evidence than the heavier impactor with the larger tup.

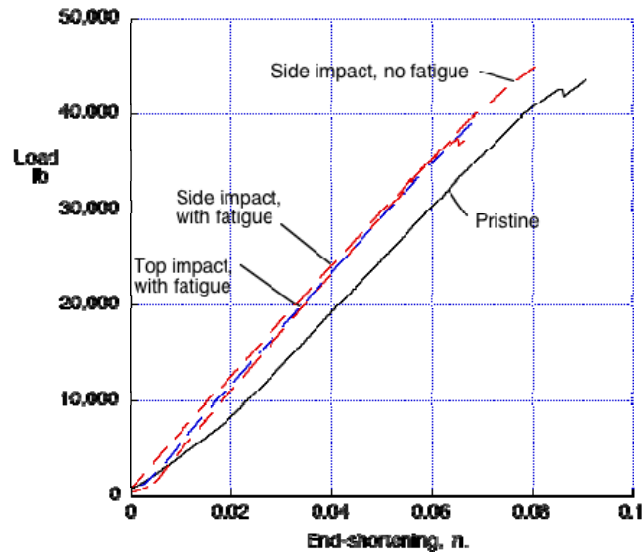
Figure 14. Load vs. end-shortening behavior.

Failure loads ranged from 38,091 to 45,080 lb for the four PRSEUS specimens examined in the current study, as shown in Table III. A comparison of their stiffness based on the applied load and end shortening is shown in figure 14. End-shortening measurements for the three loading platen locations indicate a uniform displacement was applied to the end of each specimen so the end-shortening shown was determined by averaging these three displacements. Data for

the pristine specimen is shown as a solid black line and data for the impacted specimens are shown as dashed lines. Side impacts are shown in red and the top impact is shown in blue. The stiffnesses vary by approximately 10% however, the least stiff specimen is the pristine specimen with no cyclic loading so it is unlikely that this difference is related to the impact or fatigue but rather scatter in the specimens. From these limited results, there appears to be no effect of either fatigue cycles or impact to the rod-stiffener on the stiffness of the specimen.

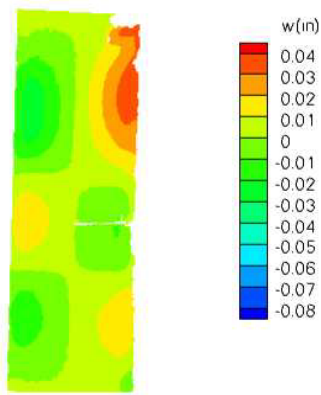
Figure 16. Full-field out of plane displacement at 39,064 lb for top impacted specimen after fatigue.

Full-field results for out-of-plane deformation of the un-stiffened surface at approximately the maximum applied load are shown in figures 15-18 for specimens 1-4, respectively. In all the full-field results, regions where strain gages and wires obscure the specimen surface are removed from the plot. These out-of-plane results indicate all specimens buckled prior to failure. The centerline where the rod

was located did not move out-of-plane during loading while the unloaded edges did move out of plane despite the edge restraints. A buckle pattern of approximately three half waves developed in each specimen. In each specimen, at the centerline one edge moved in the positive z direction while the other edge moved in the negative z direction about the same magnitude. Impacts to the rod had no effect on the skin behavior.

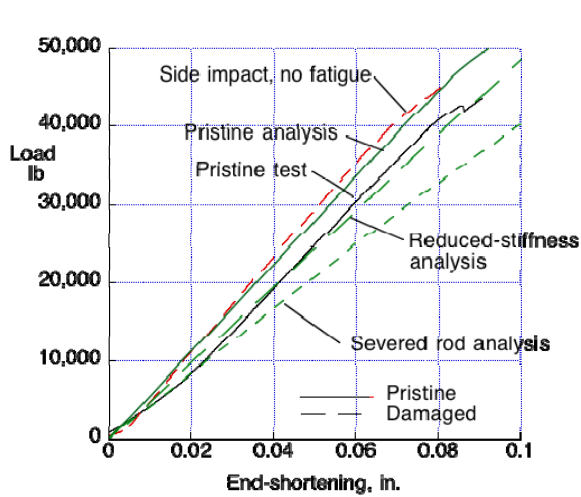
Figure 19. Load-shortening of pristine, reduced stiffness-rod and severed-rod analysis.

The shortening of the control test specimen is shown with the corresponding analytical result in figure 19. The analytical result for the model with no assumed damage agrees well with the results for the control test specimen. The analytical prediction of the full-field out-of-plane displacement at a load of 38,000 lb is shown in figure 20 and shows the same pattern as found for the test as shown in figure 15.

The analytically determined shortening for the severed rod and reduced-stiffness rod are also shown in figure 19. Test data and the analytical prediction for the pristine specimen are shown as solid lines. Data for the impacted specimen with no fatigue is shown as a dashed red line and the analysis of the severed rod and the reduced-stiffness rod results are shown as dashed green lines. Little effect in this global measure of specimen behavior is seen due to the locally reduced stiffness in the rod. Full-field-out-of-plane predictions for the reduced-stiffness rod and for the severed-rod analyses are shown in figures 21 and 22, respectively. Out-of-plane deformation is not significantly effected by the reduced stiffness but is effected by the severed rod.

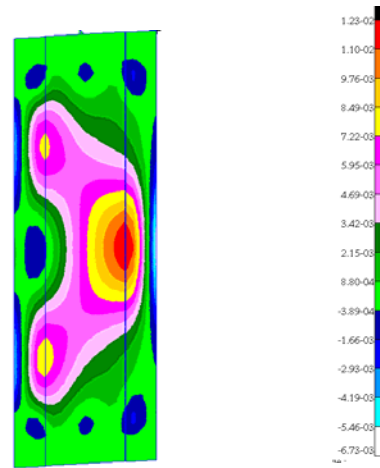
Figure 20. Analytically determined full-field out-of-plane deformation for pristine specimen at 38,111 lb.

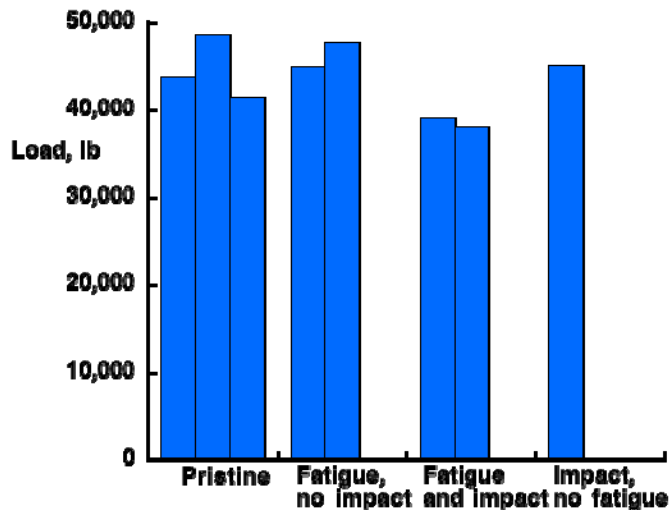
Figure 23. PRSEUS specimen failure loads.

specimens in those references were impacted. Including all eight specimens, non-fatigued, non-impacted specimens failed at loads between 41,454 lb and 48,500 lb. Fatigued non-impacted specimens had failure loads within this range. The impacted but not fatigued specimen also had a failure load within this range. Fatigued, impacted specimens had failure loads slightly less than the lowest non-impacted failure, however, not enough specimens were examined to quantify the effect of impact. These results indicate that fatigue cycling alone had no impact on failure load and impact alone had no impact on failure load. However, impact followed by cycling may have reduced load-carrying ability by as much as 13%, as shown in figure 23.

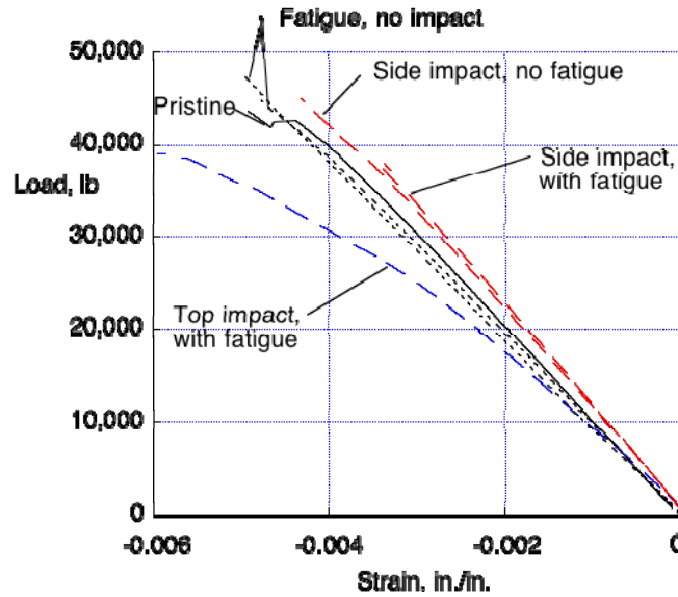
Figure 24. Strain on rod overwrap.

The load-strain relationship measured by the strain gage on the overwrap midlength for the pristine and impacted specimens are shown in figure 24. Data for the pristine specimen are shown as solid lines and data for the impacted specimen are shown as long dashed lines and data for fatigued specimens with no impacts are

shown in short dash lines. The fatigue cycles had no effect on the behavior at this location for the unimpacted specimen. The impact at the top of the rod also did not significantly affect the behavior at this location, as shown by the dashed red lines. However, impact on the top of the rod may have caused enough damage to lead to nonlinear behavior of the gage at this location as shown by the long-dash blue line. It is important to note that while the impact affected the strain near the impact site, the fatigue cycles did not lead to a further change in the shape of the load-strain curve, as seen by comparing red lines representing side impact followed by fatigue and side impact without fatigue.

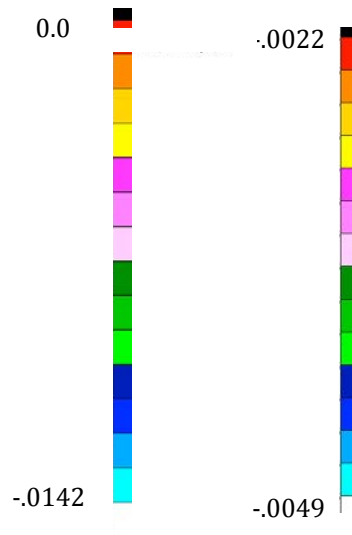
Figure 30. Analytically determined full-field axial strain at 44,000 lb for reduced-stiffness specimen.

Analytical strain results for the OML surface are shown in figures 29-31 for the pristine, reduced-stiffness rod, and severed-rod models, respectively. These results indicate that the strain in the region of the reduced stiffness is greater than the corresponding location in the pristine model but not significantly greater than the strain in the skin midlength, which is unaffected by the reduced stiffness rod region. Therefore, the analysis would indicate that the impact should have little effect on the compressive failure load. This conclusion is supported by the experimental results and implies that such non-visible damage may not require repair in a flight vehicle. The analysis with the severed-rod model shows significant increases in strain in the web where the rod is severed. This increase implies a significant

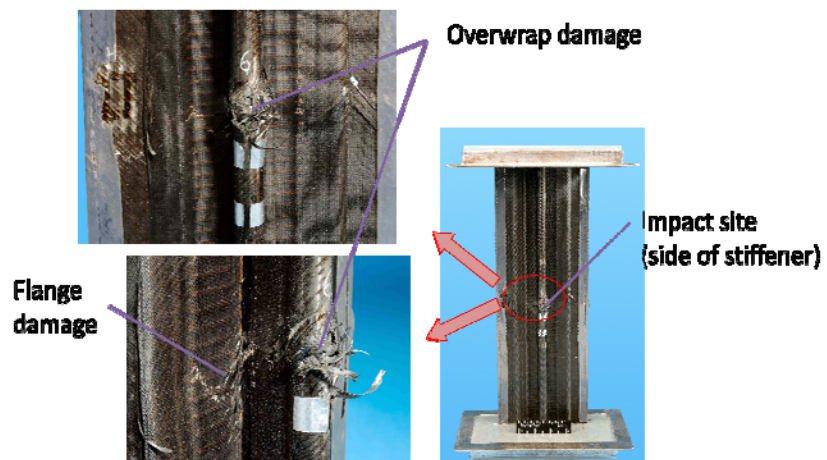
Figure 35. Failed specimen with side impact and no fatigue.

A comparison between failure loads obtained in the present study and those obtained in studies of nominally identical specimens with no impact damage are shown in figure 15 and Table III. Photographs of failed pristine and impacted specimens are shown in figure 32-35. These results indicate that fatigue cycling has no effect on failure loads and non-visible impact damage has only minimal influence on failure load or mode. In addition, fatigue cycling in the presence of impact damage did not influence the failure load any more than impact alone, implying there is no damage growth through the fatigue cycles.

Rod-stiffened specimens failed midlength across the full width of the specimen. Minimal delamination can be seen between the flange and skin. Overwrap damage can be seen around the rod. Specimens R3 and R4 failed in the same manner [2].
