# External Tank Program Legacy of Success

Chief Engineer's Council  
Montreal  
8/23-24/2010

*Ken Welzyn – NASA MSFC*  
*Jeff Pilet – Lockheed Martin*

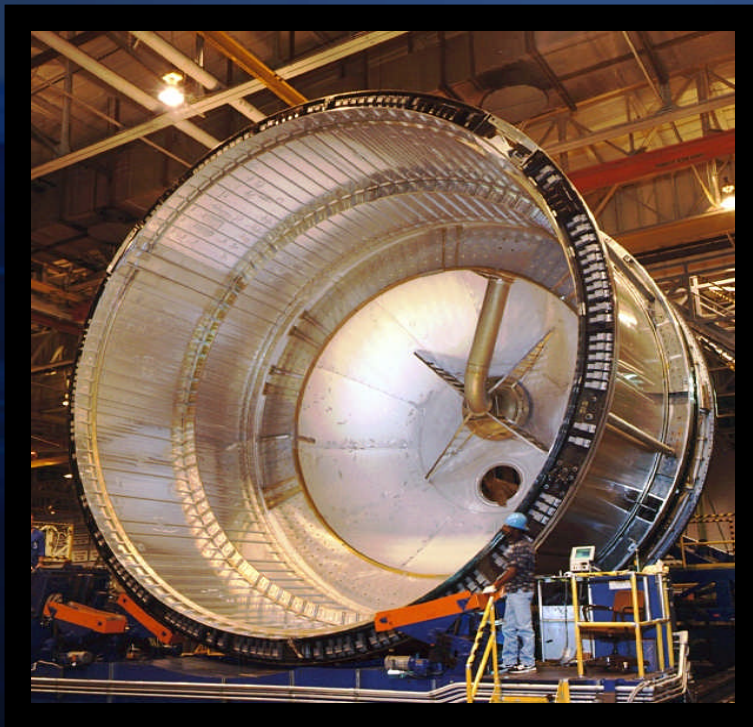
*Standard Weight (SWT) and  
Lightweight (LWT) – Al 2219 alloy*

- *Major configuration change implemented on SLWT LH2 Tank barrels*
  - Was: Al 2219 T-stiffened
  - Now: Al 2195 Orthogrid
    - Required development of new manufacturing process for machining, forming, and welding

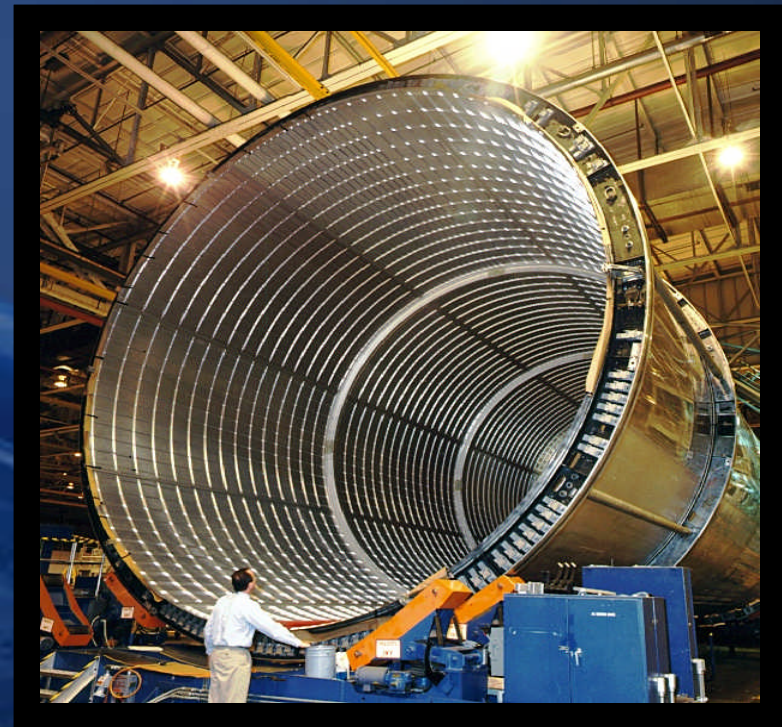
*Super Lightweight  
(SLWT) – Al 2195 alloy*

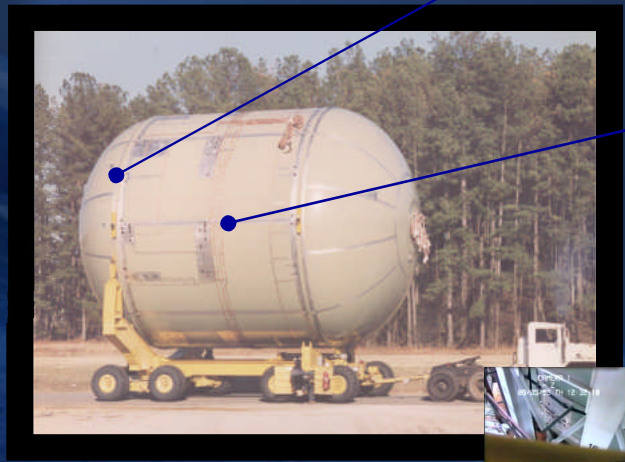
ALTA at MSFC

**ALTA used to verify multiple hardware elements and failure modes**  
 -- LH2 Barrel Panels, LO2 Dome, Fusion Welding

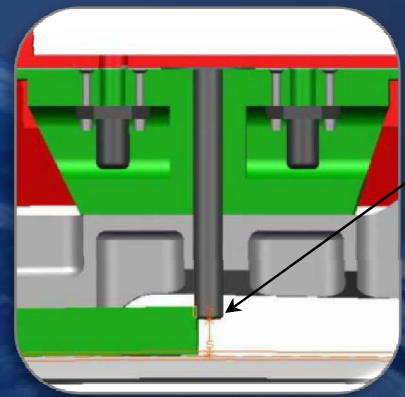
Cryopumping path along shear pin hole eliminated – Issue identified through ET-120 dissections and testing

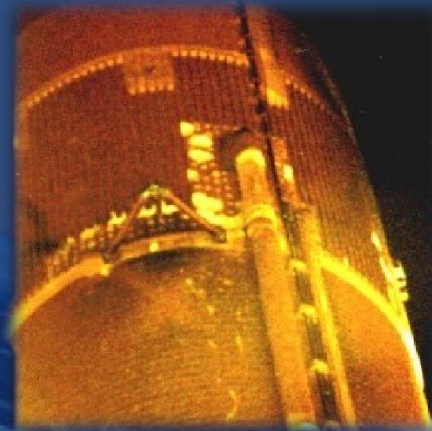
**STS-26/ET-19**

- Intertank foam loss (two tone acreage foam) 18 divots, 3" to 30" diameter

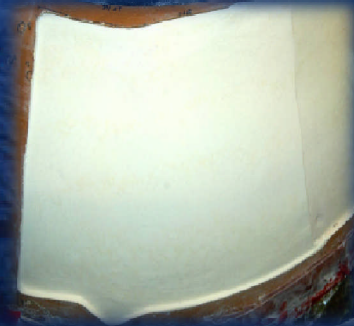
LO<sub>2</sub> Forward Ogive Area  
(pencil sharpened area)

- Post Hail PDL Repair
- Sand & Blend
