Oxidation of SiC/BN/SiC Composites in Reduced Oxygen Partial Pressures

Elizabeth Opila, NASA Glenn Research Center, Cleveland, OH

Meredith Boyd, University of Rochester, Rochester, NY

SiC fiber-reinforced SiC composites with a BN interphase are proposed for use as leading edge structures of hypersonic vehicles. The durability of these materials under hypersonic flight conditions is therefore of interest. Thermogravimetric analysis was used to characterize the oxidation kinetics of both the constituent fibers and composite coupons at four temperatures: 816, 1149, 1343, and 1538°C (1500, 2100, 2450, and 2800°F) and in oxygen partial pressures between 5% and 0.1% (balance argon) at 1 atm total pressure. One edge of the coupons was ground off so the effects of oxygen ingress into the composite could be monitored by post-test SEM and EDS. Additional characterization of the oxidation products was conducted by XPS and TOF-SIMS. Under most conditions, the BN oxidized rapidly, leading to the formation of borosilicate glass. Rapid initial oxidation followed by volatilization of boria lead to protective oxide formation and further oxidation was slow. At 1538C in 5% oxygen, both the fibers

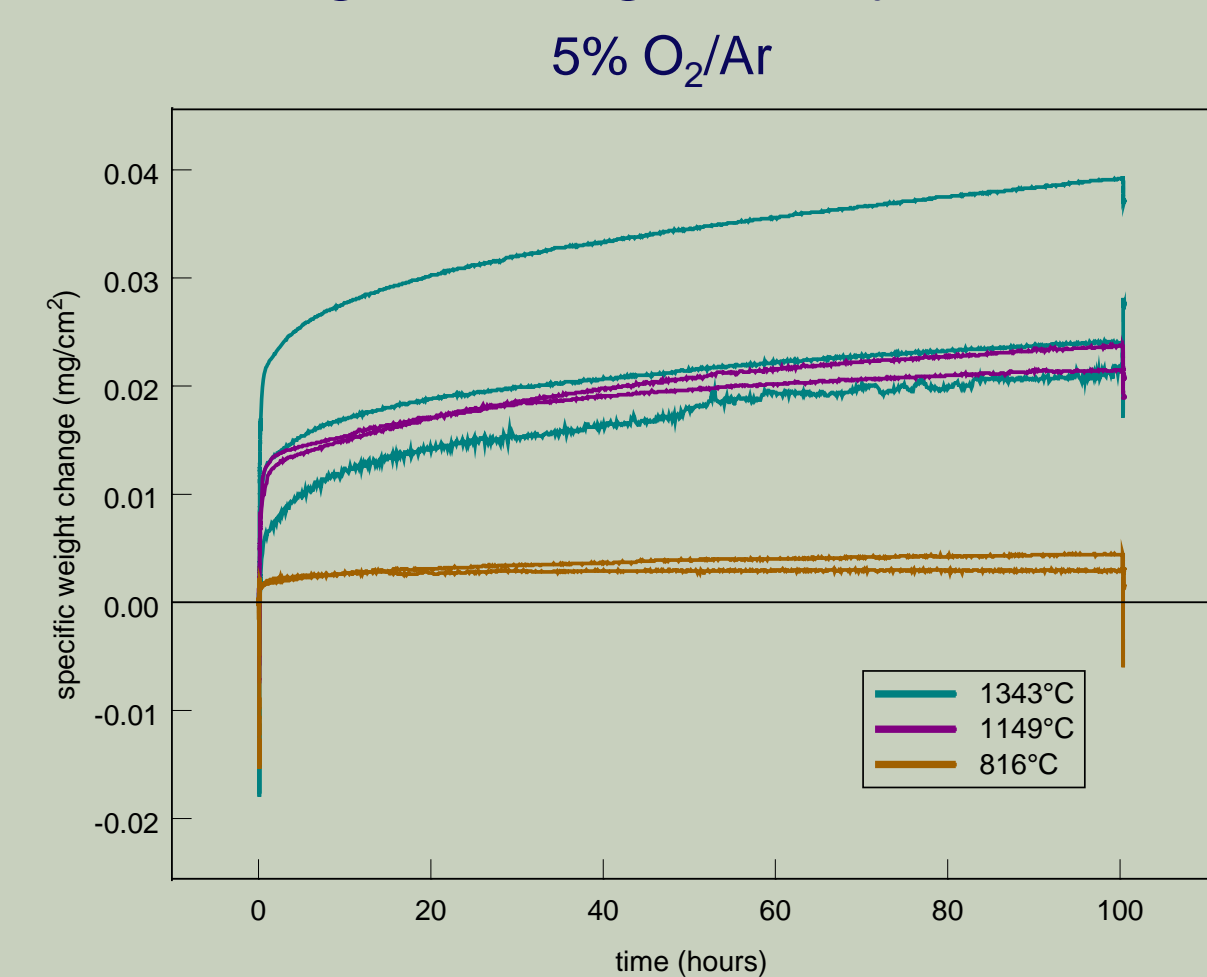
Oxidation weight change for Sylramic iBN fibers

- Rapid transient weight gain followed by slow oxidation rate
- Variation in weight gain during transient phase at 1343°C
- Weight change at 1538°C not available due to extensive borosilicate bubble formation/interaction with furnace tube

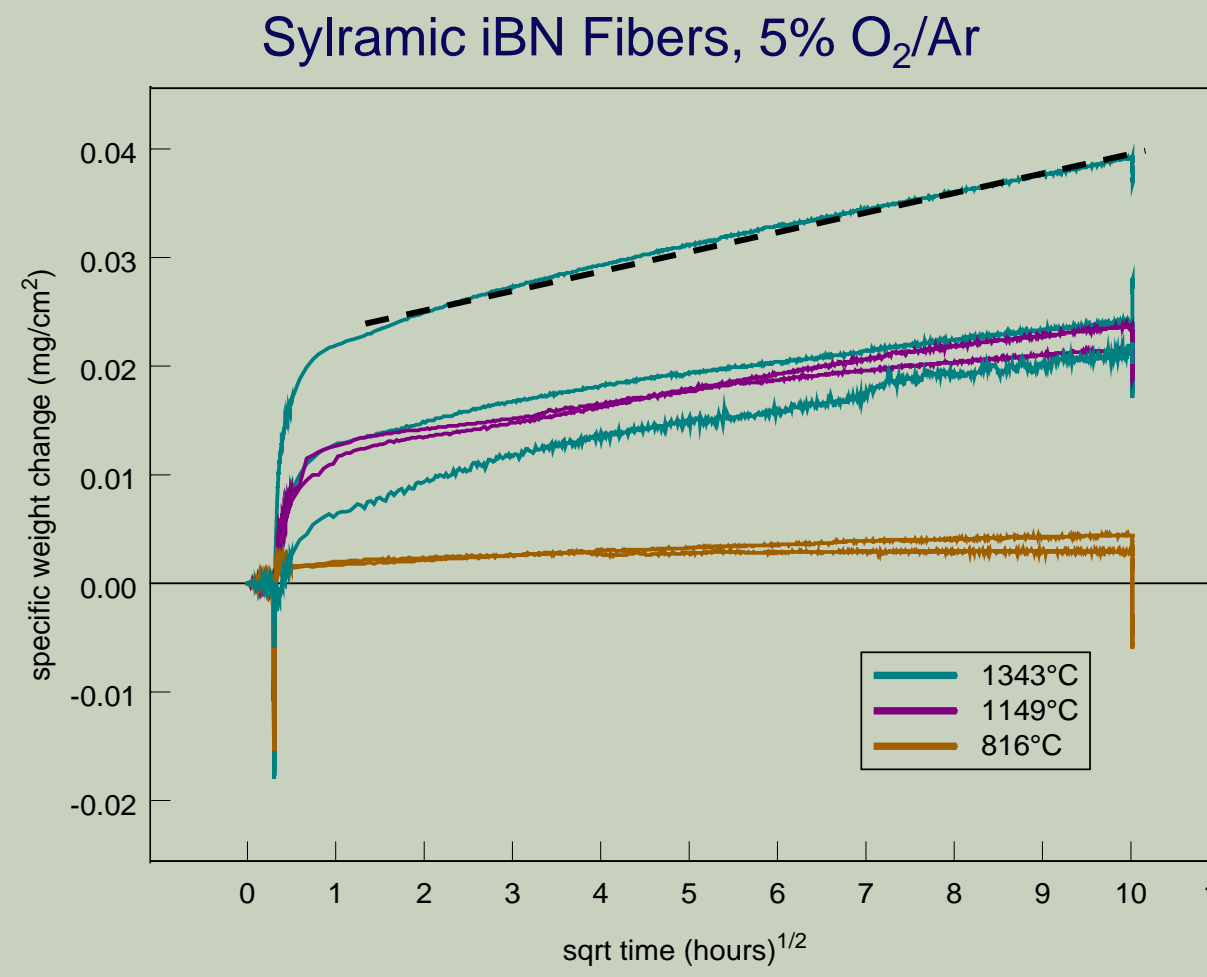
"Parabolic" oxidation kinetics observed after transient

- Low rates and balance drift result in large uncertainty in measured slopes, rate constants
- Apparent parabolic rates are slower than those predicted for oxidation of pure SiC

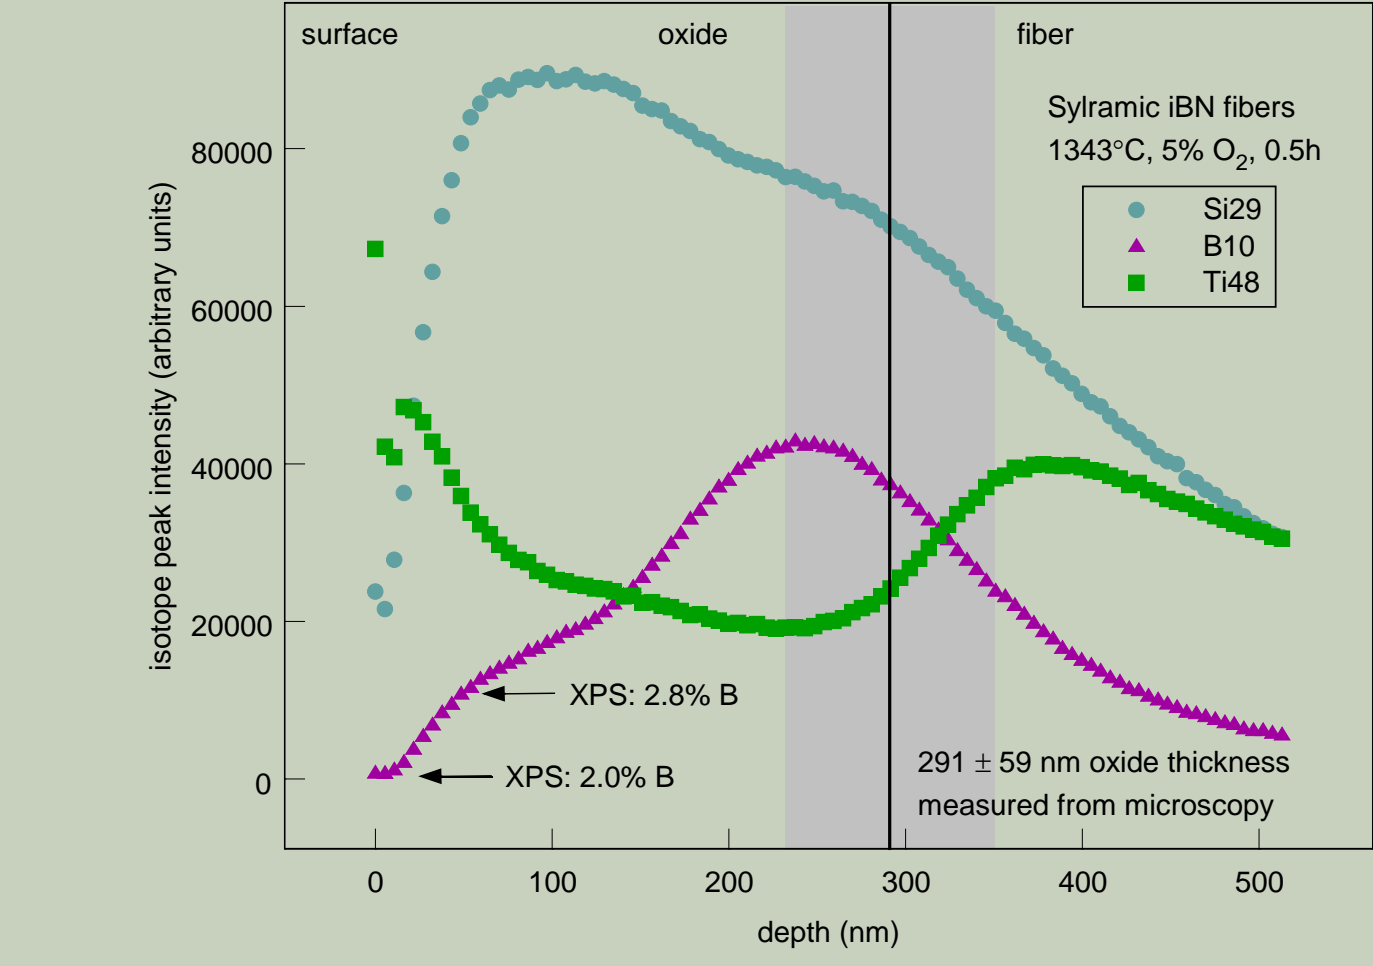
TOF-SIMS and XPS analysis of oxide scale

Sylramic iBN fibers

TOF-SIMS and XPS show boron gradient in oxide and boron depletion at surface.

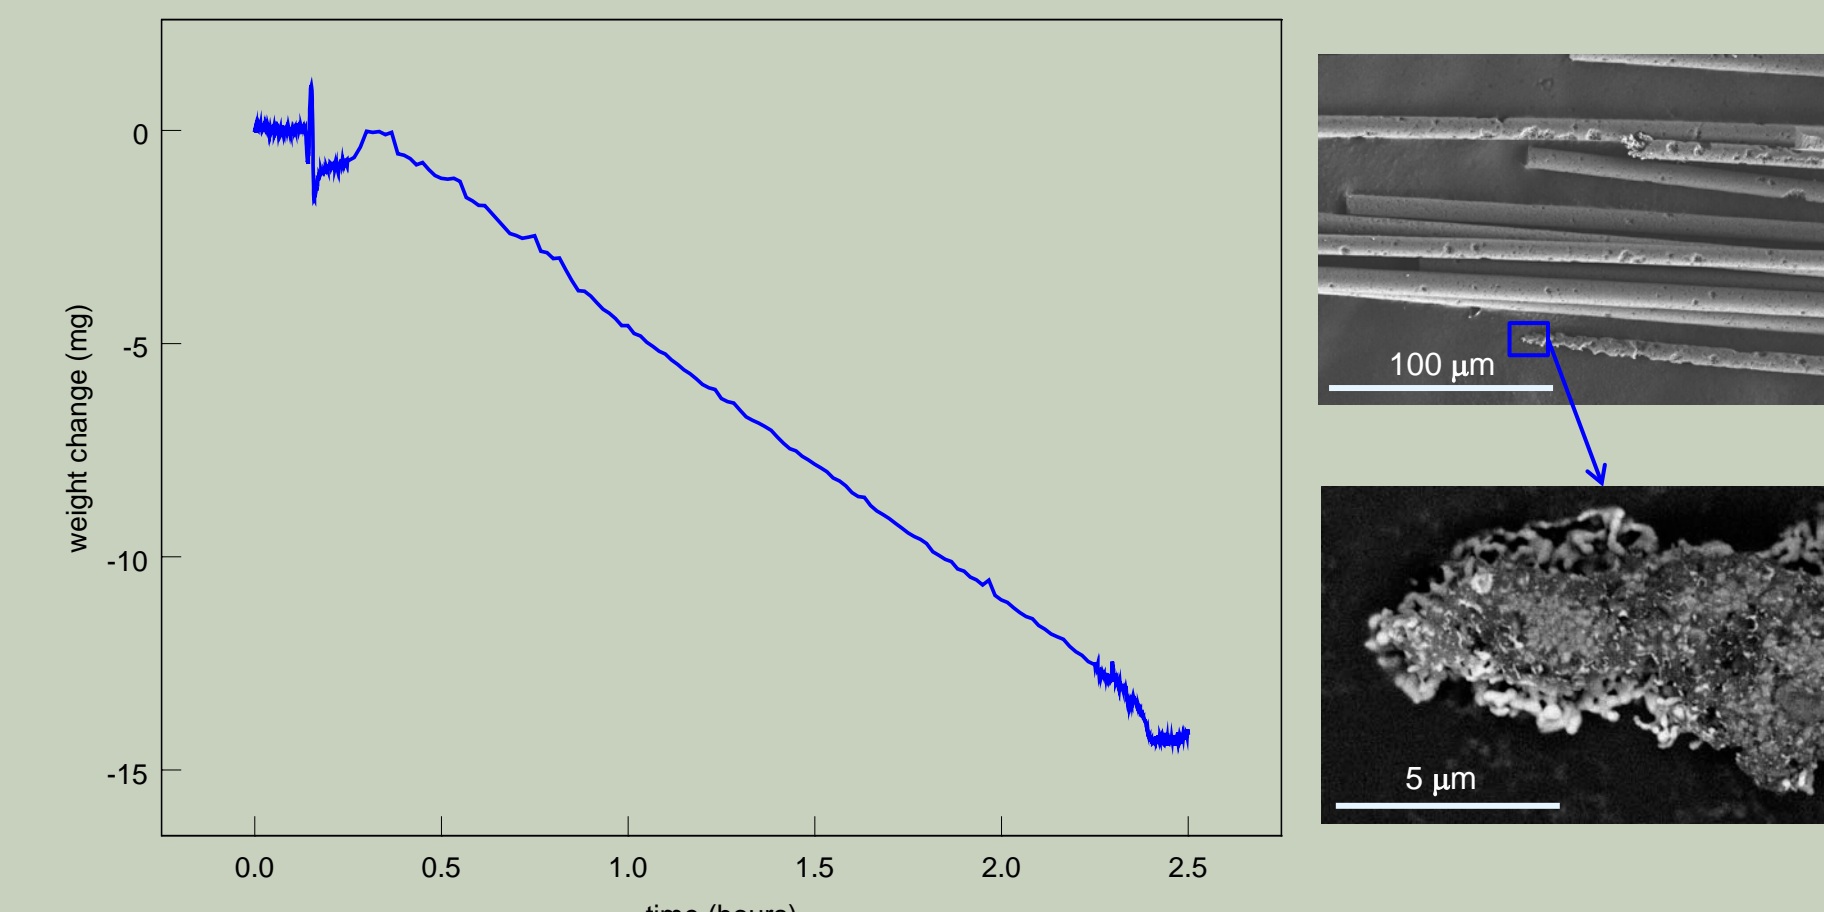
Active oxidation of Sylramic iBN Fibers

1538°C, 0.1% O_2

Rapid weight loss and degradation of fibers observed due to active oxidation of SiC to form SiO(g).

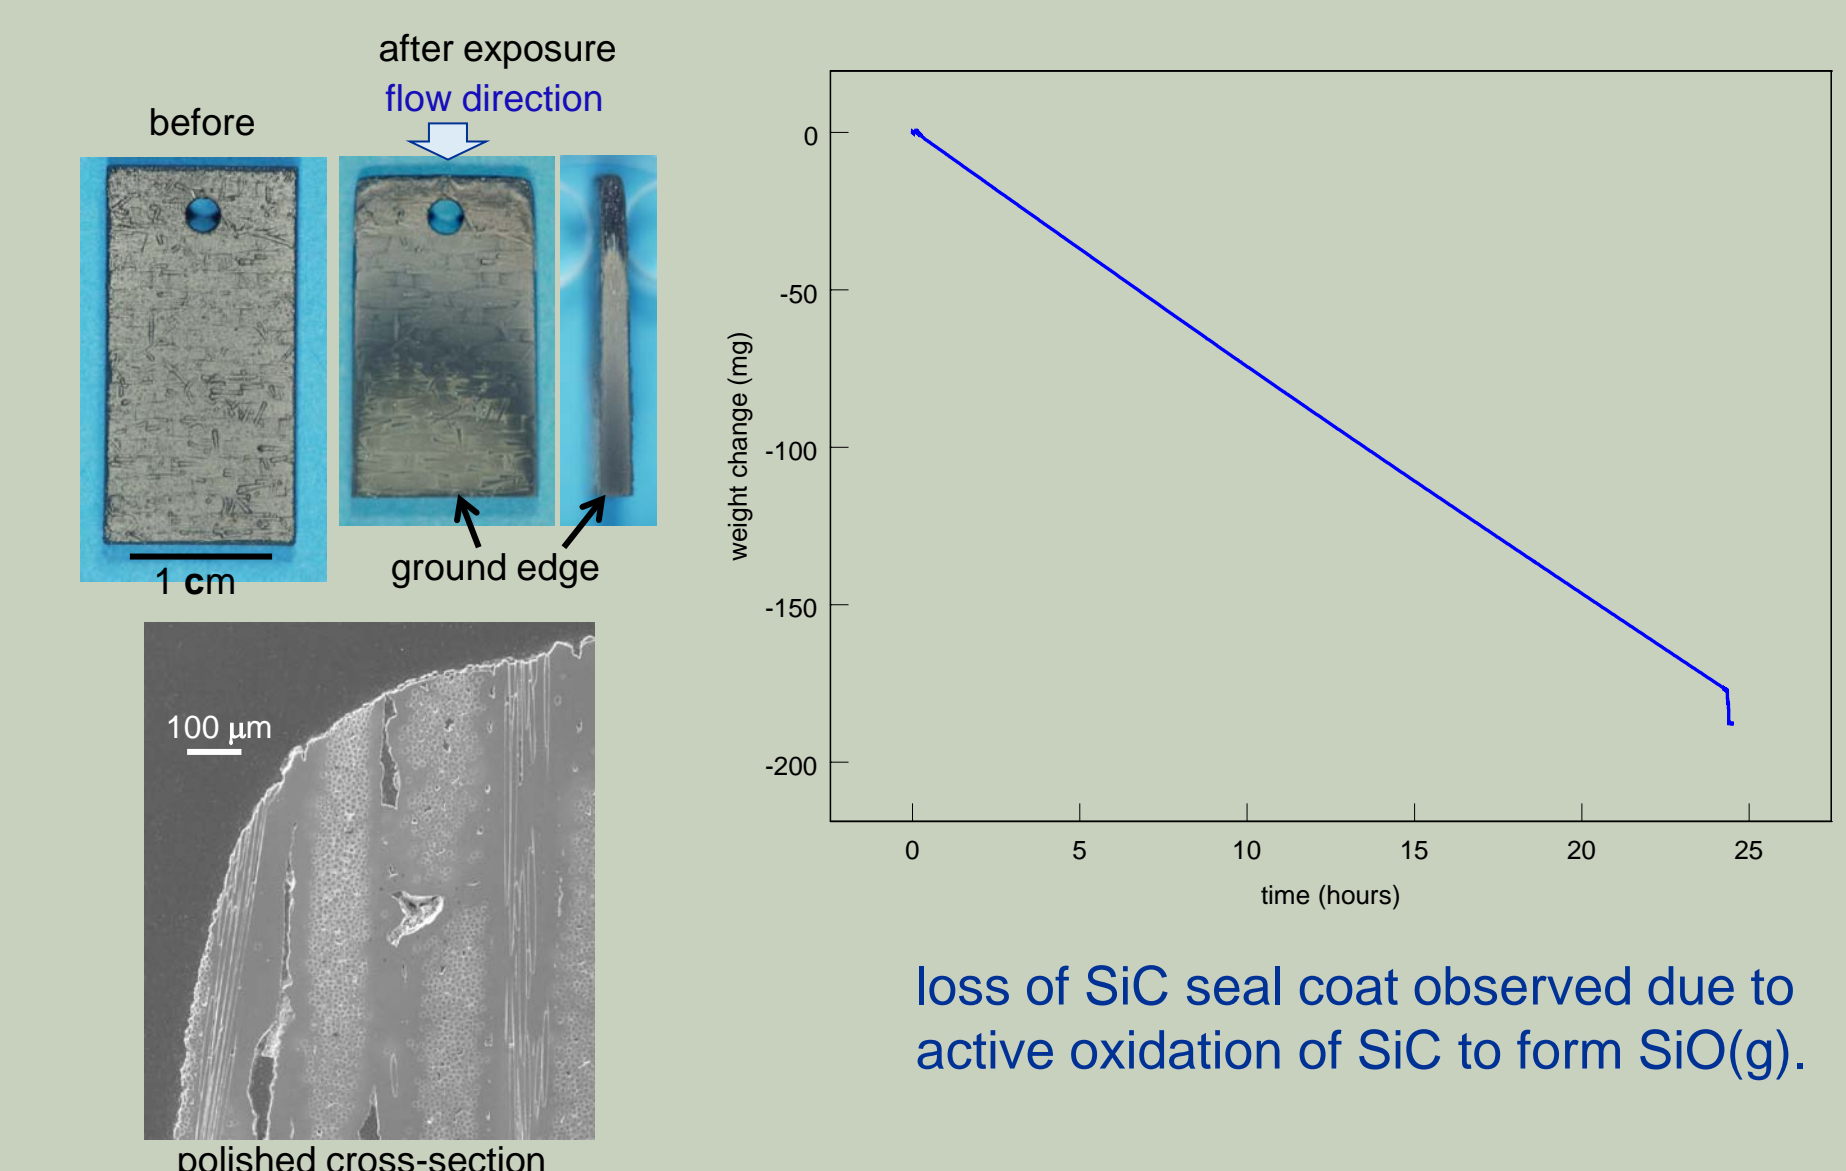
Active oxidation of SiC/BN/SiC coupons

1538°C, 0.1% O_2 , 24h

loss of SiC seal coat observed due to active oxidation of SiC to form SiO(g).
