# NASA's Evolutionary Xenon Thruster (NEXT) Prototype Model 1R (PM1R) Ion Thruster and Propellant Management System Wear Test Results

*Jonathan L. Van Noord and George C. Soulas  
Glenn Research Center, Cleveland, Ohio*

The results of the NEXT wear test are presented. This test was conducted with a 36-cm ion engine (designated PM1R) and an engineering model propellant management system. The thruster operated with beam extraction for a total of 1680 hr and processed 30.5 kg of xenon during the wear test, which included performance testing and some operation with an engineering model power processing unit. A total of 1312 hr was accumulated at full power, 277 hr at low power, and the remainder was at intermediate throttle levels. Overall ion engine performance, which includes thrust, thruster input power, specific impulse, and thrust efficiency, was steady with no indications of performance degradation. The propellant management system performed without incident during the wear test. The ion engine and propellant management system were also inspected following the test with no indication of anomalous hardware degradation from operation.

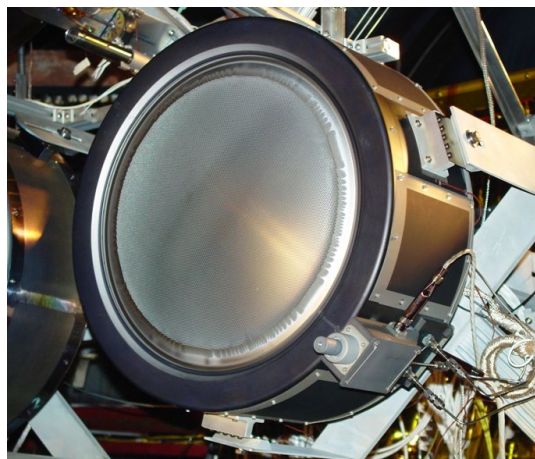
The engineering model thruster (previously labeled prototype model, or PM) used in the wear test is labeled PM1R, and is shown in Figure 1. The PM thruster design is functionally identical to the thruster developed by NASA (Ref. 22). The PM design improved upon the GRC thruster design with emphasis on surviving vibration and thermal environments and on reduced thruster mass. Manufacturability was also improved with this new design. The PM thruster design included innovative coatings to increase emissivity for enhanced thermal margin, more uniform ion optics aperture diameters with much shallower cusps, a 36 cm beam extraction diameter to reduce edge aperture erosion, and graphite discharge cathode keeper to mitigate keeper erosion. The PM1R thruster mass, including the cable harnesses, is 13.5 kg. The thruster input power throttling range is 0.5 to 6.9 kW, with thrust and specific impulse ranges of 26 to 236 mN and 1400 to 4200 s, respectively. A more detailed discussion of the PM thruster design can be found in Reference 23.

Figure 1.—Photograph of the NEXT PM1R ion thruster.

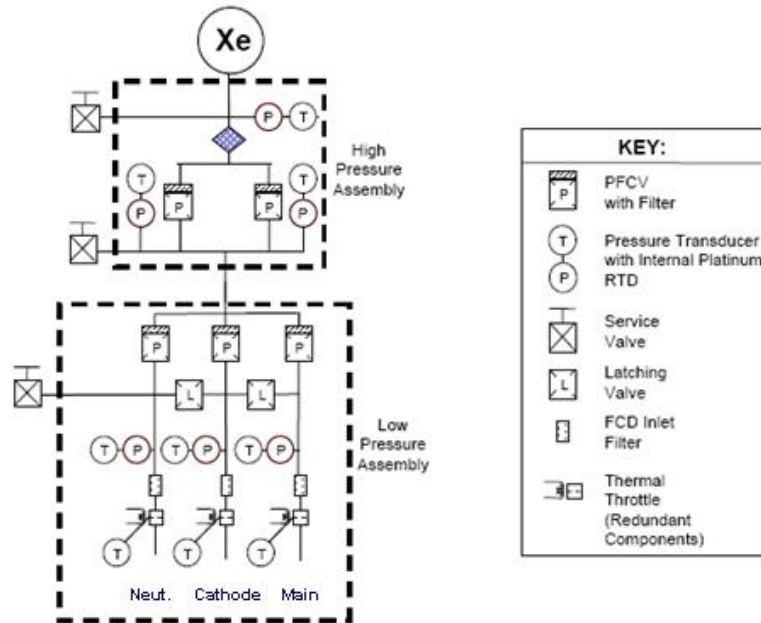
The LPA provides independent flow control to each of the three thruster propellant inputs, labeled neutralizer, cathode, and main in Figure 2. During normal operation, each LPA branch flow rate is set by regulating the pressure to a heated porous plug, or thermal throttle, with a separate PFCV and pressure transducer. Thermal throttle temperature is controlled using a sheathed heater with a temperature sensor for feedback. As with the HPA, thermal throttle inlet pressure is regulated with a PFCV using a pressure transducer for feedback. The thermal throttle temperature is set to 75 °C and thermal throttle inlet pressures range from 77.9 to 189 kPa (11.3 to 27.4 psia) to achieve the commanded flow rates. To support fault tolerance in the design, the LPA design includes latch valves between the three branches of the LPA and the thermal throttle was designed for operation up to 400 °C. The thermal throttle design also incorporated a redundant heater and temperature sensor for fault tolerance.

Figure 2.—Schematic of the NEXT PMS. The xenon tank is not included in the NEXT PMS development.

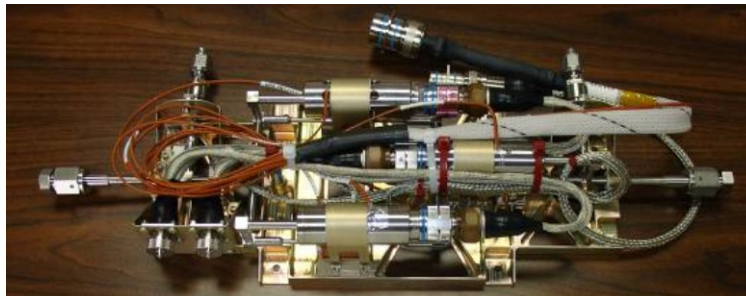
Photographs of the NEXT engineering model HPA and LPA are shown in Figure 3 and Figure 4, respectively. The HPA's redundant PFCV and outlet pressure transducer were mass model mock-ups to reduce assembly cost. The LPA main flow branch can output a xenon flow rate of up to 50 sccm, while the cathode and neutralizer branches can output up to 6 sccm each. The HPA and LPA weigh 1.9 and 3.1 kg, respectively. These masses include each assembly's mounting plate, connectors, and component heaters used for the system integration and wear tests.

Figure 3.—Photograph of engineering model HPA.

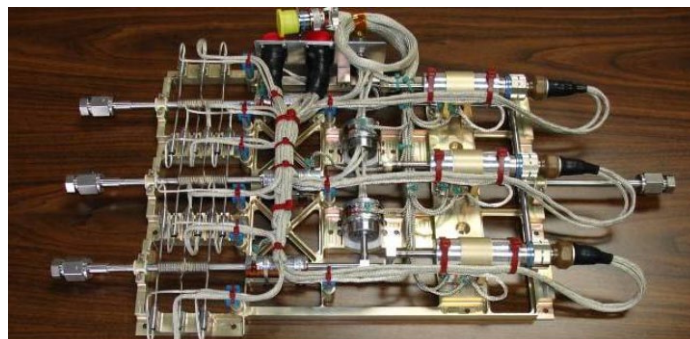
Figure 4.—Photograph of engineering model LPA.

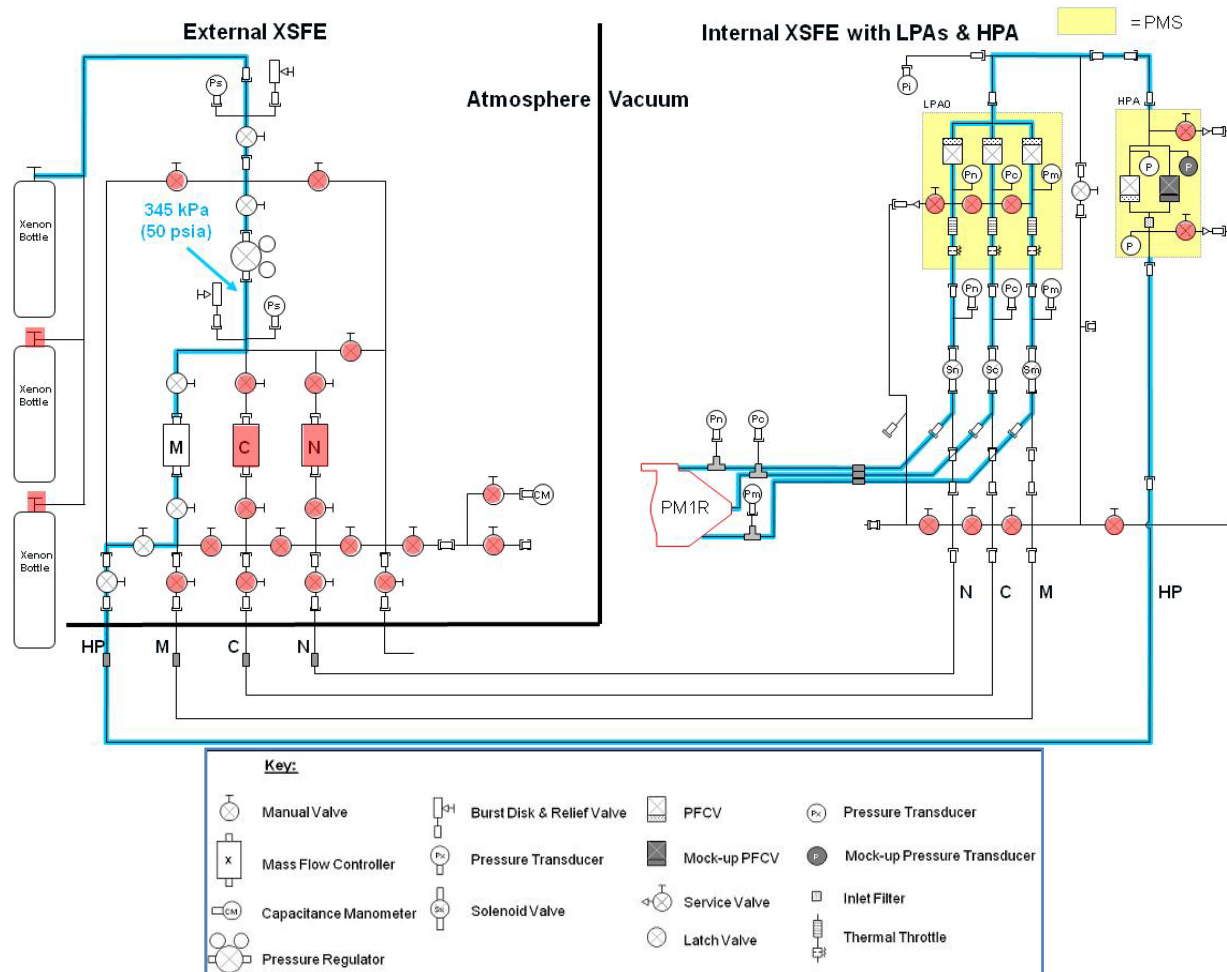
The PMS was integrated into a Xenon Feed System Equipment (XFSE) assembly, as shown on the schematic in Figure 5. The XFSE is ground test-support equipment and, therefore, not a part of the flight system. The XFSE was used to monitor the operation of the PMS during the wear test, but could also provide a secondary thruster gas feed system. The XFSE was divided into two systems. The external XFSE was located on atmospheric side of the vacuum facility. It included mass flow controllers for checking LPA flow rate calibrations and could independently provide flow to the thruster using mass flow controllers, thus allowing for thruster operation using a standard flow regulation configuration. The internal XFSE was located within the vacuum facility. It included manual and solenoid valves that allowed for configuration changes, such as thruster operation with and without the engineering model PMS. The internal XFSE included one HPA and one LPA, which represented a single thruster string PMS, as shown in Figure 5. The internal XFSE and PMS were covered with a polyimide foil for protection against back-sputtered material deposition. A photograph of the test setup is shown in Figure 6.

Figure 5.—Schematic of the PMS and XFSE. The HPA and LPA of the PMS used in this study are highlighted in yellow. Here, “M”, “C”, and “N” are the main, cathode, and neutralizer flow branches, respectively, and “HP” is the high pressure outlet of the internal XFSE that leads to the HPA inlet. The flow path from the xenon bottle is shown in blue. A red-tinted valve indicates that it was closed during the wear test. Although all three xenon bottles were used during the test, only one bottle at a time was opened.

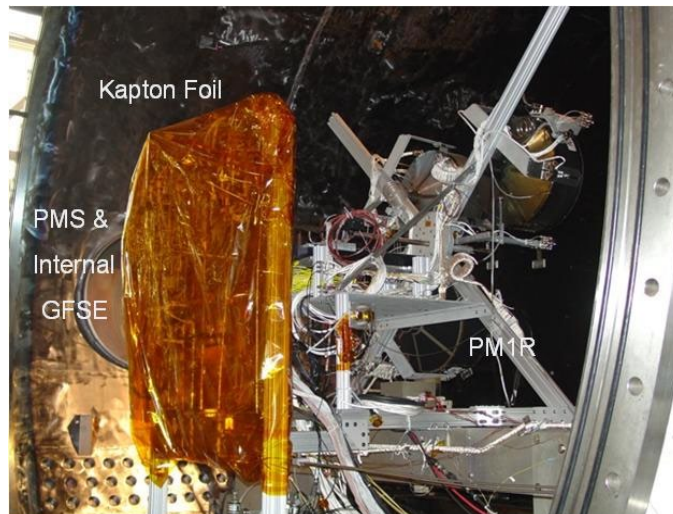
Figure 6.—Photograph of the PMS and internal XFSE mounted in VF5 prior to the start of the wear test. The location of the PM1R thruster is also shown.

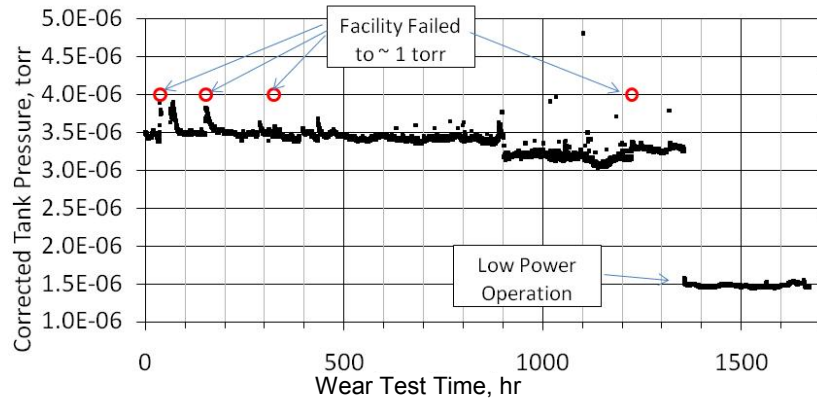
The facility pressure measured near the ion engine and corrected for xenon is shown in Figure 7. The vacuum facility suffered four failures where the background pressure rapidly increased to approximately 1 torr on each occasion. These occurred at hours 41, 156, 327, and 1228 during the wear test. These rapid pressure increases following facility pumping system shutdowns were due to a liquid nitrogen leak near the cryopanel. This leak was not evident in the background pressures since it froze out rapidly on the cryogenically cooled panels. However, when the cryogenic system was interrupted, it led to rapid and high background pressures. After the first failure at 41 hr, the vacuum chamber was opened for an unrelated facility issue. The vacuum chamber was then closed and not opened until the completion of the test. The panel related to the liquid nitrogen leak was removed from the system after the fourth facility failure, with no adverse effects to the tank pressure.

Figure 7.—Vacuum facility pressure corrected for xenon as a function of time.

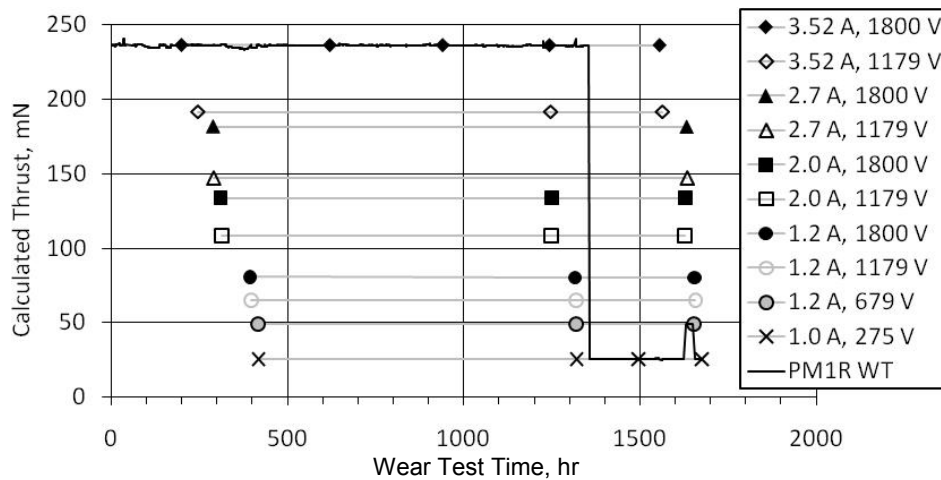
Figure 8.—Calculated thrust as a function of time. The legend lists corresponding beam currents and beam power supply voltages.

Engine performance parameters of interest to mission planners include thrust, input power, specific impulse, and thrust efficiency. Calculated thrust, input power, specific impulse, and thrust efficiency as a function of time are shown in Figure 8 to Figure 11 for operating points throughout the throttle table. Ingested mass flow due to facility background pressure was included in the total mass flow rate to the engine for determining specific impulse and thrust efficiency.

The average calculated thrust, input power, specific impulse, and thrust efficiency at full power were 236 mN, 6.85 kW, 4184 s, and 0.707, respectively, and at low power were 25.5 mN, 0.53 kW, 1425 s, and 0.337, respectively. The beam current variations were as much as +0.07/−0.05 A at full power and +0.02/−0.02 A at low power. The beam current variation was primarily due to a lack of an automated closed loop control of beam current on discharge current. Variations in other parameters were predominantly due to changes in beam current. So, for example, when the beam current decreased, the input power and thrust decreased, leading to decreases in specific impulse and thrust efficiency as well. Regardless, maximum variations throughout the test of these full power values were +5/−3 mN, +0.14/−0.09 kW, +69/−64 s, and +0.011/−0.010, respectively, and for low power +0.4/−0.6 mN, +0.02/−0.01 kW, +40/−32 s, and +0.006/−0.007, respectively. These variations are comparable to previous wear tests (Refs. 19 and 32).

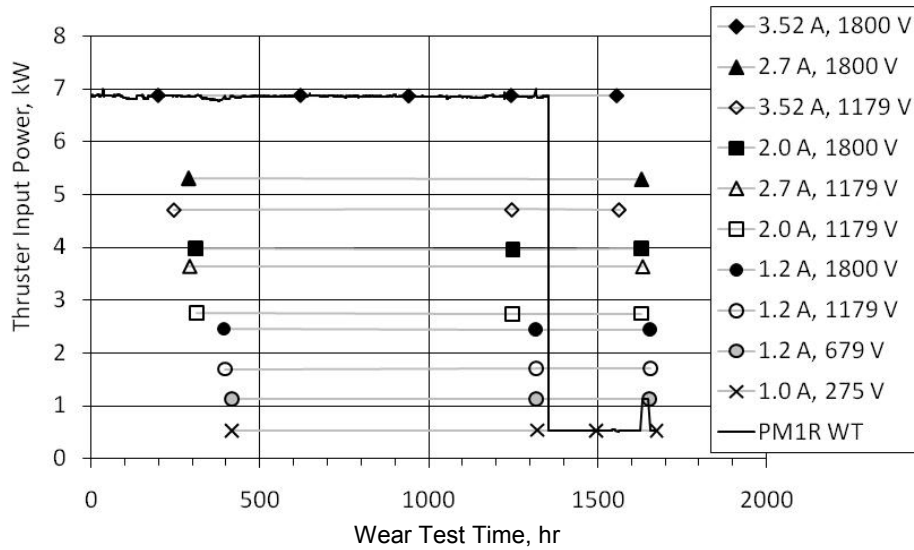
Figure 9.—Thruster input power as a function of time. The legend lists corresponding beam currents and beam power supply voltages.

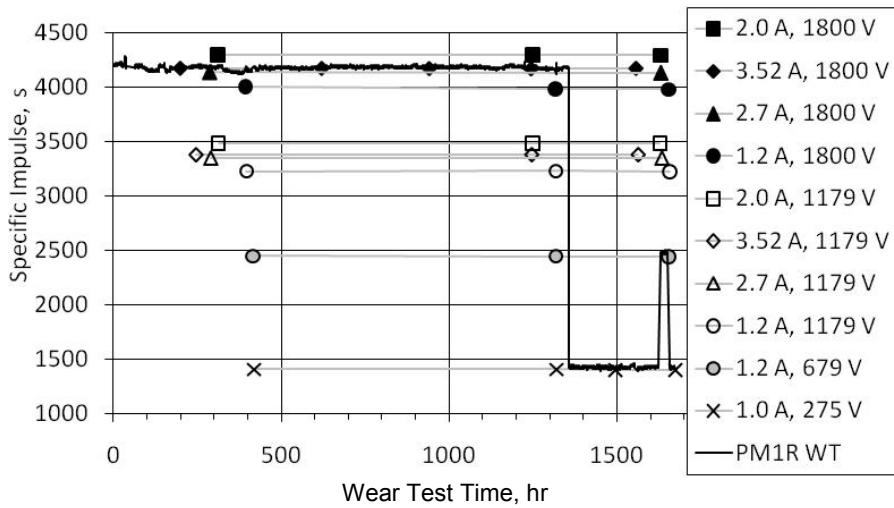
Figure 10.—Specific impulse as a function of time. The legend lists corresponding beam currents and beam power supply voltages.

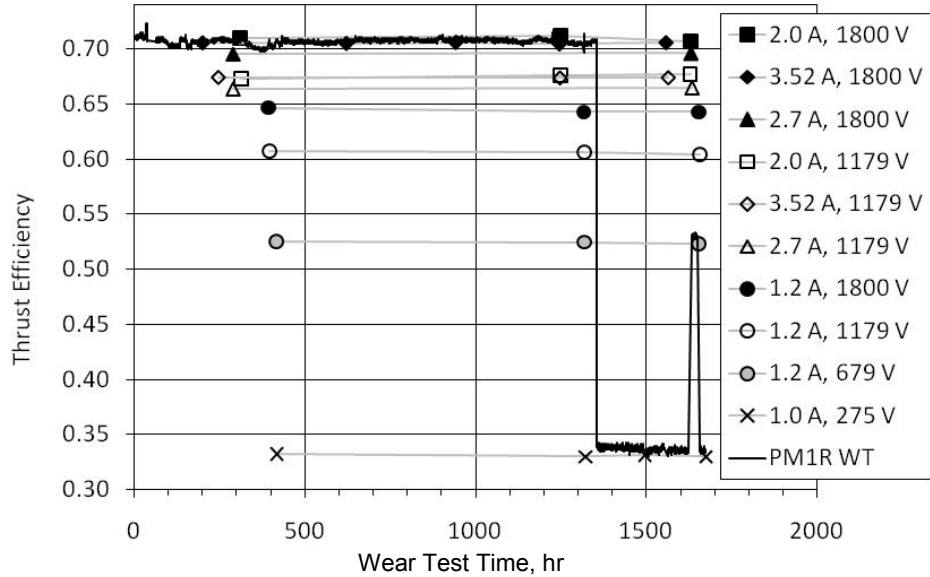
Figure 11.—Thrust efficiency as a function of time. The legend lists corresponding beam currents and beam power supply voltages.

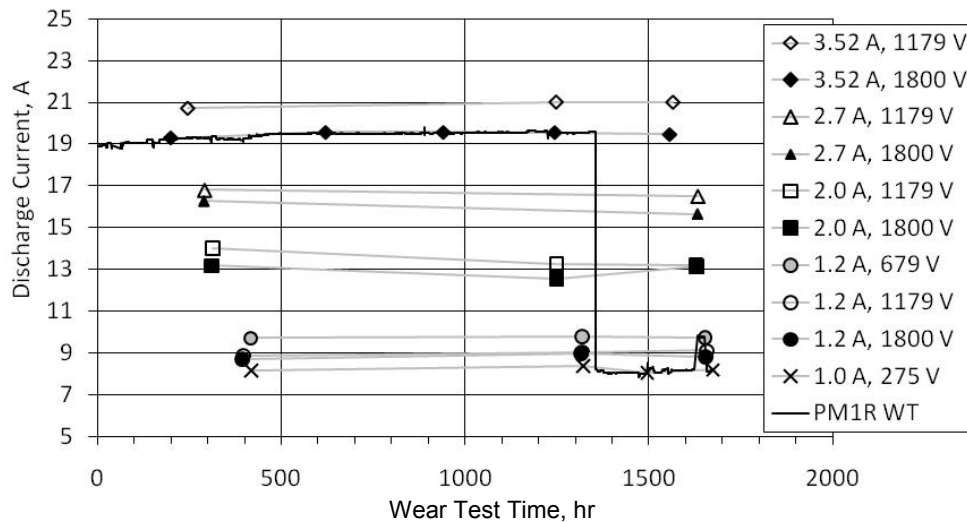
Discharge current and voltage as a function of time are shown in Figures 12 and 13, respectively. Average discharge currents and voltages at full power were 19.4 A and 23.9 V, respectively, and at low power were 8.12 A and 26.0 V, respectively. The discharge current and particularly the discharge voltage exhibited slightly larger variations than previous NEXT wear tests (Refs. 19 and 32). Previous NEXT wear tests reported that the discharge current and voltage variations were generally  $\pm 3$  percent, and the variations for the PM1R wear test are closer to  $\pm 3.5$  percent at full power (Refs. 19 and 32). At low power, the variations are typically within  $\pm 3$  percent. Some of the larger variations were due differences in thruster startup procedures. Ion beam extraction occurred 15 min following discharge ignition for this wear test. In previous wear tests, the beam extraction was at least 1 hr after ignition and yielded a warmer thruster closer to thermal steady state conditions.

As with other wear tests, the discharge current trended higher with time. The current increased about 0.7 A in the first 500 hr of testing and then leveled off. The discharge voltage trended downward in the first few hundred hours of testing. During that timeframe, the voltage decreased gradually from 24.6 V down to 24.0 V three times. In contrast, after the first 400 hr, the voltage periodically dropped abruptly about 0.5 V, which was frequently associated with a thruster shut down where it had sufficient time to cool, only to rise back over the next 100 hr. These voltage drops were seen early in the LDT, but with a magnitude of 0.3 V (Ref. 32). It is uncertain if the NSTAR thruster had the same type of variations, but it did exhibit short-term voltage variations of  $\pm 0.6$  V (Ref. 6).

Figure 12.—Discharge current as a function of time. The legend lists corresponding beam currents and beam power supply voltages.

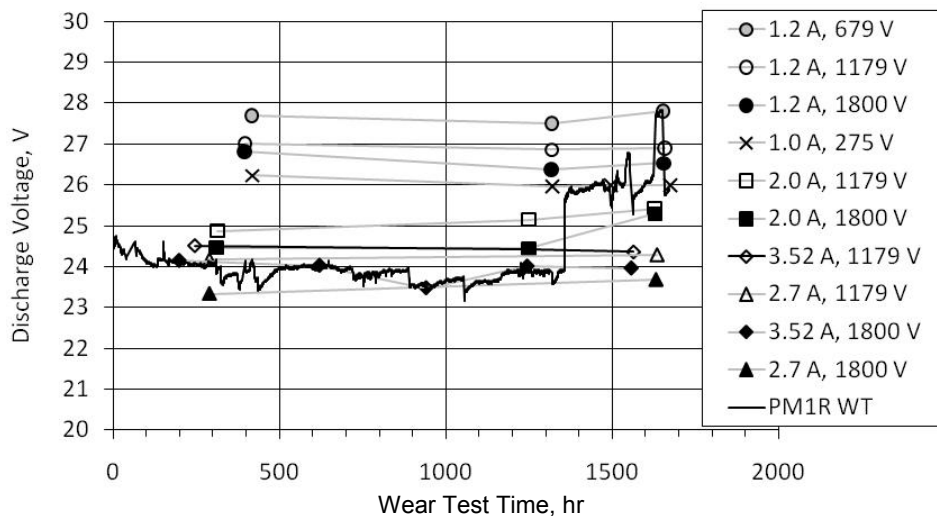
Figure 13.—Discharge voltage as a function of time. The legend lists corresponding beam currents and beam power supply voltages.

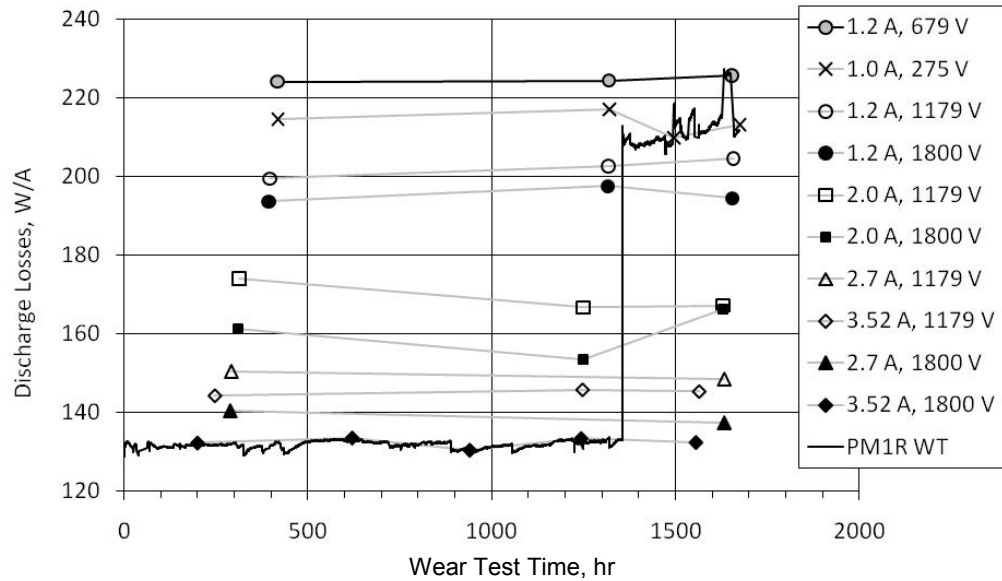
The discharge losses with time are shown in Figure 14. At full power, the discharge losses generally increased 1 W/A from the beginning of test to end of test, with periodic variations between 129 W/A to 133 W/A (i.e. a bandwidth of 4 W/A or 3 percent), with the discharge losses dropping rapidly at times and then slowly increasing. Prior to the wear test, the discharge losses had increased quickly after the first performance acceptance testing of PM1R. The discharge losses initially tested on PM1R were 126 W/A, but after about 60 hr of operation on a new cathode, the losses increased to 129 W/A, which is what they were at the beginning of the wear test. After a few hundred hours into the wear test, changes in discharge losses strongly tracked changes in discharge voltages. Closer examination of the first two thousand hours of the LDT reveals that there were similar, but smaller, fluctuations in discharge losses from 123 to 125 W/A (i.e., a bandwidth of 2 W/A or 2 percent) along with a slight trend from 122 to 125 W/A at the end of 2,000 hr (Refs. 18 and 32).

While these changes are small, it is speculated that some of these variations could be due to changes in cathode thermal losses. The hollow cathode contains a barium impregnated porous cylindrical insert inside of a cylindrical tube. As the cathode operates, barium is released from the insert and migrates out of the insert and into the gap between the insert and the tube. While initially the heat loss out of the insert to the tube is primarily through radiation heat transfer, the barium provides a thermally conductive path out of the insert and into the tube, which increases the losses. Thermal modeling of the cathode has indicated an increase of 10+ W can occur from the increased thermally conductive losses, which is of the same order of magnitude of the discharge loss variations seen in the NEXT thruster. When the thruster is shut off and the cathode cools, the gap expands and enables a break in the barium conductive path, only to be reestablished over time during further operation. Only a small amount of barium would be needed to affect the thermal conduction away from the insert. This mechanism would explain why the ion engine can rapidly become more efficient following ignition and then take 50 to 100 hr to settle into higher discharge losses. These discharge loss step changes occurred not only at times of cold cathode restarts, but also at times during operation. It should also be noted that after several thousand hours, the variations were no longer seen in the LDT, which could correspond to sufficient barium in the gap causing it to maintain thermal contact.

Figure 14.—Discharge losses as a function of time. The legend lists corresponding beam currents and beam power supply voltages.

This phenomenon could also explain behavior causing the test shutdown after 437.5 hr of operation. The shutdown was initiated by the DACS when the beam current immediately dropped, while the thruster performance increased. Prior to this event, the thruster was operating with a beam current of 3.5 A, a discharge current of 19.4 A, and a discharge voltage of 23.7 V, which corresponds to 131 W/A in discharge losses. The recording rate was once a second, and the thruster shifted performance in 1 sec. The thruster shutdown because the low beam current, 3.3 A, triggered a limit violation in the DACS software. The discharge current remained unchanged since it was a controlled parameter, but the discharge voltage dropped to 22.0 V, yielding a discharge loss of 129 W/A. The thruster immediately became more efficient, possibly due to the barium breaking contact and lessening the thermal loss out of the insert. Following the test interruption, the thruster impedance was checked and found to be nominal. After the thruster was restarted, it initially operated at 129.2 W/A of discharge losses. Over the next 90 hr, the discharge losses returned to 133 W/A.

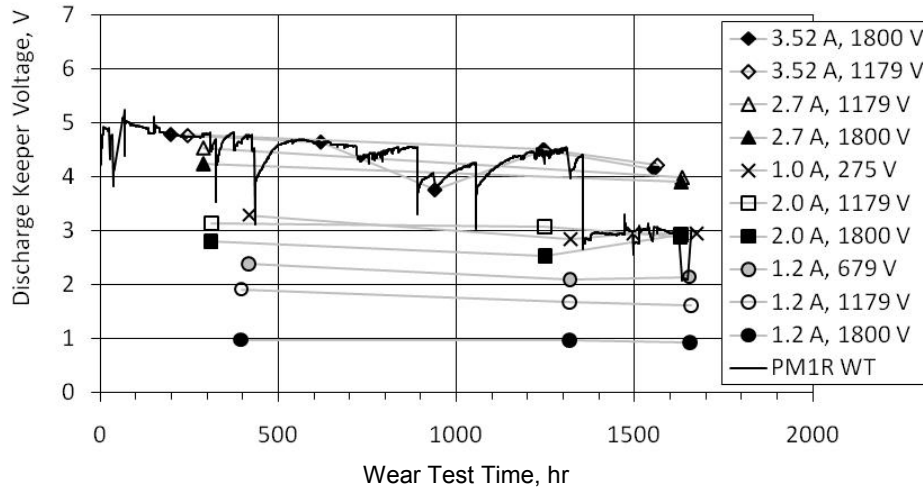
The discharge keeper voltage is shown in Figure 15. The discharge keeper voltage trended downward over the test duration from 5.0 to 4.5 V, with a shorter term variations of 0.8 to 1.5 V. Several of the downward “spikes” were associated with engine restarts. The LDT showed an initial downward trend of 0.3 V with similar short term variations of 0.5 to 1.0 V (Ref. 35). The discharge keeper voltages exhibited similar behavior between the two tests.

Figure 15.—Discharge keeper voltage as a function of time. The legend lists corresponding beam currents and beam power supply voltages.

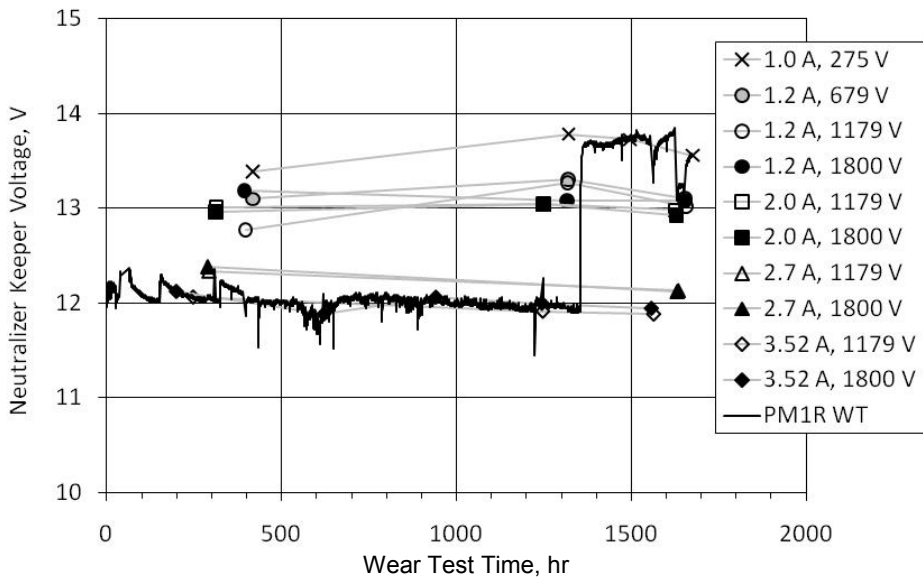
Figure 16.—Neutralizer keeper voltage as a function of time. The legend lists corresponding beam currents and beam power supply voltages.

Neutralizer keeper voltage as a function of time is shown in Figure 16. The average neutralizer keeper voltage at full power was 12.0 V and at low power was 13.7 V. This is different than previous NEXT tests (Refs. 19 and 32), because the cathode-to-keeper gap was changed on the PM thrusters to allow additional spot-to-plume margin (Ref. 24). The maximum variations at full power were +0.9/−0.6 V and +0.2/−0.5 V at low power. The neutralizer keeper voltage followed a similar trend as the discharge voltage during the first 200 hr by starting at a higher voltage and decreasing. This is likely due to the facility failures and the resulting exposure of the cathodes to the higher pressures. The neutralizer keeper voltages exhibited voltage “spikes” corresponding to engine restarts, which are similar to previous NEXT and NSTAR neutralizer behavior (Refs. 6, 8, 18, 19, and 33). The increased bandwidth in voltages after 500 hr of operation also occurred during periods of increased engine recycling. During engine recycling, the neutralizer cathode emission current is changing from 6.5 to 3.0 A, which will change the neutralizer keeper voltage.

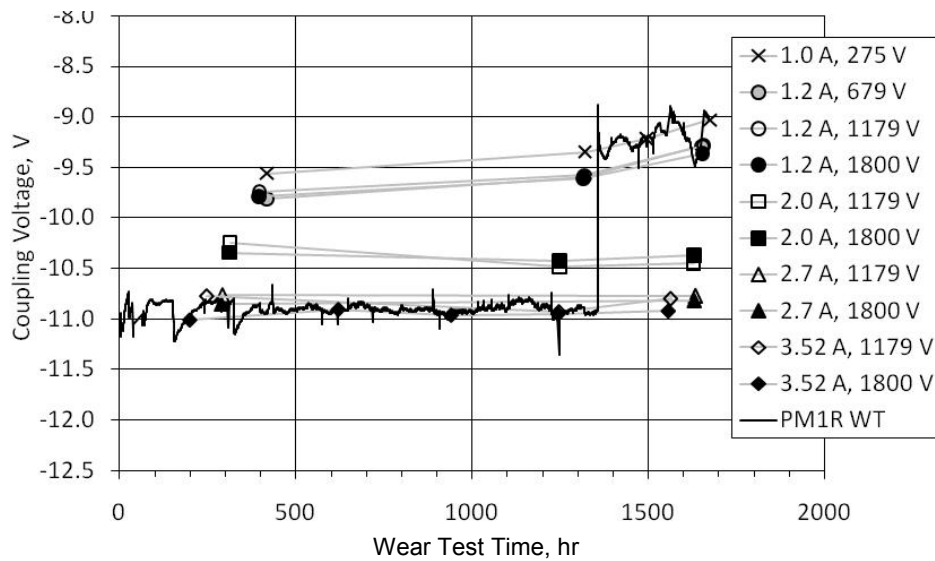
Figure 17.—Coupling voltage as a function of time. The legend lists corresponding beam currents and beam power supply voltages.

Coupling voltage, which is the measure of neutralizer cathode potential relative to vacuum facility ground, is plotted in Figure 17 as a function of time. The mean coupling voltage at full power was  $-10.9 \text{ V} \pm 0.2 / -0.5 \text{ V}$  and at low power was  $-9.2 \text{ V} \pm 0.3 \text{ V}$ , both of which are similar to previous tests. The neutralizer keeper and coupling voltages indicate no neutralizer performance degradation.

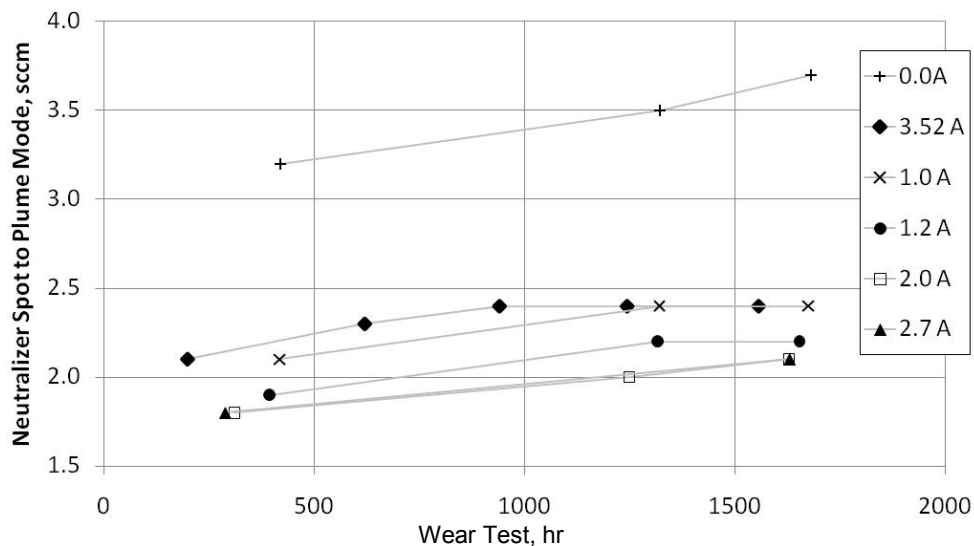
Figure 18.—Transition to plume mode neutralizer flow as a function of time at various beam currents.

was greater than  $5 \times 10^{-4}$  sccm on xenon. No leak was found prior to the wear test. This leak adds uncertainty to the measurements and will be further quantified after the PM1R is operated again with no leaks in the line. Even though a leak was found in the PM1R wear test, the changes in flows are consistent with that of the LDT, which increased by 0.3 sccm during the first 2000 hr.

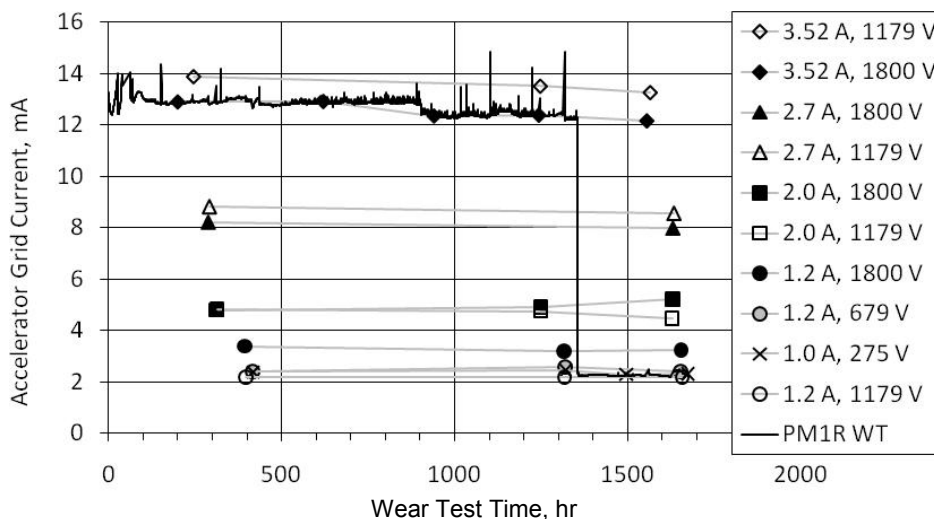
Accelerator currents as a function of time from performance data covering the throttle table are plotted in Figure 19. The “spikes” in the accelerator current at full power correlate with engine recycles. The mean value at full power was 12.7 mA. The slight drop in current at ~900 hr corresponded to a drop in facility pressure as can be seen in Figure 7. The higher current at the beginning of the test also corresponded to a higher facility pressure. The mean value of the accelerator current at low power was 2.2 mA. Other than variations due to recycles or facility pressure, the accelerator current showed negligible variation with time. These results are consistent with the previous NEXT wear tests (Refs. 19 and 20), and showed less initial variation than NSTAR engine accelerator currents that started higher than normal and required up to 1500 hr to decrease to nominal values (Refs. 6 and 33).

Figure 19.—Accelerator current as a function of time. The legend lists corresponding beam currents and power supply voltages.

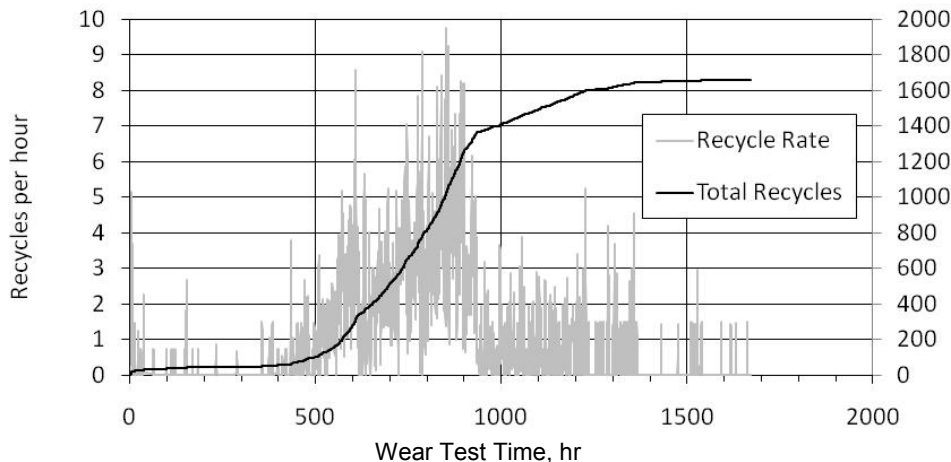
Total engine recycles and recycle rate as a function of time are plotted in Figure 20. In the first 400 hr of testing the recycle rate was quite low and generally below 1 recycle/hr. From 400 to 900 hr of testing, the recycle rate dramatically rose to 9.5 recycles/hr. During this timeframe, high potential impedance measurements between the grids indicated that the recycles were likely due to debris between the grids. The debris source was likely the excessive amount of backsputter material from the stainless steel chamber walls. Post-test inspections showed that surfaces that were grit-blasted effectively contained the backspattered material, but surfaces like the PM1R front mask, which was not grit-blasted, spalled easily. The spalled material likely fell into the grids and into the intergrid region through an accelerator aperture during the test. The material appeared to clear after hour 900 when the recycle rate dropped to about 2 recycles/hr.

Figure 20.—Total recycles and recycle rate as a function of time. Recycle rate is the slope of the total recycles versus time over a 15 hr period.

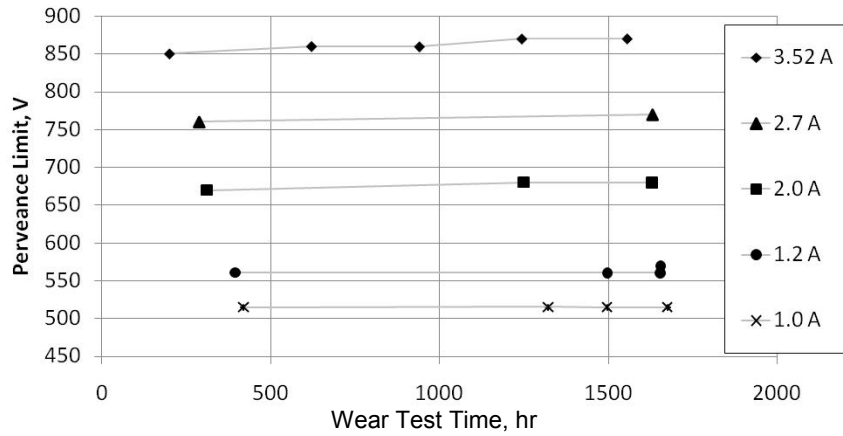
Perveance limits and electron backstreaming limits throughout the wear test are shown in Figure 21 and Figure 22, respectively. Perveance limits were determined from plots of accelerator currents as a function of total voltage where the slope was  $-0.02 \text{ mA/V}$ . Here, the total voltage is defined as the sum of the beam power supply voltage and the absolute value of the accelerator voltage. Electron backstreaming was determined by lowering the magnitude of the accelerator grid voltage until the indicated beam power supply current increased by 1 mA due to backstreaming electrons.

Figure 21.—Perveance limit as a function of time. The legend lists corresponding beam currents.

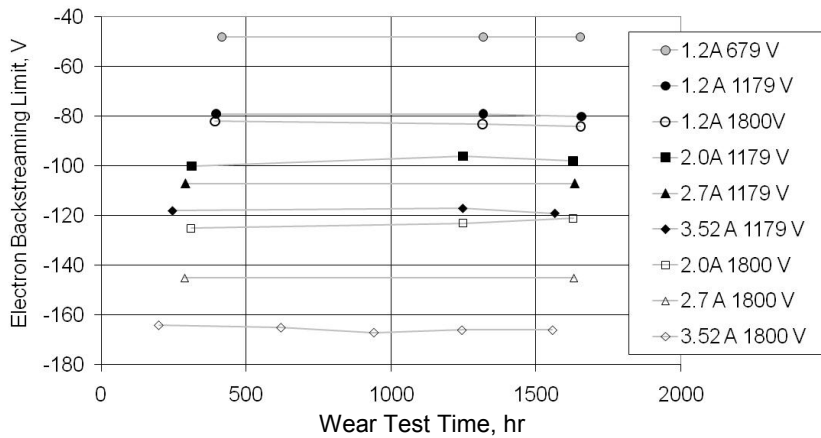
The electron backstreaming limits showed negligible change throughout the wear test. This is consistent with LDT, with the optics of the same fidelity and construction as PM1R, where negligible changes were seen in the first few thousand hours (Ref. 35).

Figure 22.—Electron backstreaming as a function of time. The legend lists corresponding beam currents and beam power supply voltages.

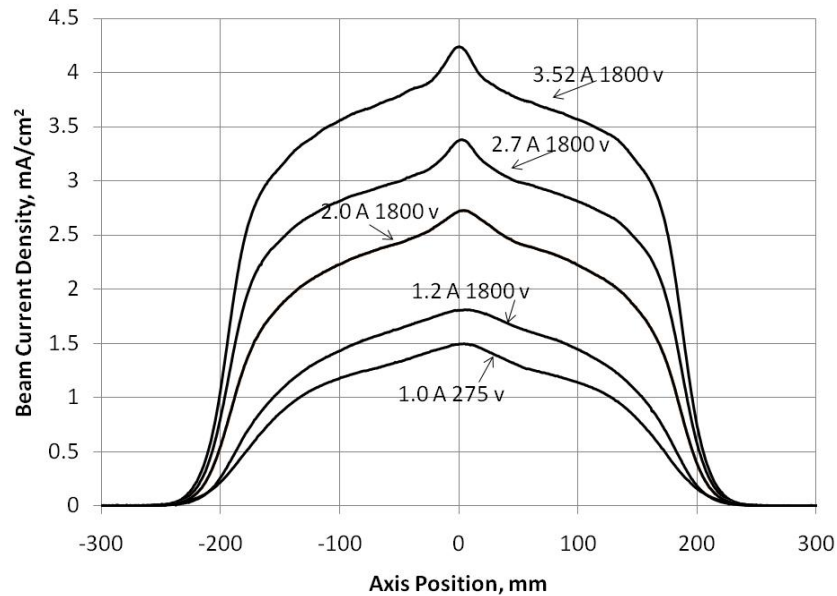
Post-test radial beam current density profiles are shown in Figure 23 taken at 45 mm downstream of the ion optics. Beam current density profiles did not change significantly during the wear test. Variations in peak beam current density as a function of time at full power are shown in Figure 24. Full power peak beam current densities at this axial location varied between  $4.22$  to  $4.31 \text{ mA/cm}^2$ . The resulting ion engine beam flatness parameter (i.e. the ratio of average-to-peak ion current density) ranged from 0.81 to 0.83 throughout the wear test at full power. The beam density profiles also indicate no degradation in the performance of ion optics or the discharge chamber.

Figure 23.—End-of-test radial beam current density profiles. All densities were measured 45 mm downstream of the ion optics center.

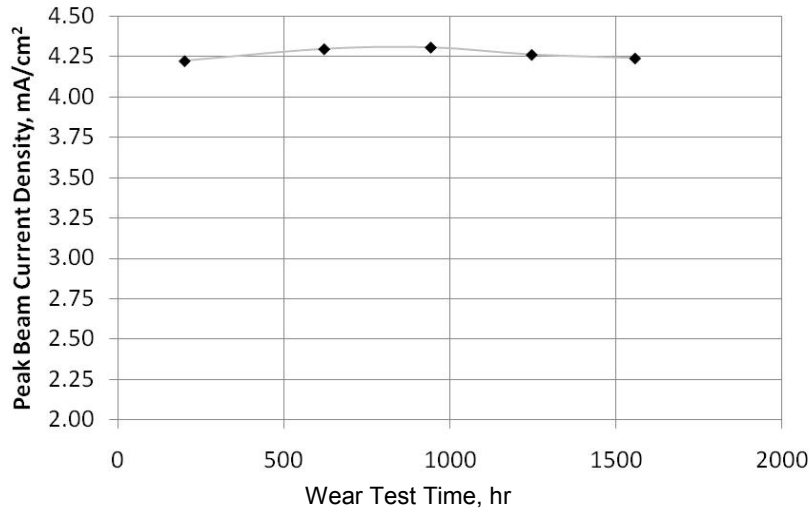
Figure 24.—Peak beam current density as a function of time at full power. All densities were measured 45 mm downstream of the ion optics' center.

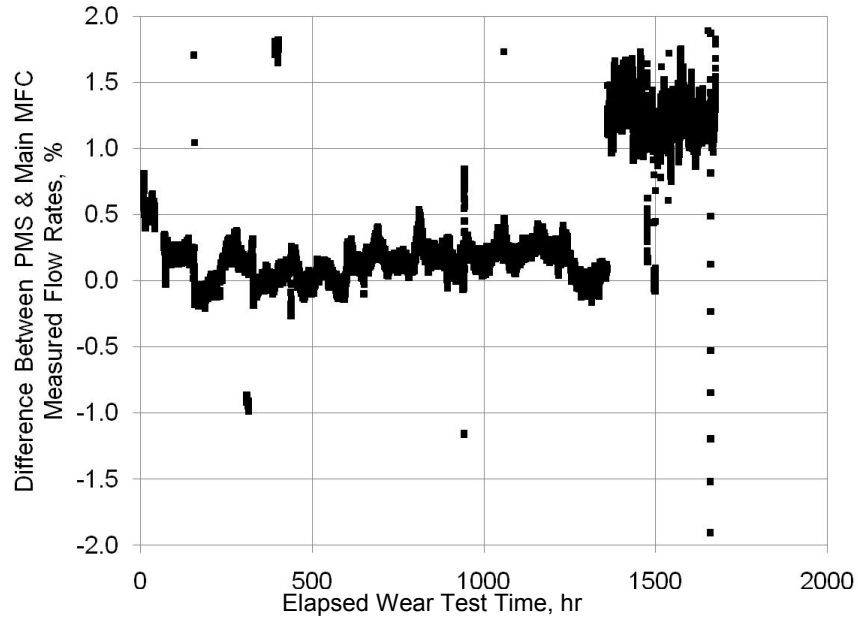
Figure 25.—Percentage difference between the total PMS flow rate and the main mass flow meter measurement as a function of wear test time.

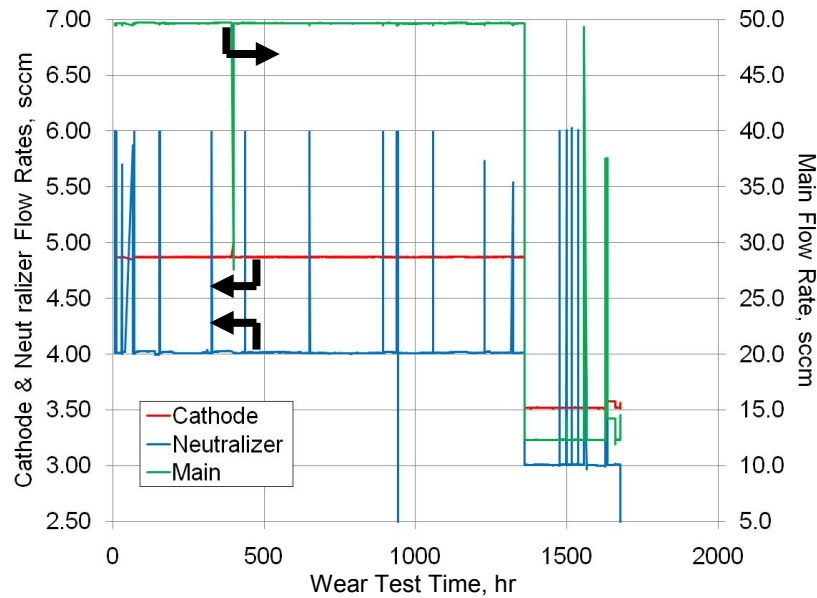
Figure 26.—Mass flow rates measured by the PMS during the wear test. All flow spikes were due to wear test restarts or test interruptions.

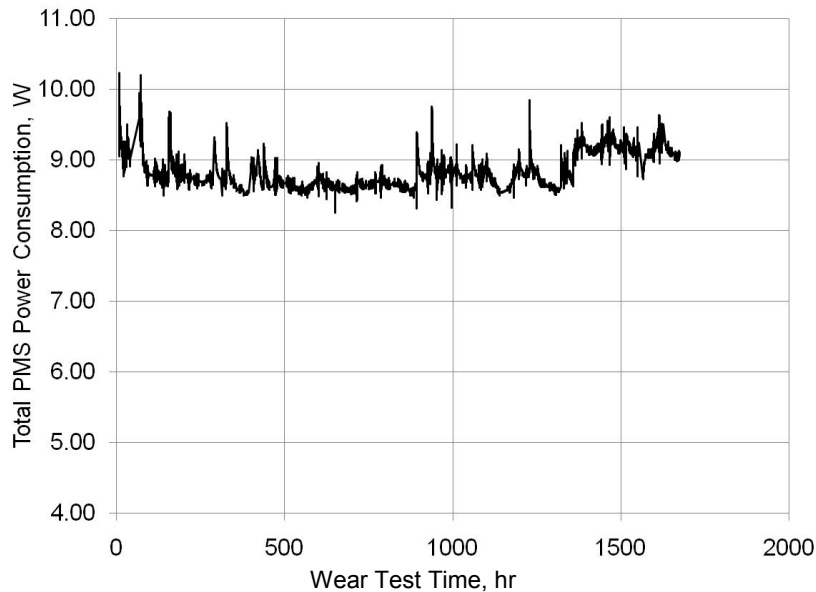
Propellant management system power consumption during steady state operation is plotted as a function of wear test time on Figure 27. Because pressure transducer power was not monitored during the test, average measured pressure transducer powers were used from Reference 27. Total PMS power consumption was within 8.5 to 10.2 W throughout the wear test during steady state operation. The thermal throttles consumed 42 to 46 percent of the total power, while the proportional flow control valves

consumed 28 to 31 percent and the pressure transducers consumed 26 to 27 percent. Total PMS power consumption throughout the wear test was lower than the project-required maximum of 20 W.

Figure 27.—Total PMS power consumption as a function of wear test time. Pressure transducer power was taken from Reference 27.

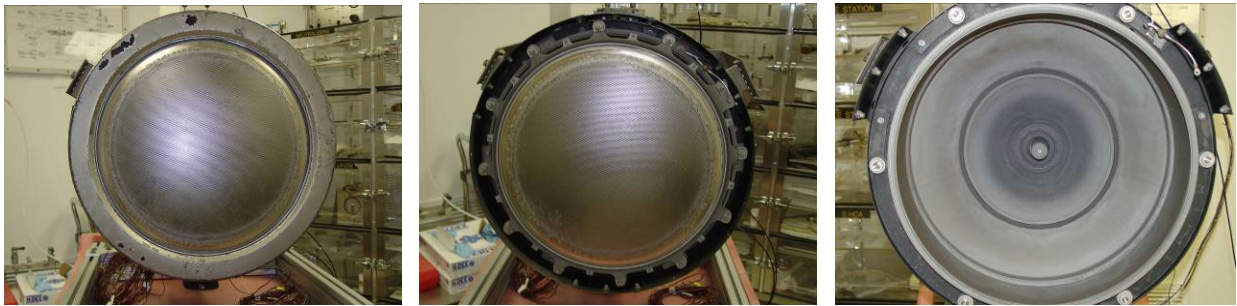
Figure 28.—Thruster PM1R in various states of assembly following the wear test.

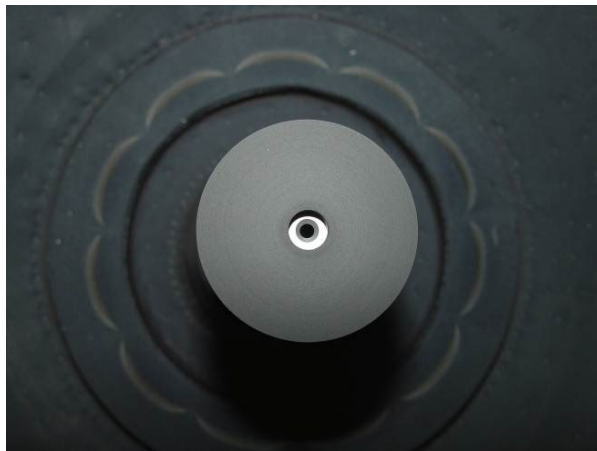
Figure 29.—Discharge cathode and keeper orifice following the wear test.

The change in keeper and cathode orifice diameters over the course of the test was within the measurement uncertainty of 0.025 mm. The electrode gap was measured post test and was found to be within specifications. High voltage impedance checks immediately after the wear test and during the inspection phase indicated no evidence of flakes bridging the cathode-keeper gap.

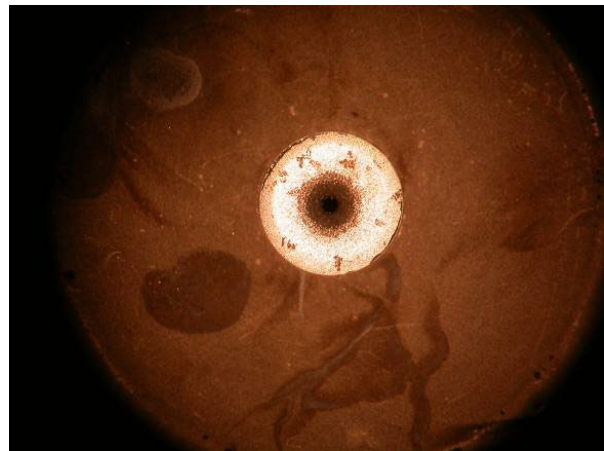
The NCA is comprised of the hollow cathode, the cathode heater, and the keeper electrode. Visual and photographic inspection indicated the NCA was in good condition after the wear test. Both orifice plates showed discolorations over their surfaces. Figure 30 shows that there is some slight evidence of these discolorations before and after the wear test. The cathode orifice plate has some ion texturing of the surface, particularly in the chamfer region.

Figure 30.—Neutralizer cathode and keeper orifice plate following the wear test.

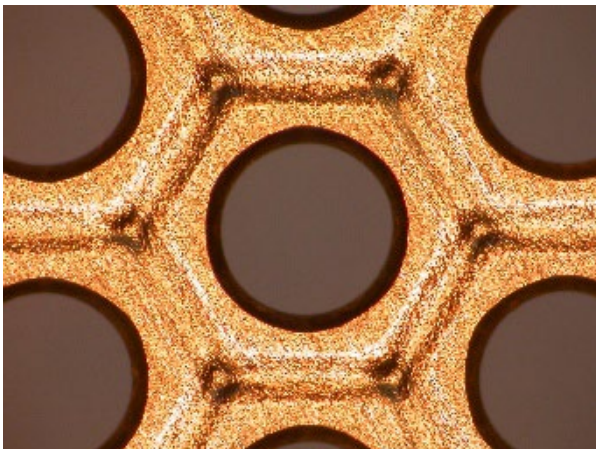
Figure 31.—Thruster EM1 accelerator center aperture after 2000 hr test.

Pin gages were used to measure the aperture diameters of the screen grid and the accelerator grid. From the initial assembly of the thruster to the post test inspection there was no measured change in the pin gauge measurements within the accuracy of the measurements. Changes in gap are also within the accuracy of the measurements. This is consistent with the ion optics of the LDT where the cold grid gap at the center has been not been changing (Ref. 20). This finding is further evidence that the problem of the changing grid gap in the NSTAR design has been resolved. The lack of changes in the grid gap and the aperture diameter also supports the observation that there has been negligible change in electron backstreaming. Figures 31, 32, and 33 show the accelerator grid center aperture after the initial 2000-hr test of EM1 (Ref. 19), the LDT after 2176 hr (Ref. 35), and after the PM1R thruster test with 2098 hr of testing, respectively. The 2000-hr test grid clearly shows evidence of the usual pit and groove erosion from charge exchange ions. The image from the LDT does not clearly show evidence of pit erosion at the hexagon vertices. The image from the subject wear test shows accelerator grid groove erosion, but there is very little evidence of pits. Laser profilometry measurements of the center aperture are shown in Figure 34. These measurements indicate a groove depth of 3.1 percent of the accelerator thickness and a pit depth of 5.6 percent of the accelerator thickness. Figure 35 shows the accelerator grid outer radius apertures, which are distorted by “erosion ears.” The aperture “ears” are expected (Refs. 35 and 36). Erosion of the “ears” is complete after a few hundred hours, and this effect should not compromise performance or grid lifetime. The basic observations of the ion optics’ dimensions and erosion patterns do not differ significantly from the results of the ongoing NEXT LDT that has operated for over 24,400 hr (Refs. 20 and 21).

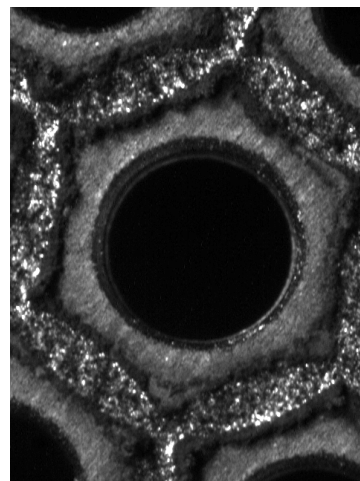
Figure 32.—Thruster EM3 accelerator center aperture at 2176 hr in LDT.

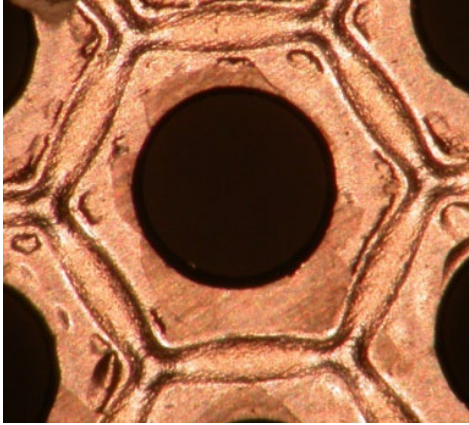
Figure 33.—Thruster PM1R accelerator center aperture after 2098 hr.

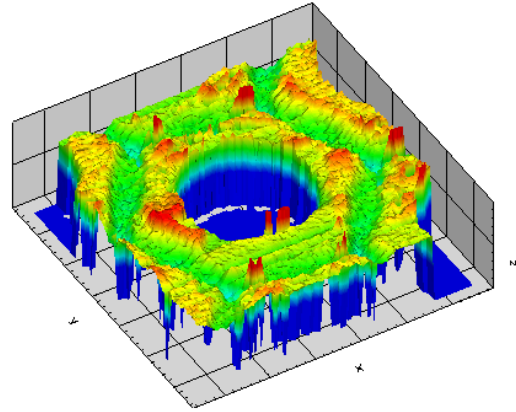
Figure 34.—Profilometry image of PM1R center aperture after the wear test.

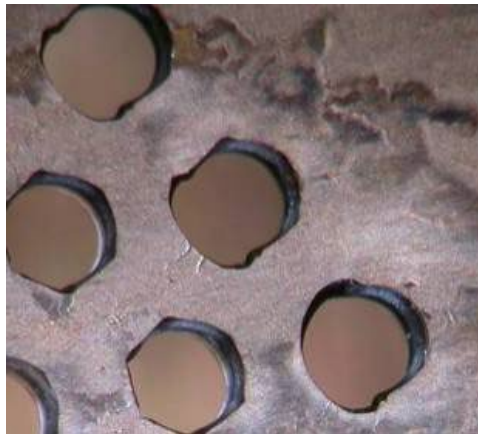
Figure 35.—Thruster PM1R accelerator grid outer apertures after the wear test.
