Composite Overwrapped Pressure Vessels (COPV) Stress Rupture Test Part 2

Rick Russell
Materials and Processes Engineer
Materials Science Division, NE-L4
Kennedy Space Center, Florida

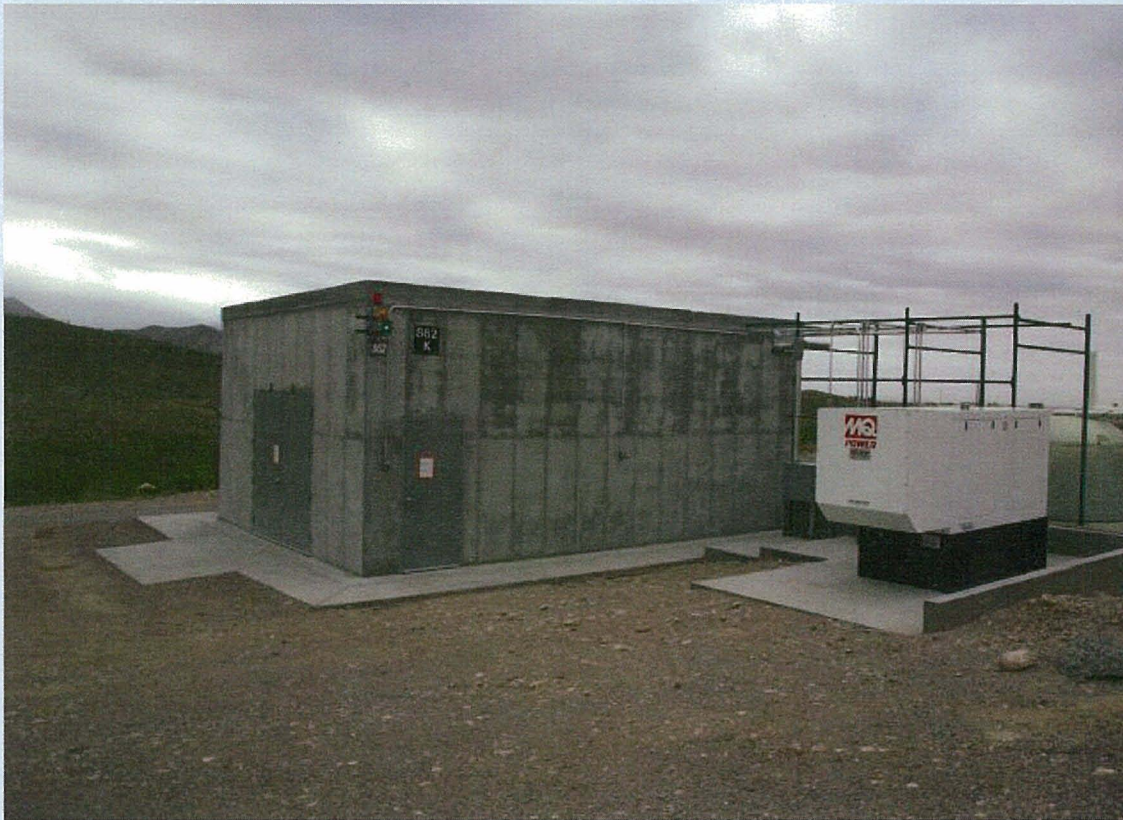
WSTF Test Cell, thermally controlled test cell with generator back-up. Precludes thermal control concerns akin to those of the LLNL tests.

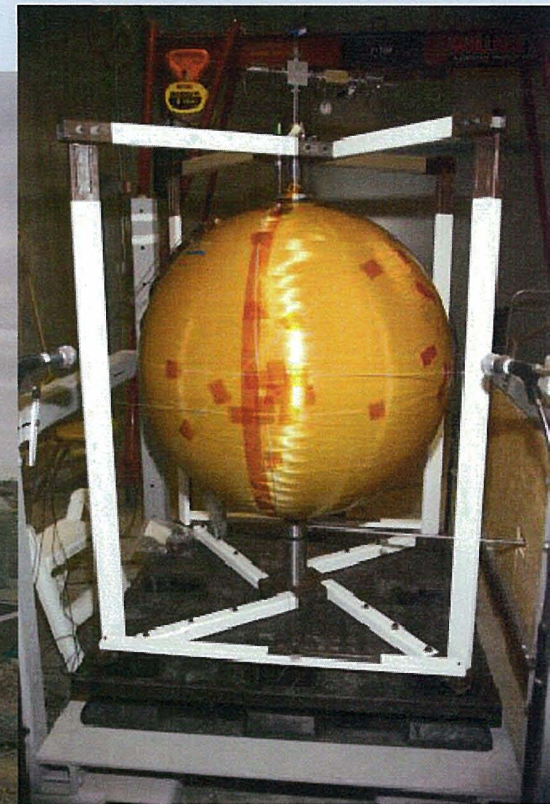
OMS/RCS test article in test frame. Allows freedom of movement to monitor vessel dimensional changes during test.

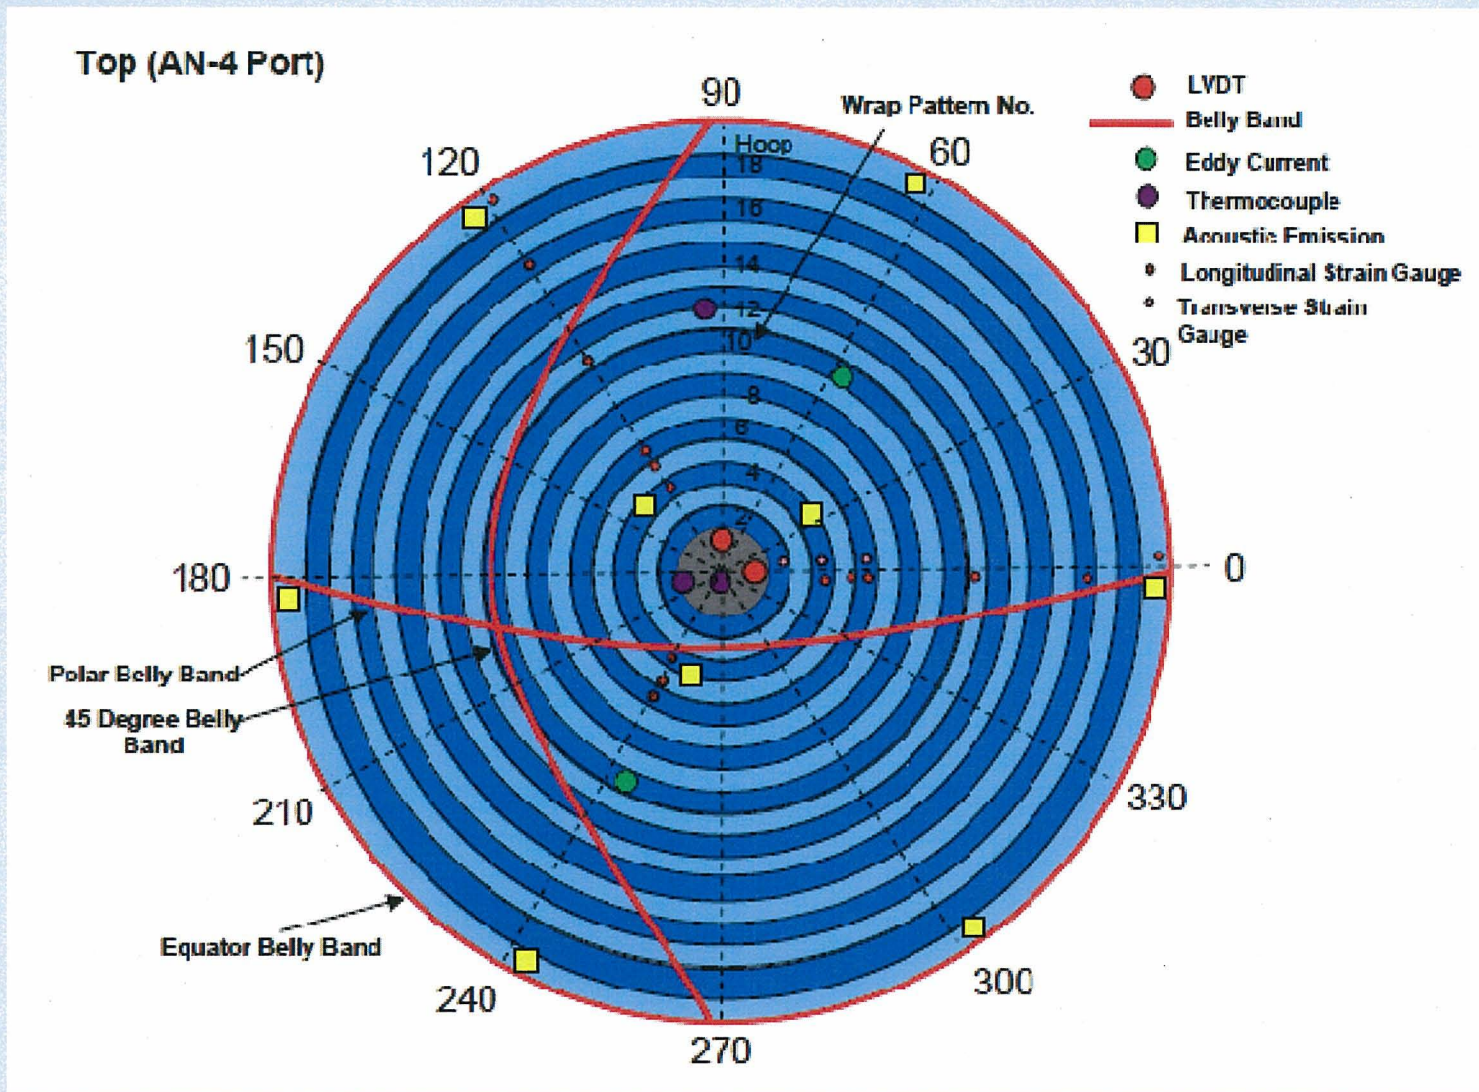
Instrumentation Map - Top

Test/Measurement	Purpose
Fluid Temperature	Test control parameter
Fluid Pressure	Test control parameter
Belly Bands	External diameter measurement
Acoustic Emission	Pinpoint failure location (triangulate)
Strain Gauges	Outer surface strain
Axial LVDT	Boss-to-boss growth
Eddy Current	Through wall thickness change
Video/Audio	Test documentation
Raman Spectroscopy	Engineering information – NDE development for external residual stress elastic strain
