Development of Backscatter X-Ray Imaging Techniques for Space Vehicle Applications

United Space Alliance, LLC

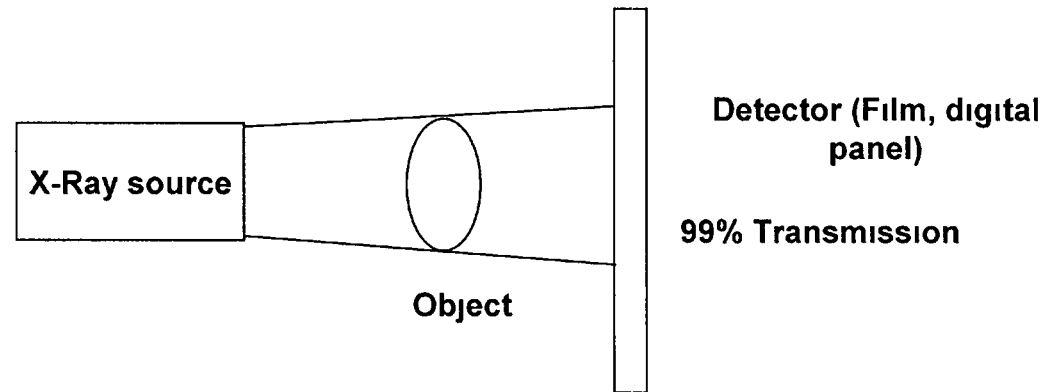
Through Transmission X-Ray Imaging

- **Through Transmission**
- **Scatter Imaging (BSX)**
- **Backscatter uses detectors on same side as source**
- **Beams usually highly collimated**
- **Detectors more sensitive than through transmission technique**
- **Beam rastered across part with backscatter technique**

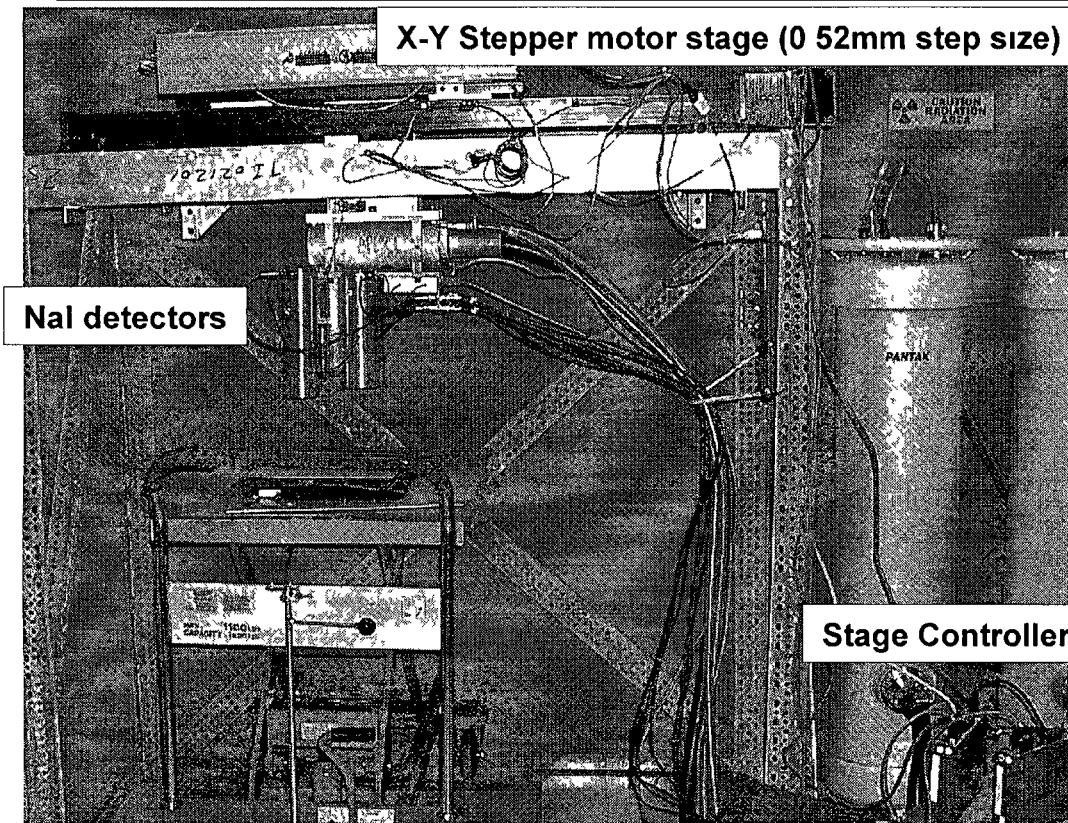
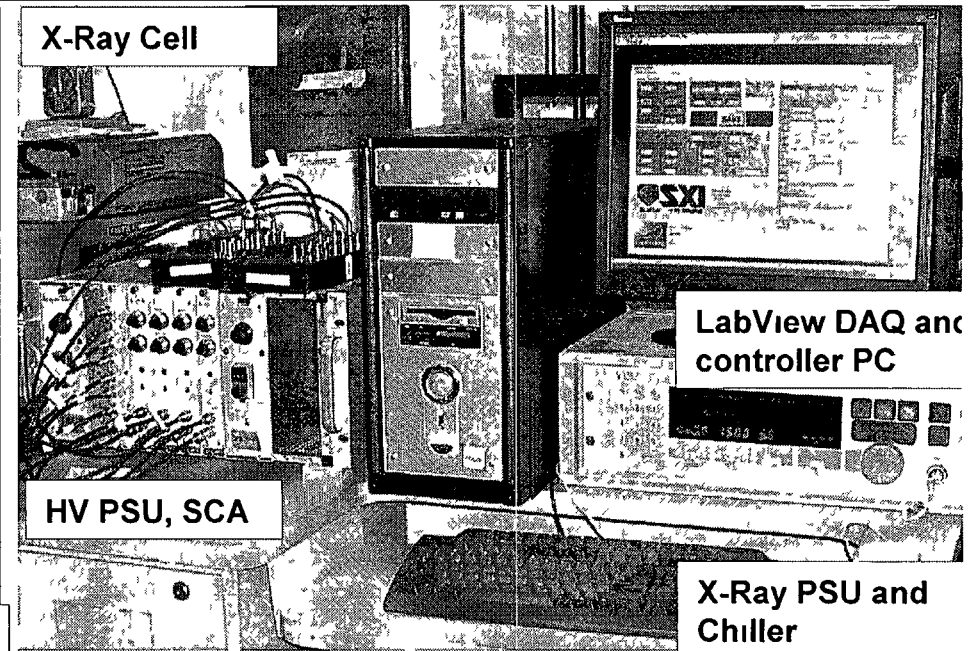
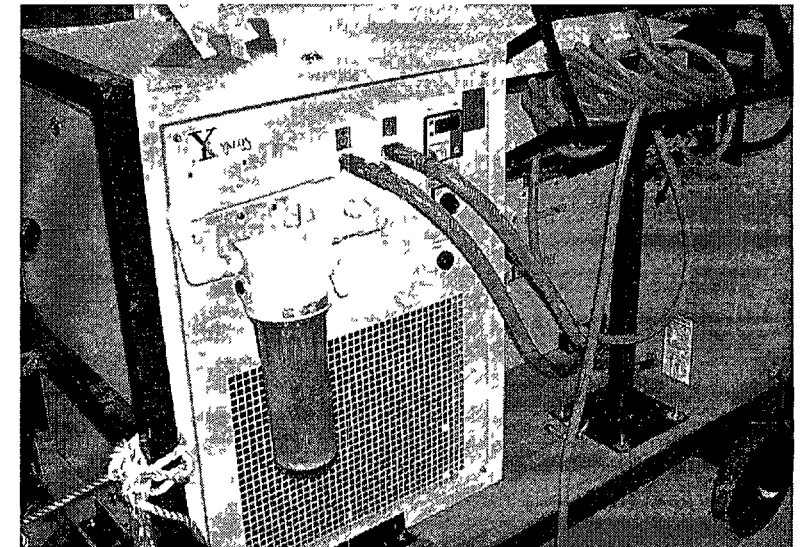
Backscatter X-Ray Experimental Setup

- Yxlon x-ray source
- Maximum settings 110kV 20mA
- Four NaI detectors
- 5 5mm spot size
- LabView stage control and DAQ

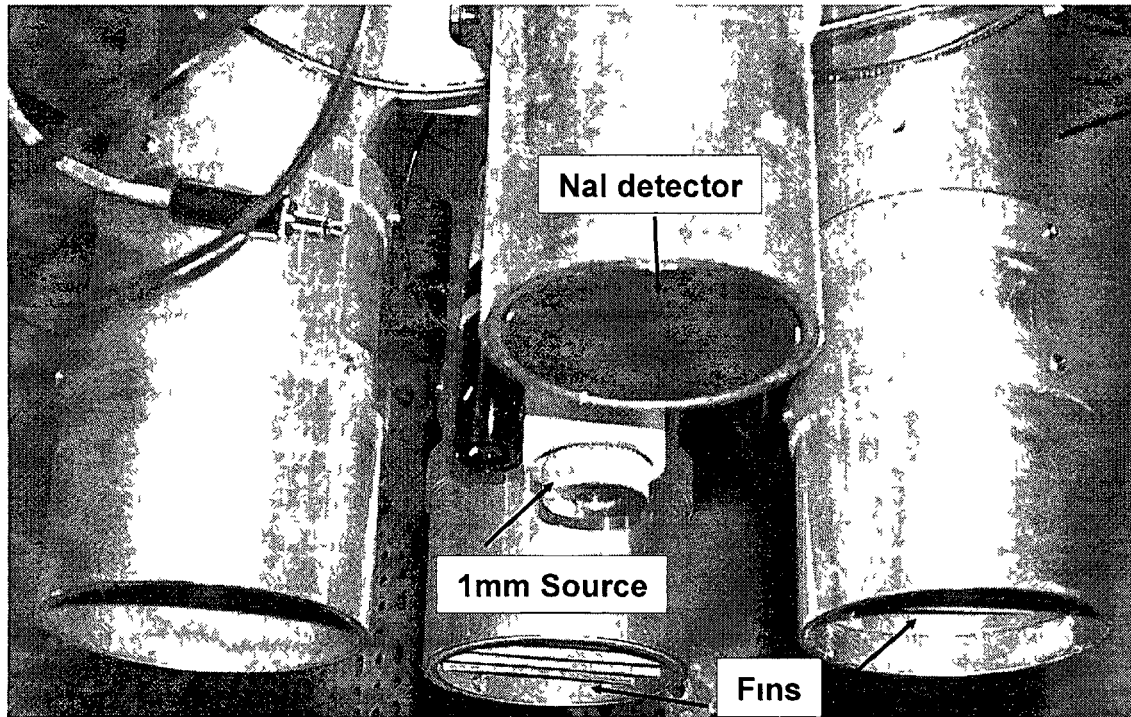
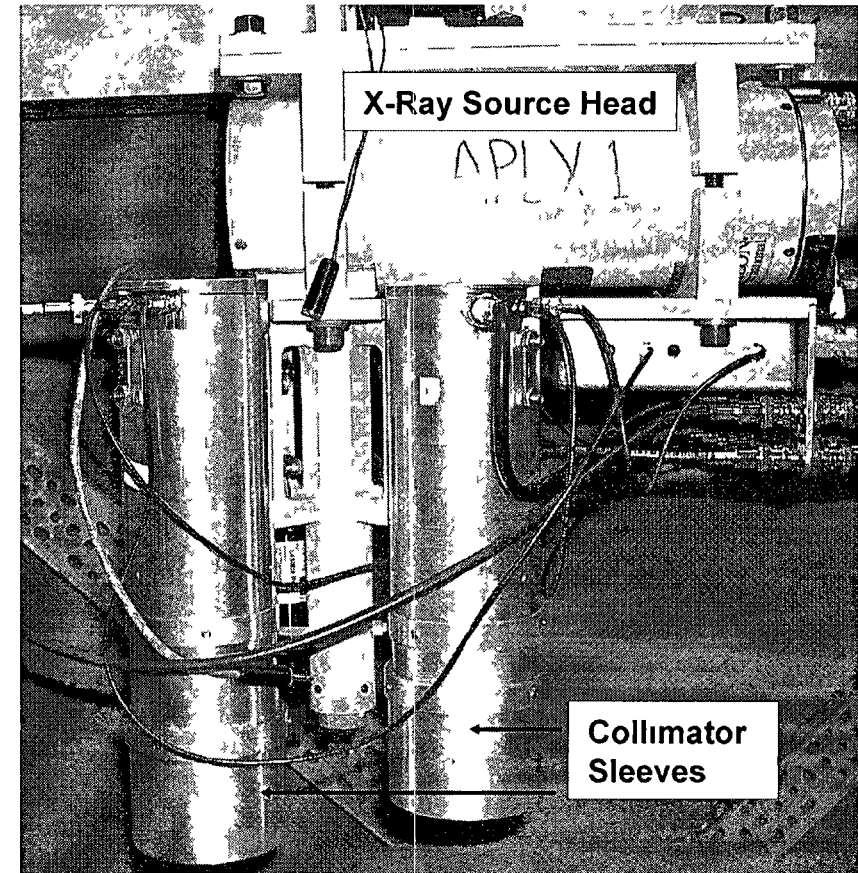
Backscatter X-Ray Experimental Setup

- Spot size focused to 1mm with lead apertures
- Collimator sleeves have 60mm travel length
- Lead fins are inside collimator sleeves and can be rotated to block out primary backscatter x-ray signals
- The Source and the detectors raster across the imaging area of interest

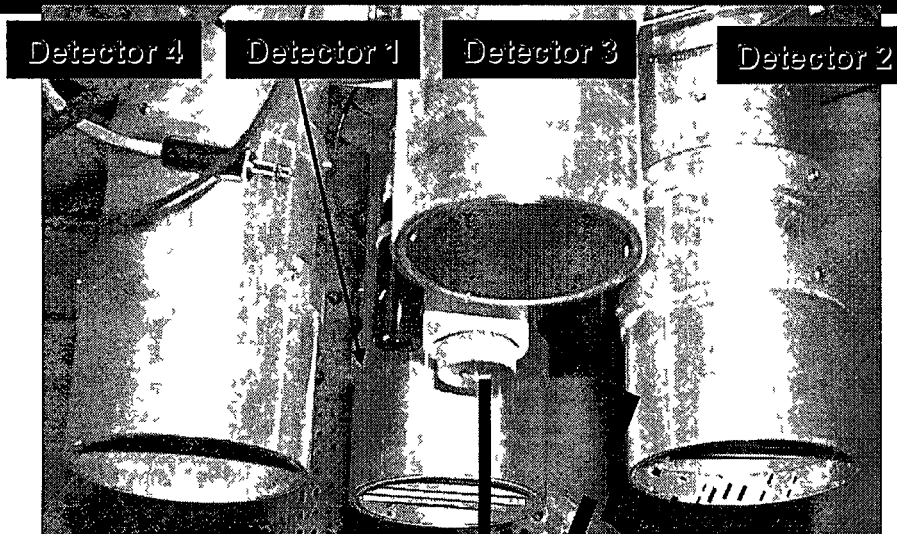
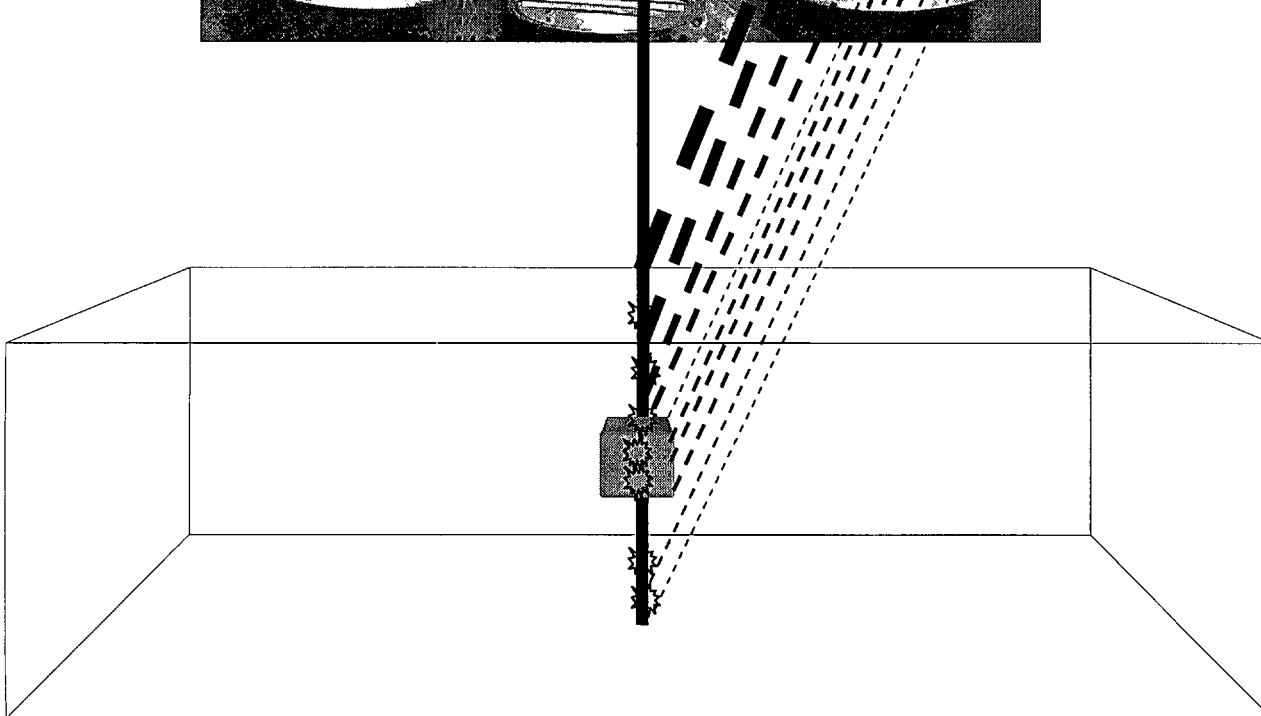
Collimator Setting BSX Imaging Basics

- High collimator settings allow photons from all depths to enter the detector

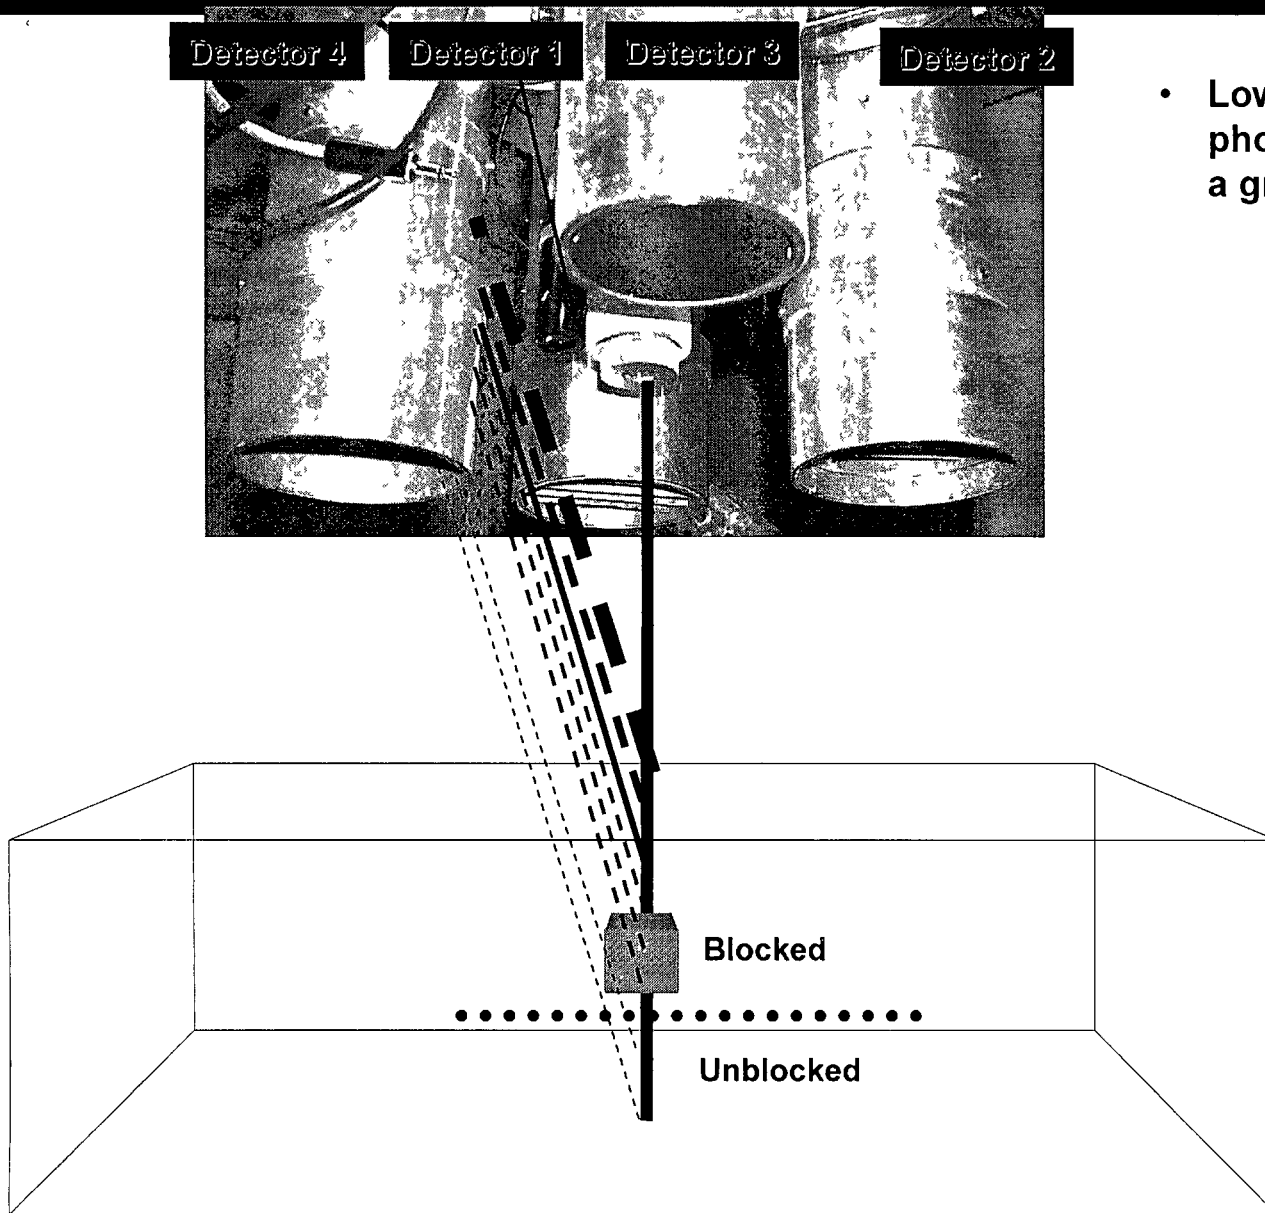
Collimator Setting BSX Imaging Basics

- Low collimator settings block out photons scattered from the surface and a given depth into the subsurface

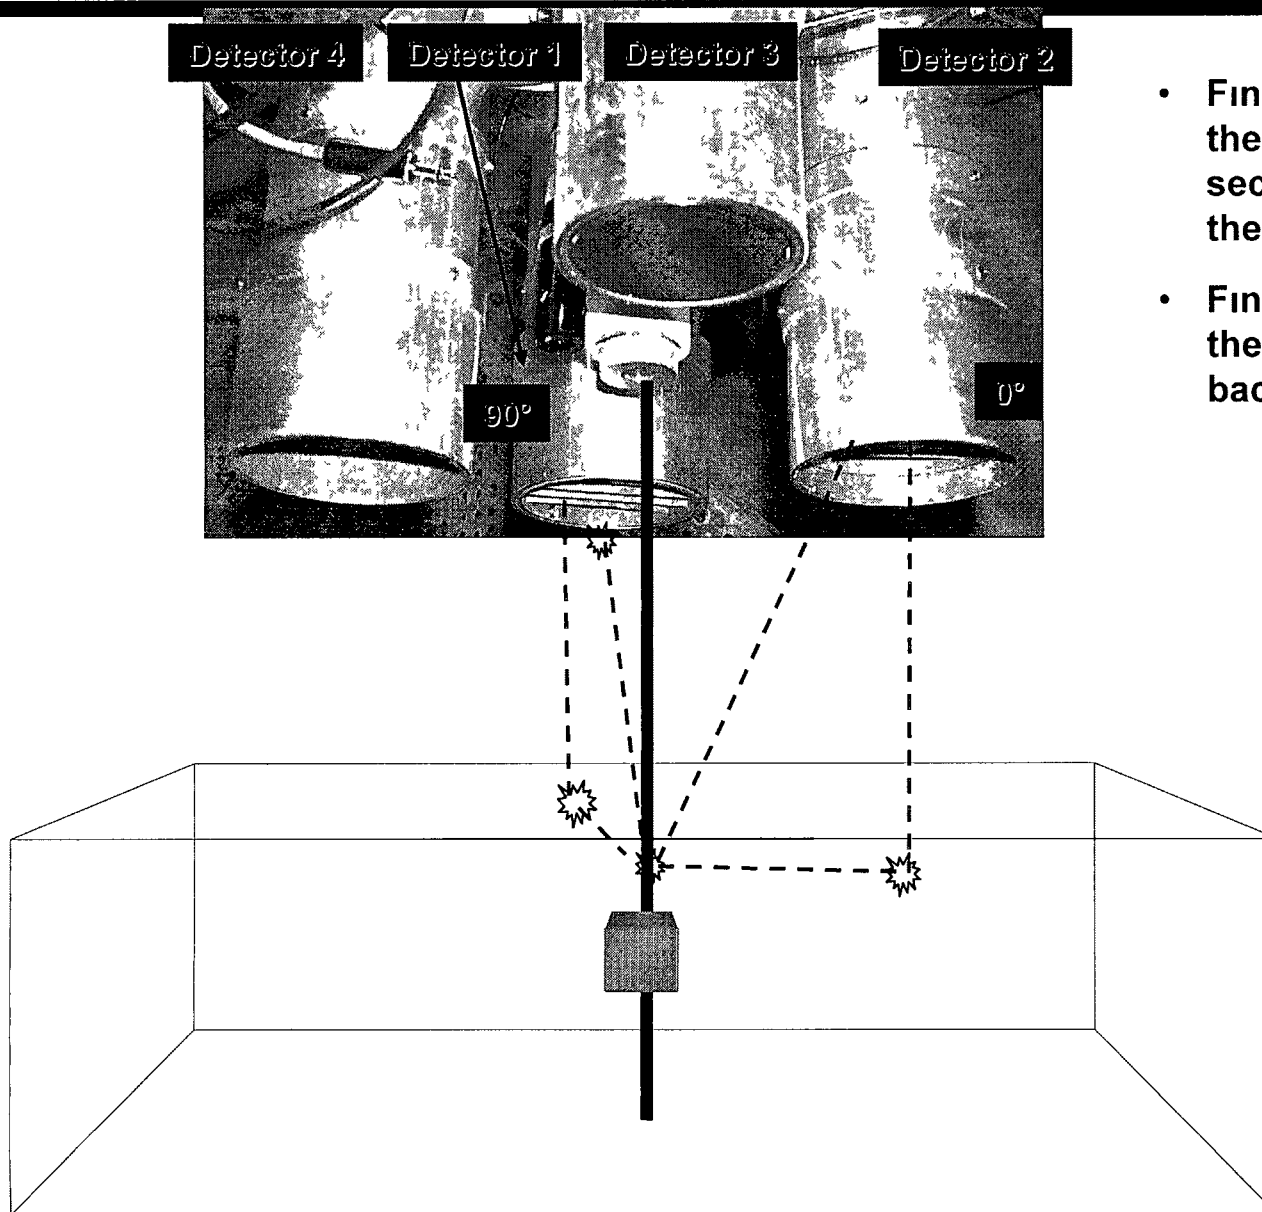
Fin Rotation BSX Imaging Basics

- Fin setting of 0 degrees with respect to the source allows both primary and secondary backscatter photons to enter the detector
- Fin setting of 90 degrees with respect to the source block out primary backscatter signal

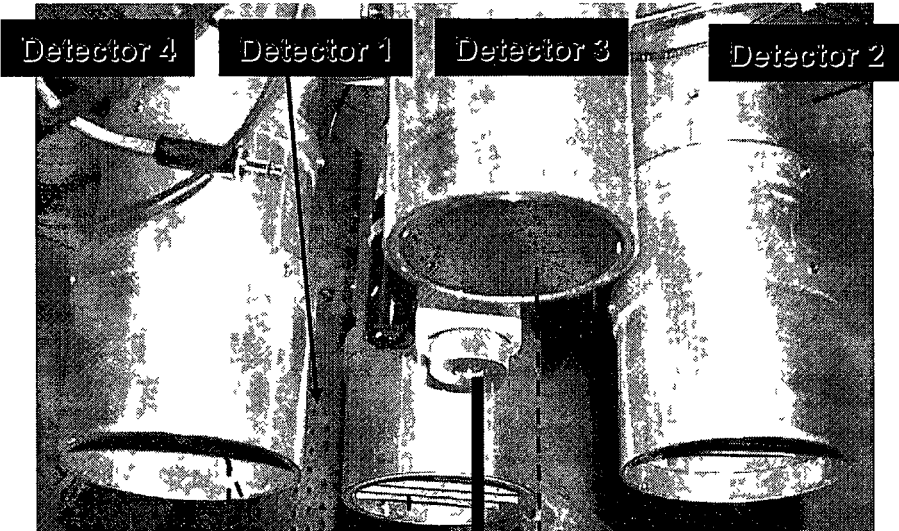
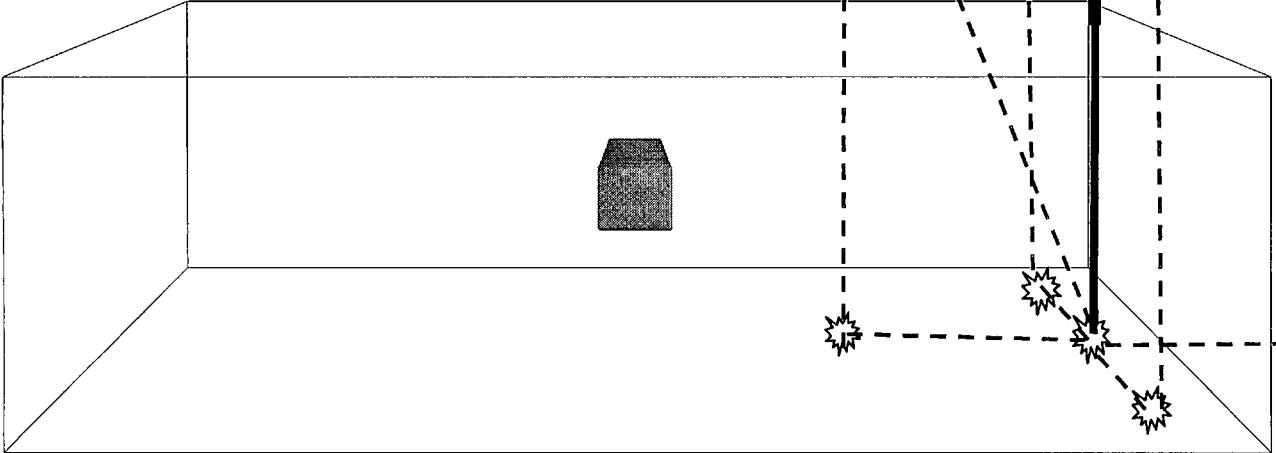
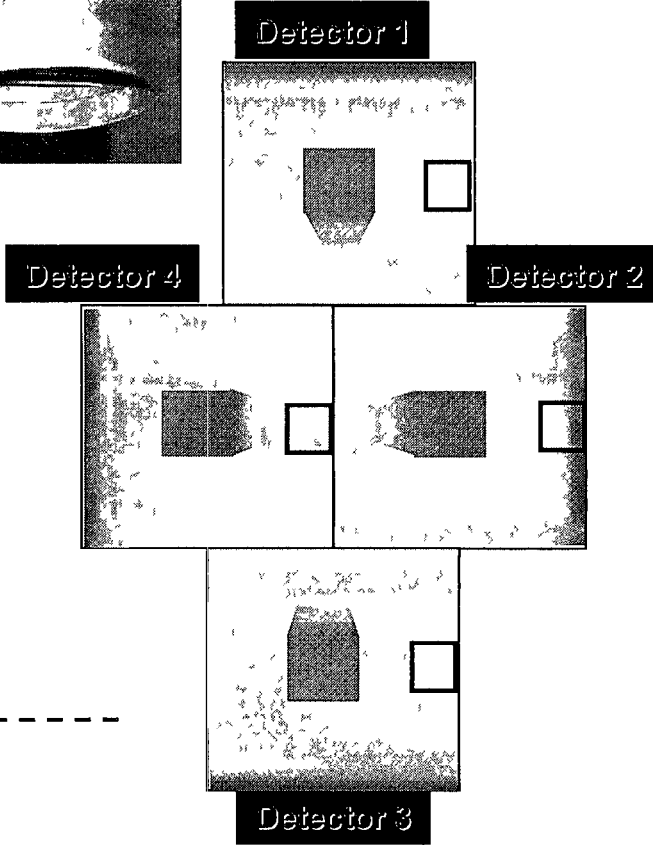
Edge Effect BSX Imaging Basics

- X-ray beam
- - - Primary backscatter
- - - Secondary Backscatter

- Near specimen edges a lower signal is collected due to the inability of the photons to backscatter to the detector

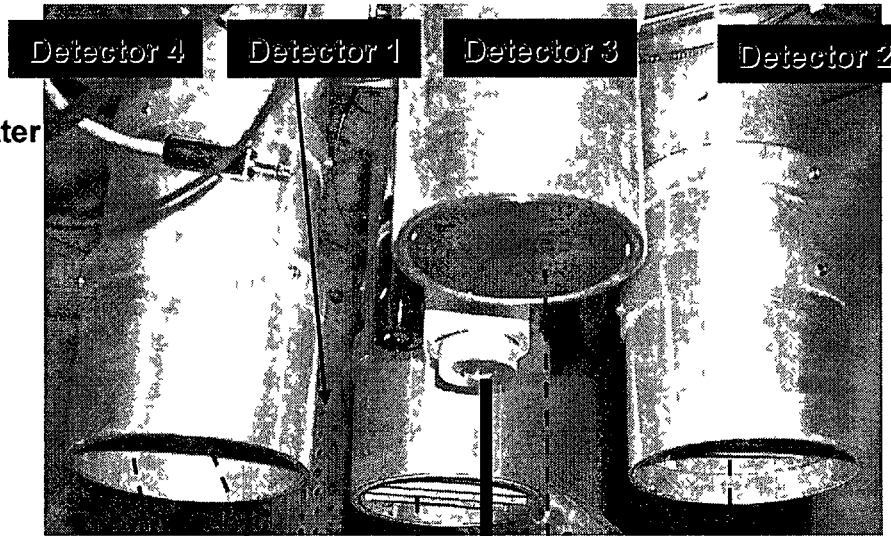
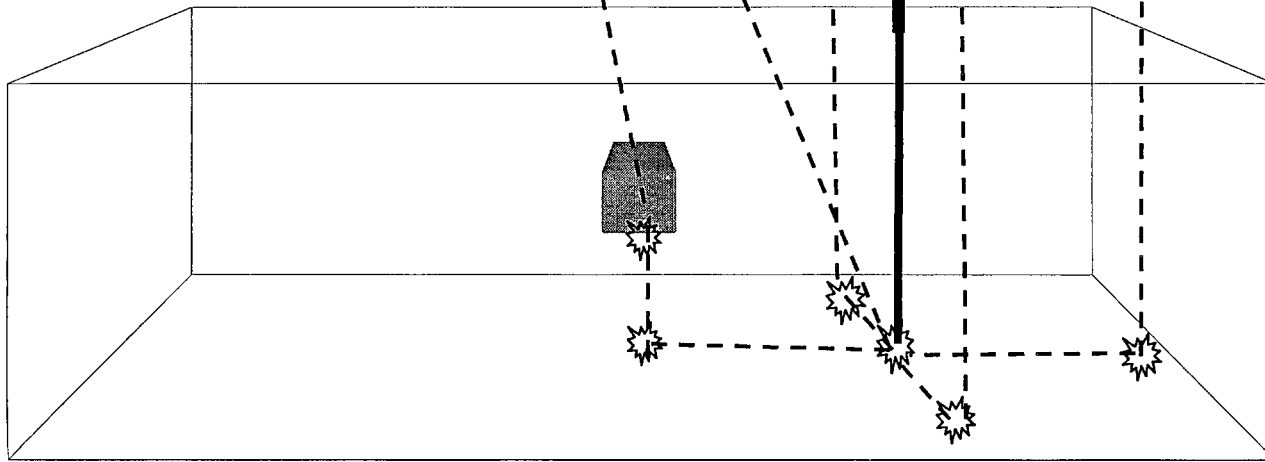
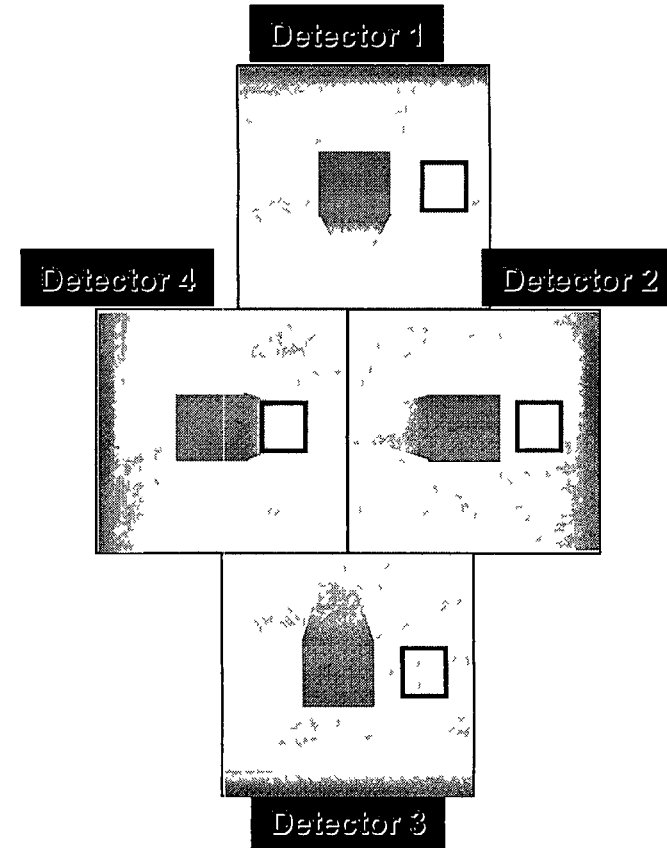
Shadowing Effect BSX Imaging Basics

- X-ray beam
- - - Primary backscatter
- = = = Secondary Backscatter

- A shadowing effect near objects is produced due to tertiary backscatter
- Edge effects disappear near the center of the sample
- There would be no shadowing effect if the detector is exactly at the location of the source

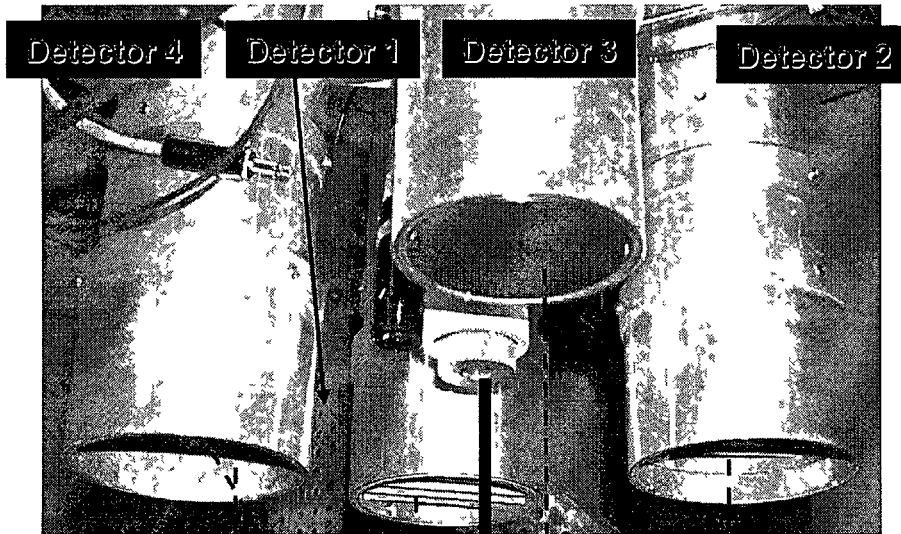
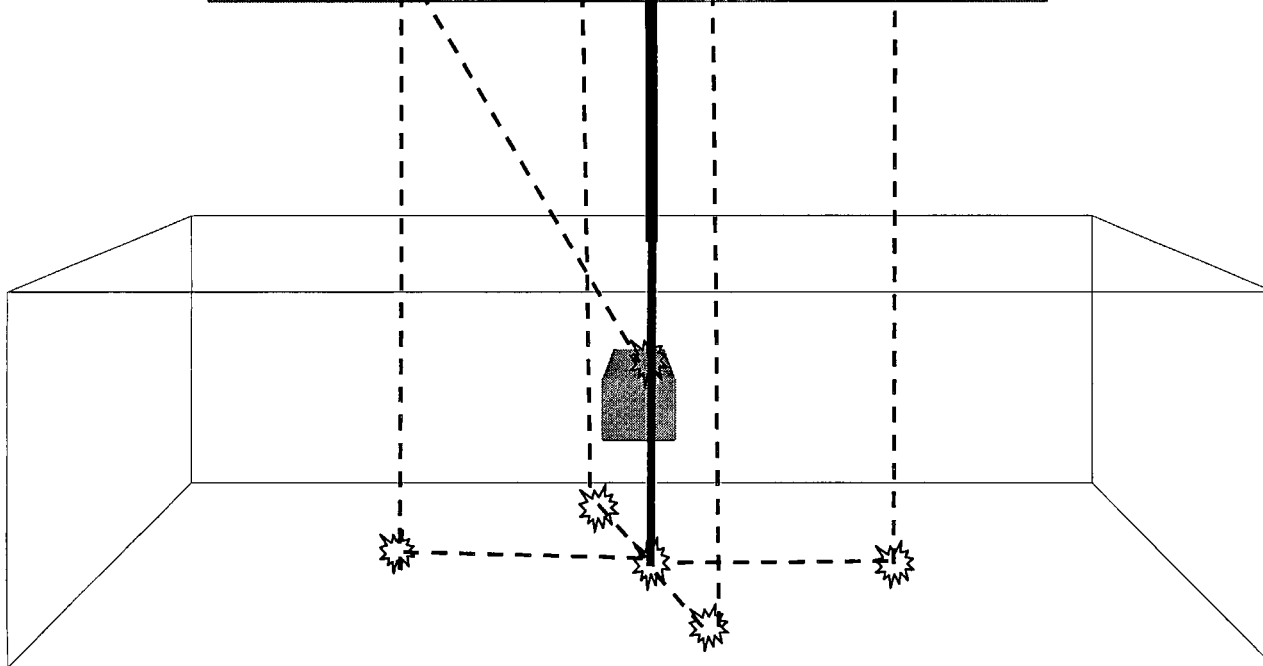
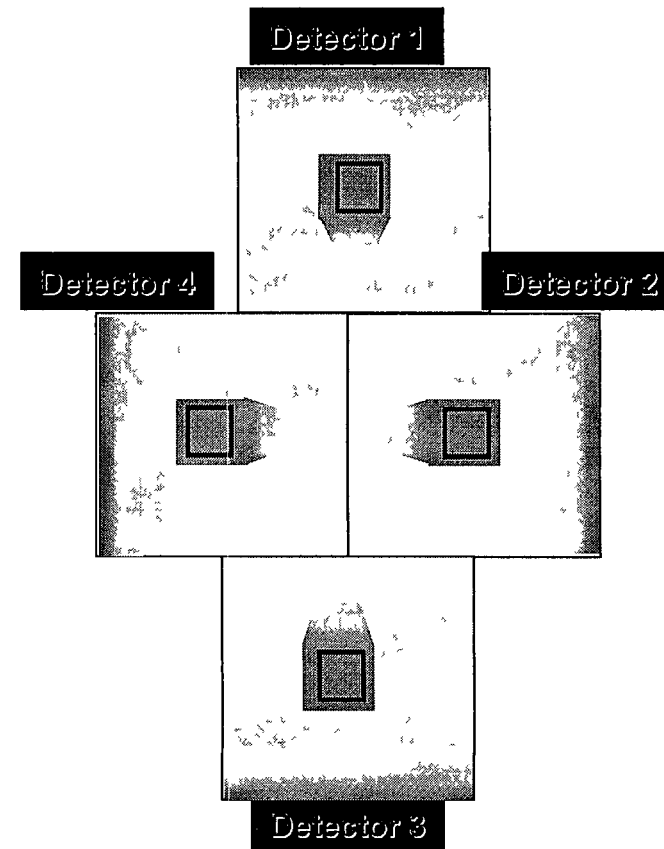
BSX Imaging Basics

- The best signal is produced when the source is over the object

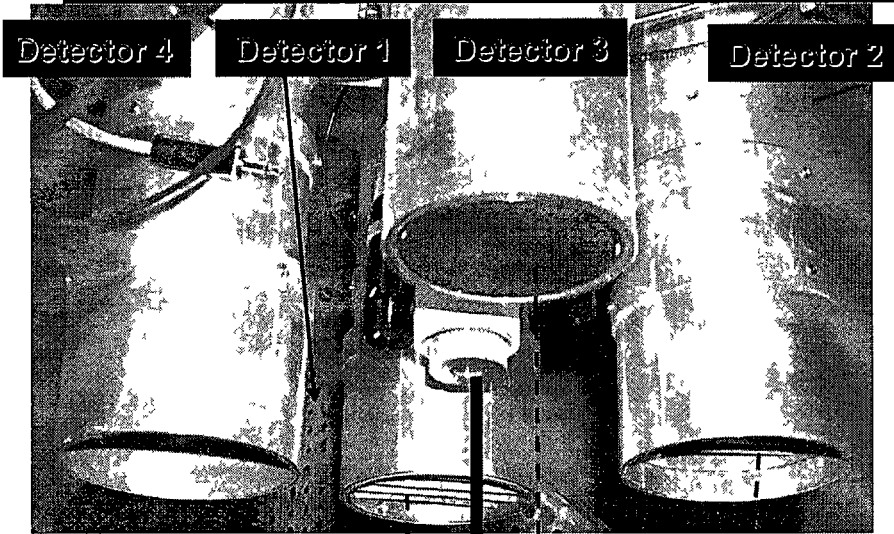
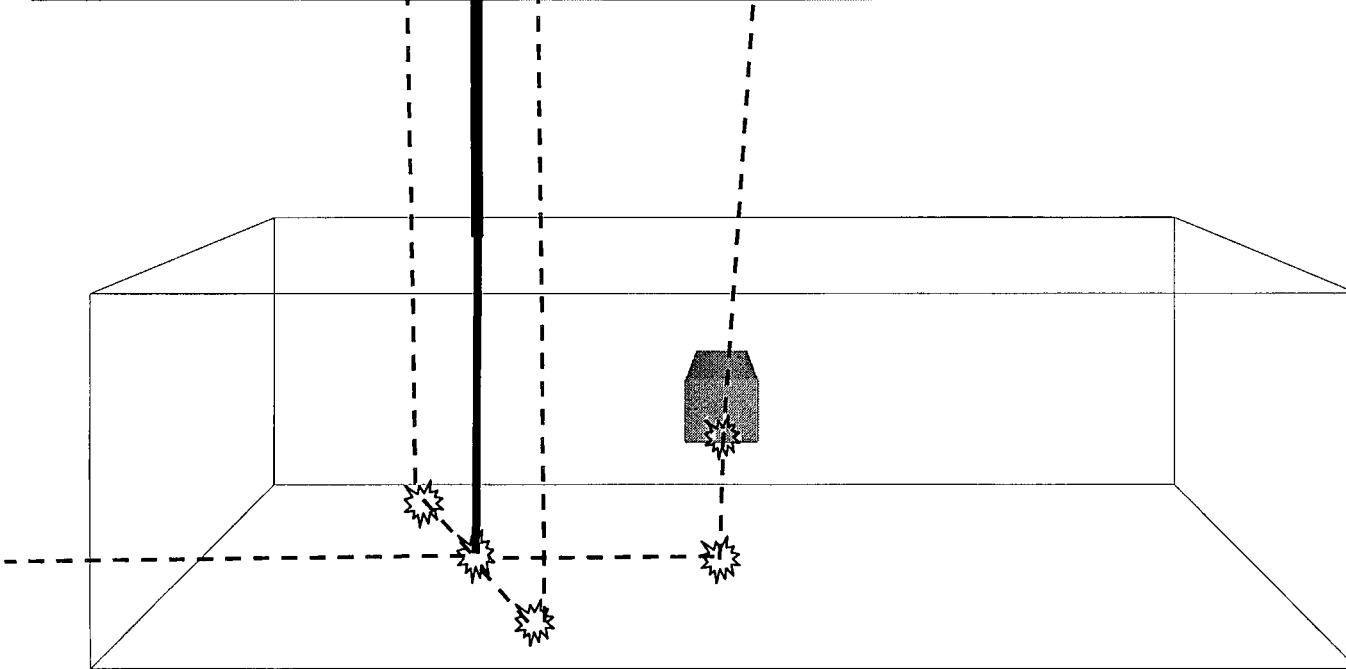
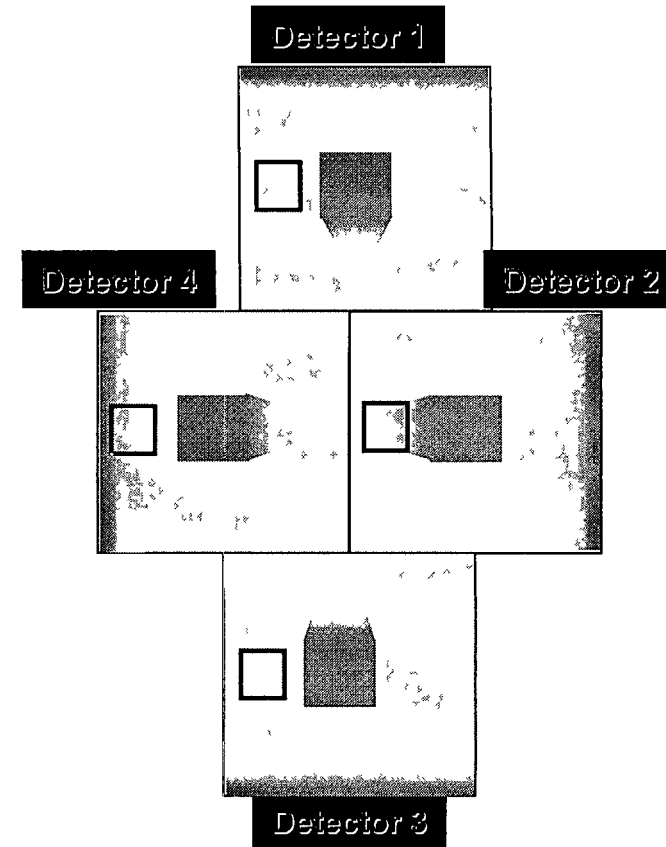
Edge and Shadowing Effect BSX Imaging Basics

- Shadowing effect is produced again in the detector directly above the object
- Edge effect is produced in the detector off of the edge of the object

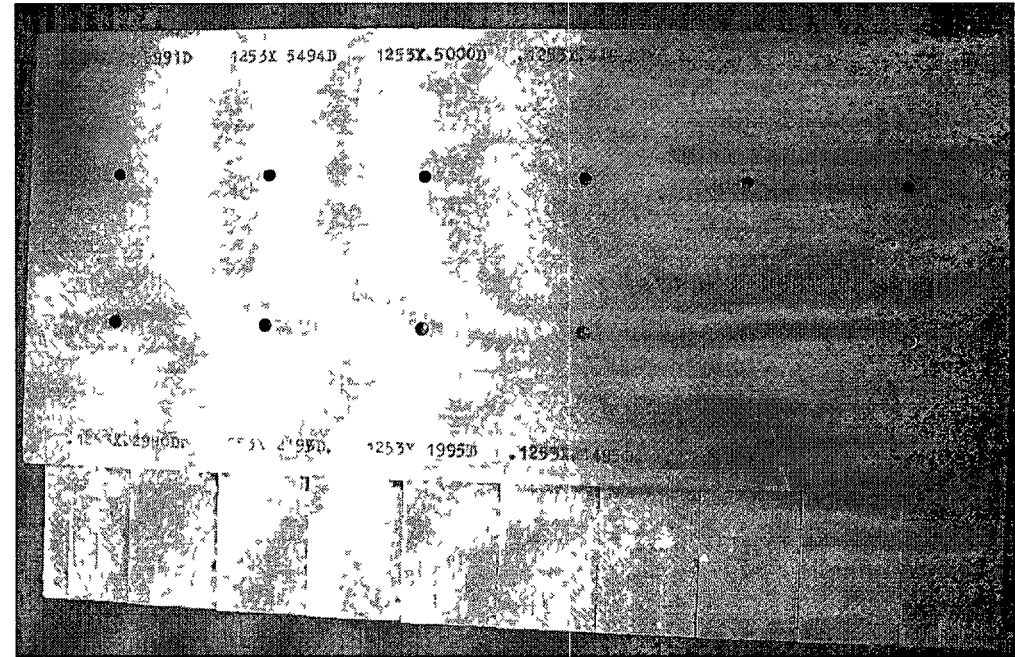
Aluminum Wedge Block Setup

- Aluminum standard wedge block with thickness from 1.59mm (1/16in) to 15.9mm (5/8in) thickness in 1.59mm (1/16in) increments
- Flat bottom holes (FBH) of 3.18mm (1/8in) diameter with depths from 1.27mm (0.050in) to 15.24mm (0.60in)
- Each area was imaged using the BSX detector with 100kV, 20 mA, 5mm/s scan speed 1mm pixel size, 0 degree fins, and a source to object distance of 127mm (5in)

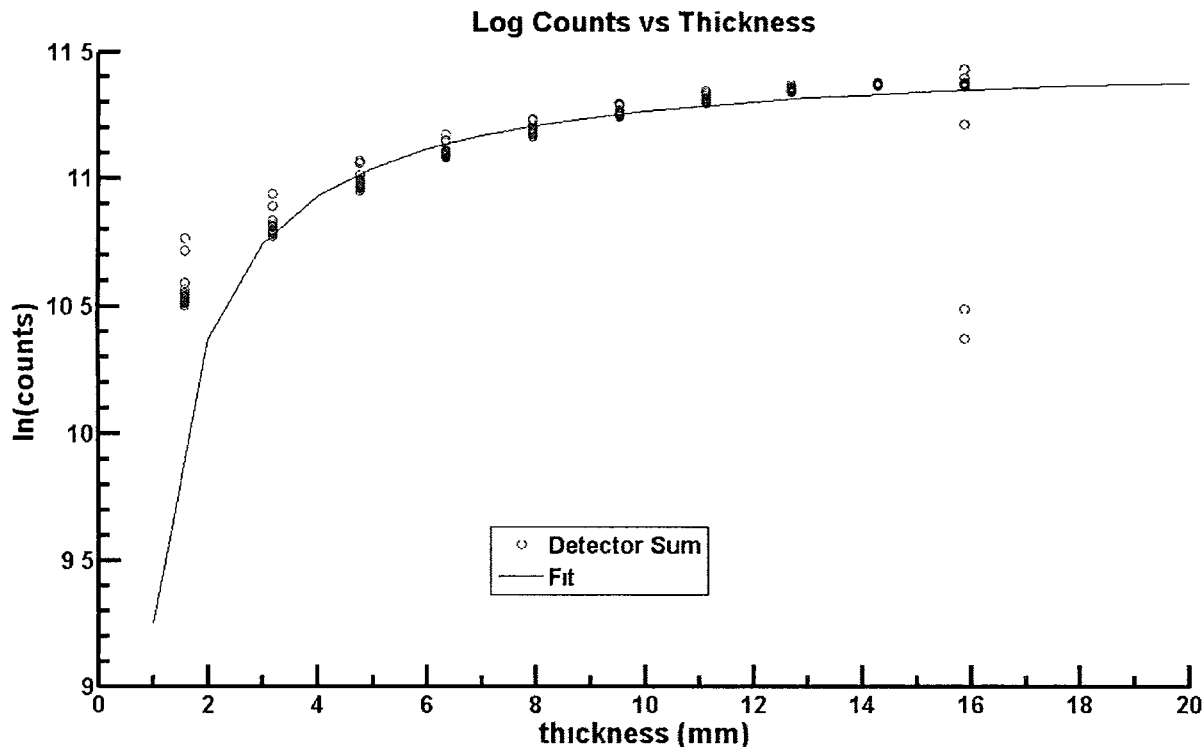
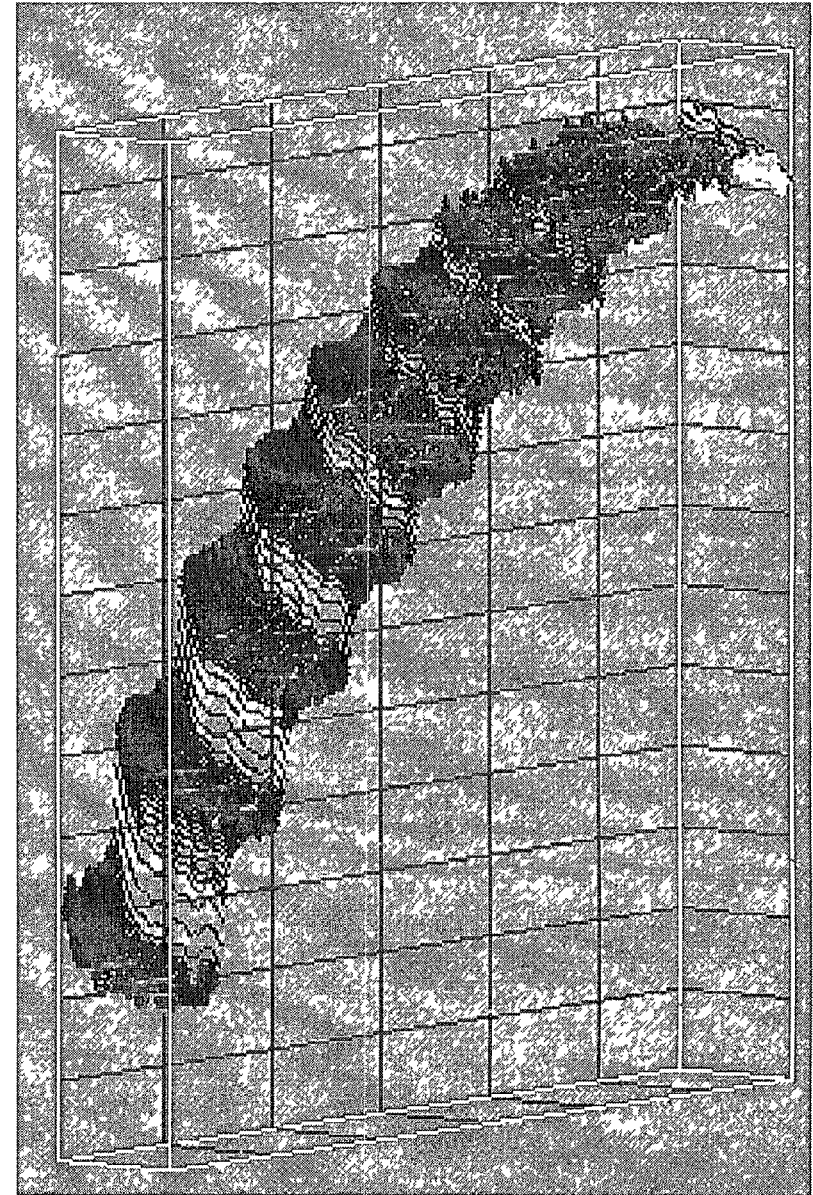
Wedge Thickness vs Photon Counts

The data was fit assuming that the photon counts decay exponentially to 0 with decreasing thickness

$\text{counts} = \exp(-A/\text{Thickness})$ where (A is a constant)

The change in each wedge thickness was detectable up to 15.9mm aluminum thickness

It is difficult to use the entire data set for the fit since the photon counts change near all the edges of the wedges

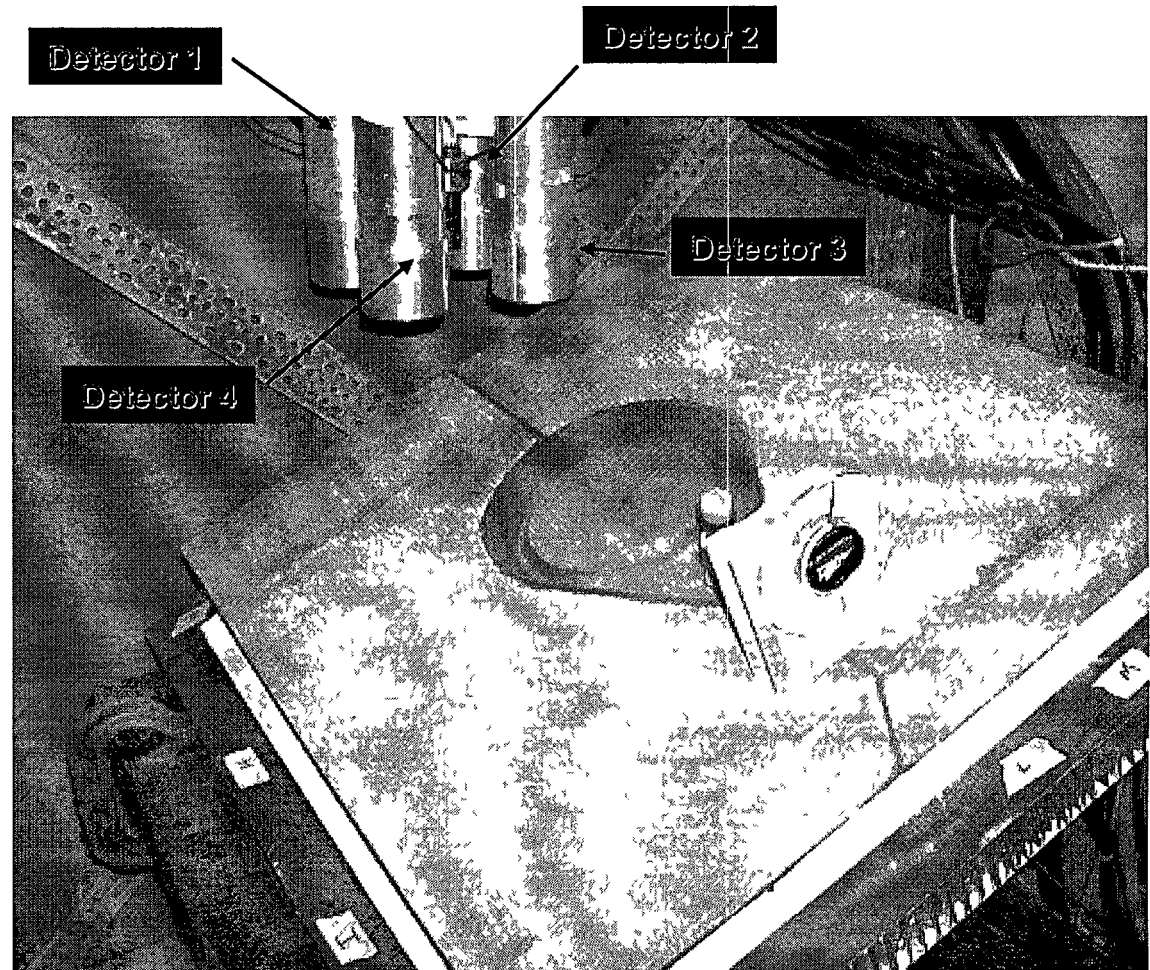
LDDU Experimental Setup

- LDDU scans were conducted with a step size of 0.52mm, scan speed of 2.6mm/s, 90degree fin rotation, 112mm source to object distance and LDDU tilt angles of 0, 11, and 23 degrees
- Three areas of interest were investigated in the RTV seams that joined the PICA pieces together

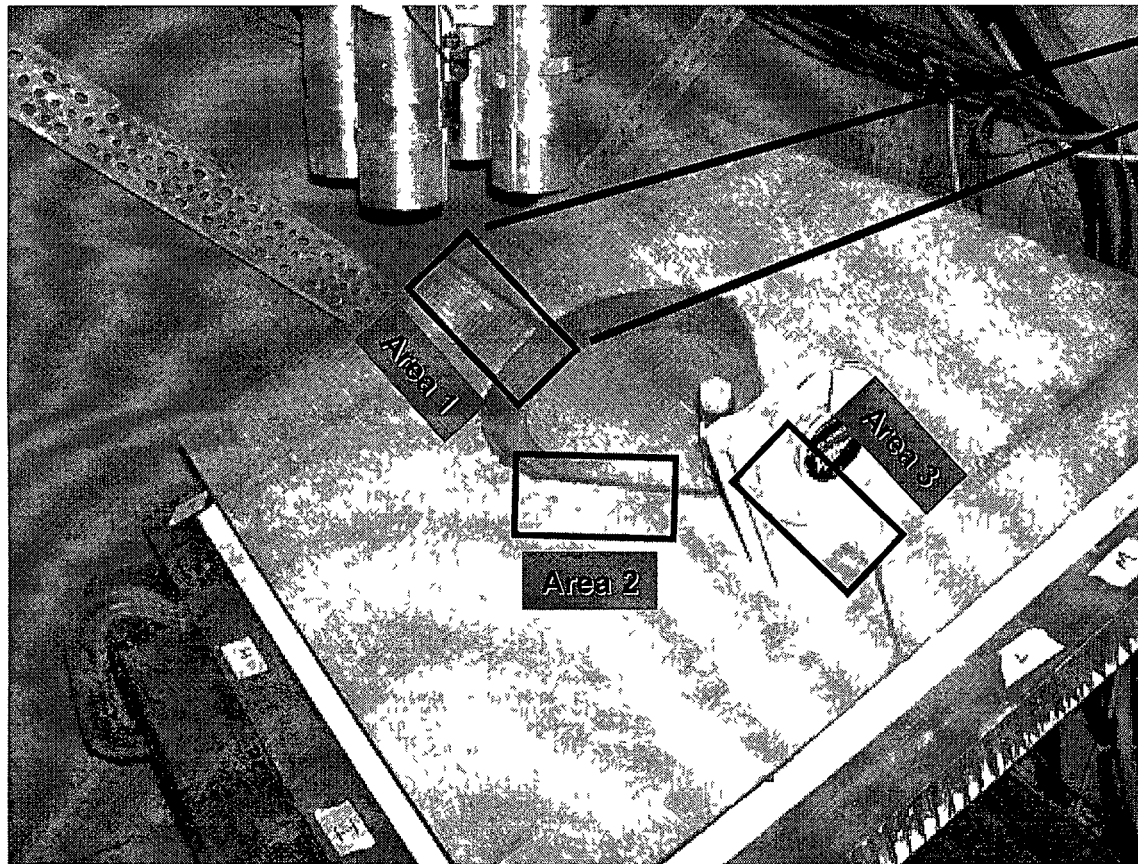
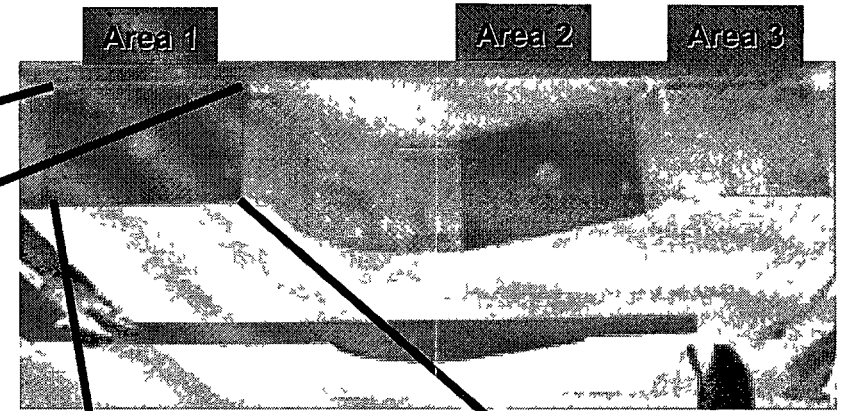
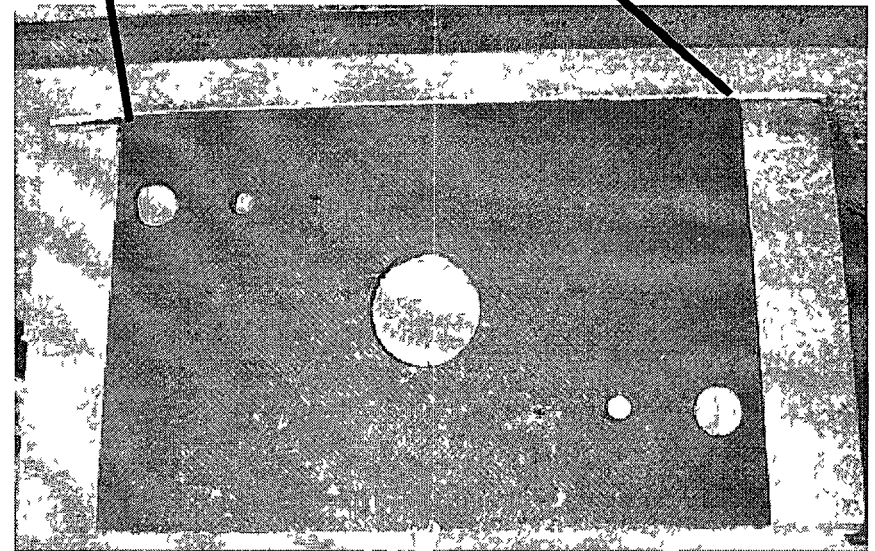
LDDU Regions of Interest

- RTV voids exist outside of the pre-cured RTV region
- The 0.5in holes are shown to be partially filled
- It must be noted that the voids labeled 0.125in are realistically at the most 0.0625in which is near the limit of the current system configuration of 0.039in source beam diameter (1mm)

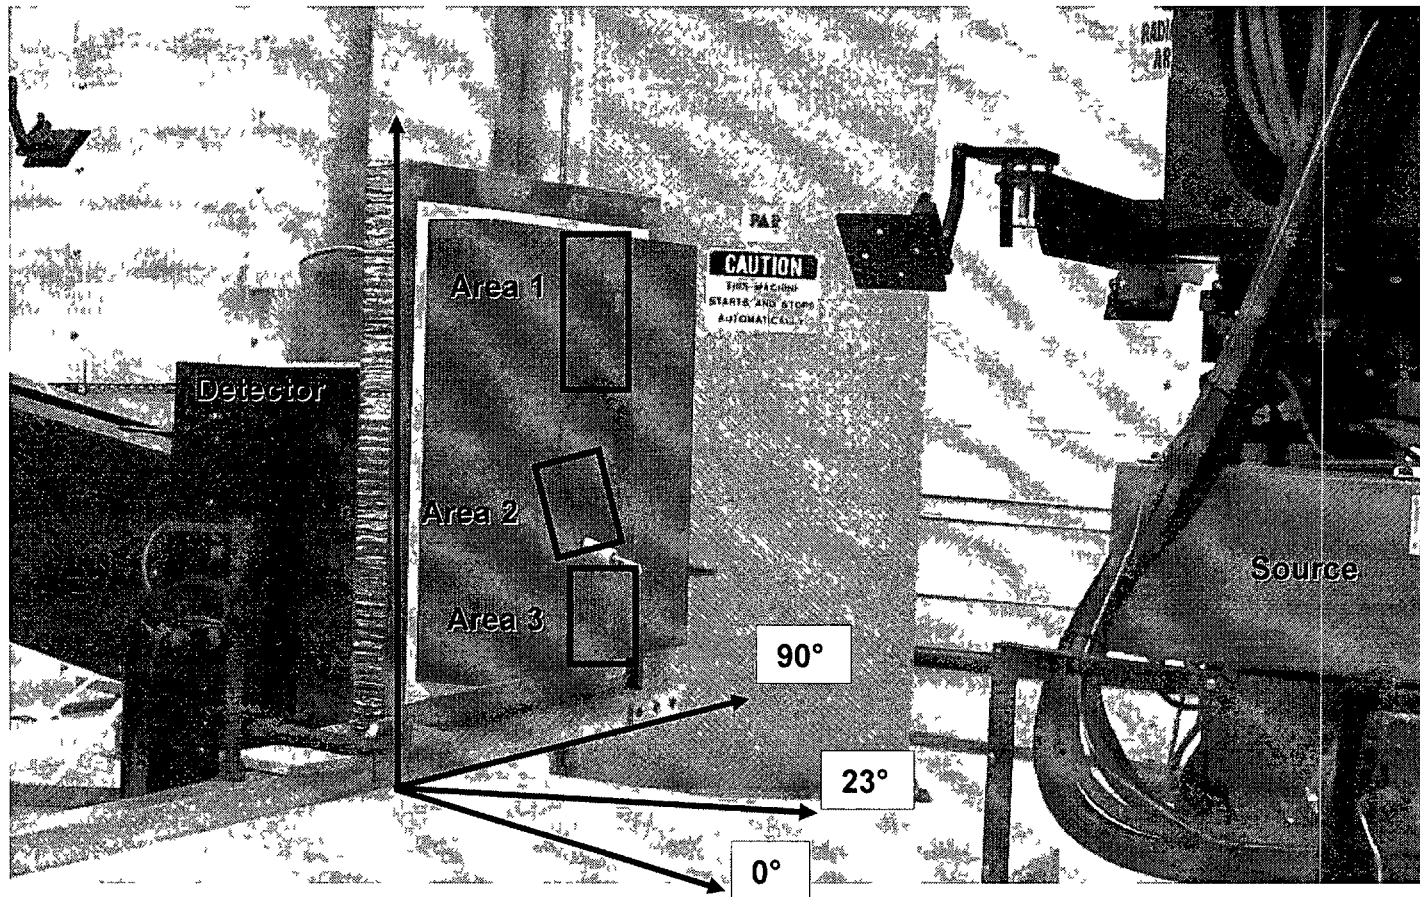
LDDU Through Transmission X-Ray Setup

- Through Transmission X-Ray scans were conducted at 130kV and 60in source to object distance on the two pre-cured RTV areas and one non pre-cured RTV area for three separate angles
- The LDDU was set flat on the table for the 90 degree scans
