Development of Backscatter X-Ray Imaging Techniques for Space Vehicle Applications

United Space Alliance, LLC

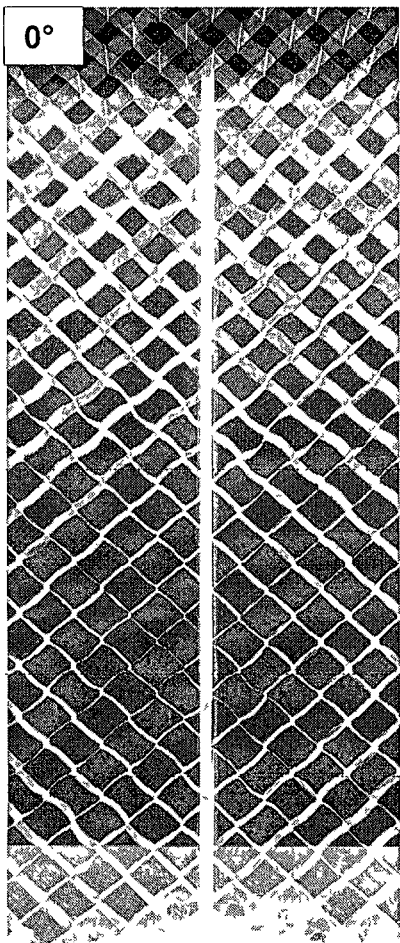
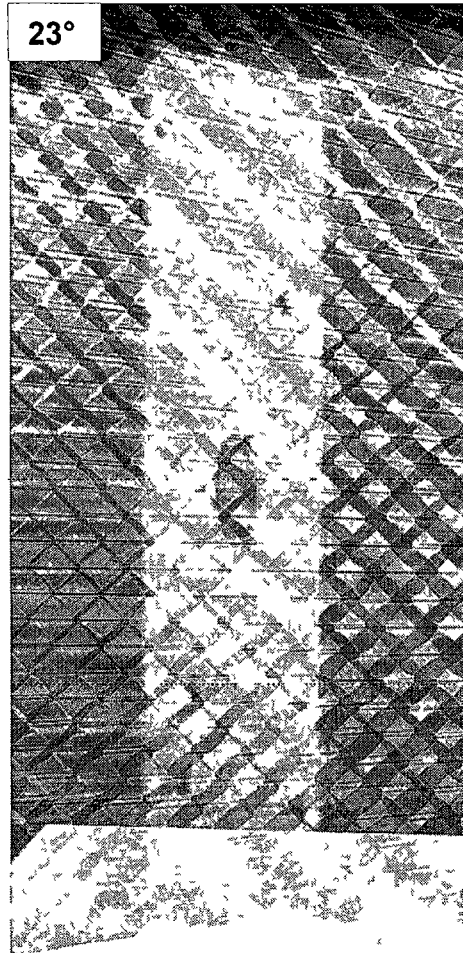
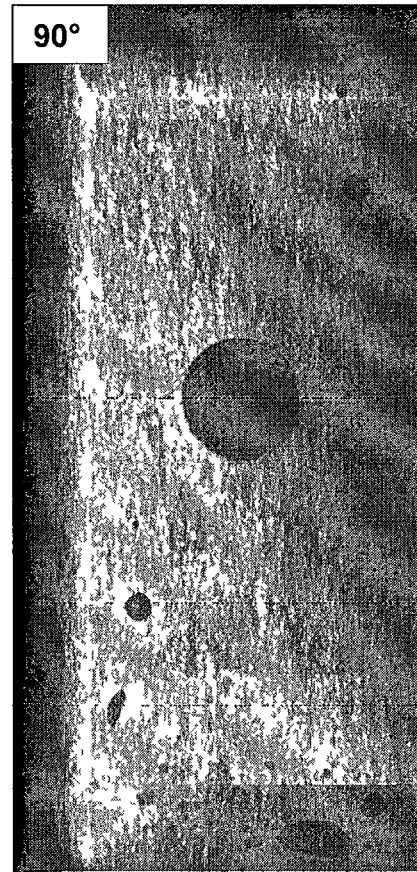
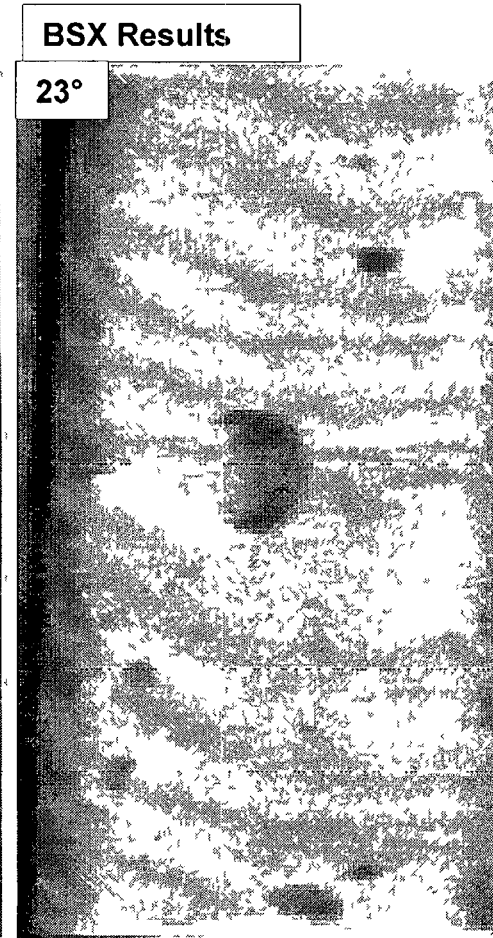
LDDU Through Transmission X-Ray Area 1 Results

- Results compare well to BSX Results
- A disbond in the RTV seam is detected and may explain why the 0.5in RTV voids were filled in during processing
- 0 and 23 degree results show the honeycomb substructure in the image that interferes with the detection of some of the RTV voids

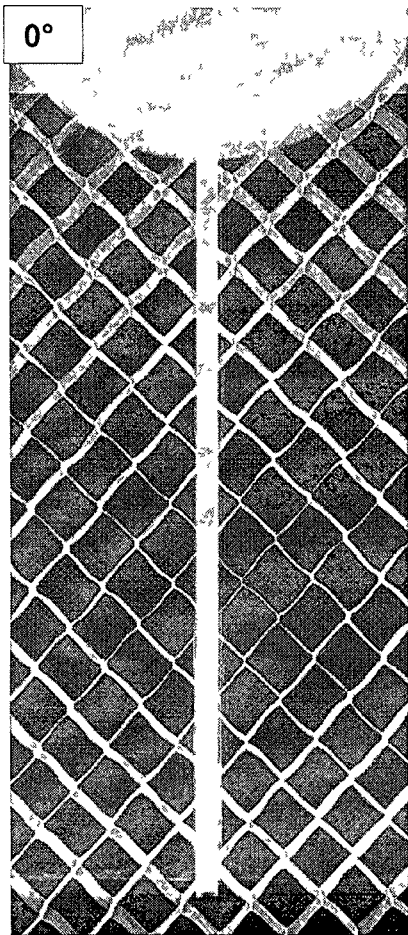
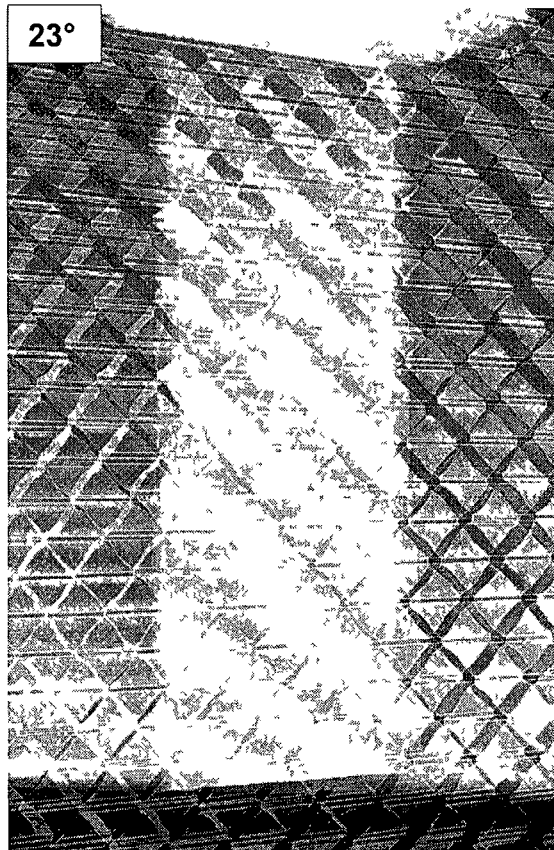
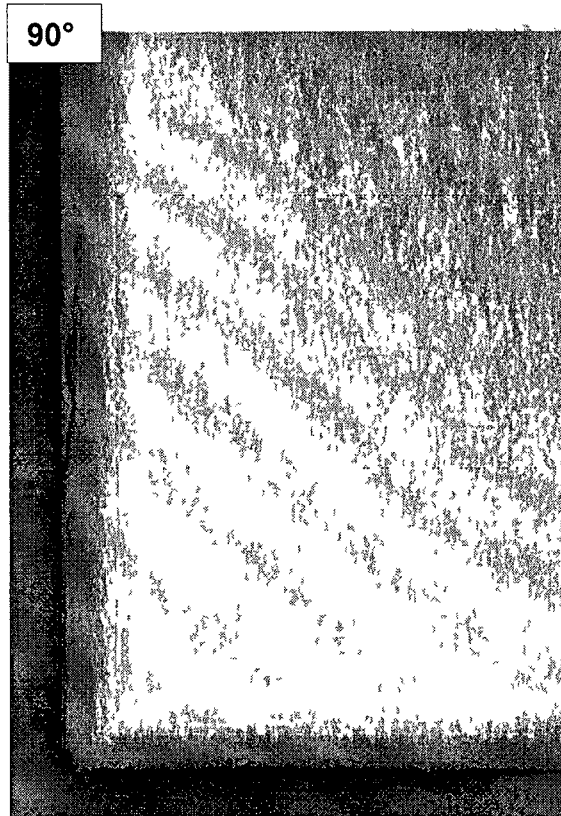
LDDU Through Transmission X-Ray Area 3 Results

- Void in the non pre-cured RTV was detected with both x-ray systems near the surface of the PICA

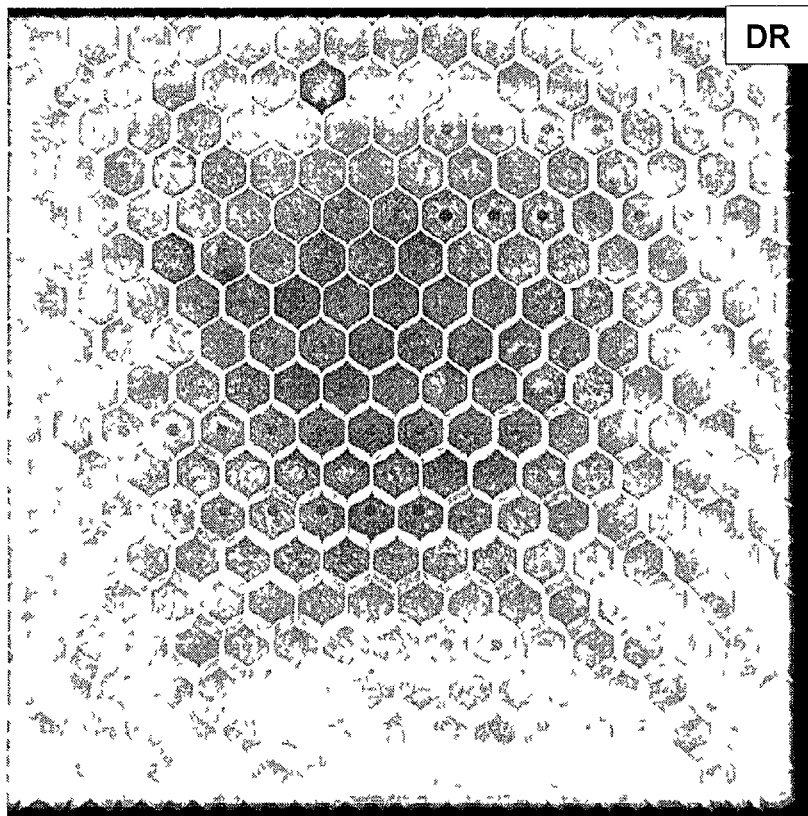
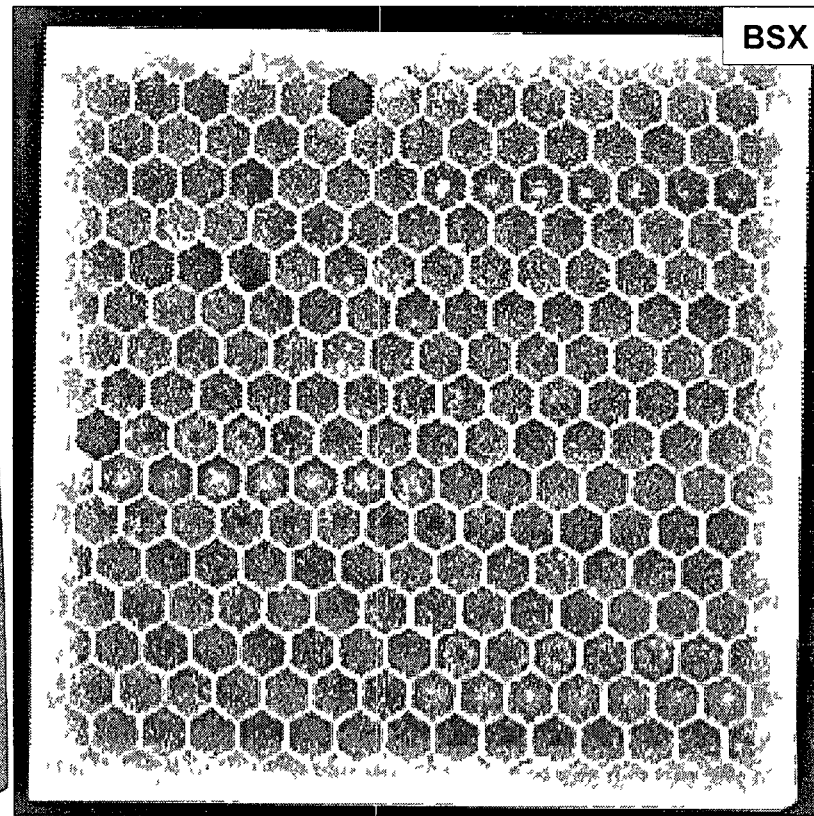
Avcoat Reference Block

Sum of 4 detectors and filter

114kV
15mA
1mm Aperture

Able to detect all flat FBH and gap fills

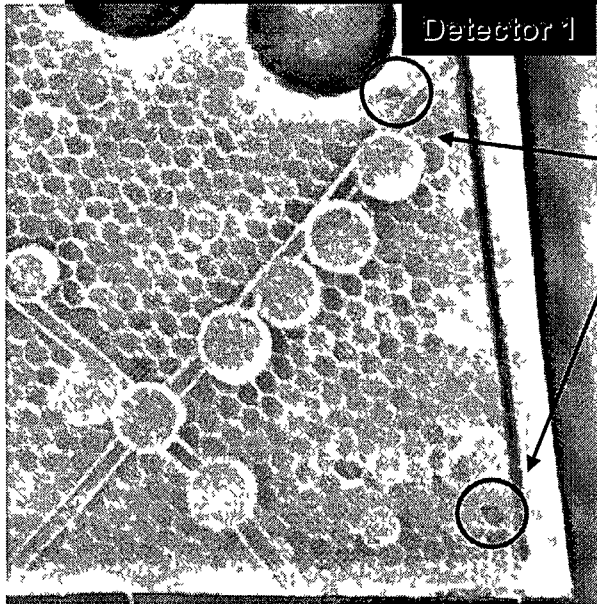
Large Scan Area 1mm Spot Resolution

•Possible void in Avcoat Honeycomb Cell

90kV
30mA
0.75mm Aperture

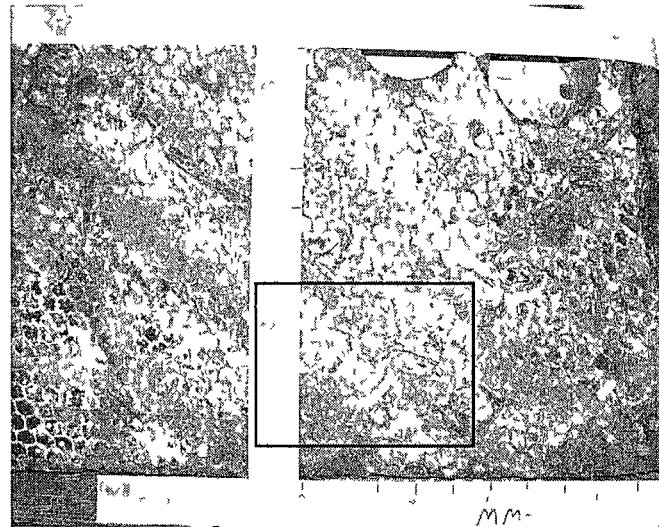
Small Scan Area 0.52mm Step Size 20 Degree Tilt

- Ability to detect honeycomb liner
- Possible steel honeycomb core detected as darker regions with detectors 1 and 4 near edge of specimen

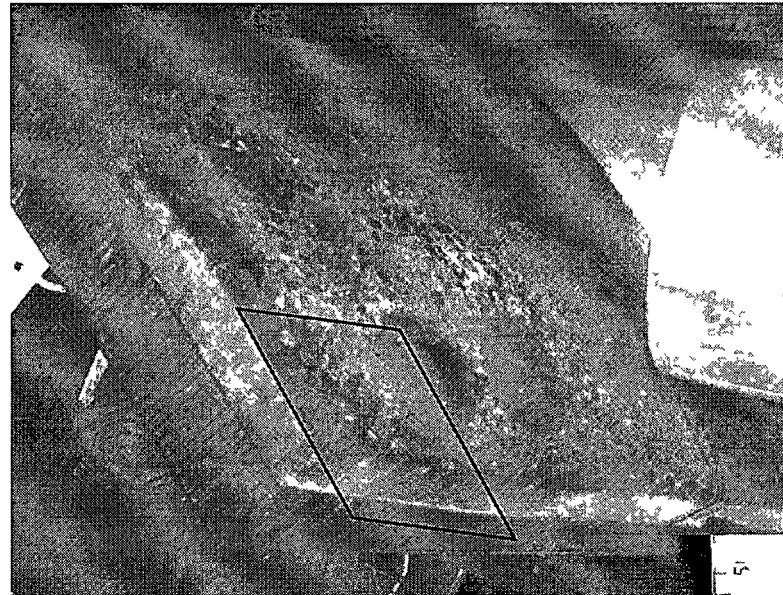
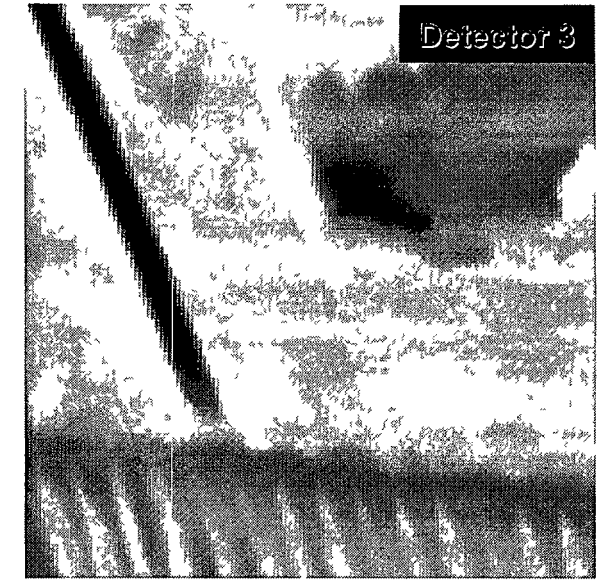
Small Area 45 Degree Tilt Near Edge

100kV
30mA
1mm Aperture
Slow Scan 2 6mm/sec

- Depth of penetration is approximately 0.5 inch maximum with optimum settings

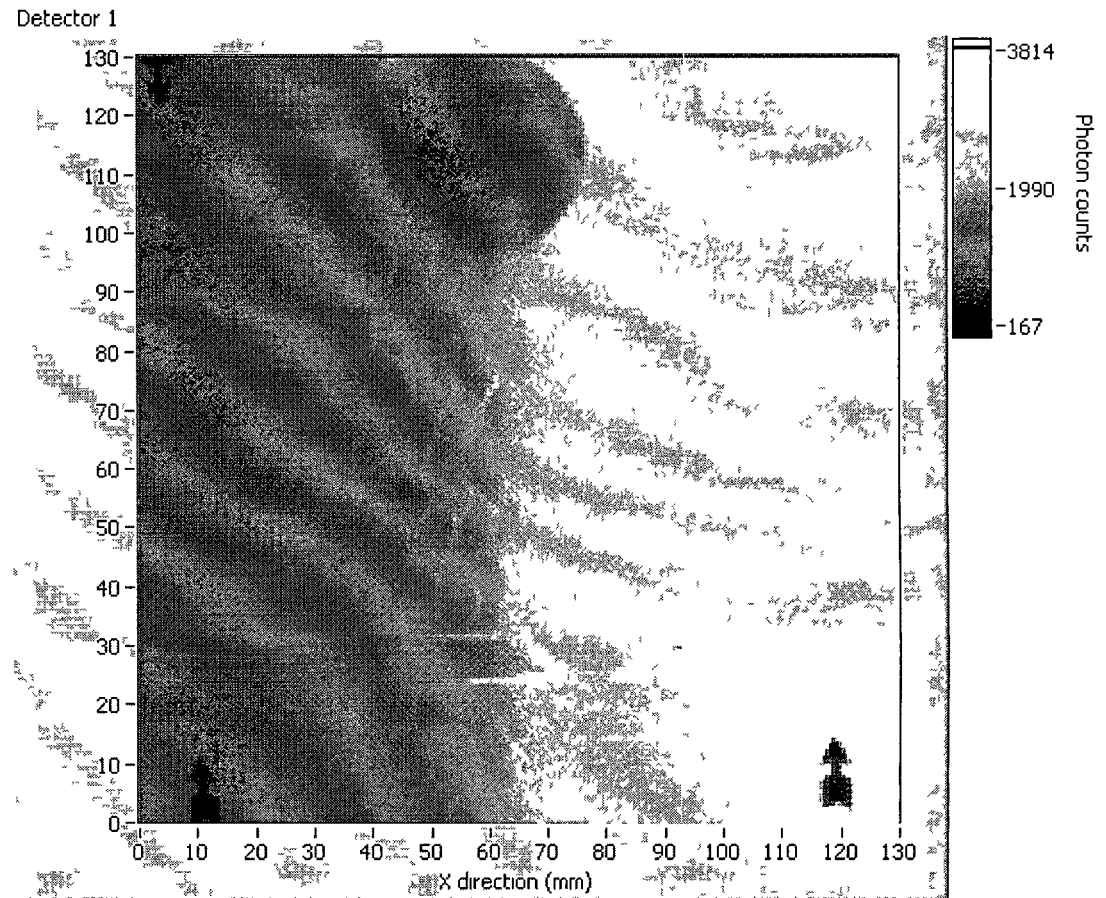
SCAN PARAMETERS

- Apollo sample A19731423005 was scanned 0.52mm step size with 0.75mm aperture at a scan rate of 10mm/s
- X-Ray parameters were 115kV and 15mA
- Fin settings were at 90 degrees with sleeves at 1.25" height

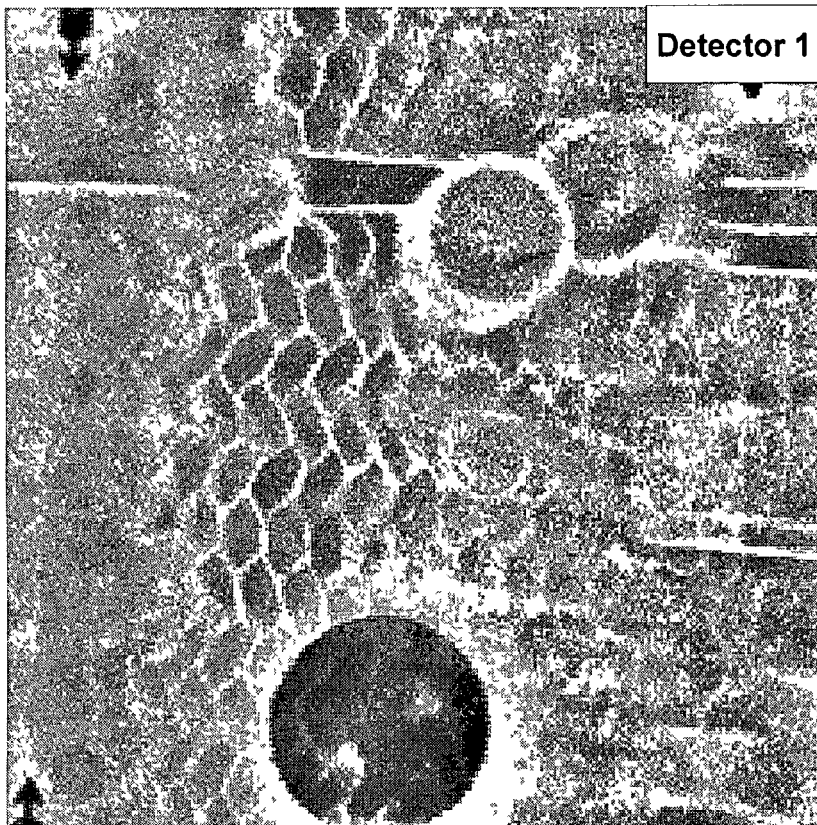
IMAGE RESULTS Area 1

- Images were processed using FFT band pass filter and contrast enhancement
- Able to see through Avcoat sample using 115kV unlike in previous Avcoat Piece

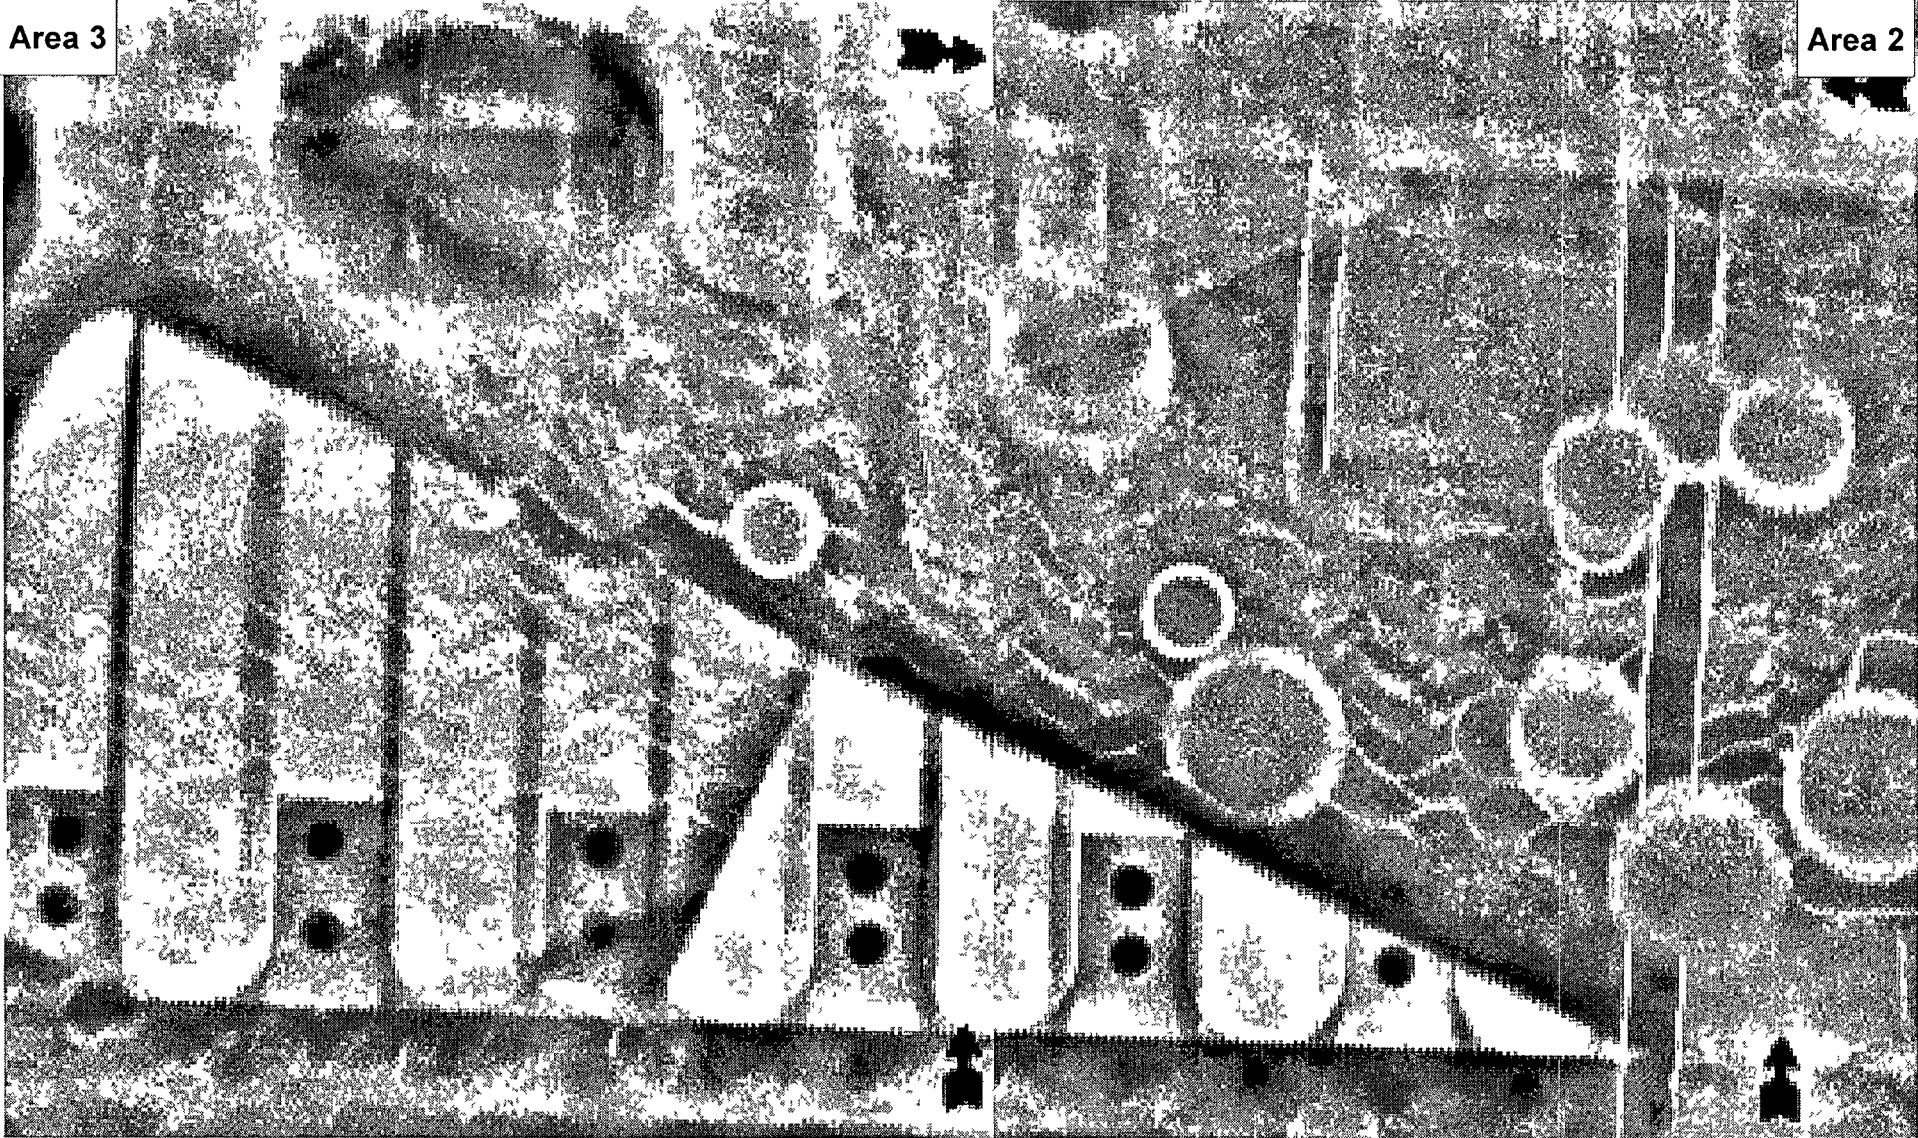
BSX Image results Area 2 and 3

Combination of scans show large triangular area due to wooden shim underneath sample
