Avionics Box Cold Plate Damage Prevention

Lecture

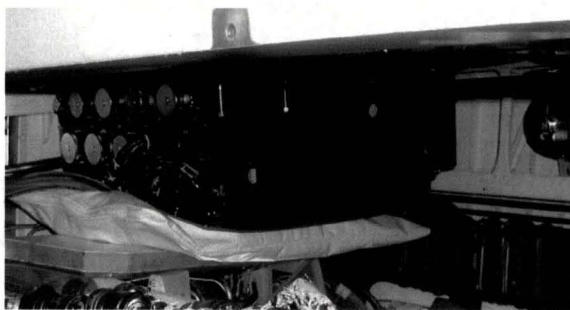
Figure 8 Air Bag Method

The airbag method utilizes an inner tube enclosed in a bag along with associated hardware. The box is still manually lifted into the opening, but the airbag aids in lower/lifting the box to the cold plate. This method is only useful on LRUs that hang under the shelf. The Airbag must be checked before use for operation and lifting capability. The airbag is inflated to lift the LRU to the receiving cold plate surface during installation, and deflated to lower the LRU away from the cold plate during removal. The potential causes of damage are uneven contact of the LRU to the cold plate if the LRU mating surface does not remain parallel with the cold plate during lifting, and incidental damage to flight hardware that supports the weight of the LRU on the airbag. Unexpected LRU movement during fastener removal is another potential cause of damage. The air bag should fully support the LRU. See Figure-8

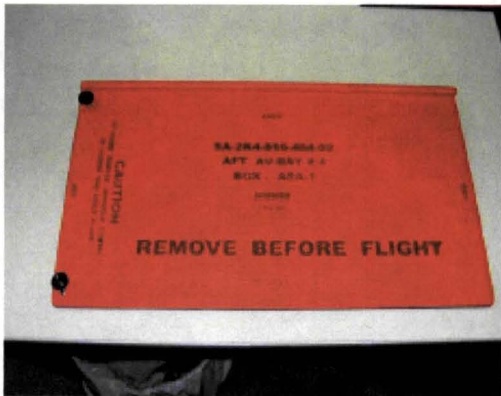
Figure 10 Cold Plate Cover

New OMI's have been developed such that all disciplines that author cold plate mounted LRU R&R procedures use these new procedures for consistency regarding added cold plate protection techniques. These new procedures address the four methods of LRU R&R. These procedures include steps for engineering to conduct a Pre-Task Briefing prior to each LRU installation or removal. These briefings are to ensure that the all disciplines (Shop, Quality, and Engineering) have reviewed the WADs, agree on the proper installation method, and understand the instructions. The steps also include that engineering is present for all first time LRU installations, and that the protective covers are used for all vehicles (See Figure-10).

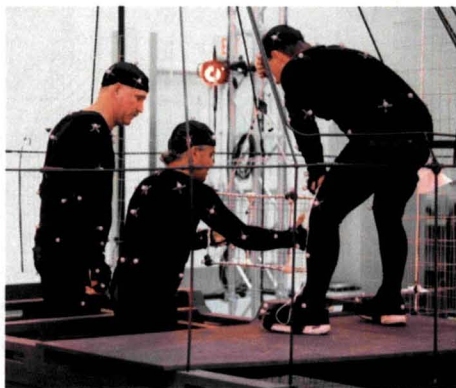
Figure 12 Recent Study on Orion Avionics Boxes

Most recently for the Orion vehicle motion capture is being used to design the avionics box and cold plate configuration for boxes lowered into the floor. [4, 5] The computer models include the CAD flight hardware and human Avatars. The envelope spaces between the human the avionics shelf and the box and avionics shelf can be viewed and the stresses to the human can be determined. These kinds of studies help us

to determine the best design solution for installing the boxes. See Figure-12
