Highly Loaded Composite Strut Test Development

K. Chauncey Wu*

NASA Langley Research Center, Hampton, VA 23681

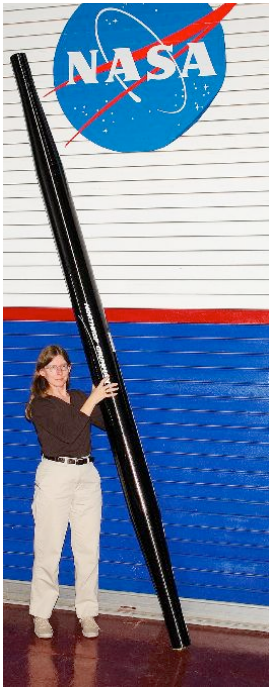
Figure 2. Composite struts.

2a. Long strut.

2b. Short struts.

The composite struts shown in Figure 2 were tested in both tension and compression to demonstrate the test capability's readiness for evaluating the struts described in Refs. 5 and 6. Since these struts were fabricated as manufacturing demonstration hardware rather than test articles, they were deemed to be appropriate for this purpose. While tension test results are not presented here, these tests were all concluded successfully with no external indications of failure in the struts or test hardware. Measured displacements and strains from compression tests of the long and one of the short composite struts in Figure 2 are presented and discussed in this section. The long strut, shown during its compression test in Figure 19, buckled elastically at a maximum load of -103.6 klb into a half-sine wave mode shape. The short strut also buckled elastically at -27.4 klb, which is shown in Figure 20 (note the large lateral deflection at the strut mid-length). Note that these figures are not shown to the same scale. After the applied displacement was released, the struts returned to approximately their untested geometry, with no external indications of failure in the struts or test hardware.

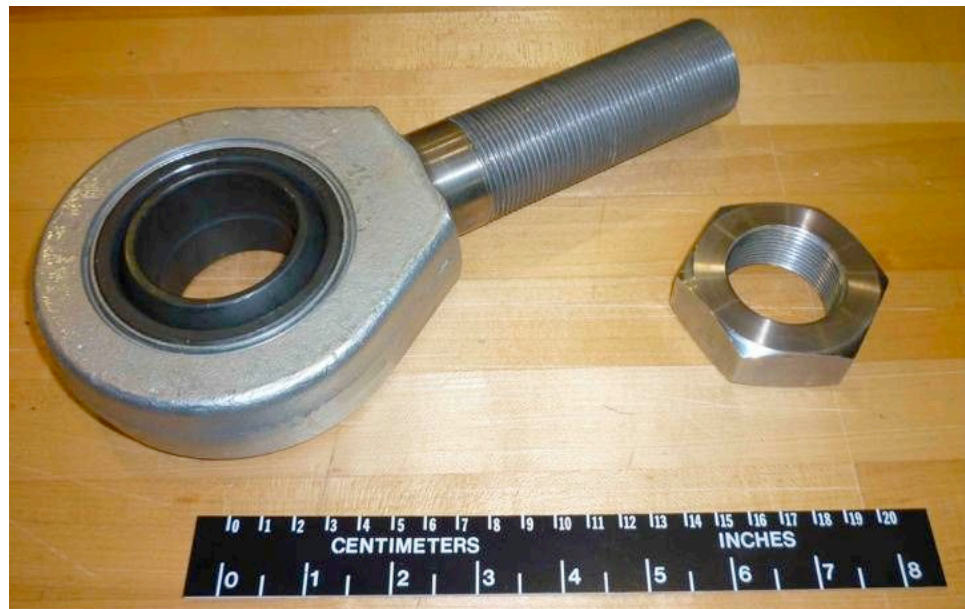
Figure 3. Rod end bearing test fitting.

Further consideration of these options led to selection of commercial, high load-capacity rod end bearings with an internal spherical bearing and supporting race (Figure 3) for development as test fittings.

The threaded studs on these test fittings were then machined to match the threads inside the composite strut ends, and a jam nut (shown in the figure) was used to prevent their relative motion. These test fittings allowed free rotation in three orthogonal axes about a common point (the spherical bearing center), while also preventing translation of that point. Because they do not constrain free rotation of the strut ends, these test fittings should be insensitive to alignment of the strut geometric imperfection, as well as any rotational misalignment between the upper and lower strut ends. Since the strut was loaded through applying an

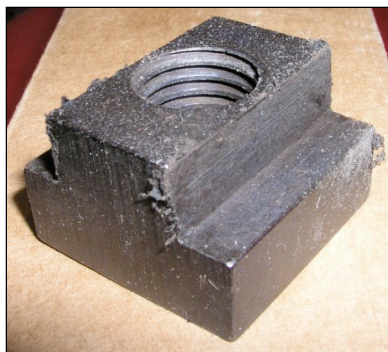
7a. T-nut hardware.

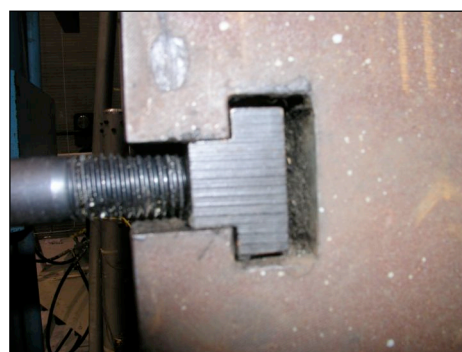
7b. T-nut and bolt in T-slot.

The test hardware was mounted to a stiff, steel backstop to react the loads applied to the composite struts. This permanent backstop was tall enough to accommodate the entire range of strut lengths. T-slots, evenly spaced on 3-inch centers and seen in Figures 5 and 6 as the black horizontal lines, allowed great flexibility in positioning the test hardware. T-nuts (Figure 7a) were placed into the T-slots, and stock bolts were threaded into the T-nuts to attach the various components, as shown in Figure 7b.

To further reduce the deadband between the T-nuts and the T-slots of the backstop (shown in Figure 7), the threaded studs shown in Figure 18 were installed. The diameter of these threaded studs were much closer to the upper bracket hole diameter, so they had much smaller clearances in the T-slots. This reduced clearance limited the potential for bolt bending or rotation, but also made them much more difficult to install in the backstop. Therefore, the threaded studs were used to replace only the two lowest, most heavily loaded, bolts at the bottom of the upper bracket. The conical washers described above were installed between the upper bracket and the nuts, and the nuts were torqued on the threaded studs.

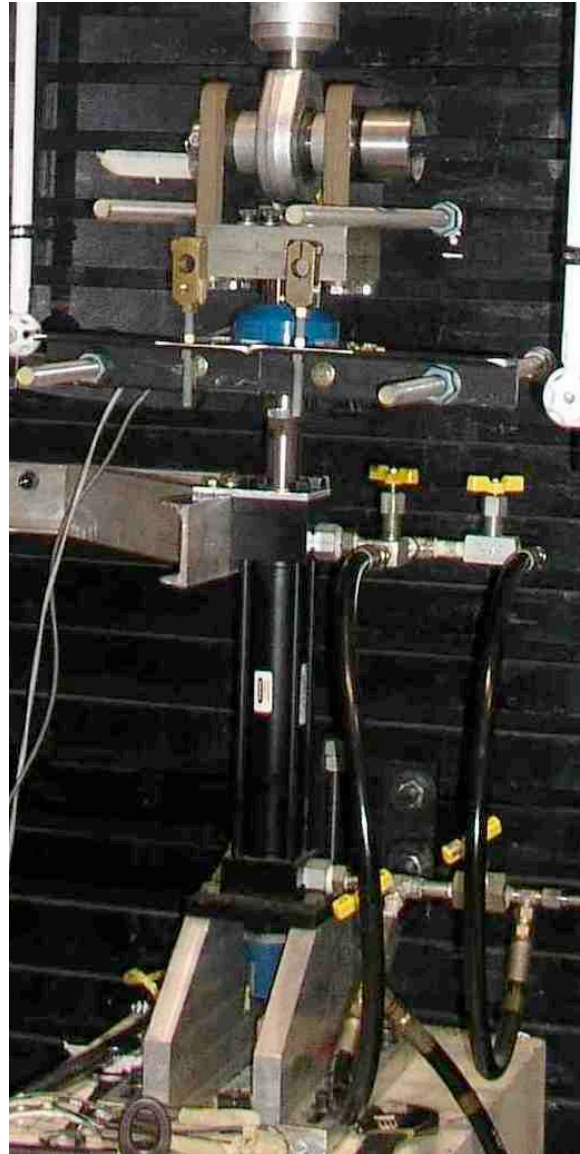
Figure 9. Hand-operated hydraulic actuator for lightly loaded strut tests.

To test the lightly loaded struts discussed in Refs. 8 and 9, the hand-operated hydraulic actuator shown in Figure 9 was installed, replacing the large actuator in Figure 8. This much smaller system could apply axial forces to the struts of up to 10 klb in either tension or compression. Except for some additional supports used to prevent undesirable rotation or translation of the lower clevis and actuator, the structural elements used during the lightly loaded strut tests were identical to those developed for the heavily loaded strut tests described herein.

Two separate load cells were installed to accommodate the different load ranges anticipated for the tests. A small, 50 klb-capacity temporary load cell was used to monitor the axial load in struts with lower failure loads, and the permanently installed 225 klb-capacity load cell was used to monitor the load applied to struts designed to support higher loads. For tests at lower loads, the lower clevis and small, 50-klb load cell were connected in series to the large, 225-klb load cell using two threaded adapters, as shown in Figure 6a. When the heavily loaded struts were tested, the 50-klb load cell was removed to prevent it from being damaged, and the lower clevis was attached directly to the 225-klb load cell with a single threaded adapter. During the lightly loaded strut tests, the lower clevis and 50-klb load cell were mounted directly to the hand-operated hydraulic actuator, as shown in Figure 9.

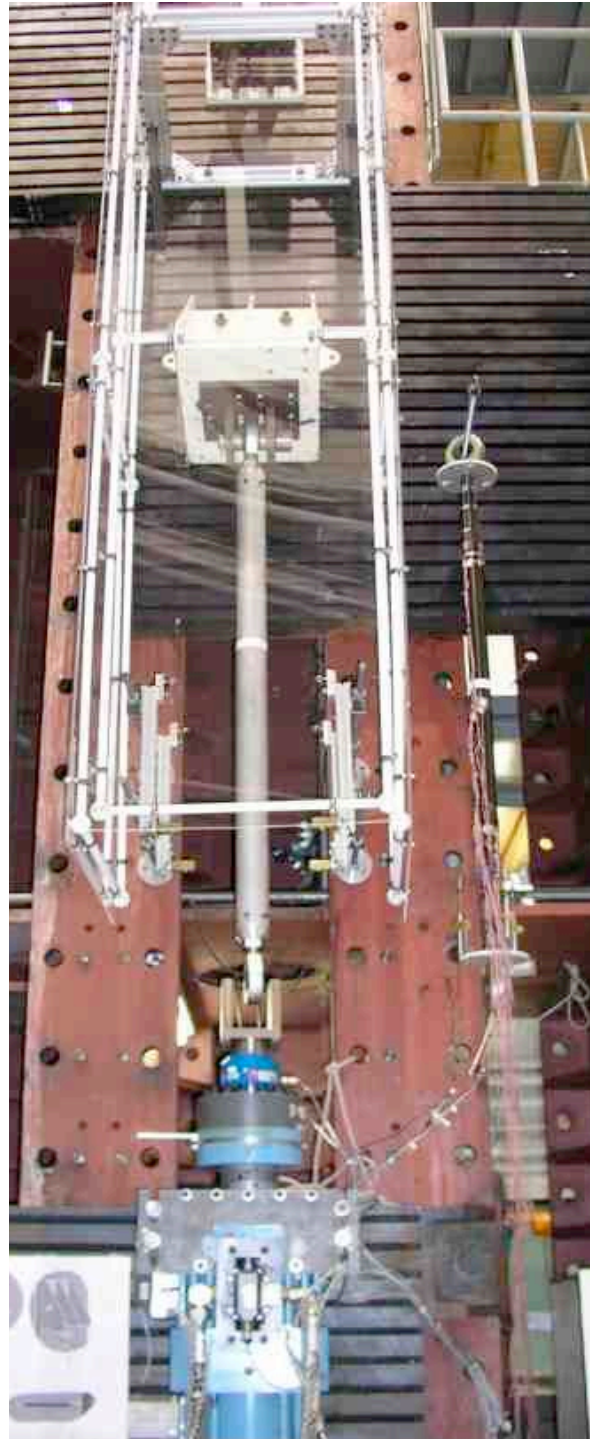
Figure 13. Plexiglass safety shield.

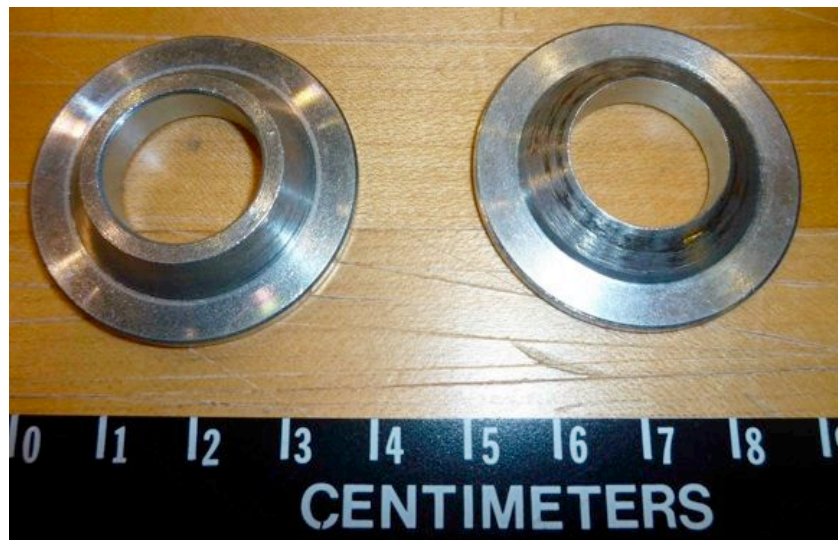
Figure 17. Conical washers (left - original; right - modified).

To reduce these clearances, conical washers were purchased and machined to reduce the smaller diameter of the truncated cone, as shown in Figure 17. These modified washers then fit better into the upper bracket holes and took up more of the clearance, and thus helped to prevent the bracket from moving as freely around the bolts. This problem arose in part because not all of the T-nuts were threaded completely through. Some T-nuts were only partially threaded to prevent the bolt from passing through the T-nut and damaging the back of the T-slot, so it was important to make sure that the bolt was being tightened against the conical washer and upper bracket, instead of bottoming out into the T-nut.

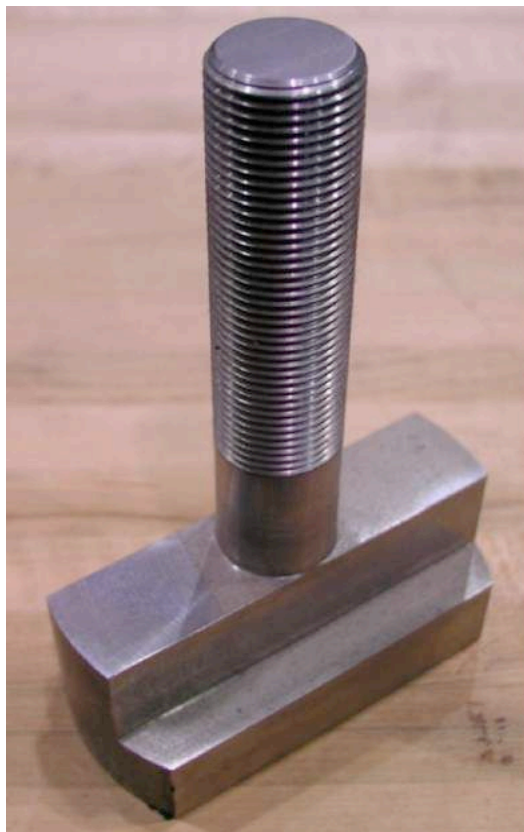
Figure 18. Threaded stud.

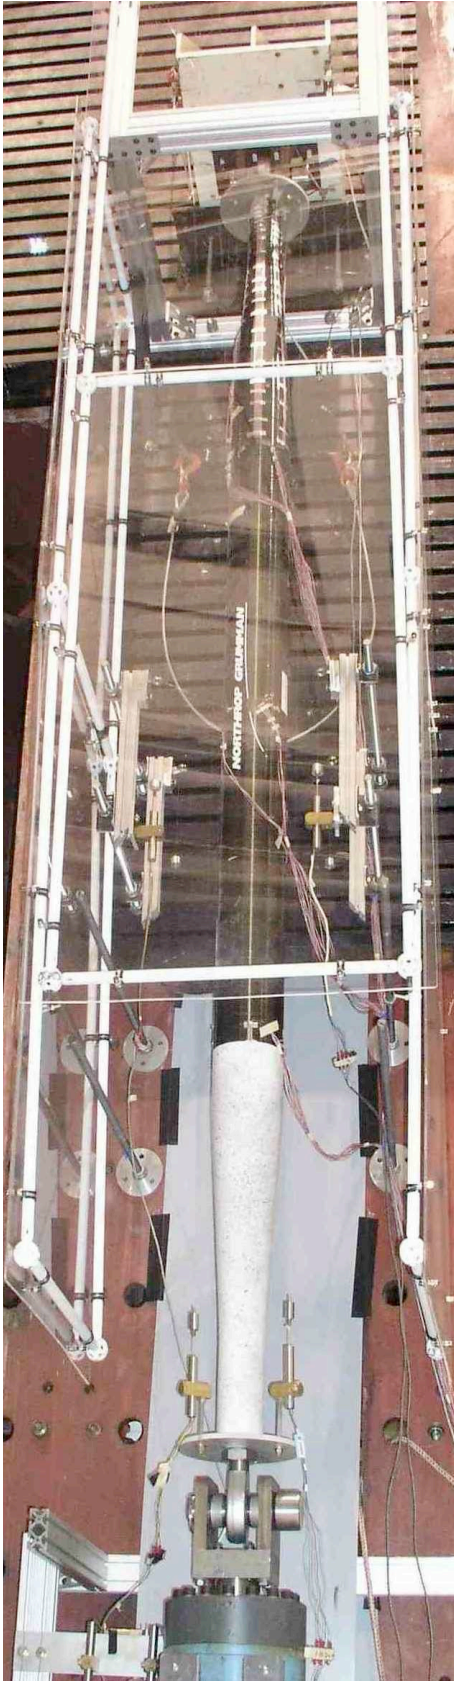
Figure 19. Long strut test.

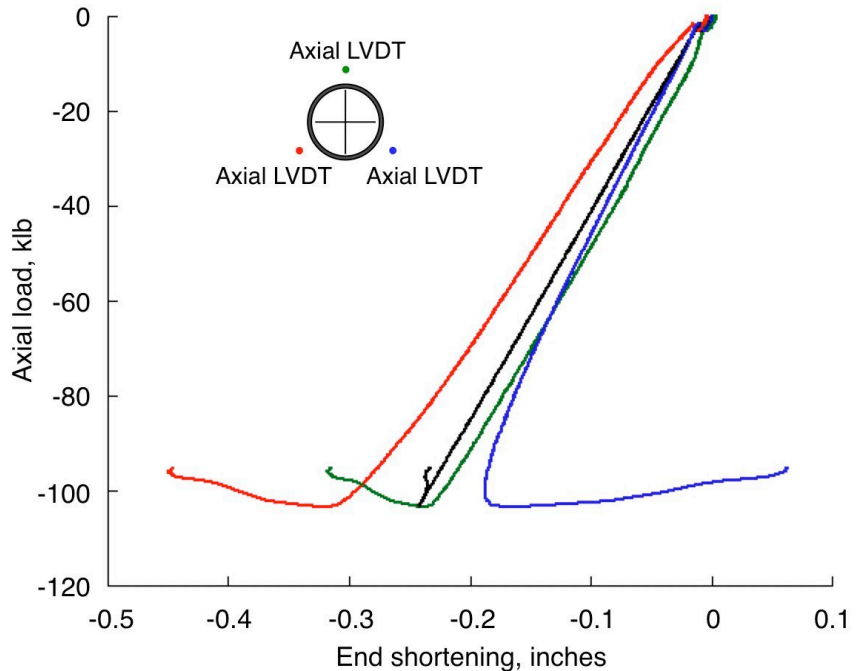
Figure 21. Long strut axial load vs. end shortening.

To evaluate the long strut's structural performance, the measured compressive axial loads are plotted versus the strut axial end shortening in Figure 21. Three end shortening measurements, shown with different colors, were taken around the strut circumference using the LVDTs shown in Figure 6a. The three LVDT measurements were roughly linear up to buckling at -104 klb, and then diverged rapidly thereafter. These trends indicate that relatively little global bending was occurring in the strut prior to buckling. The plotted responses also showed some initial discontinuities at loads below -5 klb. These are thought to be due to internal debonding of the strut end fittings. The overall strut axial stiffness of 439.83 klb/inch is calculated from the best-fit slope of the linear load versus average axial displacement response, which is shown in the figure as a solid black line.

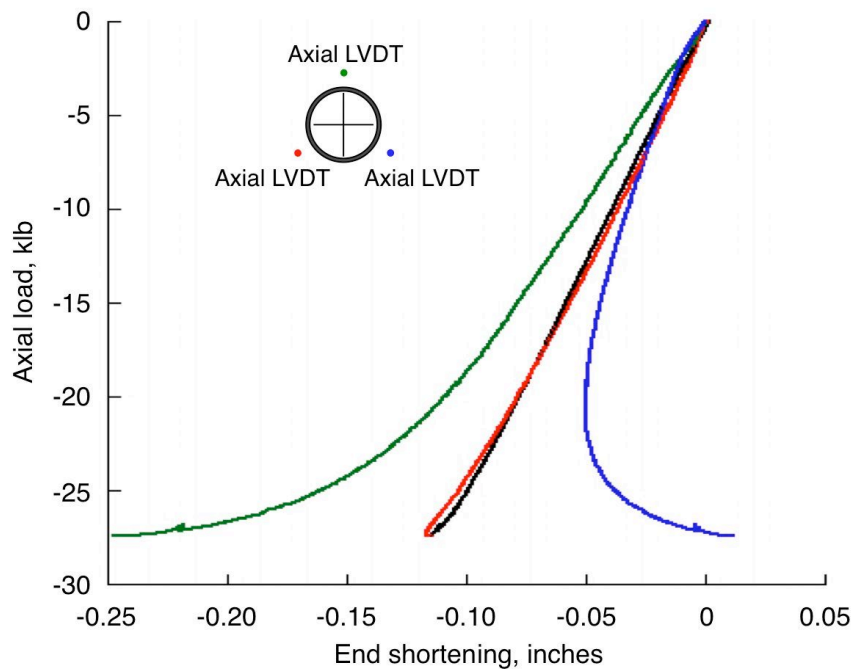
Figure 24. Short strut axial load vs. end shortening.

The measured axial compressive load versus axial end shortening is shown in Figure 24 for the short strut test. The three individual displacement measurements diverged gradually with increasing load, and then asymptotically approached the -27 klb buckling load. The large differences between the individual displacements indicated that significant global bending was occurring in the strut before failure, and suggest that this strut had a larger initial geometric imperfection (relative to its length) than the long strut. The overall axial stiffness of the short strut is 254.21 klb/inch, as calculated in the same manner described previously for the long strut. The average axial displacement is shown in the figure as a solid black line.

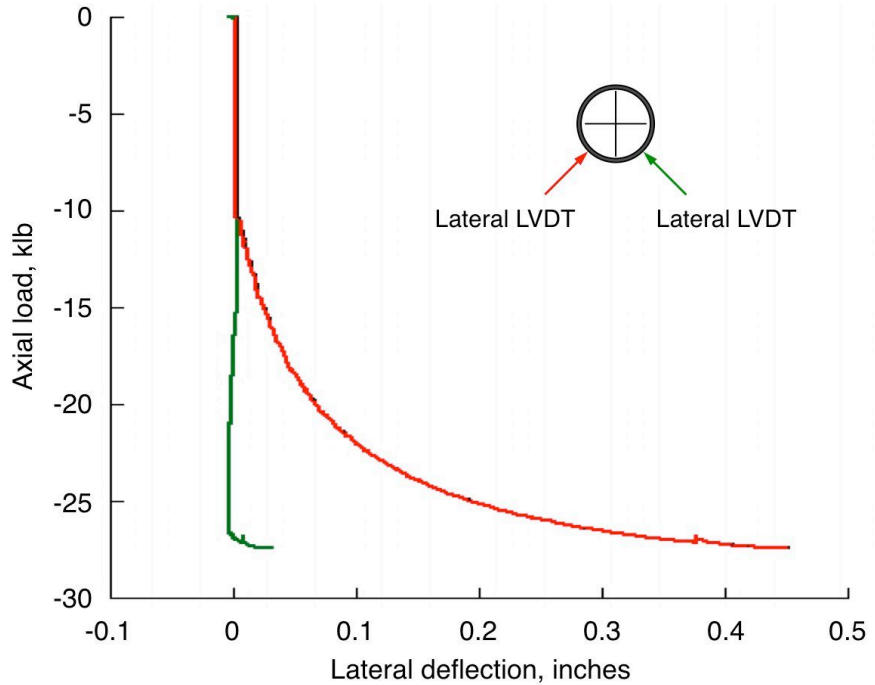
Figure 25. Short strut axial load vs. mid-length lateral deflection.

The measured lateral deflections at the strut mid-length are plotted as red and green lines against the compressive axial load in Figure 25. The vector sum of the two individual mid-length lateral deflections, shown in the figure as a black line, is hidden by the red deflection trace. The asymmetry of the plotted deflections suggests that effectively all of the strut bending was occurring in a plane that contains only one of the two measurements. When considered with the data in Figure 23, these results demonstrate that the test fittings developed here did not force the strut to buckle in a specific

orientation with respect to the clevis pins. The high prebuckling ratio of lateral deflection to strut length of roughly 1/120 (or 0.5 inch/60 inches), is indicative of significant global bending before buckling of the strut, again likely due to its relatively large initial geometric imperfection.

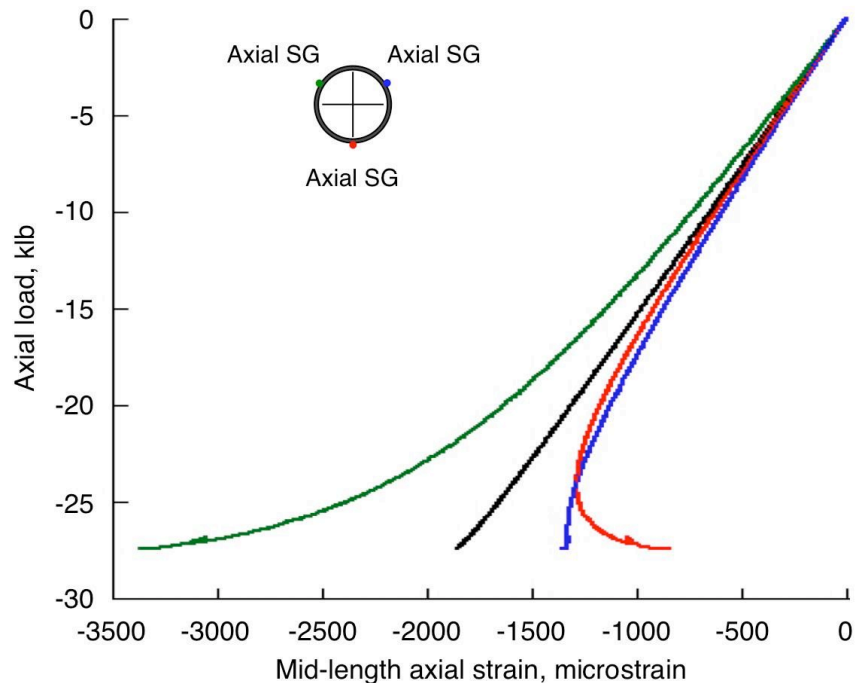
Figure 27. Short strut axial load vs. mid-length axial strain.

The strut compressive axial load is then plotted against the mid-length axial strain in Figure 27 for the short strut. The average slope of the load versus the linear average axial strain is shown in the figure as the solid black line, and is equal to 15.14 Mlb. The computed bending strains all increase from zero up to about ± 50 percent of the axial strain when the strut buckles. The larger contribution of bending to the structural response of the short strut may be a result of its larger initial geometric imperfection.
