The Orion Pad Abort 1 Flight Test A Highly Successful Test

The Orion Pad Abort 1 (PA-1) flight test was designed as an early demonstration of the Launch Abort System (LAS) for the Orion capsule. The LAS was designed developed and manufactured by the Lockheed Martin/Orbital Sciences team. At inception it was realized that recovery of the Orion Capsule simulator would be useful from an engineering analysis and data recovery point of view. Additionally this test represented a flight opportunity for the Orion parachute system, which in a real abort would provide final landing deceleration.

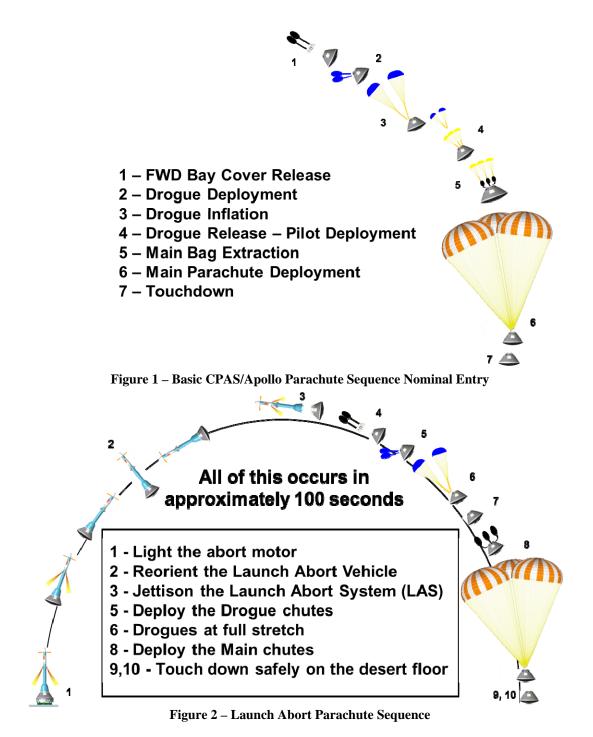
Figure 2 provides an illustration of this sequence.

- 1) Drogue parachutes for deceleration and capsule stabilization
- 2) Drogue release followed by pilot parachute deployment (mortars)
- 3) Main parachute deployment by pilot parachutes
- 4) Descent under main parachutes

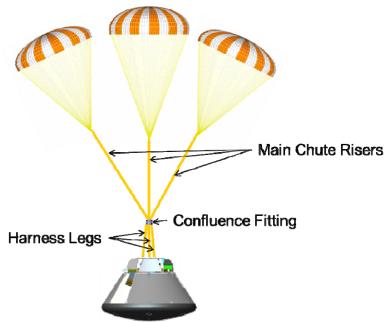
At the time of CPAS inception into the PA-1 program, the Orion landing baseline was land landing on airbags. This required a rather flat hang angle of the capsule under parachutes and the necessity of a harness and confluence system to provide the flat hang angle under main parachute. Figure 3 provides a schematic of the harness and confluence system required to provide the desired hang angle.

Figure 3 - Schematic of Harness and Confluence System

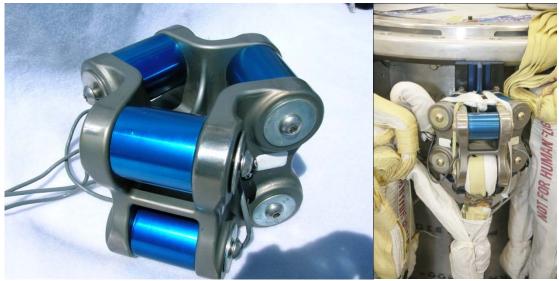
While this configuration differs from the final Apollo configurations, it is not without precedence. The early Apollo Block 1 systems used a very similar system. Unfortunately, the Apollo program experienced a rather spectacular failure in early testing and quickly moved away from confluence fittings. That being said, the PA-1 flight was set on this path and changing to another attachment scheme represented impacts to the parachute system and the spacecraft simulator structure. And at this time, this remained the baseline for the objective spacecraft. One specific challenge was the stowage and deployment of the confluence fitting which is discussed below. Figure 4 presents a pair of photos, one of the basic confluence fitting and another of the fitting stowed in the PA-1 spacecraft simulator as rigged for flight.

Figure 4 -Confluence Fitting and Fitting Stored in Spacecraft

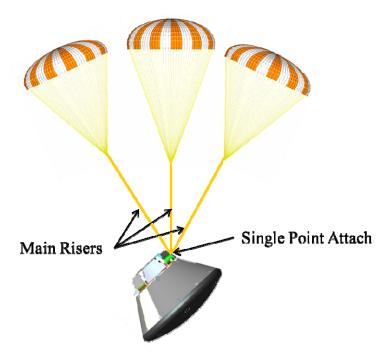
This requirement suggests a single parachute attachment point to the spacecraft (ala Apollo) rather than the harness arrangement employed for PA-1. This approach greatly simplifies the parachute rigging, perhaps provides some additional capsule dynamics, but in general in a reliability enhancement over the harness/confluence fitting approach. Figure 5 provides a schematic indicating the single point attach and the spacecraft hanging from a single point.

Figure 5 - Single Point Parachute Attachment Schematic

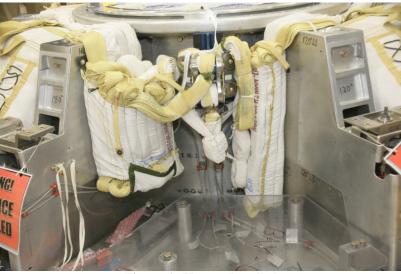
occur again and any improvements would be discussed. Some changes were not only to the vehicle but to the CPAS system itself. For example it was found that during installation, the harness leg stowage bag hung down much lower in the PA-1 vehicle due to the location of other subsystems in the area. A design change was made to include a keeper that was added to the harness leg stowage bag to pull it free from interference. That keeper can be seen in Figure 6.

Figure 6 - Keeper Installed

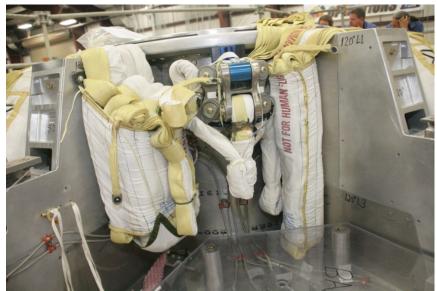
The stowage and deployment of the main parachute confluence fitting involved a tray to mount the system and stowage tie and release system (Figure 7). This was a concern due to the significant vibration environment created by the launch abort motors. Additionally, the deployment of the main parachute harness and confluence fitting represents a significant problem in parachute energy management. If the parachute deploys and begins to inflate before the confluence is deployed and the harness is erected, significant inertial related loads can be created and these can exceed the basic design loads for the parachute system.

Figure 7 - Main Parachute Confluence Fitting in its Stowage Location.

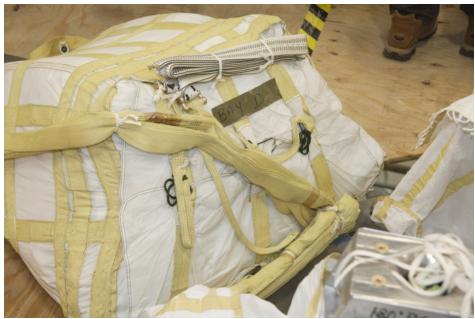
In the end two risk mitigations were employed. The first was a set of tear webbing attenuators which provided a reduced but positive force to deploy the confluence fitting and erect the main parachute harness. While bulky, and rather inefficient, these devices helped to manage the inertial loads during this critical portion of the main parachute deployment. Figure 8 presents a view of these during integration for the PA-1 flight test.

Figure 8 - Main Parachute Confluence Fitting with Attenuators
