**Structural Verification of the First Orbital Wonder of the World – The Structural Testing and Analysis
of the International Space Station (ISS)**

John J. Zipay / Deputy Branch Chief, Structures Branch

NASA-Lyndon B. Johnson Space Center, Houston, TX.;

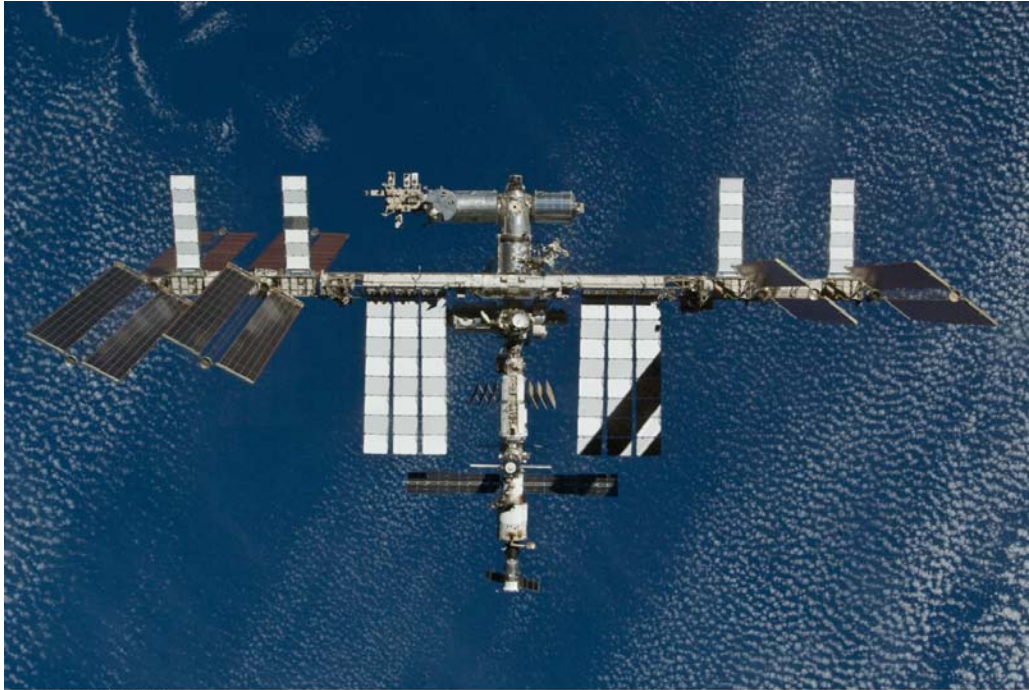
Figure 1 – The International Space Station (ISS) as seen during the fly-around of the Space Shuttle Atlantis (OV-104) during the STS-132 mission in May, 2010.

The ISS (Figure 1) is composed of pre-integrated truss segments and pressurized elements supplied by NASA, the Russian Federal Space Agency (RSA), the European Space Agency (ESA) and the Japanese Aerospace Exploration Agency (JAXA). Each of these elements was delivered to orbit by a launch vehicle and connected to one another either robotically or autonomously. The primary structure of each element was assembled and verified by teams of responsible structural engineers within and among their respective agencies and agency contractors. This paper is primarily focused on the structural

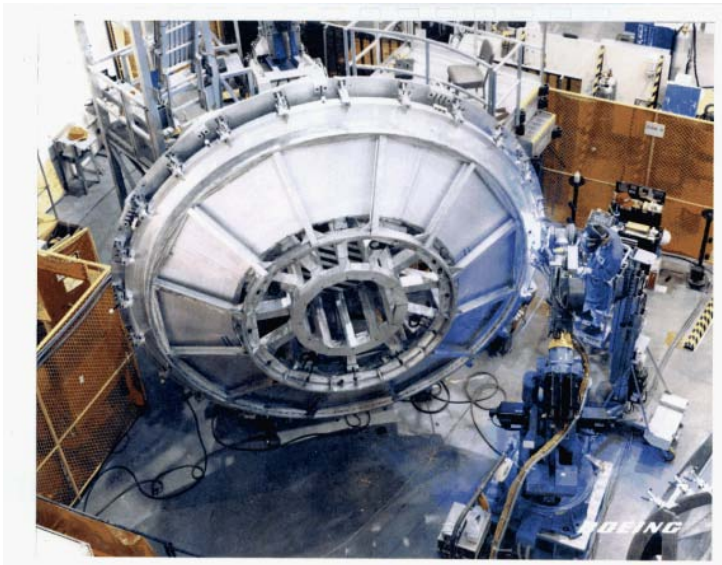
Figures 5 –Overview of welding fixture at The Boeing Company, Huntsville, AL.

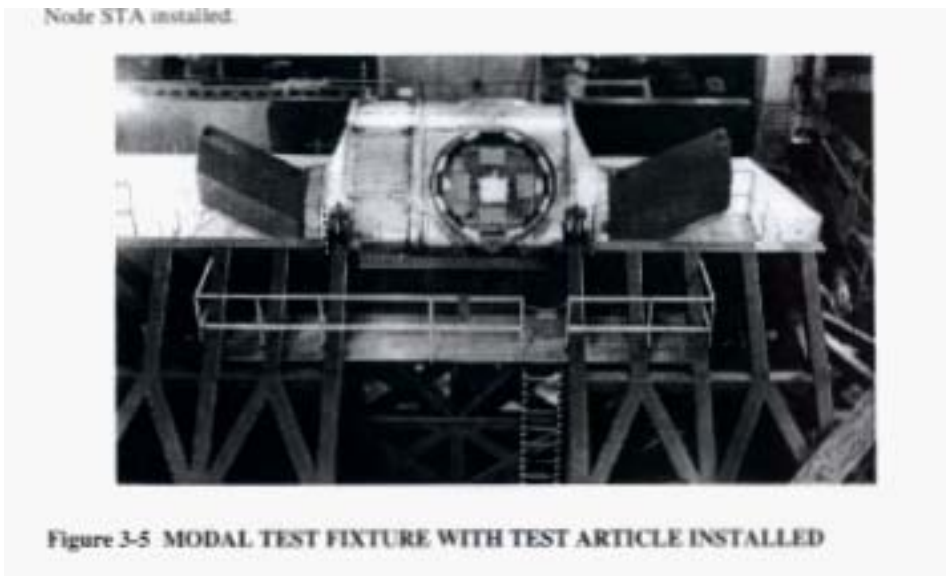
Figure 47 – Node STA with PMA mass simulators on each end installed in the Modal Test Bed.

The Node 1 STA was then lifted from its static test fixture and moved to the adjacent Space Shuttle Payload Modal Test Bed in Building 4619 (Figures 47 [15] and 48 [16]). During this operation, the facility crane stalled, leaving the Node STA hanging twenty feet in the air over the modal test fixture. The crane was fixed the next morning and it was determined that this prolonged hang load did not cause any damage to the test article. For the modal test, a 3200 lb mass/c.g. simulator was attached to both the forward and aft axial ports of the Node STA to represent the PMAs which would be attached to the Node 1 for launch in the Orbiter. A full modal test campaign including sine sweep and driving-point impedance testing on one axial and one radial port was undertaken in order to provide a verified Craig-Bampton-reduced model to both the Shuttle Program for verification coupled loads analysis of the ride to orbit and to the ISS Program for incorporation into the integrated ISS dynamic model used for on-orbit loads development. Pre-test predictions for the launch configuration (Figure 49) [17] and the configuration of the Node berthed to the Orbiter Docking System (Figure 50) [18] were performed and correlated with the modal test results. An excellent detailed discussion of the modal testing of the ISS

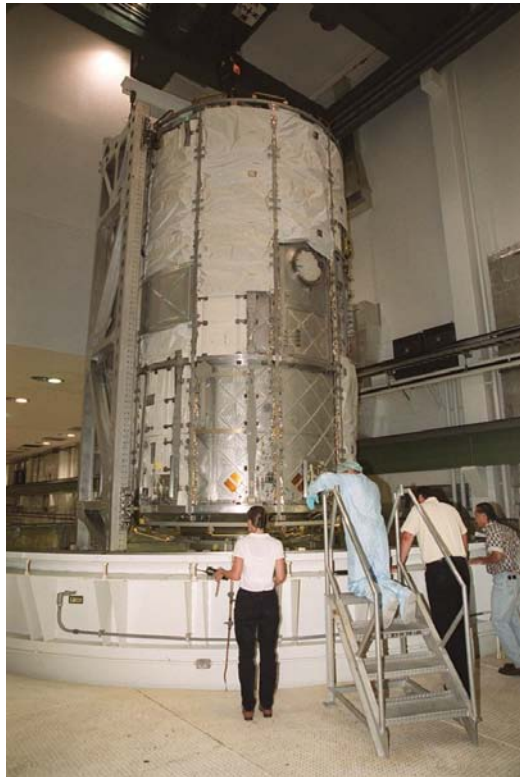
Figure 63 – U.S. “Destiny” Laboratory being lowered into KSC vacuum chamber for element leak testing (Isogrid skin panels and nadir window installation are visible).

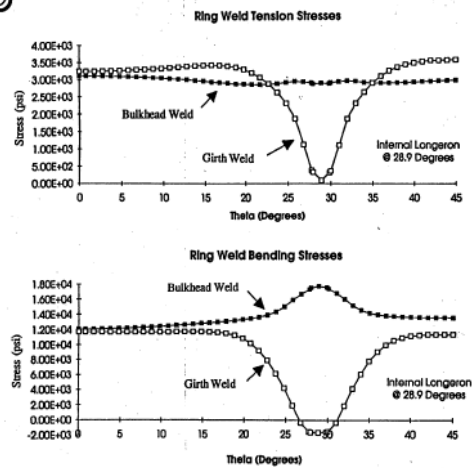
(2) & (3) Fwd/Aft Ring Girth and Bulkhead Welds

Figure 75 – Stresses in Forward and Aft Ring Girth and Bulkhead Welds for the CM STA with weld mismatch included.

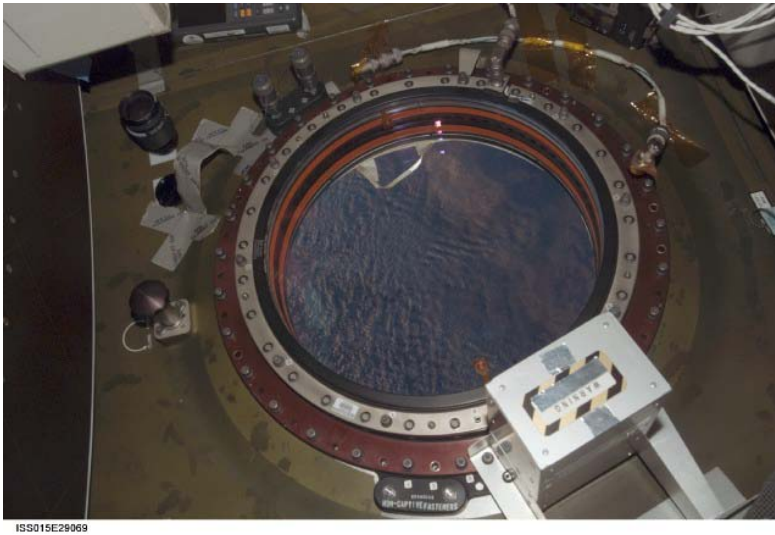
Figure 78 - "Destiny" Laboratory 20" diameter nadir-facing windows with flex hose cover installed.

Since glass is subject to static fatigue, a fleet leader window of identical construction as the Lab 20" window was built and has been under 15.2 psid pressure at the NASA-Lyndon B. Johnson Space Center's Structures Test Lab since the year 2000 (Figure 86 and 87). It is periodically inspected for flaws and leak tested. The fleet leader window has remained in excellent condition while the U.S. Lab window is periodically inspected on-orbit for flaws. As described above, the debris pane which covers the exterior of the Lab window and the scratch pane which covers the interior of the Lab window are present on-orbit to prevent incidental damage to the redundant pressure panes from micro-meteoroids and orbital debris as well as crew-induced damage. The only maintenance activity that has had to be performed on the Lab window on-orbit to-date involved replacing a leaking flex hose that is used to keep the cavity between the two panes at vacuum. The flex hose was inadvertently damaged and was replaced on-orbit. A protective cover was installed over the flex hose to prevent any recurrence of this problem.

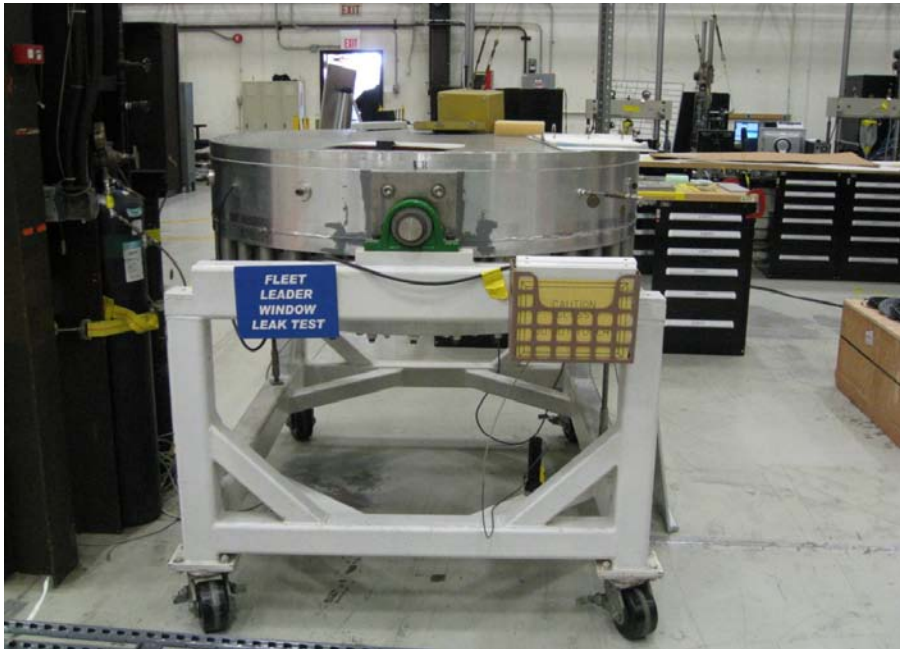
Figure 86 – Fleet leader window test article currently residing in the Building 13 Structures Test Lab at NASA-JSC.

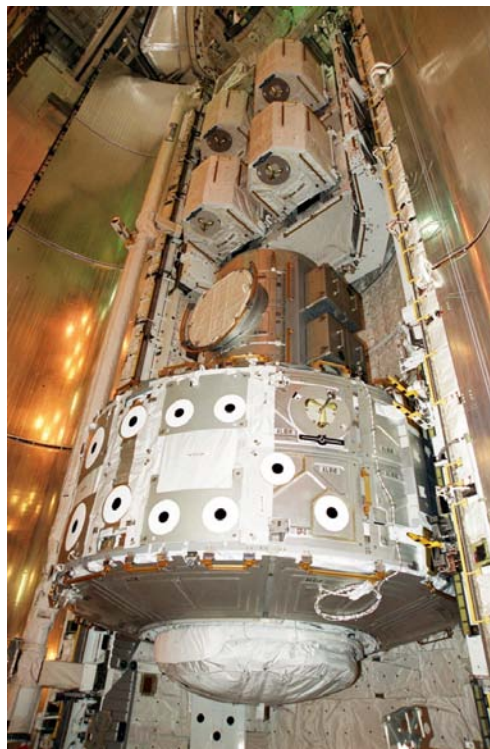
Figure 114 – STS-104 cargo element in the Orbiter Payload Bay (Four HPGT's on their carrier are shown at the top of the photo).

The HPGT themselves are Composite Overwrapped Pressure Vessels composed of carbon-fiber/resin with stainless steel liners. These tanks were proof-pressure tested to 1.5 x MDP and their stress-rupture life was calculated. About a decade after they were launched, concerns were raised regarding the stress-rupture life of composite overwrapped tanks used on the Space Shuttle and the ISS. (Composite Overwrapped Pressure Vessels (COPVs) are also used on the ammonia and nitrogen tanks on the S1 and P1 trusses as well as in the Plasma Contactor Xenon tank on the Z1 truss.) After extensive analysis and testing, the stress rupture life issues for the ISS COPVs were resolved.

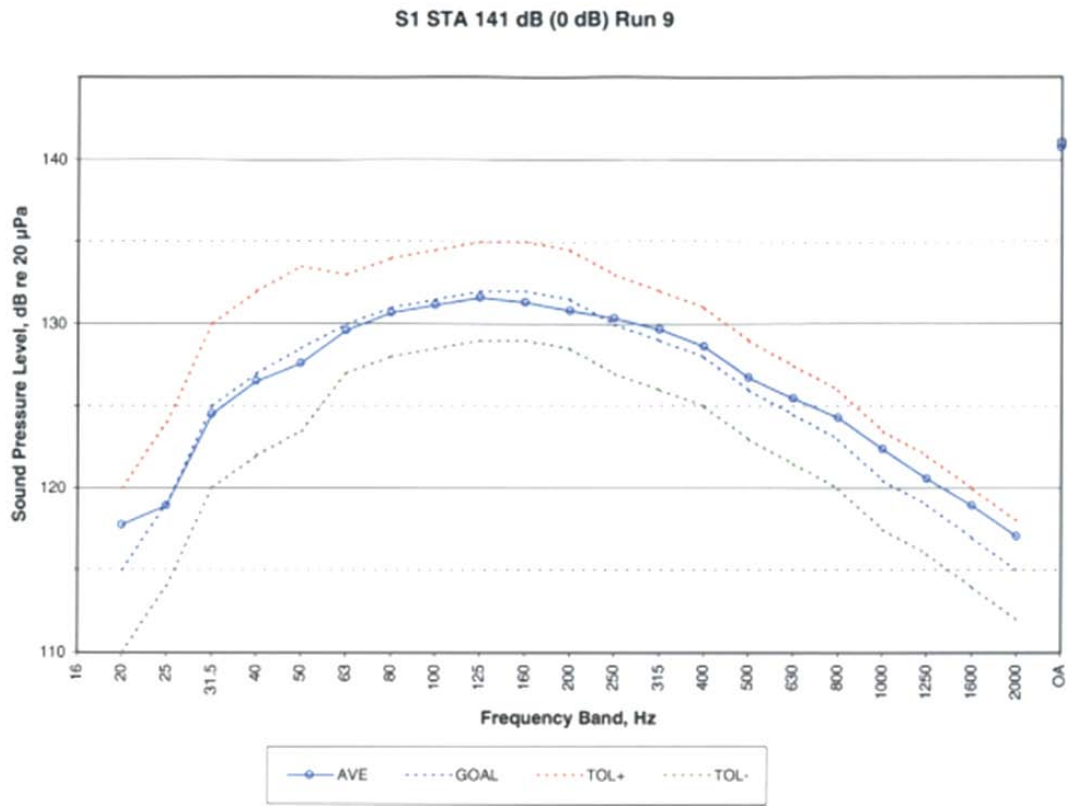
Figure 155 – S1 STA Acoustic Test Environment (+10% contrast again).
