42nd AIAA Thermophysics Conference, Honolulu, Hawaii, June 2011.

Fracture in Phenolic Impregnated Carbon Ablator

Parul Agrawal* and Jose F. Chavez-Garcia†

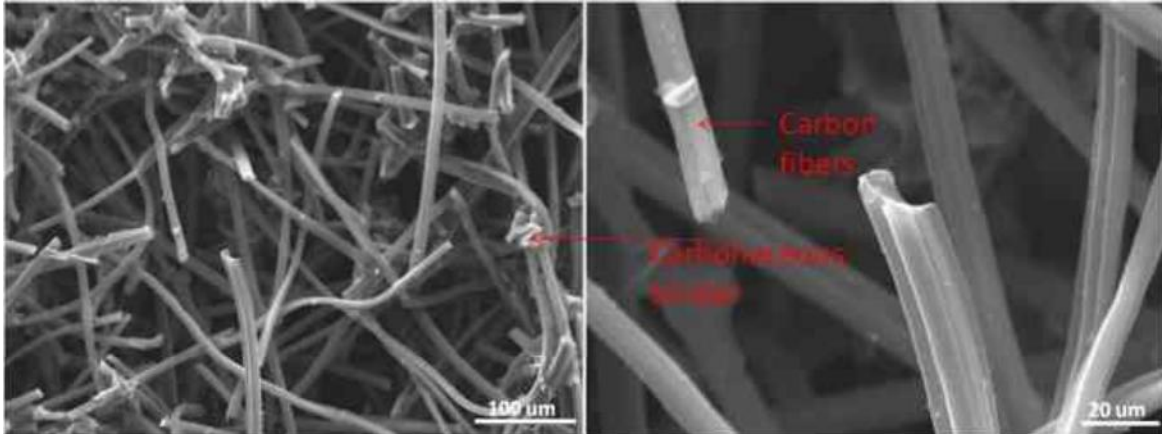
Figure 1: Micrographs of FiberForm at different magnifications.

FiberForm is a low density very porous carbon fiber insulation material designed for high temperatures applications. It is processed at Fiber Materials Incorporated (FMI) and is the precursor substrate for processing PICA. Micrographs of FiberForm at different magnifications are shown in Figure 1. It consists of a group of carbon fibers bonded to each other by means of an organic binder that is carbonized at very high temperature. After carbonization, all the organics evaporate and only a thin carbonaceous phase remains as the binder that holds the fibers together. The binder concentration varies and, in some places, there are smaller concentrations while in other places there is a fairly large group of fibers bound together. Some cross-linking that joins the fibers together and makes it a rigid preform also takes place during the processing. Each individual strand of carbon fiber consists of 5-6 individual fibers of diameter 5-6 μm that are joined together as shown in the higher magnification micrograph of Figure 1. The carbon fibers in FiberForm are oriented preferentially in one plane, as a result of the manufacturing process, making it a transverse isotropic material with different material properties in through-the-thickness (TTT) and in-plane (IP) directions. The IP strength and stiffness of FiberForm is significantly higher compared to the TTT direction. This material was tested first in the in-plane direction to obtain tensile strength and understand the failure mechanism.

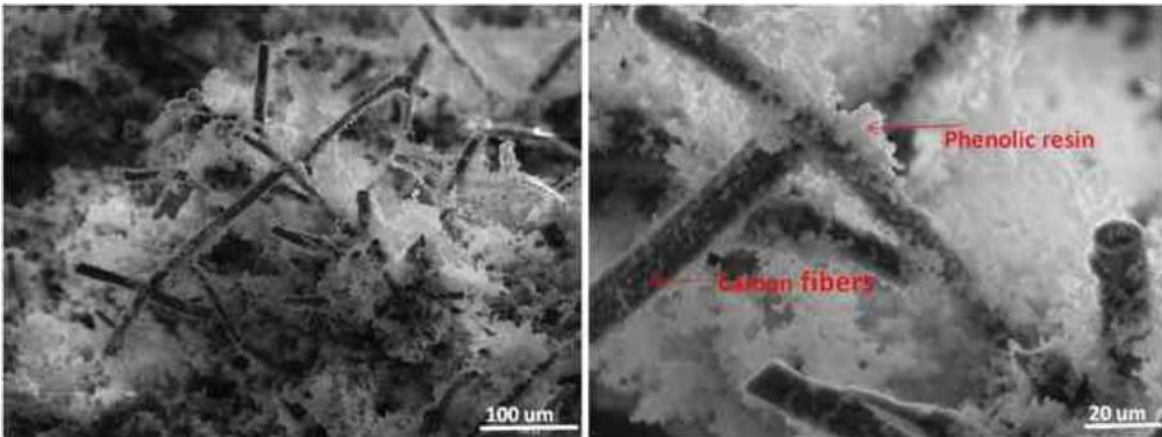
Figure 2: Micrographs of PICA at different magnifications.

As the name suggests, PICA is made by impregnation of phenolic resin within the FiberForm, followed by a cure cycle at an elevated temperature. It could be viewed as a two phase material consisting of a network of carbon fibers and a very porous phenolic matrix dispersed on and in-between the fibers as shown in Figure 2. This highly porous structure makes it a low density ablator. Due to the preferential orientation of carbon fibers in the FiberForm, PICA also displays the transverse isotropic behavior with significantly higher strength and stiffness in the in-plane direction compared to TTT direction.

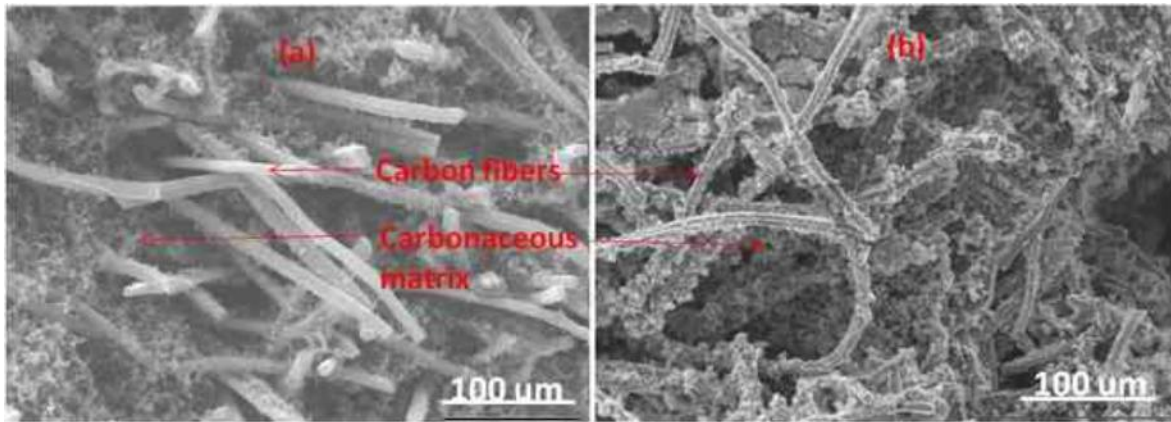
Figure 3: Micrographs of a) arc-jet char and b) furnace charred PICA.

was still present between the carbon fibers. The arc-jet charred PICA samples were prepared by cutting the upper charred PICA layer of post arc-jet test samples. Micrographs of both arc-jet and furnace charred PICA materials are shown in Figure 3a and 3b, respectively. Both materials show the presence of porous and thin carbonaceous matrix phase dispersed between the carbon fibers. However, in the arc-jet charred PICA the matrix on the top char layers is sparser compared to the furnace charred PICA. This is caused by the oxidation in arc-jet environment. This phenomenon was also observed in the PICA char on the Stardust reentry probe¹³.

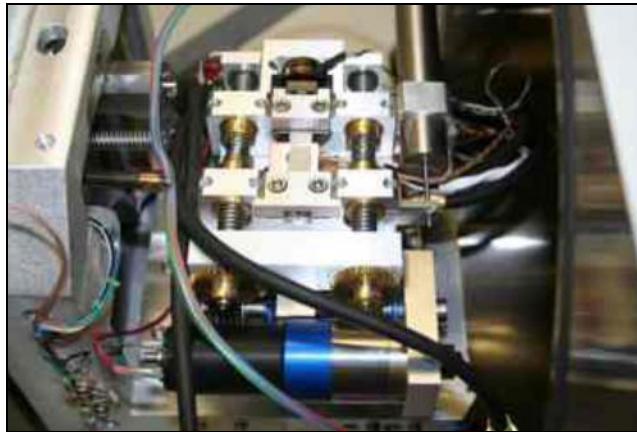
Figure 5: Close up of the mechanical sub-stage

The experiments were performed inside a Philips XL-30 electron microscope unit from FEI (Fig. 4). A miniature custom designed mechanical stage was mounted inside the microscope chamber as shown in Figure 5. A data acquisition system was integrated to the stage to acquire stress-strain data during the tests. The mechanical sub-stage was driven by a small motor and could exert a tensile or compressive load of up to 5 kN on a suitable test specimen. A strain transducer was mounted on the stage that provided the displacement measurements. The stage can accommodate a range of samples with dimensions varying from 20.0 mm to 60.0 mm in length, 5.0 mm to 15.0 mm in width and 0.01 mm to 6.0 mm in thickness. These dimensions are ideal to obtain preliminary mechanical properties data for an experimental material.

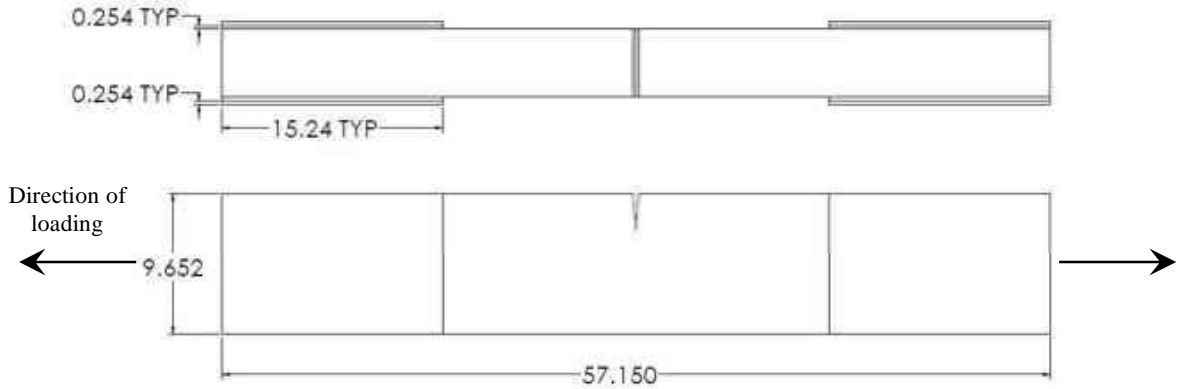
Figure 6: Specimen geometry (dimensions in mm).

Small samples of dimension 5.7 cm x 1.0 cm x 0.38 cm were cut from a single PICA billet and FiberForm block. Sample dimensions and drawings are shown in Figure 6. To initiate fracture in a controlled manner and focus the electron beam to obtain high magnification micrographs, fine notches were cut into the samples at the midline, using a micro scribe tool. One of the notched charred PICA samples is shown in Figure 7. Specimens were fabricated with

and without notches for each FiberForm, virgin and charred PICA materials to compare the stress-strain behavior and in-plane tensile strength. The notches were nominally 1.27mm to 2.54 mm in depth. The notch tip radius in most specimens was approximately 100 μm . These dimensions were sufficient to initiate crack at the notch tip and view the failure mechanisms in FiberForm and PICA. Thin aluminum tabs were glued to the ends of all the coupons with help of transfer coated RTV-560 (room temperature vulcanized) adhesive. This was required to avoid any local damage, slipping and premature failure of specimens near the grips.

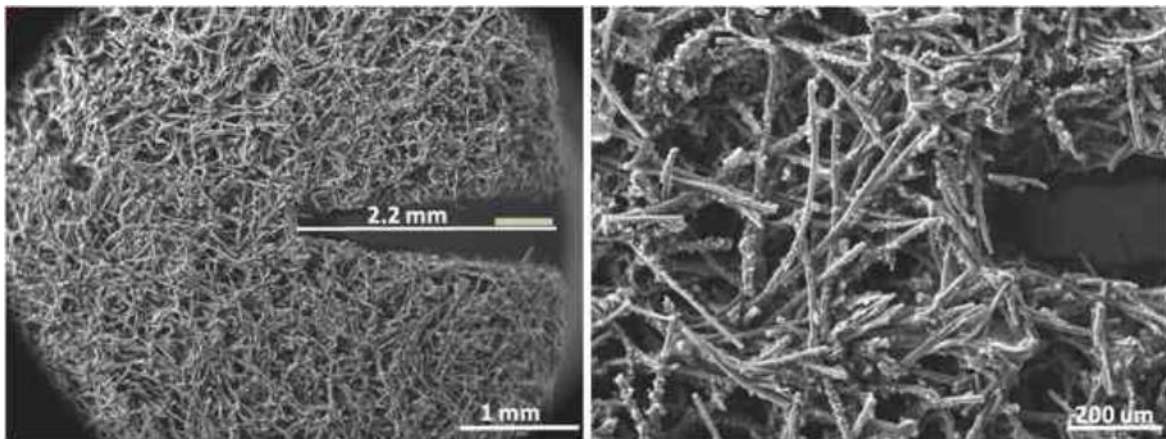
Figure 7: Micrograph of a charred PICA coupon with a notch at different magnifications.

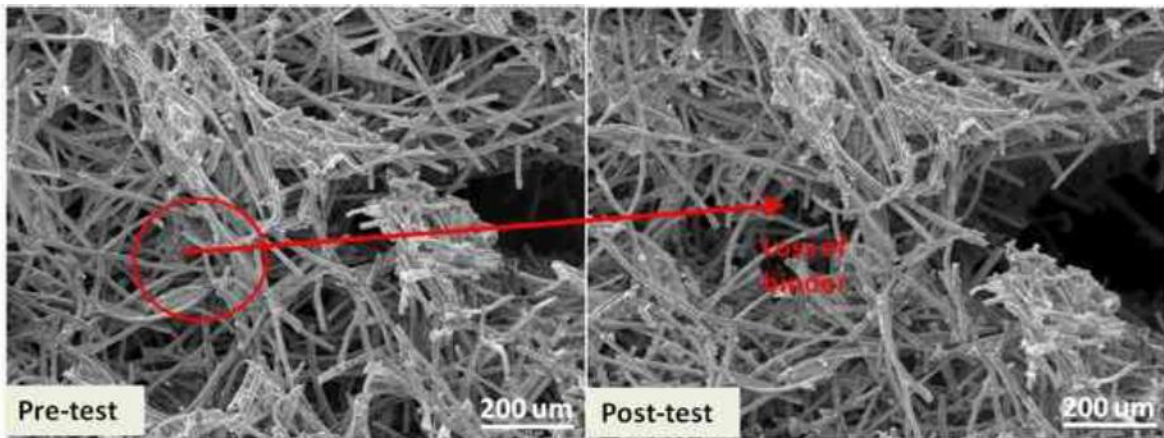
Figure 9: Loss of binder where it is sparser.

Fracture tests were performed on both notched and un-notched FiberForm samples. The dimensions were kept constant across the samples to obtain consistent results. A 450N load cell was used for these tests because it provides more accurate information for smaller magnitude loads. For all the specimens with notches, cracks initiated and grew near the tip of notch. All the specimens fractured in a brittle manner as soon as they reached a critical tensile stress. The crack initiation was captured on video. Figure 8 shows the crack initiation near the notch tip in one of the specimens. By examining the videos and comparing pre-test versus post test micrographs, it can be seen that when the specimens reached a critical stress magnitude, the carbon fibers were pulled away from the binder where it was in smaller concentration. Figure 9 shows the loss of binder material and Figure 10 shows micrograph of fiber separation near the binder phase. Figure 11 also shows a magnified view of broken carbonaceous binder. Fiber breaking was not observed in any of the specimens. The tensile strength values and stress-strain data for representative un-notched and notched FiberForm coupons are shown in Figure 12. All the specimens fractured in the range of 400-600 KPa stress magnitude and presence of notches did not make a significant difference in tensile strength. This phenomenon is very different from traditional dense material and it will be important to take this into account when modeling fracture behavior of porous material. The stress-strain curves obtained for these samples also suggested nonlinear stress-strain behavior from the very beginning. For most specimens, the strain-to-failure was between 0.6%-1.0%. The strength data is comparable to the data obtained on FiberForm in the CM database for the Orion program¹⁴.

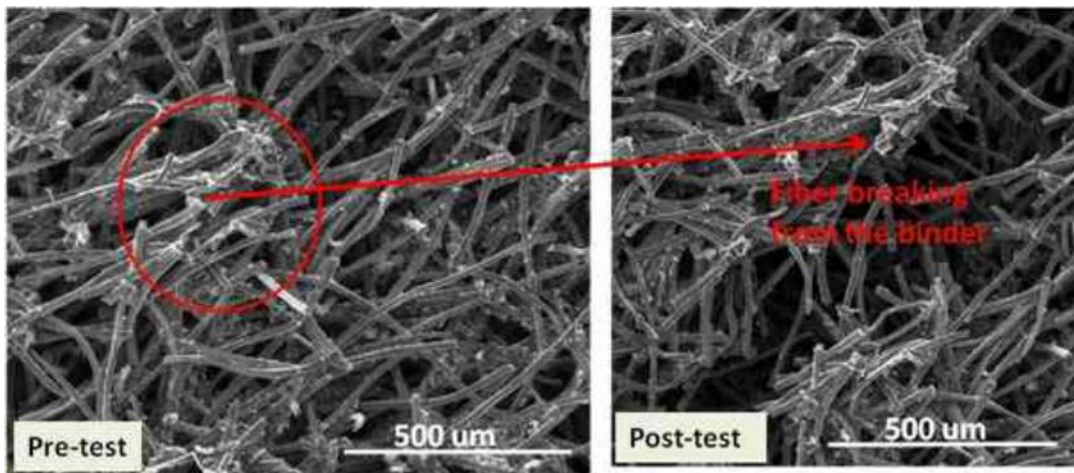
Figure 10: Fiber separation near the binder.

Figure 11: Magnified view of broken binder in FiberForm specimen.

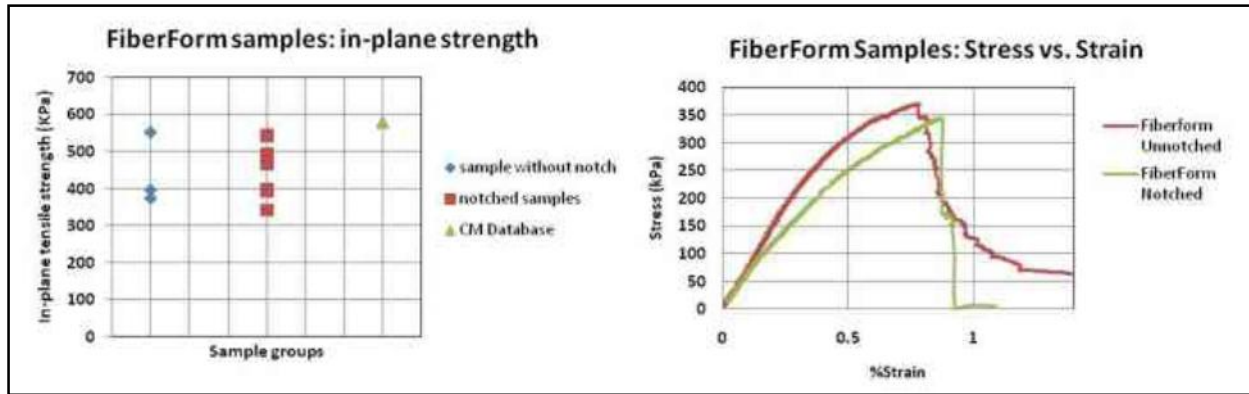
Figure12: In-plane tensile strength and stress-strain data for FiberForm specimens.

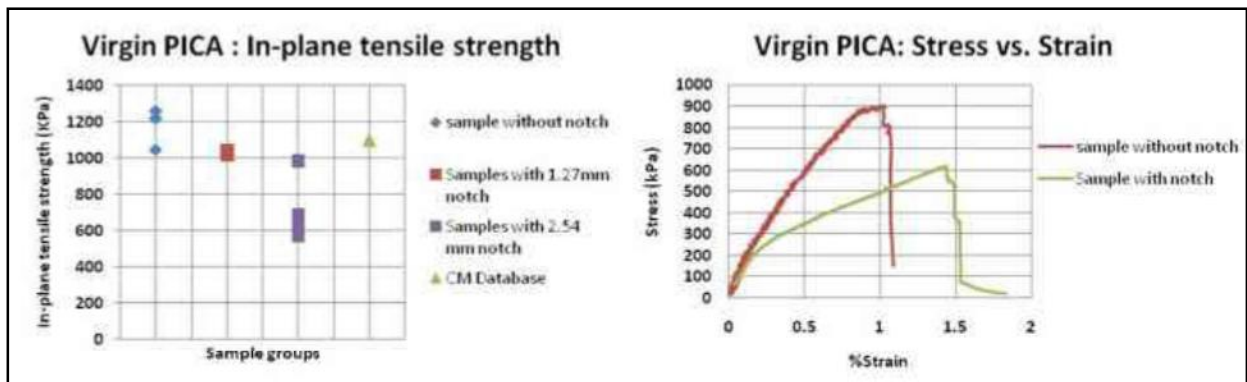
Figure 15: In-plane tensile strength and stress-strain data for virgin PICA specimens.

The specimens showed nonlinear stress-strain relation early on starting at 0.3% strain. The strain-to-failure for these samples was in the range of 1.0% - 1.2% and tensile strength was in the range of 0.8 to 1.2 MPa, similar to the CM database values, obtained during the in-plane tension test for Orion project¹³.

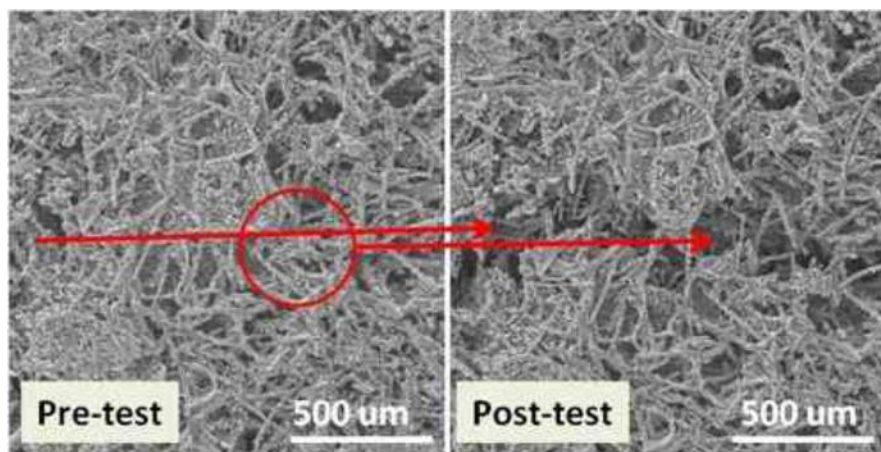
Figure 17: Matrix cracking in charred PICA samples.

The charred PICA samples were prepared by two methods: charring the virgin material inside an inert furnace, and sectioning pieces off of the charred portion of arc-jet tested PICA articles. Several furnace charred PICA specimens with ~2.54 mm notch size were tested inside the electron microscope. The crack initiation and growth was rapid once the critical stress was achieved, showing very similar behavior as virgin PICA samples. Videos and micrographs were obtained for the notched specimens. The crack initiated in the porous matrix phase and the crack path followed the porous matrix. Carbon particle shedding in the porous matrix was also observed in some videos. Fiber pull-out and bridging phenomenon, similar to virgin PICA samples, were observed at some locations as shown in Figure 16. Figure 17 shows the evidence of matrix cracking. Most specimens failed between 600 kPa - 900 kPa. The charred PICA samples made from arc-jet articles showed similar behavior and tensile strength as the furnace char. Again, based on test data from most of the samples, the introduction of a notch did not make significant difference in maximum tensile stress at which failure occurred. The stress-strain data and tensile strength for representative samples are shown in Figure 18. The maximum tensile stress achieved for these specimens was slightly higher than FiberForm samples but lower than virgin PICA. This suggests that fracture toughness of PICA ablator is driven by the extent of energy that can be absorbed by the porous matrix phase. The charred PICA specimens showed a similar non-linear stress-strain relation as FiberForm and virgin PICA samples. However, the strain-to-failure in charred PICA samples was lower than virgin PICA. To the best of our knowledge, to date no other tensile testing of charred PICA material has been conducted. This was the first test series where stress-strain plots and tensile strength data for the in-plane tension loading configuration were obtained.

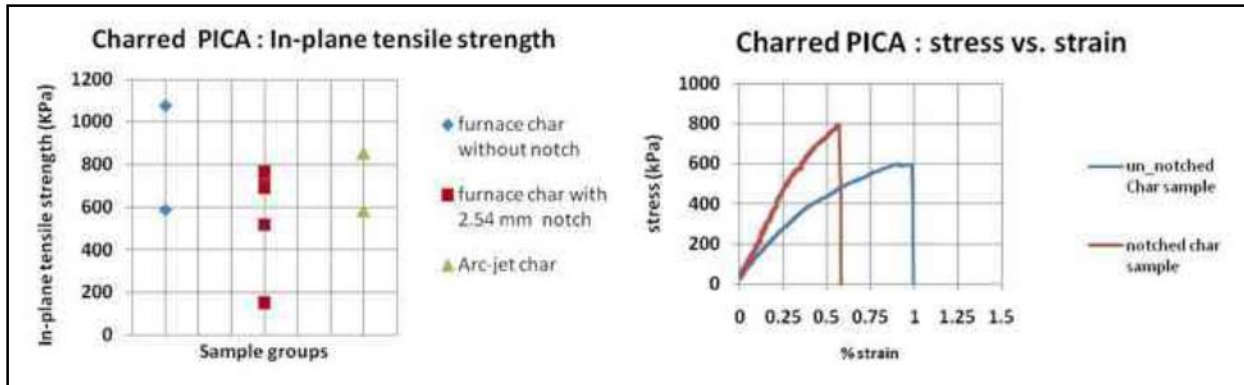
Figure 18: In-plane tensile strength and stress–strain data for charred PICA specimens.
