AIAA Conference, Shuttle Legacy Track
Long Beach, CA
September 2011

Abstract – Structures and Mechanisms

Space Shuttle Orbiter Structures & Mechanisms

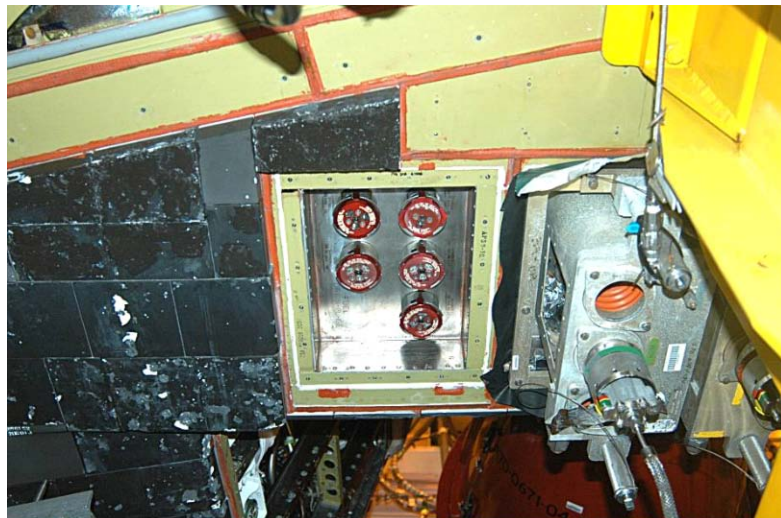
Figure 4-1. Typical Propellant Servicing Opening & GSE Scupper Installation.
Fastener receptacles for Door Installation are Inaccessible for R&R

The main design feature that drove most of these issues revolved around the use of a servicing panel/ servicing well at each of the propellant servicing openings. The servicing well was installed behind the propellant ports and closed out the external opening so that none of the hazardous commodities could propagate into the interior vehicle compartments. The unwanted side effect of this design is that the servicing well also closed out the access to the receptacles used for the servicing door installation. Thus if a receptacle failed, the only available access to remove and replace it was through the interior of the vehicle which required significant internal access and does not lend itself to a launch pad/ vertical operations event timeline. A better solution would have been to keep the receptacles

on the external side of the servicing well/ pan so that they could be replaced externally from the same area. Also many times when a failed fastener receptacle needed to be replaced it required replacing the entire receptacle (drilling out and installing new rivets). A better solution is to use replaceable nut element receptacles, if available for the particular fastening system, wherever high cycle or late installation of access doors occurs.

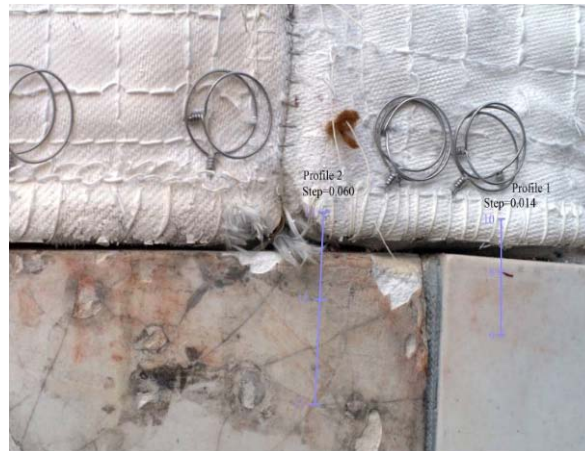
epoxy facesheet, with the 1.5" high blanket protuberance increasing the local aeroheating, temperatures reaching ~900° F were predicted. If .5" of sub-insulation was retained on the facesheet, then temperatures could reach ~400° F. Given that both of these temperatures exceed the limit of 262° F, an astronaut performed a repair of the damaged blanket during an extra vehicular activity (EVA) (Figure 4-4).

Figure 4-4 Repair that Astronaut Performed during STS-117

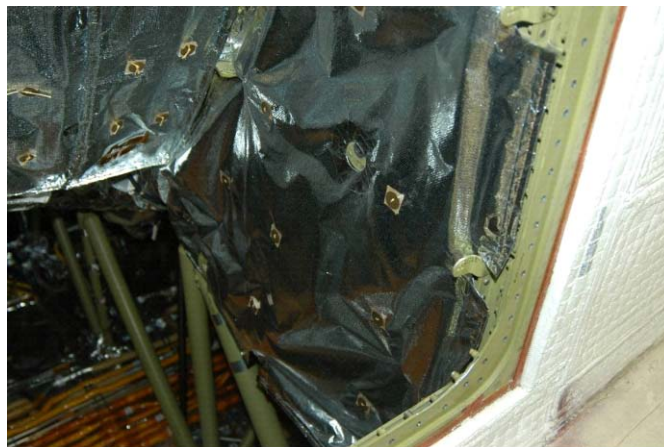
For example the Space Shuttle Orbiter utilizes a very thin walled struts in the truss like ring frames of the mid-fuselage. There is one main ingress / egress access point to the mid-fuselage and then a platform system is used down the centerline to facilitate traffic through the length of the fuselage. A large number of these highly sensitive primary structure boron aluminum struts that are close to these traffic paths incurred damage that resulted in expensive replacement parts. As the program matured and protective covers were refined (soft covers to hard covers), less damage occurred. However, the problem was best corrected when the damaged boron aluminum tubes were replaced with new thicker walled aluminum tubes that did not share the same high sensitivity traits. The weight penalty trade was acceptable in this case and the cost was lower for the new replacement struts. If this type of more robust configuration had been utilized in the high traffic areas many of the strut replacement issue and high

Figure 5-2. Main Ingress/ Egress into the Space Shuttle Mid-Fuselage Compartment.
Highly sensitive thin Boron/ Aluminum Struts line ingress/ egress route.

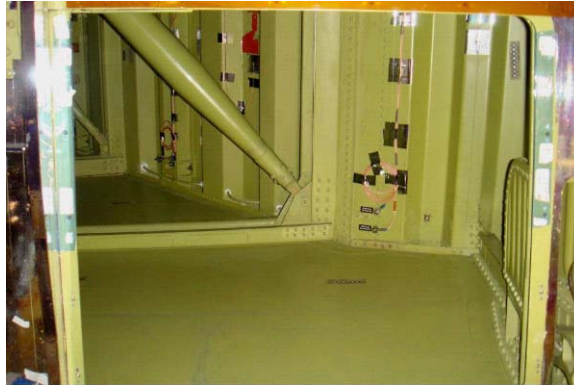
traffic. Both the thin walled aluminum wing struts and the honeycomb panels received significant repair activity over the life of the program. The Space Shuttle also used lightweight thin face sheet aluminum honeycomb panels to house the avionics compartments/ bays. The avionics boxes were frequently removed for testing and evaluation and also saw a high percentage of personnel traffic. Despite the use of GSE to support the weight of the boxes and protective covers, these compartments still received a large number of damages. Even though these structural components were not part of the primary load path, damage to this type of sensitive hardware needs to be repaired so that propagation of an initial defect cannot lead to a more serious damage event. This problem was significantly mitigated on the Space Shuttle program by installing thick aluminum doublers over the thin honeycomb panel face sheets to provide a more robust surface that was less susceptible to damage.

Figure 5-3. Main Ingress/ Egress into the Space Shuttle Wing Compartment.

Lower surface is thin aluminum honeycomb face sheet with thin walled struts in close proximity.

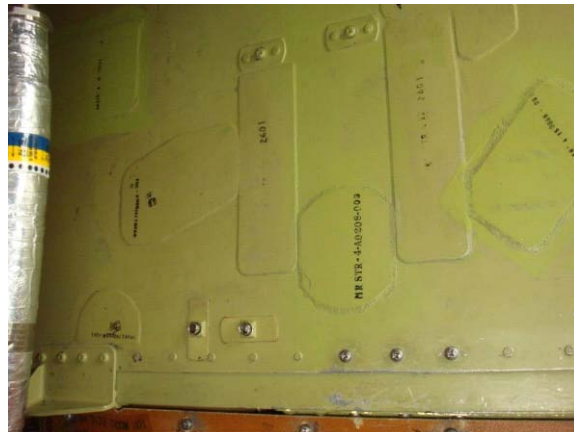
Figure 5-4. Typical Avionics Bay Honeycomb Panel Damages.

Thin face sheet was easily damaged by high traffic and required repairs.
