# Why Major Programs Need Innovation Support Labs: An Example from the Space Shuttle Launch Program at KSC

Robert C. Youngquist<sup>1</sup>, Stanley O. Starr<sup>2</sup>, Charles G. Stevenson<sup>3</sup>, Jorge E. Rivera<sup>4</sup>, and Steven J. Sullivan<sup>5</sup>  
*NASA, Kennedy Space Center, Florida, 32899*

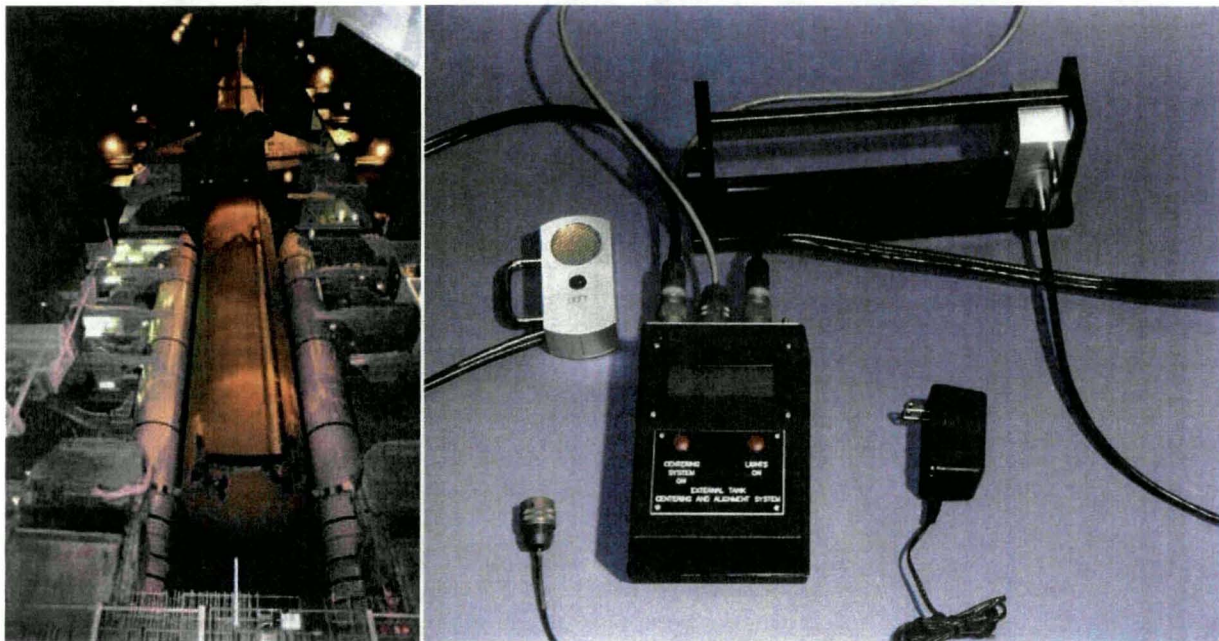
**Figure 1. The External Tank Centering and Alignment System.** The first major deliverable to the KSC Space Shuttle Program from the Applied Physics Lab was a system that measured the gaps between the Solid Rocket Boosters and the External Tank at the aft end.

figure, displays the gap distances between each SRB and the ET as well as the adjustment distance needed to center the ET. This, "External Tank Centering and Alignment System," was well received and was converted to Ground Support Equipment (GSE), allowing it to be used as the primary means for meeting this positioning requirement.

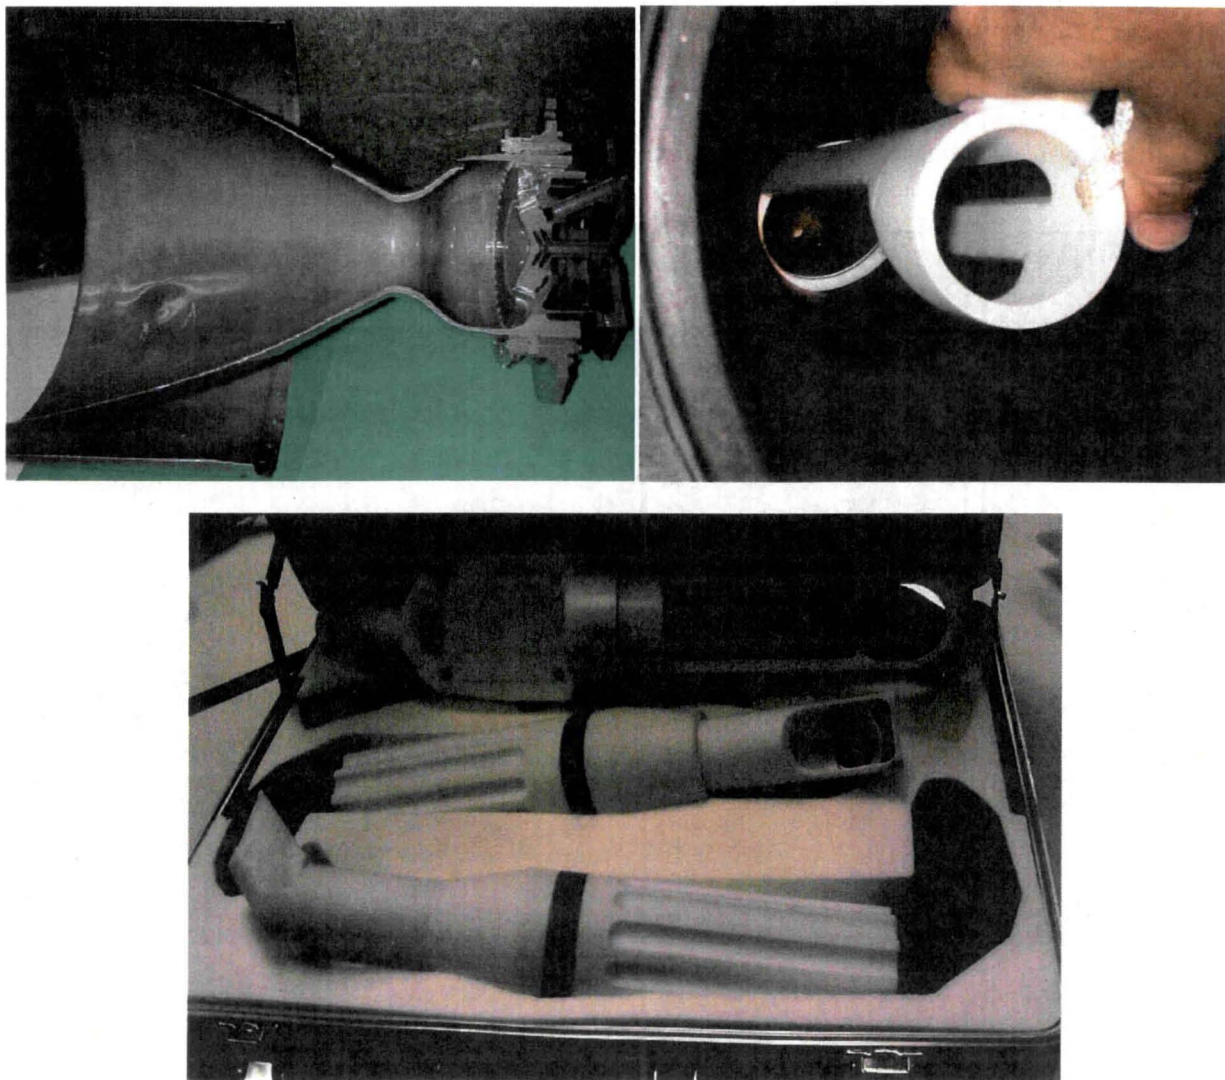
**Figure 8. The RCS Nozzle Inspection Tools.** The upper left image shows a cut away cross section of a Reaction Control System (RCS) Thruster. Thrusters, such as this, allow the Orbiter's position and orientation to be controlled while in orbit. Tools were designed and constructed, shown in the lower image, to allow these to be inspected. In the upper right one of these tools is shown imaging a small defect on the inner surface of the nozzle within the reaction chamber.

While in orbit, the Orbiter's position and orientation are controlled by firing small thrusters, part of what is referred to as the Reaction Control System (RCS). These small rocket engines burn hypergols; liquid propellant (a form of hydrazine) and liquid oxidizer (nitrogen-tetroxide) that combust on contact with each other. The thruster, as seen in the cutaway image in Fig. 8, is composed of a manifold and inlets to direct and inject the hypergols into a firing or reaction chamber. This is followed by a shaped nozzle, directing the plume away from the Orbiter. Also, there are a large number of acoustic openings located around the firing chamber that admit nitrogen to help protect the nozzle. The nozzle itself is constructed from niobium (C-130) with a silicide based protective coating.

There are three primary goals in the inspection of these nozzles; to look for chips in the silicide coating, to determine if any of the hypergolic inlets are plugged, and to look for debris in the acoustic openings. Dental mirrors were being used to do this, but visibility was poor, viewing angles were not correct, and there was concern that the metal handles would damage the nozzle. The KSC Applied Physics Laboratory resolved these concerns by designing and delivering three custom inspection tools, each constructed specifically to meet one of the three different needs. Each tool was constructed with a Teflon body and plastic optics (both lenses and mirrors) to minimize the chance of damage and liberating debris. Each also had built in lighting (white light LEDs) to illuminate the inspection area. Figure 8 shows all three devices in the lower image. In the upper right image the coating inspection tool is shown being used to image a chip in the firing chamber of a nozzle on the Orbiter. The second tool, the hypergolic inlet inspection tool, has a built in lens to provide magnification and an angled mirror allowing the inspector to look into the inlets. The third tool, the acoustic opening inspection device, has a small periscope built into it allowing the inspector to look directly down the acoustic openings located along the outer edge of the thrusters firing chamber. All three tools were accepted into the hypergol processing area and were converted to shop aid status.

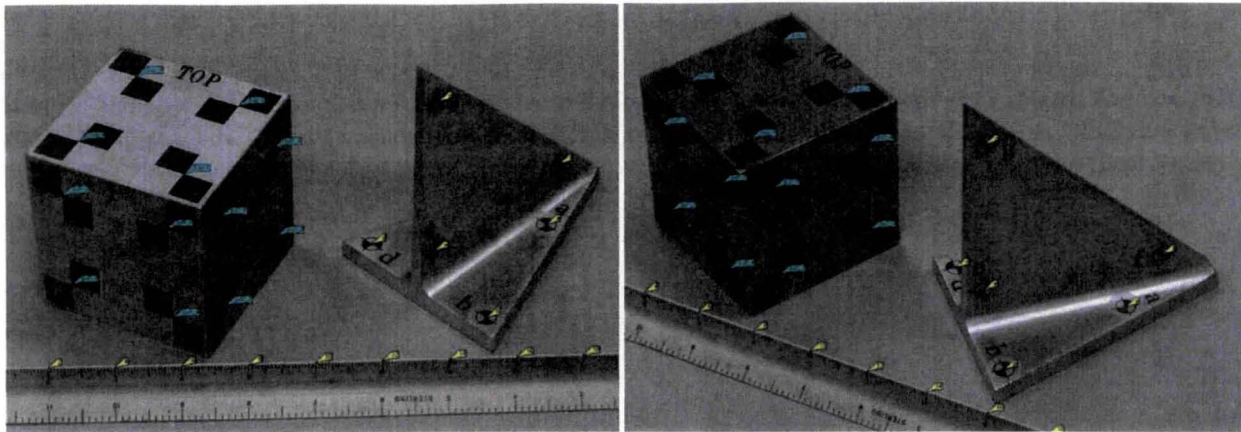
**Figure 14. Three Dimensional Object Tracking using Multiple Images with Reference Points.** Using a mathematical algorithm developed to track foam debris in Columbia imagery, a software package was generated to track debris at the launch pad. This software was later modified to create a system where 3-D location information could be obtained from 2-D imagery, an example of which is shown in this figure.

such as the cube, and a standard camera, replaces the need for an expensive 3-D scanning system. It has been used for several measurements within the NASA community, typically to measure sensitive space hardware components that cannot be touched or moved. In addition, this system was recently taken to Haiti by a civil engineering professor to use to measure displacements in structures caused by the 2010 earthquake.

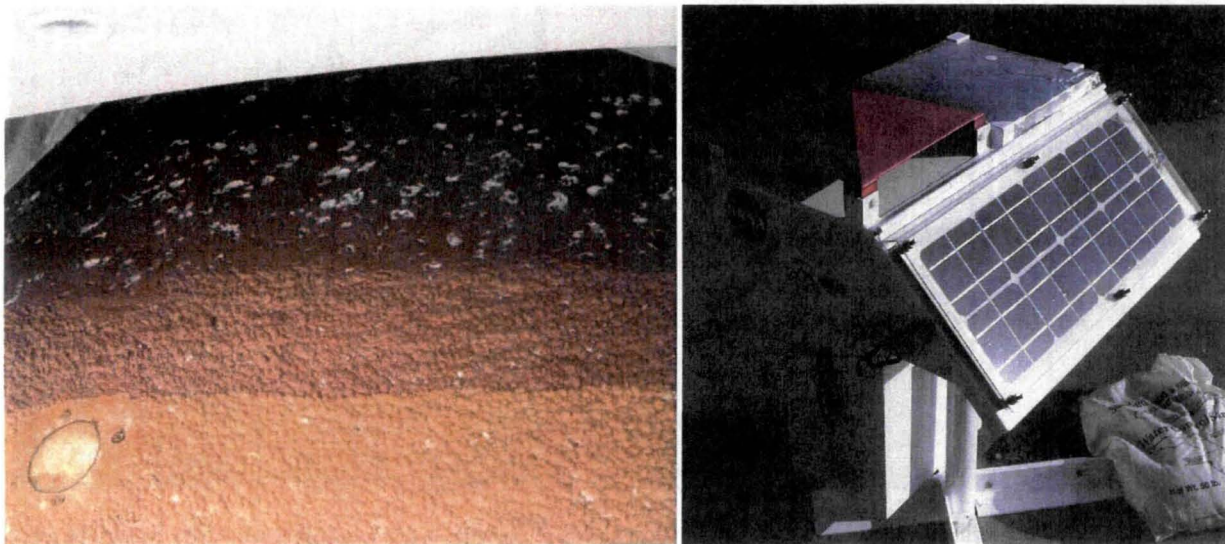
**Figure 18. A HailStone Monitoring System.** On the left side is an image of hail induced damage on the External Tank foam. On the right hand side is a hail monitor developed by the KSC Applied Physics Laboratory and used to support Shuttle launches.

There have been cases where hail stones have impacted the External Tank and have caused damage to its foam. In 2002 the KSC Applied Physics Laboratory was asked to develop a hail monitor<sup>16,17</sup> that could determine the size of hail stones falling around the launch pad in order to provide an indication that damage may have occurred to the ET. There was a concern that hail might fall, damaging the tank, and that no one would know. After study a hail sensor was fabricated based on monitoring the impact of hail stones on an aluminum pyramid structure (see the right hand image in Fig. 18). This design separates rain from hail impacts, directs the hail stones away from the sensor so that secondary impacts from bouncing are minimized, and allows some estimate of the size of the hail stones. The completed system was solar powered and included an aluminum wrapped foam panel as a back-up record of the hail events. Three of these were constructed and placed at the pad whenever a Shuttle was present. Then, in 2007 an intense hail storm passed over the launch pad, significantly damaging the ET (see the left hand image in Fig. 18). The hail monitors provided information on the stone sizes and relative number of impacts to the Space Shuttle Vehicle. They continued to be used at the launch pad until the end of the Space Shuttle Program.

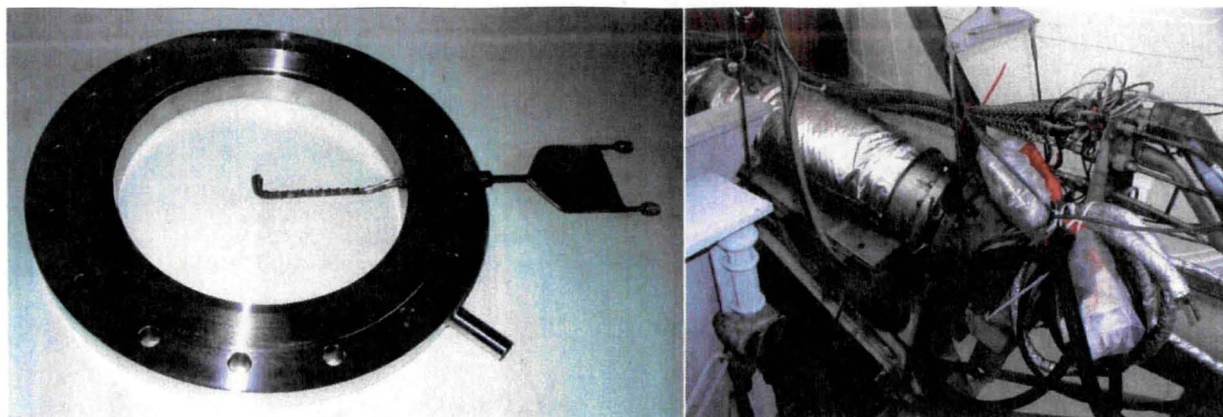
**Figure 23. The External Tank vent-line leak monitoring system.** The image on the left is a custom pitot-tube based sensor used to monitor the gas leakage from the External Tank. The image on the right is of the ET vent line with the sensor located in a gap between two of the flanges.

designed, built, tested, and installed in an eight day period. It was used during the next filling test and, surprisingly, showed that the vent line was not leaking, that there was another reason for the ullage pressure decay.
