History of the Development of Liquid-Applied Coatings for Protection of Reinforced Concrete

Joseph J. Curran
ASRC Aerospace
NASA Corrosion Technology Lab
Kennedy Space Center, FL 32899

Marlin H. Hansen
Cortec Corporation
St. Paul, NM

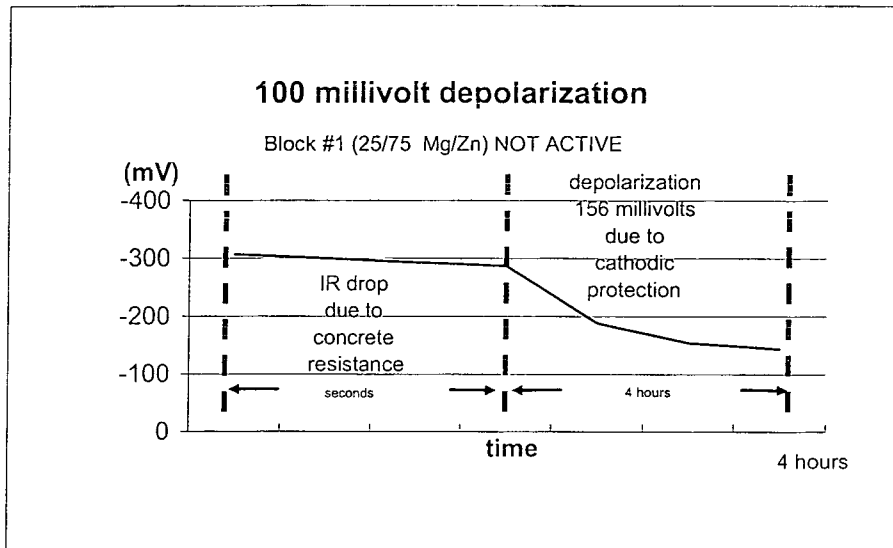
Figure 3. Results of Phase One Depolarization Test

Task B. Determine Which Formulation Will Give The Best Corrosion Protection. The final selection of 25 % Mg and 75 % Zn was made on the basis of the depolarization method (instant-off). The results of these measurements, made in the field on Jan. 21, 2000, are shown in Table 2. A graph of the depolarization test is shown in Figure 3. The best performer was considered to be the largest positive change in the rebar potential after disconnection from the anode, i.e., instant-off measurement.

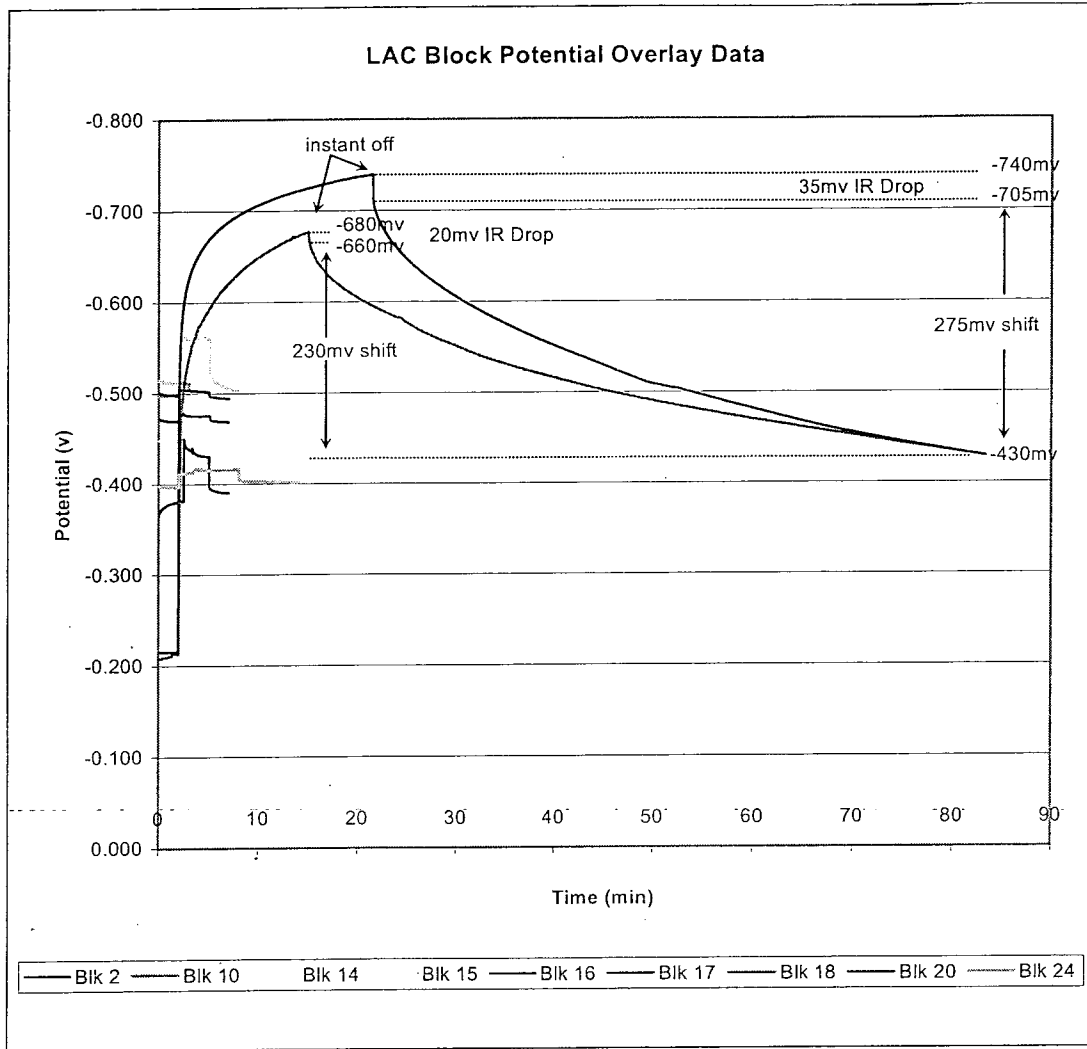
Figure 5. Potential Data

Blocks 18 and 20 met the criteria for cathodic protection according to NACE RP0290 100mv shift. Further research is needed to discover why these two blocks are performing well while the others have failed. The test blocks were placed back on the exposure stand and reinstalled to the DAS computer system on June 16, 2003.

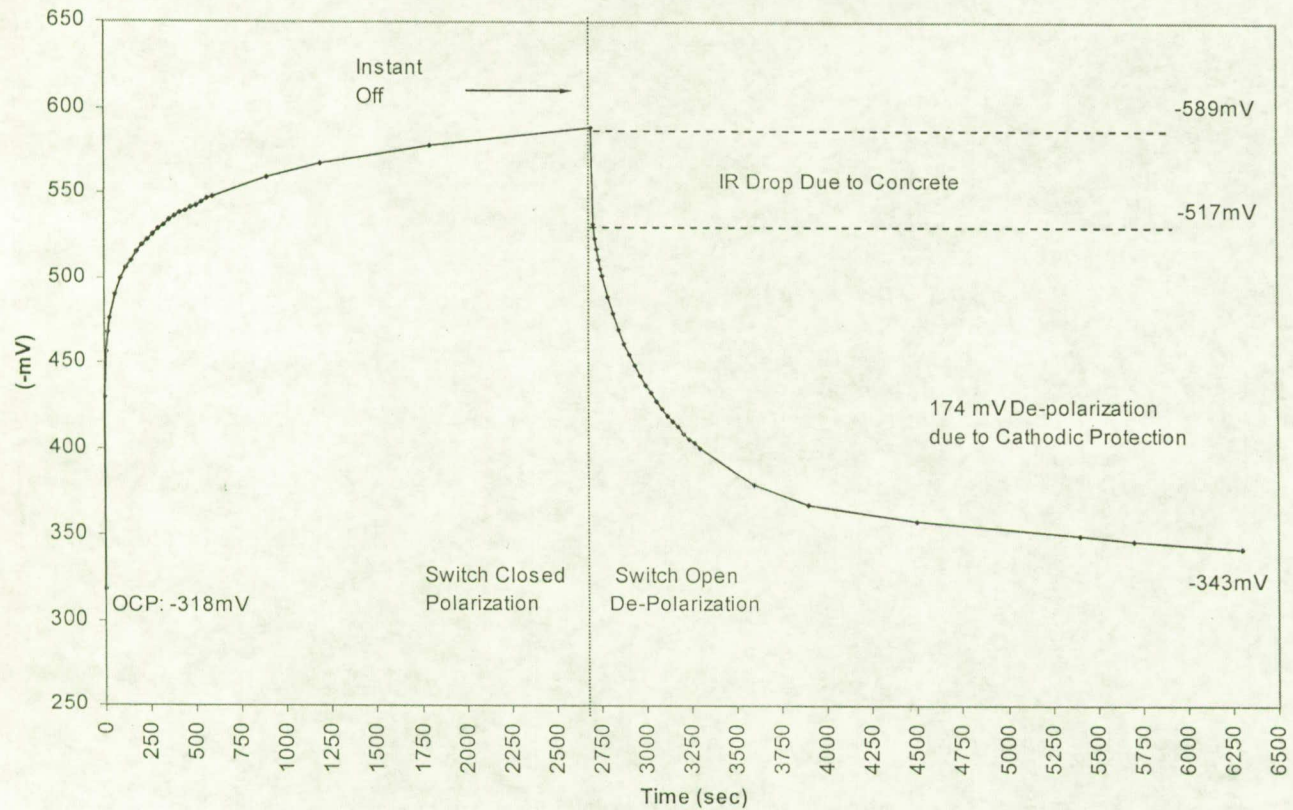
Results of Depolarization Test (NACE RP0169-96)

Mg/Zn (%)	Active ¹	Depolarization (mV)
0/100	NO	47 mV
0/100	YES	78 mV
25/75	NO	156 mV
25/75	YES	145 mV
50/50	YES	28 mV
100/0	NO	35 mV
