# *AIAA Technical Paper – External Tank Program – Legacy of Success*

Jeffery C. Pilet<sup>1</sup>, Dawn Diecidue-Conners<sup>2</sup>, Michelle Worden<sup>3</sup>, Michelle Guillot<sup>4</sup>  
*Lockheed Martin Space Systems Company, New Orleans, LA, 70129*

The largest single element of Space Shuttle is the External Tank (ET), which serves as the structural backbone of the vehicle during ascent and provides liquid propellants to the Orbiter's three Main Engines. The ET absorbs most of the seven million pounds of thrust exerted by the Solid Rocket Boosters and Main Engines. The design evolved through several block changes, reducing weight each time. Because the tank flies to orbital velocity with the Space Shuttle Orbiter, minimization of weight is mandatory, to maximize payload performance. The initial configuration, the standard weight tank, weighed 76,000 pounds and was an aluminum 2219 structure. The light weight tank weighed 66,000 pounds and flew 86 missions. The super light weight tank weighed 58,500 pounds and was primarily an aluminum-lithium structure. The final configuration and low weight enabled system level performance sufficient for assembly of the International Spa

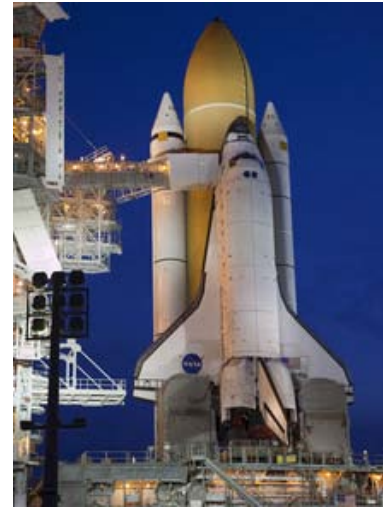
Figure 1: STS on Pad

THE Space Shuttle's External Tank (ET) is a highly evolved and optimized system that serves as the structural backbone of the Space Transportation System (STS) launch vehicle (*Figure 1*). Several major design changes to the ET have occurred since the first flight of the Shuttle 30 years ago, with emphasis on improving overall system payload performance, reducing manufacturing flow time, and improving design robustness. Through the process of evolving the ET design, many challenges were experienced and ultimately overcome by a very proud, resilient, and cohesive team consisting of National Aeronautic and Space Administration (NASA) and Lockheed Martin engineers from NASA's Marshall Space Flight Center (MSFC) in Huntsville AL and the Michoud Assembly Facility (MAF) in New Orleans, LA. The purpose of this paper is to provide an overview of some of the more challenging issues and resulting lessons learned to potentially benefit the follow-on Space Launch System (SLS) core stage booster program. The paper provides an overview of the ET design, a discussion of the major structural design evolutions, innovative welding techniques, the debris minimization efforts that occurred after the Columbia accident, and several key technical challenges that were recently experienced and overcome.

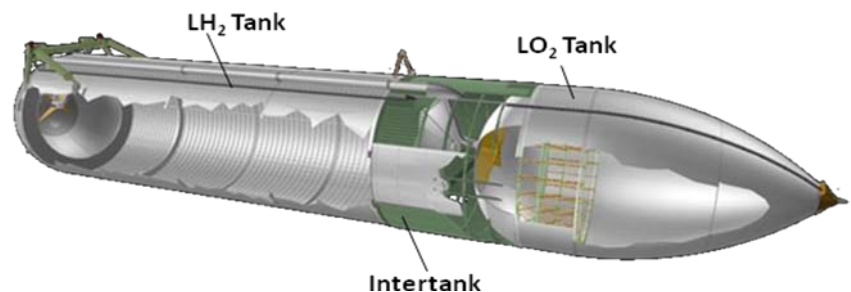
Figure 2: ET Primary Structures

Three primary structures make up the ET; a  $\text{LO}_2$  tank, an Intertank, and a  $\text{LH}_2$  tank (*Figure 2*). Since the ET is the only expendable element of the Space Shuttle, the design philosophy has been to minimize active or moving parts. All power, pressure, and purges are received from either the Orbiter or ground facility. The only active components on the ET are the vent/relief valves. All operational instrumentation is hardwired to the Orbiter. The separation is pyrotechnically actuated. Slosh baffles are mounted in the  $\text{LO}_2$  tank and the  $\text{LH}_2$  tank has a vortex baffle to dampen fluid motion and minimize liquid residuals. Both tanks contain liquid level sensors for propellant loading control.

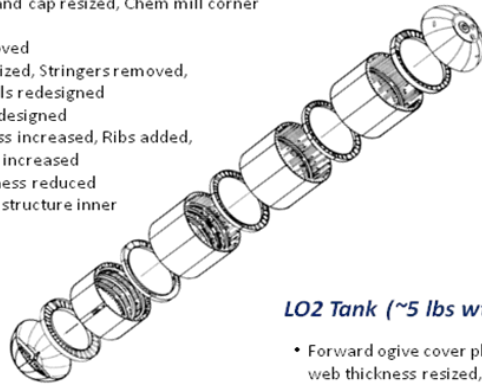
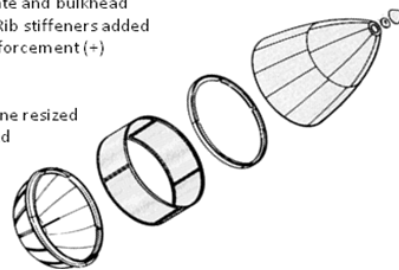
**Figure 3: Structural Changes for LWT**

**LH<sub>2</sub> Tank (>3000 lbs wt savings)**

- Forward dome gorges and cap resized, Chem mill corner radii increased
- Stabilizer frames removed
- Barrel membranes resized, Stringers removed, compression skin panels redesigned
- Longerons resized / redesigned
- Aft dome gore thickness increased, Ribs added, Chem mill corner radii increased
- Dome weld land thickness reduced
- X<sub>7</sub>1129 frame primary structure inner chord reduced

**Intertank (>1200 lbs wt savings)**

- Skin/stringer panel resized
- Thrust panel resized
- Main and intermediate frame resized
- SRB thrust beam resized
- Thrust fitting resized
- Frame stabilizers resized
- Splice plate resized

**LO<sub>2</sub> Tank (~5 lbs wt savings)**

- Forward ogive cover plate and bulkhead web thickness resized, Rib stiffeners added
- Forward ogive skin reinforcement (+)
- Aft ogive resized
- Barrel panel resized
- Aft dome gore membrane resized
- Dome weld lands resized

**Interface Hardware (>800 lbs wt savings)**

Design development of the LWT was initiated prior to the first flight of the Space Shuttle. A lighter weight tank was required to support manifest planning of the Galileo spacecraft in the early 1980s. The light weight tank design (*Figure 3*) was achieved through a series of modifications that were enabled through test calibrated model refinement, operational enhancements and a method to tailor margins. These enhancements provided the foundation to resize structural membranes, elimination of hardware elements (e.g. thermal protection system, development flight instrumentation, the anti-geysing line), and material substitutions that were critical to achieving the desired weight reduction of 6000 lbs. Verification of the LWT design was accomplished primarily with STA-based analysis

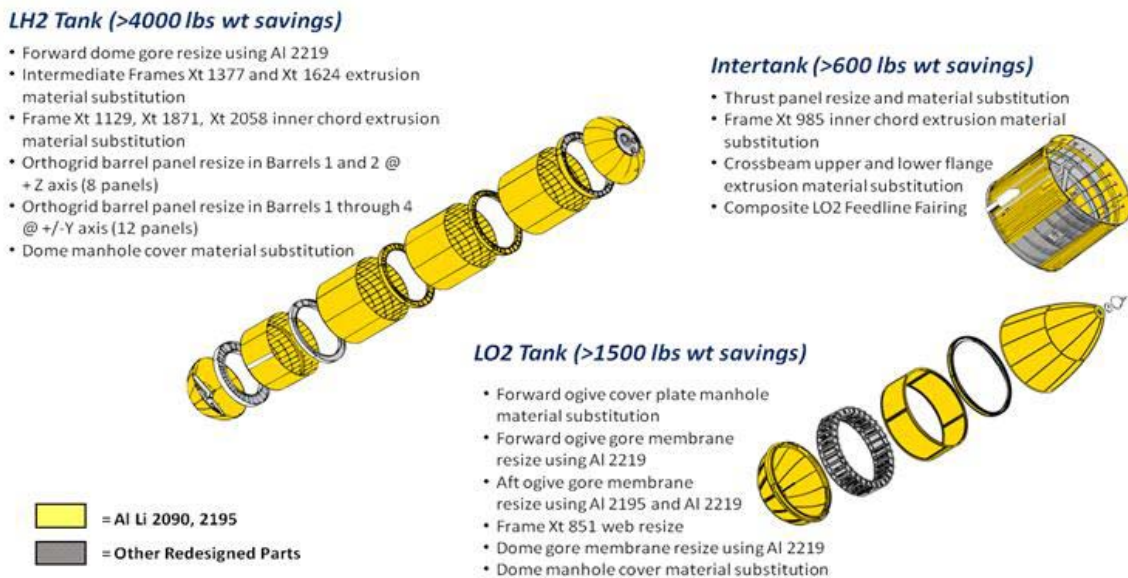
Figure 4: Structural Changes for SLWT

The SLWT used Al-Li alloys in place of traditional Al 2219 at several locations on the LO<sub>2</sub> and LH<sub>2</sub> Tanks. Aluminum-lithium (Al-Li) alloys offer the benefit of improved yield strength, stiffness, and reduced density. The use of this state of the art alloy required an extensive material test program to determine material allowables, weld land sizes, and manufacturing processes / requirements. The most significant configuration change for the SLWT was the use of Al-Li 2195 orthogrid barrel panels in place of the Al 2219 T-stiffened panels used for SWT and LWT configurations. The use of orthogrid wall construction for the LH<sub>2</sub> tank required development of new manufacturing process for machining, forming, and welding of barrel assemblies.

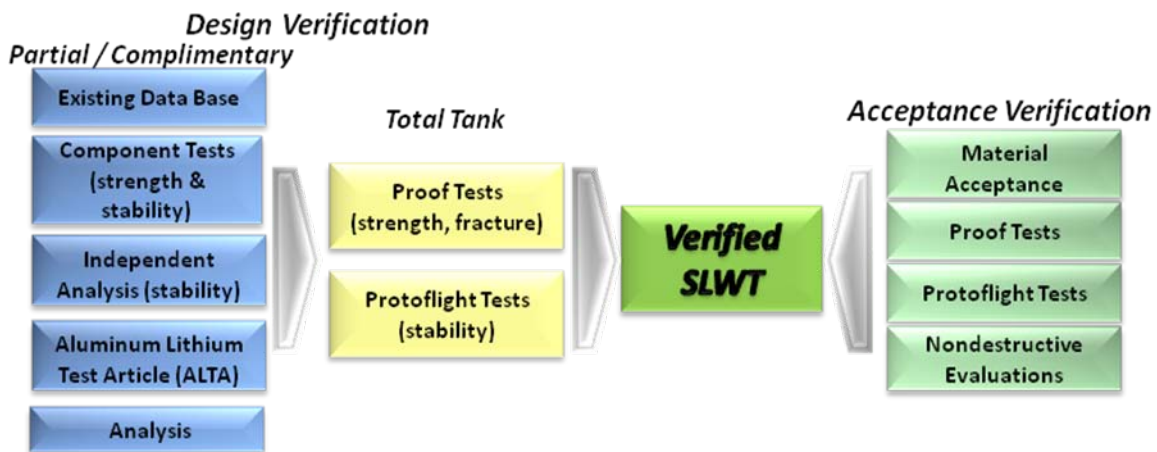
**Figure 6: SLWT ET Structural Verification Approach**

The result was an innovative, multi-faceted verification program including verification data obtained from: 1) Existing data base; 2) Component tests; 3) Independent analysis, and 4) aluminum-lithium test article (ALTA).

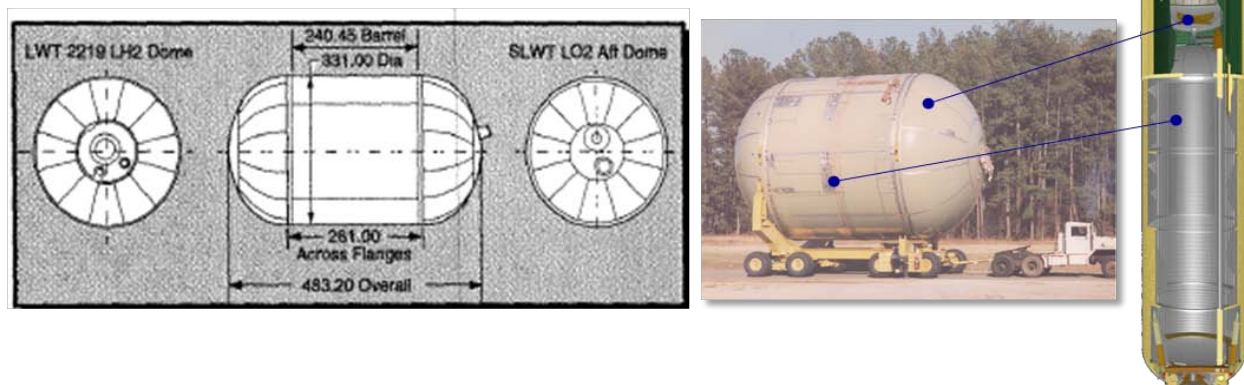
**Figure 7: SLWT Al-Li Test Article**

The loads applied to ALTA consisted of pneumatic pressurization, axial loads, bending moments and shear loads, and water and high density fluid (HDF) aft dome fill (HDF=35 lb/gal). The ALTA verified the adequacy of the LO<sub>2</sub> dome and the robust design of the orthogrid barrel panels for the general stability failure mode. In general, the ALTA demonstrated greater than ultimate load and the orthogrid barrel section was tested to failure at levels equivalent to twice the design limit load.

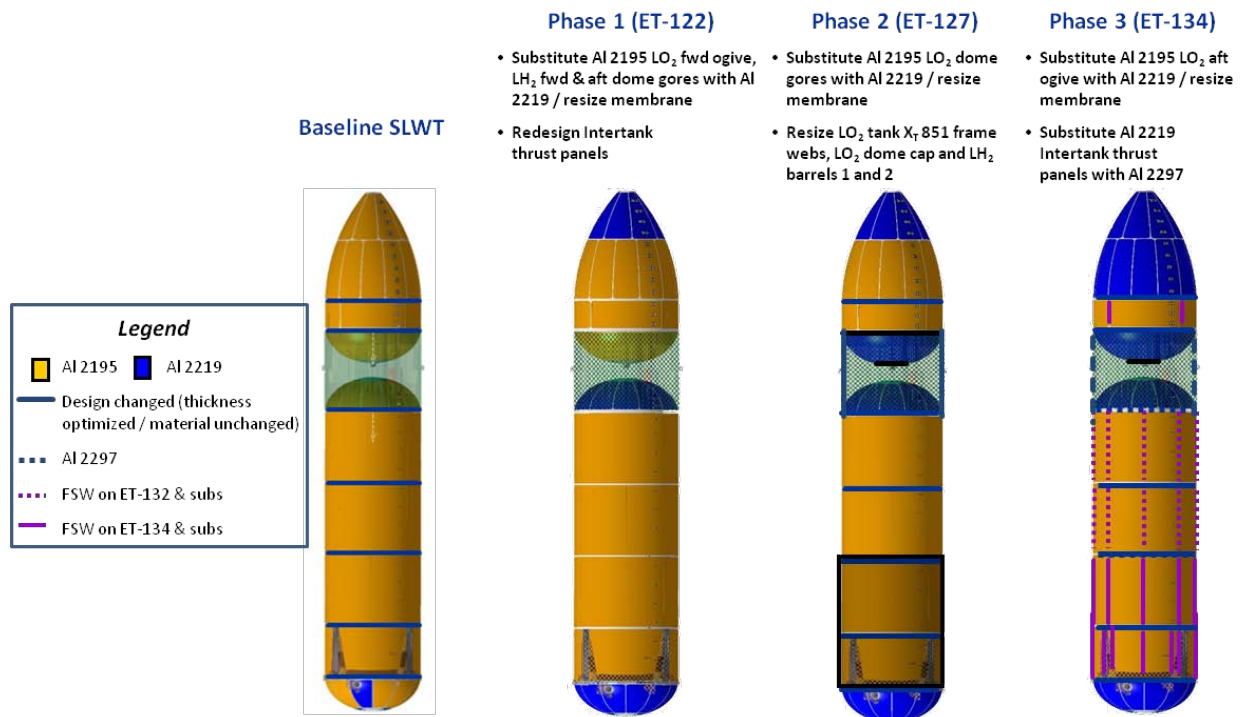
**Figure 8: SLWT Production Enhancements**

Verification of the redesigned SLWT structure leveraged the data obtained during the initial SLWT verification including use of test-based FEM analysis correlated to SWT, LWT and SLWT major structural tests. The acceptance proof and protoflight tests performed on each tank continued to provide a solid element of the verification process.

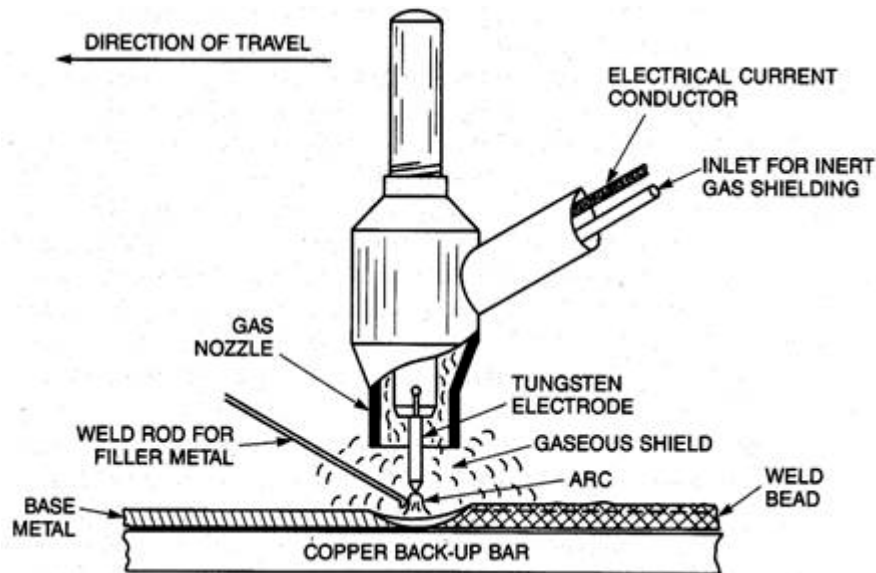
**Figure 9: GTAW Process**

Initially, the aluminum alloy used for the majority of the SWT and later for the LWT was Al 2219, a well characterized material documented in MIL-Handbook-5. The initial welding process, gas tungsten arc welding (GTAW) or the colloquial term tungsten inert gas welding (TIG), had also been used on Saturn 1C (S-1C) with Al 2219 (*Figure 9*). This allowed for an extensive welding database at MSFC for ET design use. Martin Marietta Corporation also had extensive usage history with Al 2219 and the GTAW process on the Titan II & III programs at their Denver operations.

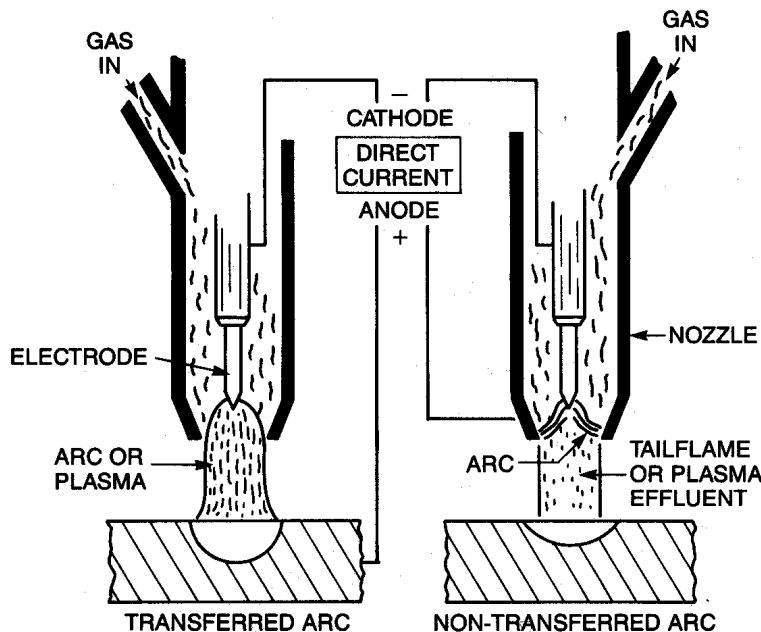
**Figure 10: VPPA Welding**

Additionally, NASA directed the development of an alternate weld process, Variable Polarity Plasma Arc (VPPA) welding (*Figure 10*). Typical Plasma Arc welding (no variable polarity) allows deposits to build up on the electrode during welding which occasionally come loose and drop into the weld puddle, contaminating the weld. Variable polarity plasma arc welding, however, employs a variable current waveform that enables the welding system to operate for preset time increments in either of 2 polarity modes. Simply stated, VPPA provides positive and negative current reversals to clean the electrode precluding deposit build up and subsequent weld contamination. Those contaminants encountered during welding are forced out the backside of the weld due to the plasma velocity, creating cleaner welds with less porosity.

The variable polarity aspect also allowed for less rigorous pre-weld cleaning and edge preparation due to the inherent cleaning action. Rather than capitalize on less cleaning, the ET manufacturing community chose to use the inherent cleaning capability of VPPA to their advantage by allowing for extended time between initial weld cleaning and weld startup. The longer weld set up times helped to reduce joint assembly issues such as out of tolerance peaking and mismatch.

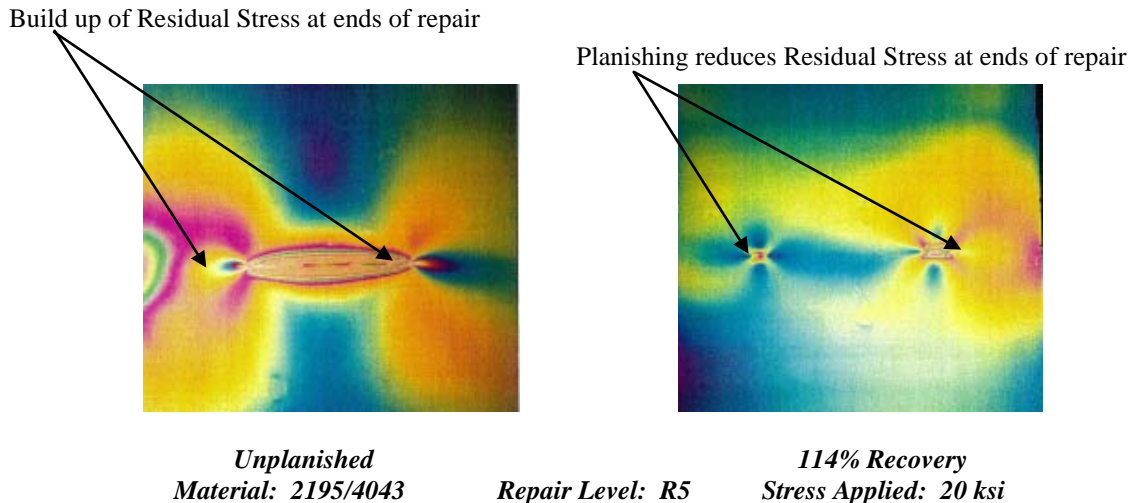
**Figure 11: Comparison of Stress State of Unplanished vs. Planished Al 2195 Repair**

An approach was developed to mitigate the concentration of residual stress in Al 2195 weld repairs. A process was developed where the repair area bead and a portion of the adjacent original weld bead were planished (to toughen and smooth the surface of a metal by hammering or rolling it from both sides simultaneously), forcing the bead back into the joint. The joint spreads out, thereby substantially reducing the recorded shrinkage and associated residual stress. Planishing activities, however, may form other cracks leading to additional weld repair/planish cycles prior to achieving an acceptable weld repair.

The welding team demonstrated that planishing weld repairs did indeed increase the weld repair properties and weld performance capabilities. The vehicle for the demonstration was an innovation for the SLWT program and it entailed the use of "wide panels". Wide panel tensile specimens were configured to contain full size repairs with the restraint of surrounding non-repaired material to retain the residual stresses. The configuration allowed for load redistribution to be assessed during test. Nonplanished vs. planished samples were tested using photo stress material to show load redistribution. Figure 11 compares wide panel test articles with and without planishing. The typical wide panel configuration started with a 20 inch wide panel (weld length) and an overall length of 52 inches.

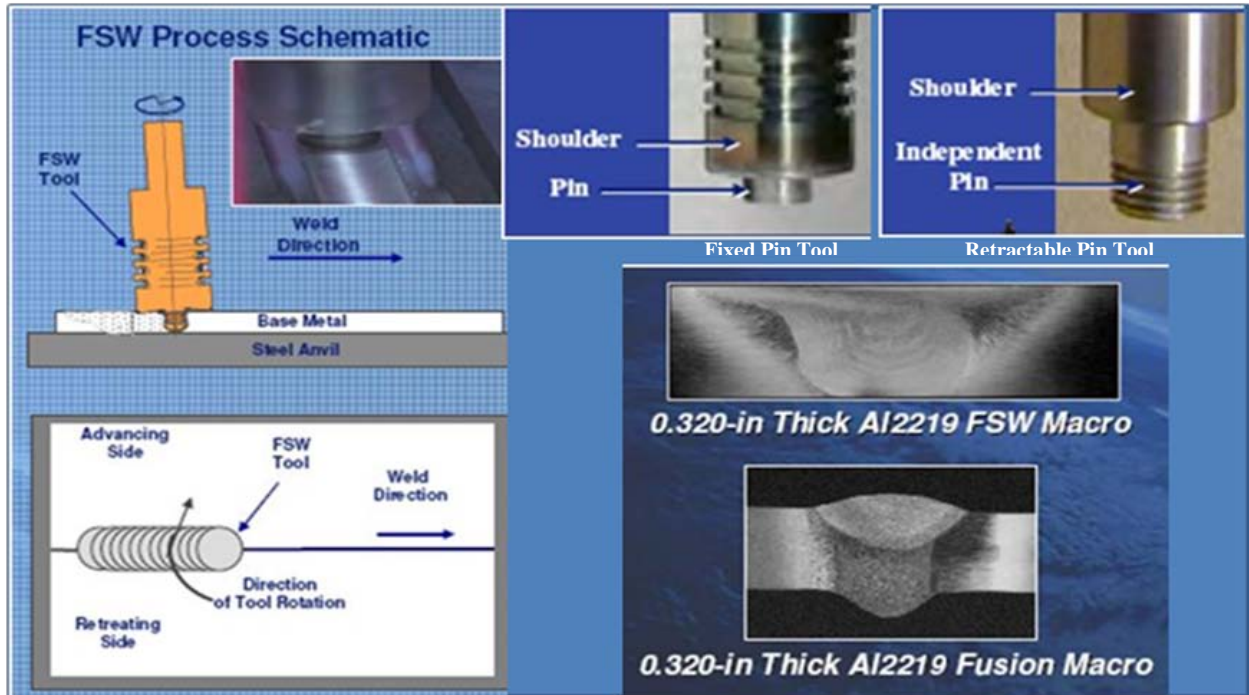
Figure 12: Friction Stir Weld Schematic and Macro Comparison

Al 2195 made the initial welds of the ET far more complex. Repair welds were difficult to make and had lower mechanical properties. This drove up production costs. Enter friction stir welding (FSW) as the most recent upgrade to the ET. FSW utilizes frictional heating combined with forging pressure to produce high-strength bonds virtually free of defects. FSW transforms the metals from a solid state into the “plastic-like” state, and then mechanically stirs the materials together under pressure to form a welded joint. As a result weld joints are more efficient, yielding 80% of the base metal strength. Fusion welding averages 40-50% of the base metal’s strength.

FSW was introduced on ET-132 LH<sub>2</sub> barrels 3 and 4 for the linear welds. At ET-134, the LO<sub>2</sub> barrel and all LH<sub>2</sub> barrels (1, 2, 3, & 4) were completed using FSW. One additional material change occurred at ET-134. The LO<sub>2</sub> aft ogive reverted to Al 2219 and the VPPA weld process.

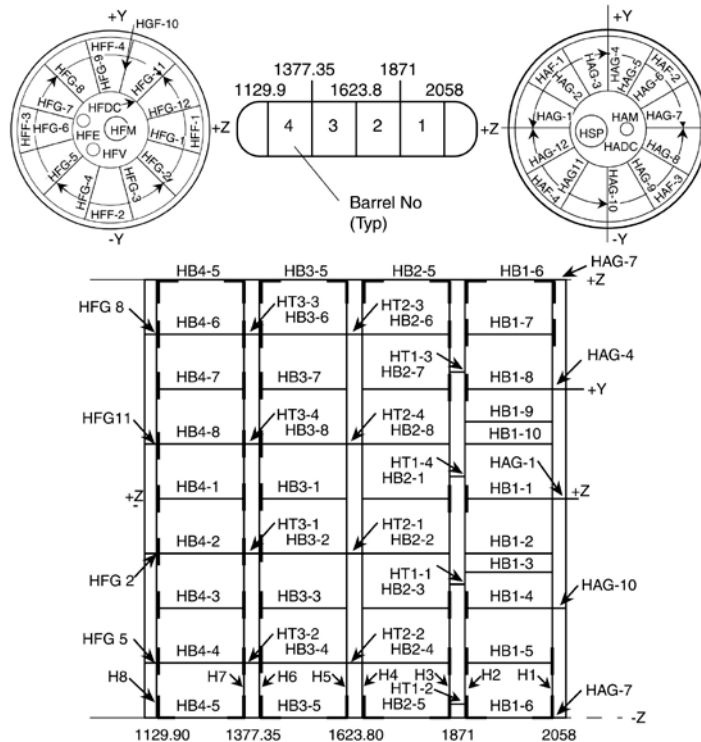
**Figure 13: LH<sub>2</sub> Tank Weld Layout**

The LH<sub>2</sub> and the LO<sub>2</sub> tanks are shown in a flat profile in Figures 13 and 14. This allows a birds-eye view of the individual sections and welds required to complete each pressure vessel build.

Following completion of each sub-assembly, each weld was inspected for defects. In order to denote where a defect was found, the inside and outside surfaces of the tanks needed to be identified. The naming convention for the exterior surface was outer skin line while the interior surface was the inner skin line. Typical inspections included: 1) visual inspection to check for peaking and mismatch due to the weld as well as for non-conforming weld configurations; 2) radiography to check for defects internal to the weld; 3) liquid penetrant inspection to determine if any defects such as cracking or laps were open to the surface. When defects were found, repair practices such as sanding, grinding, and weld heat repairs were performed. Subsequent to any repair practice, the area worked was re-inspected to assure that the existing defect was removed and that no new defects were introduced.

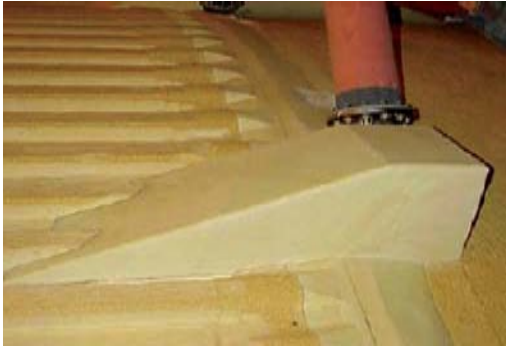
**Figure 15: STS-107 Bipod Ramp**

The bipod configuration flown on the final Columbia mission (STS-107) is shown in Figure 15 and the Return to Flight configuration is shown in Figure 16. The original configuration had parts covered with a high density material called Super Light Ablator (SLA) which was there to protect the structure from ascent heating. A 150 watt calrod heater was used in the center of the spindle to keep the exposed end of the fitting which attached to the Orbiter strut from forming ice. This entire structure (fitting, heater, wiring, ablator, and miscellaneous hardware), minus the end of the fitting, was covered in a ramp of manually applied foam insulation to prevent/eliminate ice formation and provide protection from ascent heating. It was this foam ramp that came off and struck the Orbiter during the STS-107 Columbia mission. As a result, the main goal for the bipod redesign was to eliminate this large amount of foam as a potential debris source. Due to the direct sink to the LH<sub>2</sub> tank and the necessity to have some parts bare it quickly became apparent that the new design would require a heater to minimize ice formation. See Figure 17 for an exploded view of the bipod hardware attached to the LH<sub>2</sub> tank for the redesign. The final design made use of the original thermal isolator which was used between the LH<sub>2</sub> tank wall and titanium fitting, the titanium fitting, and the internal Inconel spindle. Major new hardware components included four 300 Watt heaters,

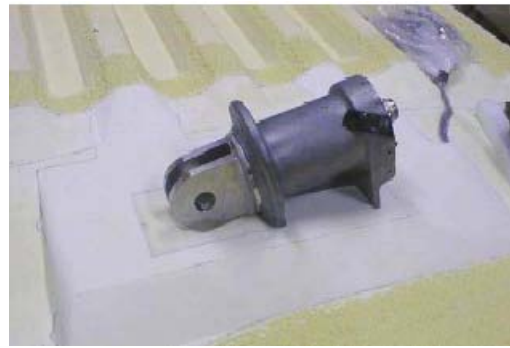
**Figure 16: RTF Bipod Configuration**

a copper plate with 2 blocks to hold the heaters (2 each) placed between the fitting and isolator to spread the heat, and a new cover for the end of the fitting not attached to the strut.

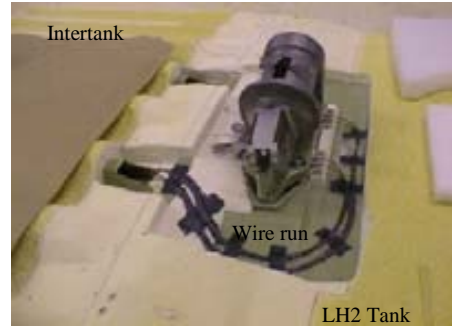
**Figure 18: RTF Bipod Fitting Prior to Foam Closeout**

Figure 18 shows the fitting after installation but prior to the final foam closeout. It also shows the wires bonded as they exit the backside of the fitting and traverse over the Intertank to LH<sub>2</sub> tank flange and enter the Intertank stringer on the forward side. Since the wires can be a reservoir for cryoingestion of N<sub>2</sub> from the Intertank, the wires within 4 feet of the fitting were injected with a filler and bonded to the tank for the entire wire run on the LH<sub>2</sub> tank side to try and prevent foam debris as a result of cryoingestion during loading and subsequent release of foam during drain of the LH<sub>2</sub> tank in flight. In addition, the foam closeouts around the fitting were done in steps to eliminate/reduce voids in the foam and around the complex substructure. In some locations foam or paste was added to fill holes/gaps that could create reservoirs for cryopumping. The paste had an additional function of providing better contact between connecting structures allowing for more consistent performance of the heating system.

Due to the variations in contacts for this bipod structural stack-up and the range of weather conditions, the heaters were controlled based on feedback from two temperature sensors located on the backside of the fitting under the foam. The requirement for this complex control system was verified throughout the operation of this new design where no two fittings (+Y or -Y) required the exact same power settings from loading to loading and throughout the loading phases. One additional lesson learned with this control system was the requirement to offset the temperature readings. Due to the high conductivity of the wiring and the cold sink to which they were attached the temperature readings were not absolute and were dependent on the type of sensor and placement of the sensors in the final design.

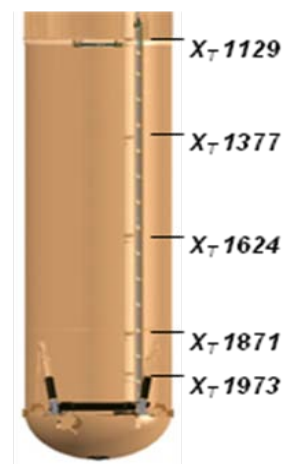
**Figure 19: LO<sub>2</sub> Feedline Bracket Locations**

During RTF II there was an initiative to reduce the debris coming from the LO<sub>2</sub> Feedline brackets which included ice, foam, and possibly SLA. These brackets attach the LO<sub>2</sub> feedline to the LH<sub>2</sub> tank barrel at 5 locations and are designed to allow relative motion between the feedline and the LH<sub>2</sub> tank during tanking/detanking cycles. Only the first four brackets, shown in Figure 19, which were identical and pose the highest risk to the Shuttle stack were redesigned. The brackets from ET-1 through ET-126 were made of aluminum and were covered with both SLA for heating and foam for ice protection. Due to the required motion of the brackets during loading/flight and clearance requirements, not enough foam could be installed to completely eliminate ice formation on these brackets. Figure 20 shows the critical icing areas which could form ice once the tank is loaded. Figure 21 shows typical ice formation as observed on the pad prior to launch. During launch, these joints articulate which can crack both the ice and also TPS. Testing showed the majority of ice debris occurs early, just after liftoff, but the TPS debris can occur later in flight (near high dynamic pressure) and can pose a higher debris risk to the orbiter.

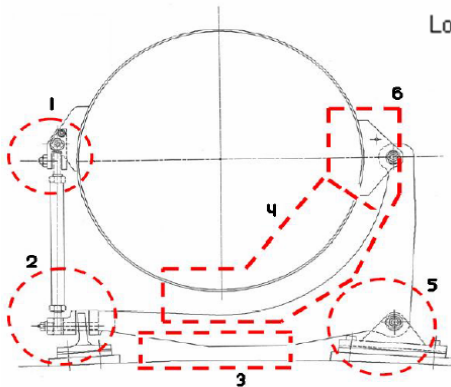
**Figure 20: Critical Icing Areas Subject to Motion**

**CATEGORY I SUBZONES**

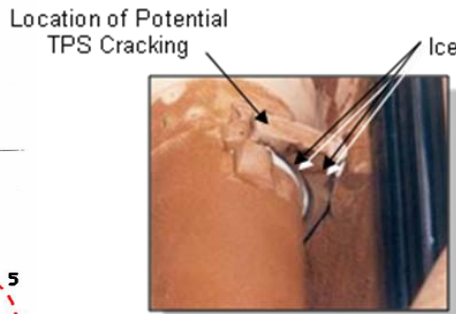
**LO2 Feedline Support Yoke Redesigned to Address Ice and Reduce Potential for TPS Cracking (XT 1129, 1377, 1624 & 1873)**

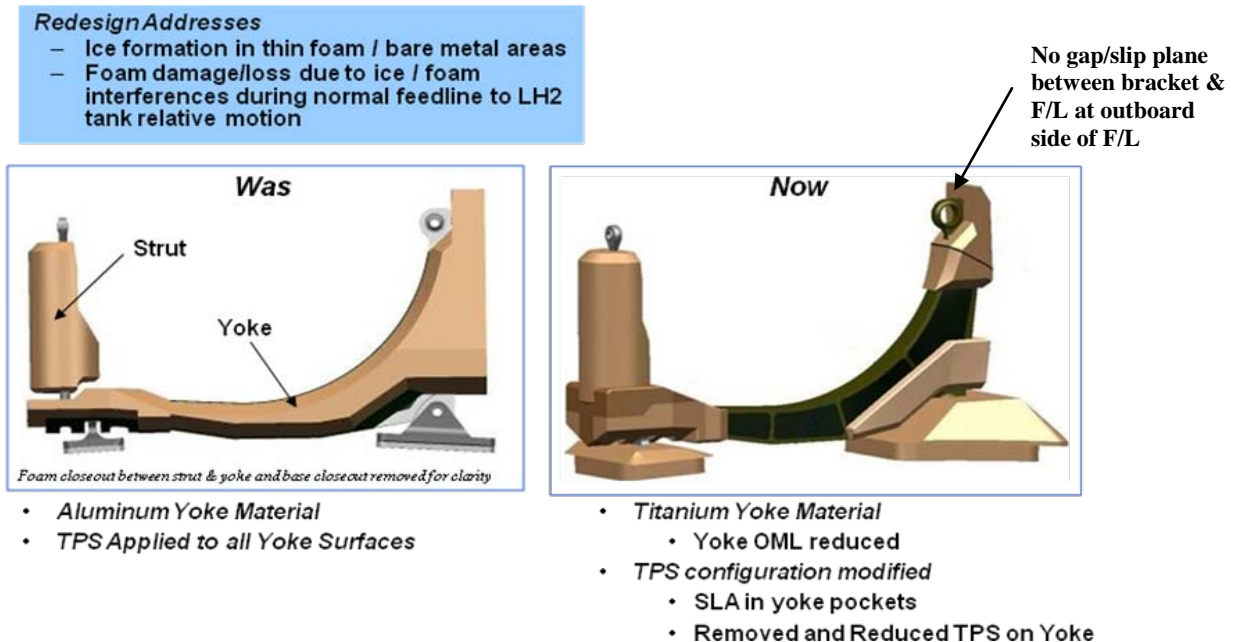
**Figure 22: LO2 Feedline Brackets Before and After Redesign**

Starting with ET-127 the aluminum brackets were replaced with redesigned titanium brackets which provided a totally passive ice mitigation solution. The redesigned bracket takes advantage of titanium's high strength and low thermal conductivity (about 10 times lower than aluminum) which allows the bracket to fly with less TPS foam insulation and more exposed metal than the previous design. By decreasing the foam insulation, more surface area of the bracket is exposed and heat is transferred into the bracket through convection and radiation with the ambient environment. This results in a warmer overall bracket with a smaller "focused" area capable of producing ice during prelaunch. Also the high strength and high temperature capability allowed the titanium bracket to be thinner than

of the bracket. This prevented ice formation in this articulating joint, eliminating foam cracking and subsequent foam loss from the bracket top in this location (which had been shown to be a high debris risk area).

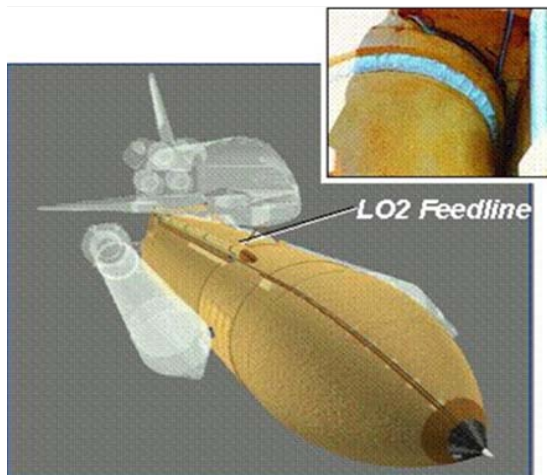
**Figure 23: Pre RTF LO<sub>2</sub> Feedline Bellows at XT 1106**

The ET has 3 bellows on the LO<sub>2</sub> feedline that runs along the LH<sub>2</sub> tank at XT 1106, 1979, and 2026. Figure 23 shows the ice/frost formation that existed at the bellows opening for the LO<sub>2</sub> feedline at XT 1106 prior to the redesign. Due to the location of the forward bellows relative to the Shuttle it was deemed the most critical location for debris liberation. As such, Kapton strip heaters were installed on the LO<sub>2</sub> feedline bellows at XT 1106 to mitigate ice accumulation, starting with ET-121. The heater strips were adhesively bonded to the inner surface of the outer rain shield and the outer surface of the end convolute shield as shown in Figure 24. Each heater strip contained independent primary and secondary circuits for redundancy. Heater operation was controlled by monitoring circuit voltage and current, which eliminated the need for temperature sensors. The heater power to the rain shield and the convolute shield were approximately 30% and 70%, respectively, in order to maintain all requirements. These 2 surfaces needed to be warmed enough to prevent ice accumulation but not too much to affect the LO<sub>2</sub> propellant running through the line or to violate the bond line temperature limit of the foam adhered to the outside of the two shields. Placement of the heater on the two shields was also critical to the success of this redesign and as such the installation requirements were stringent.

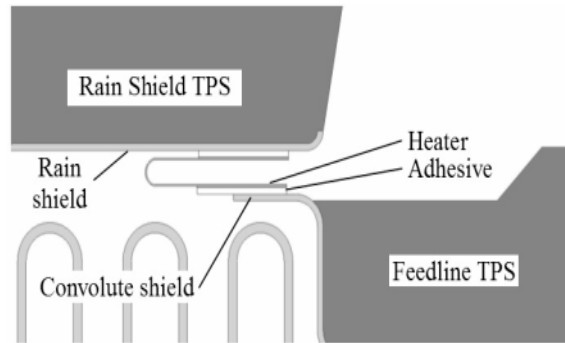
**Figure 24: RTF LO<sub>2</sub> Feedline Bellows with Heater**

Original concepts to eliminate this ice included purges, an Atlas type boot, heaters, filling the cavity with some type of insulation, or targeted heating but all of these concepts had issues. Heaters were not pursued heavily in the beginning due to the active heating system required and initial placement of the heaters on the metal in locations that indicated the heater power was excessive and propellant quality would be negatively impacted. Due to the small gap between the bellows shield and the convolute shield, installation of the heater was also a challenge to implementing a design with a heater.

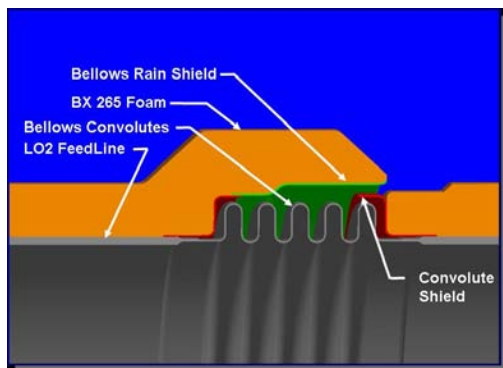
**Figure 25: Pre RTF LO<sub>2</sub> Feedline Bellows OML**

While no heaters were used at XT 1979 and XT 2026 due to reduced risk of critical damage to the Orbiter from ice debris, the outer mold line (OML) of the foam on the bellows shield was redesigned to reduce the amount of ice/frost that formed at the opening by a minimum of 40%. Condensate run-off and the configuration of the foam on the rain shield were found to be major contributors to ice build-up. The pre-RTF LO<sub>2</sub> feedline bellows configuration of the foam is shown in Figure 25. Figure 26 shows the new OML that was implemented during RTF at the 3 bellows locations which resulted from the addition of the foam labeled ‘drip lip’.

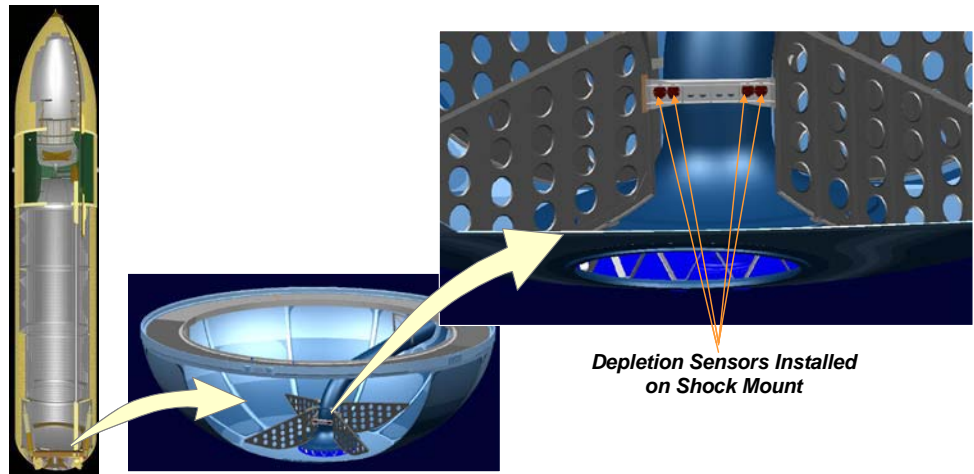
**Figure 27: Depletion Sensor Location**

Four sensors (Figure 27) are located at the bottom of the LH<sub>2</sub> tank and serve as a back-up system to ensure that the SSMEs never run LO<sub>2</sub> rich due to either a leak in the LH<sub>2</sub> tank or issues within the SSMEs. Premature depletion of LH<sub>2</sub> would result in catastrophic explosion of the SSME. Small platinum filaments are housed within each sensor (Figure 28) and are used to detect changes in resistance as

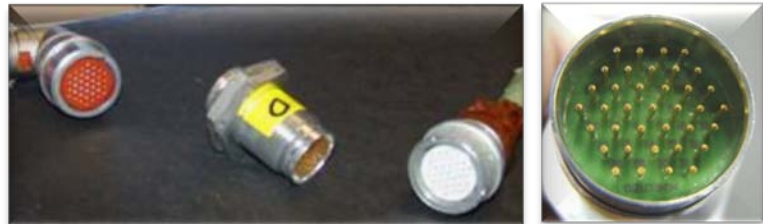
**Figure 29: Feed Through Connector**

Prior to STS-129, sensor circuit anomalies (open circuit) would randomly occur during the filling of the LH<sub>2</sub> tank at cryogenic temperature and subsequently regain functionality following tank drain at ambient conditions. Previous investigations were unable to conclusively identify the root cause, but the decision was made to implement process improvements to the sensor manufacturing process as the sensors were deemed to be the most likely cause. Several flights occurred with no issues observed; but during cryogenic loading for the STS-129 mission, multiple sensor circuits failed simultaneously. A subsequent instrumented tanking test was performed and isolated the fault to the feed thru connector (*Figure 29*). The specific root cause was determined to be the result of liquid air / condensation that would form on the pin / socket parts on the external side of the feed thru connector at cryogenic conditions (*Figure 30*). With the material formed on the mating surfaces, any relative motion between the two surfaces would result in an open circuit to occur at cryogenic temperatures

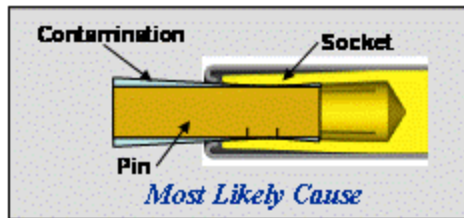
**Figure 30: Pin Contamination**

which would then resume functionality once the material had melted (i.e. post drain ambient conditions). Once the issue was isolated to the external mating connectors at the feed thru connector, the necessary corrective action was quickly identified and certified for flight. The corrective action

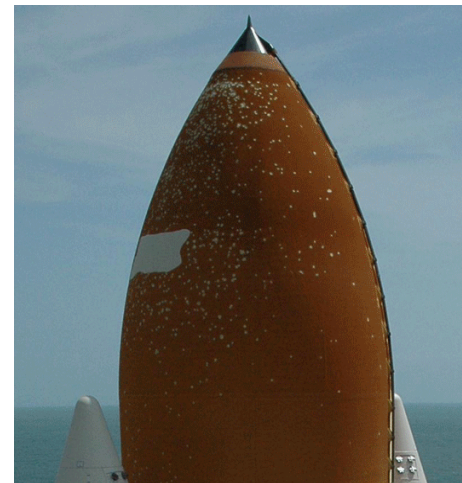
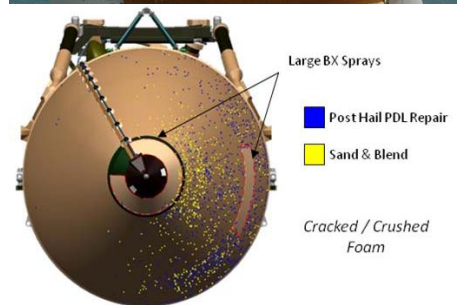
**Figure 31: ET-124 Hail Damage Repairs**

ET-124 suffered significant impact damage due to a freak hail storm while the Shuttle stack was on the launch pad prior to the STS-128 mission. Over 5,000 individual impacts were incurred on the TPS system. The damage required that the stack be rolled back to the Vertical Assembly Building for detailed assessment and repairs. A majority of the more significant impact were located on the debris critical zone section of the forward LO<sub>2</sub> tank. Following a detailed assessment of each damage location via tactile inspection, the damage sites were grouped by severity and location. Next, unique engineering requirements were developed based on the as-built configuration (i.e. TPS thickness) and weather conditions. This was critical to the overall effort as the intent was to remove as little of the original TPS as possible while ensuring that the potential for ice formation and/or TPS liberation is minimized. The

repairs (*Figure 31*) consisted of sand/blends for minor damage sites, local filling of more significant damage sites, and finally large manual sprays where the damage density was too great to address individually. Each repair method was verified by first validating the process, and, then performing tests to the critical aero-thermal ascent environments.

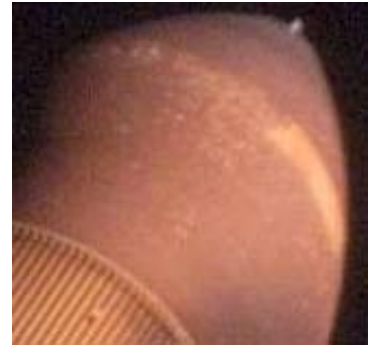
**Figure 32: Hail Damage Repair Flight Performance**

The restoration of ET-124 preserved a valuable flight asset and minimized what could've been a major impact to the Shuttle program manifest. Post flight evaluation (*Figure 32*) showed that all of the hail damage repairs performed flawlessly with no debris events observed.

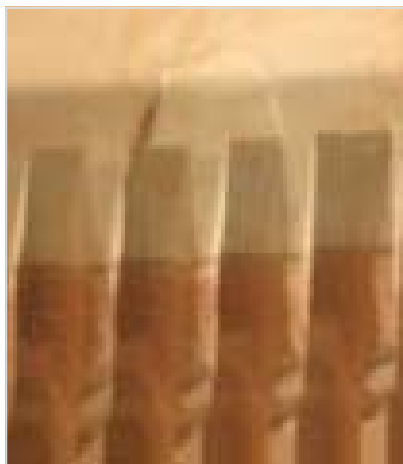
**Figure 33: STS-133 TPS Crack as Seen On Pad**

Following the scrub of STS-133 launch attempt due to launch commit criteria limit violation for GH2 leakage at the ground umbilical disconnect, a large TPS crack was observed adjacent to the LO<sub>2</sub> / Intertank flange region (*Figure 33*). Subsequent TPS removal revealed that the TPS crack (*Figure 34*) was the result of cracks in the base of the Al-Li 2090 Intertank stringers where the stringers are mechanically attached to the Intertank skin panel. Five stringers were observed to exhibit similar cracks. An extensive investigation ensued to identify the root cause and assess / implement corrective actions. The cause of the cracks was isolated to material lots that were shown to have reduced fracture toughness and uncharacteristic crack growth behavior. Those factors combined with higher assembly stresses on the LO<sub>2</sub> tank end of the stringers contributed to the observed cracks. Nondestructive evaluation of the LH<sub>2</sub> / Intertank flange confirmed crack-free conditions. The corrective action required a design change to the LO<sub>2</sub> tank side stringer ends to incorporate reinforcements on the stringer feet called radius blocks. The effectiveness of the radius block change was demonstrated by numerous component level tests and structural analyses. Radius blocks were implemented on the remainder of the ET fleet and successfully flown with no issues.

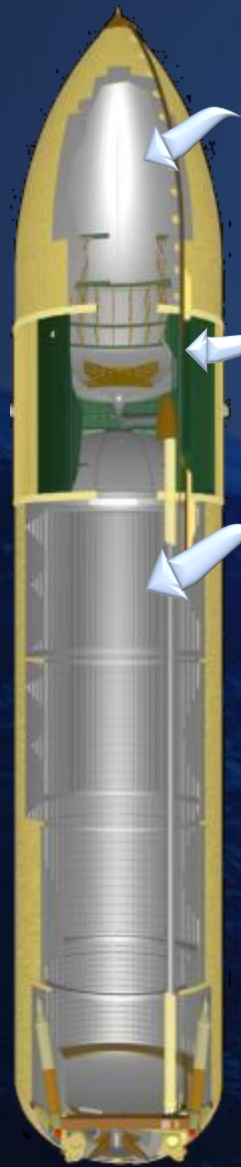
- Liquid Oxygen Tank*
- 1,385,000 lbs. / 145,138 gallons Oxidizer
  - -297 F

- Intertank*
- Unpressurized Structure

- Liquid Hydrogen Tank*
- 231,000 lbs. / 309,139 gallons fuel
  - -423 F

- Max TPS thickness - ~2.5" (LO2)
- Min TPS thickness - ~0.15" (Intertank)
- Max Al substrate thickness - ~2.06" (Intertank)
- Min Al substrate thickness - ~0.040" (Intertank)
- Max LO2 operating pressure - ~70 psig
- Max LH2 operating pressure - ~34 psig
- - ~4,000 lbs. of thermal protection materials (16,750 sq. ft.)
- ~38 Miles of Electrical Wiring
- Length = 153.8'
- Diameter = 27.6'
- > 1/2 mile of pressure vessel welds

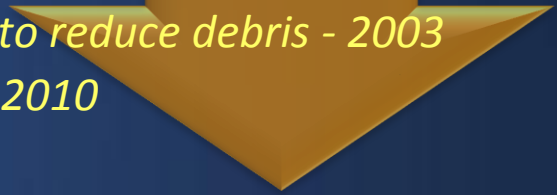
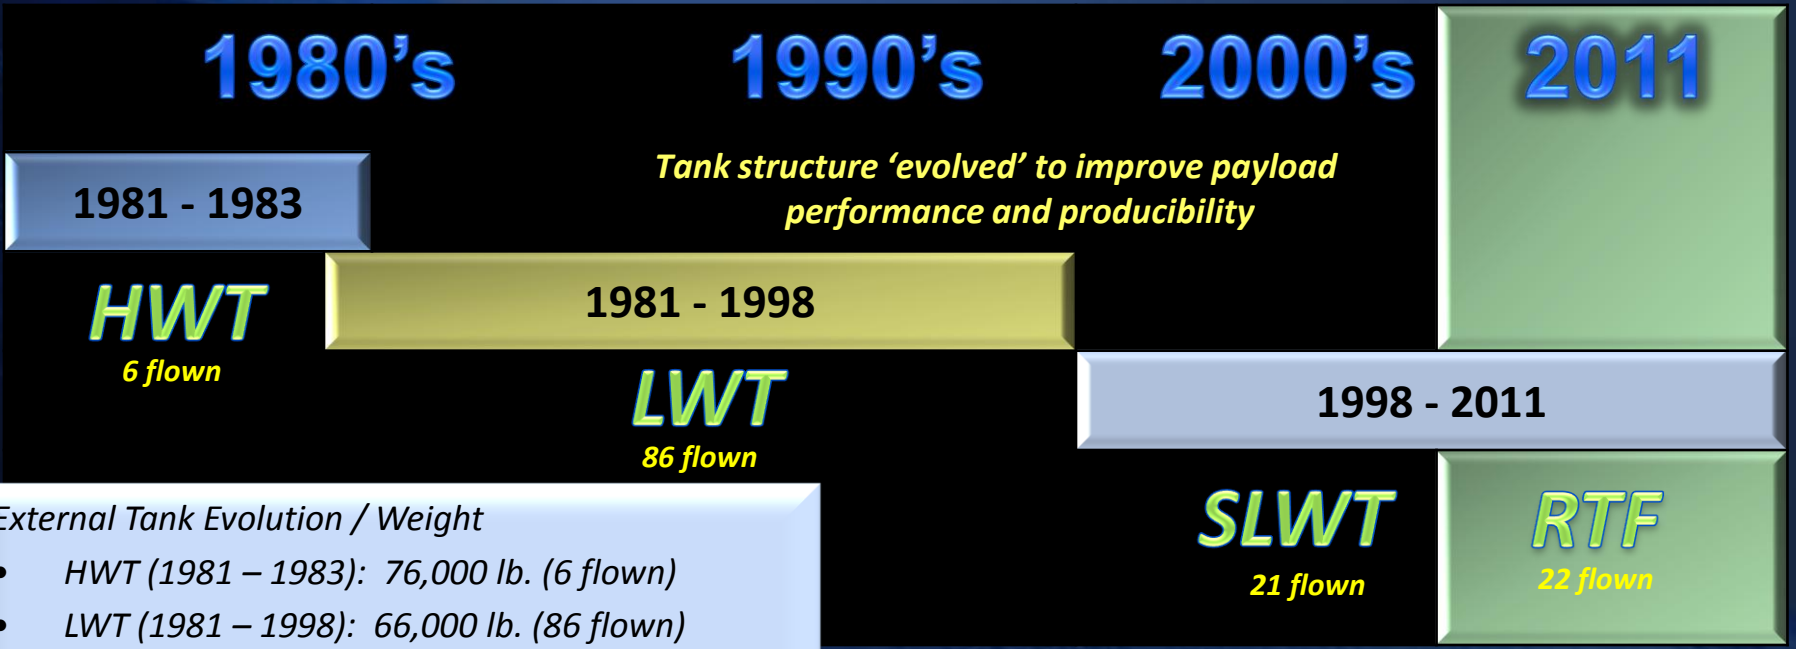
**External Tank Evolution / Weight**

- HWT (1981 – 1983): 76,000 lb. (6 flown)
- LWT (1981 – 1998): 66,000 lb. (86 flown)
- SLWT (1998 – 2011): 58,500 lb. (43 flown)

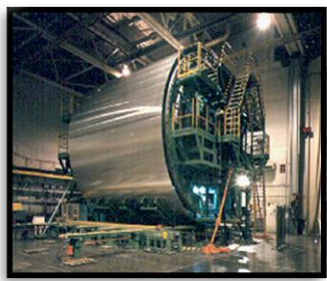
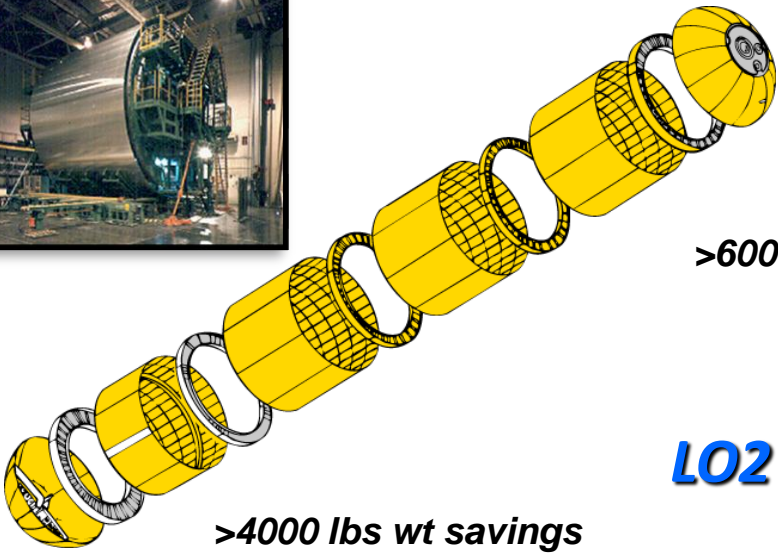
### LH2 Tank

>4000 lbs wt savings

- Substitute Al 2195 for Al 2219
- Redesign to Orthogrid Waffle
- Optimize TPS Application

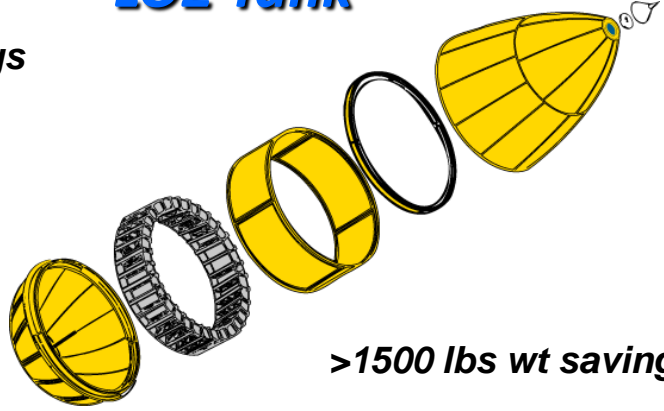
### LO2 Tank

>1500 lbs wt savings

- Substitute Al 2195 for Al 2219
- Resize

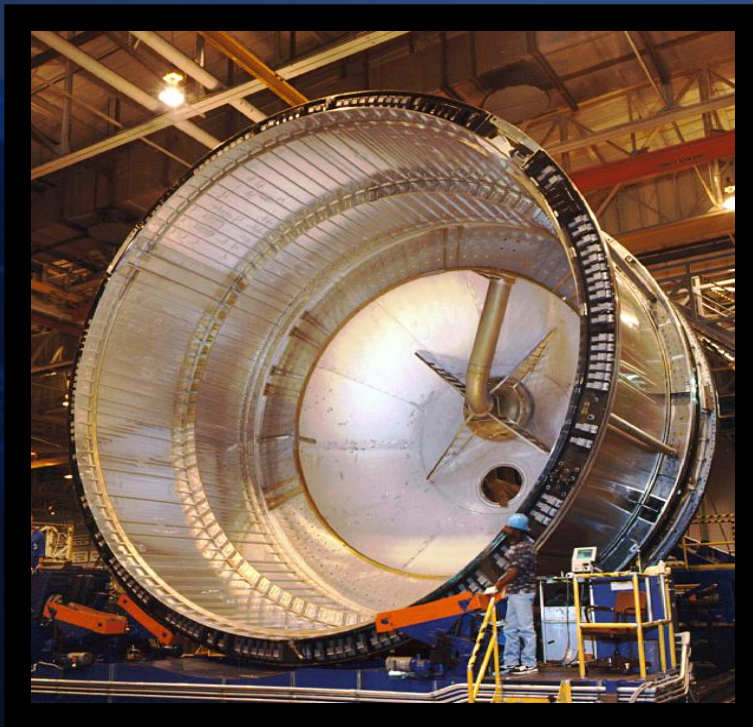
- **Major configuration change implemented on SLWT LH2 Tank barrels**
  - Was: Al 2219 T-stiffened panels (SWT and LWT designs)
  - Now: Al 2195 Orthogrid panels (SLWT)
    - Required development of new manufacturing process for machining, forming, and welding of barrel assemblies

*Standard Weight (SWT) and  
Lightweight (LWT) – Al 2219 alloy*

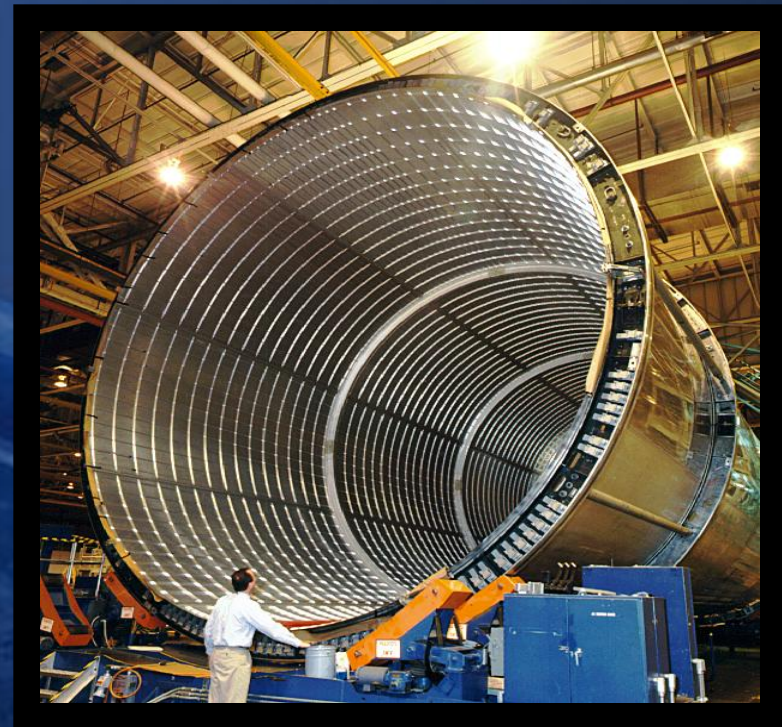
*Super Lightweight  
(SLWT) – Al 2195 alloy*

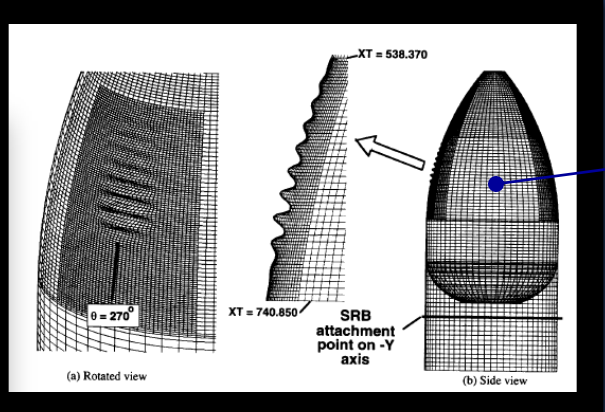
*LO2 Tank Independent Stability Analysis (LaRC)*

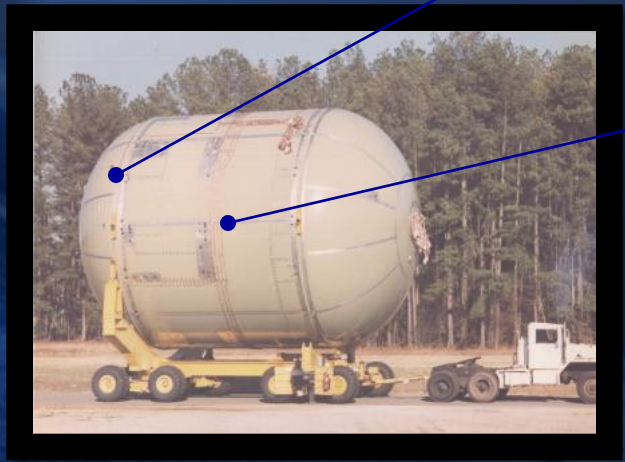
*ALTA at MSFC*

**ALTA used to verify multiple hardware elements and failure modes**  
 - - LH2 Barrel Panels, LO2 Dome, Fusion Welding

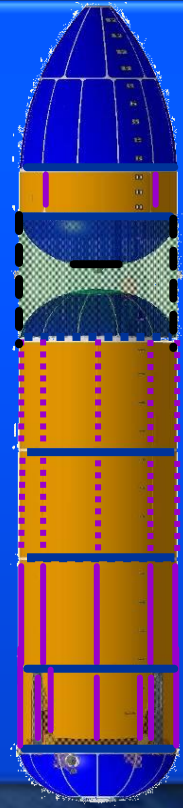
- Implemented FSW on LO<sub>2</sub> & LH<sub>2</sub> Tank barrel longitudinal welds (*barrels 3 & 4 only for ETs 132 & 133*)
- Substituted Al 2195 LO<sub>2</sub> aft ogive with Al 2219 / resized membrane
- Substituted Al 2219 Intertank thrust panels with Al 2297

- Al 2195
- Al 2219
- Design changed (thickness optimized / material unchanged)
- Al 2297
- FSW on ET-132 & subs
- FSW on ET-134 & subs
