# *AIAA Technical Paper – External Tank Program – Legacy of Success*

Jeffery C. Pilet<sup>1</sup>, Dawn Diecidue-Conners<sup>2</sup>, Michelle Worden<sup>3</sup>, Michelle Guillot<sup>4</sup>  
*Lockheed Martin Space Systems Company, New Orleans, LA, 70129*

The largest single element of Space Shuttle is the External Tank (ET), which serves as the structural backbone of the vehicle during ascent and provides liquid propellants to the Orbiter's three Main Engines. The ET absorbs most of the seven million pounds of thrust exerted by the Solid Rocket Boosters and Main Engines. The design evolved through several block changes, reducing weight each time. Because the tank flies to orbital velocity with the Space Shuttle Orbiter, minimization of weight is mandatory, to maximize payload performance. The initial configuration, the standard weight tank, weighed 76,000 pounds and was an aluminum 2219 structure. The light weight tank weighed 66,000 pounds and flew 86 missions. The super light weight tank weighed 58,500 pounds and was primarily an aluminum-lithium structure. The final configuration and low weight enabled system level performance sufficient for assembly of the International Spa

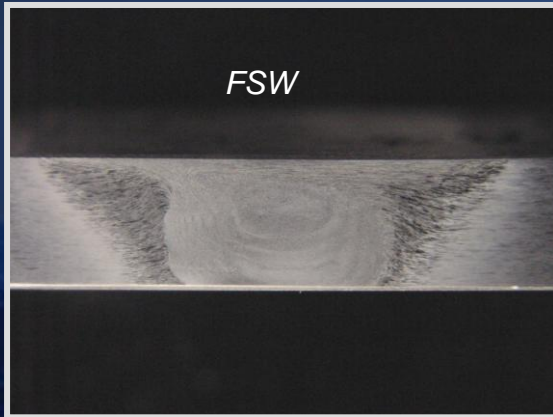
- *State-of-the-Art FSW Process Improves Robustness, Producibility, and Allows for Design Optimization*

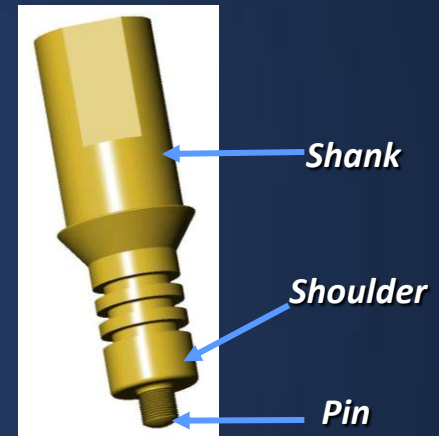
Shank

Shoulder

### Friction Stir Weld Process Primer

- *Solid-state weld process where a base material is clamped to a backing anvil*
- *FSW fixed pin tool consists of a concave shoulder and a pin with a length approximately equal to the material thickness*
- *Pin tool is rotated and plunged into the material until the shoulder penetrates below the top surface*
  - *Frictional heating from the rotating tool plasticizes the material between the anvil and the shoulder*

Al 2195 made the initial welds of the ET far more complex. Repair welds were difficult to make and had lower mechanical properties. This drove up production costs. Enter friction stir welding (FSW) as the most recent upgrade to the ET. FSW utilizes frictional heating combined with forging pressure to produce high-strength bonds virtually free of defects. FSW transforms the metals from a solid state into the “plastic-like” state, and then mechanically stirs the materials together under pressure to form a welded joint. As a result weld joints are more efficient, yielding 80% of the base metal strength. Fusion welding averages 40-50% of the base metal’s strength.

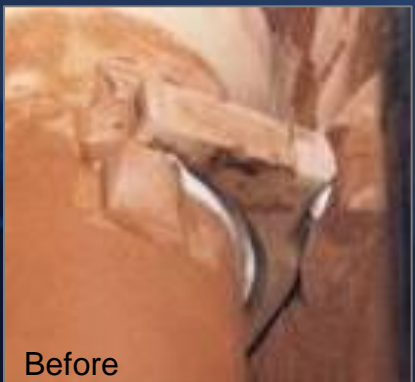
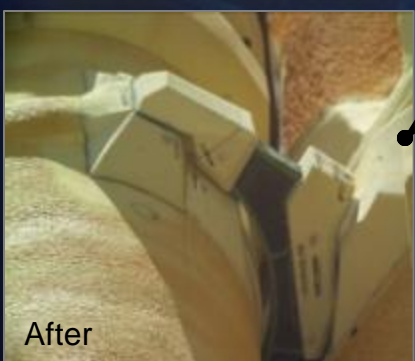
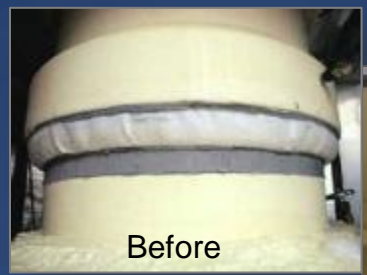
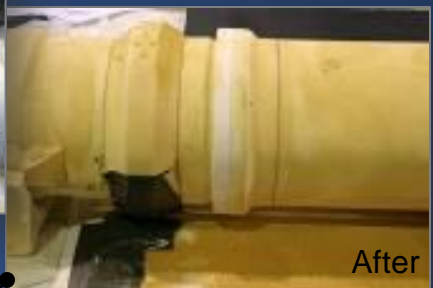
*LO2 Feedline Bracket Ice Formation and TPS Cracking Risk Reduced (4 Stations) - No TPS Loss Observed*

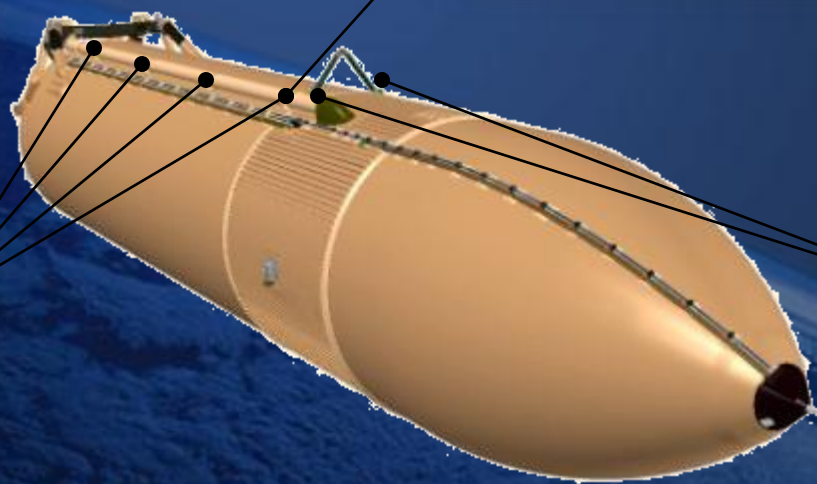
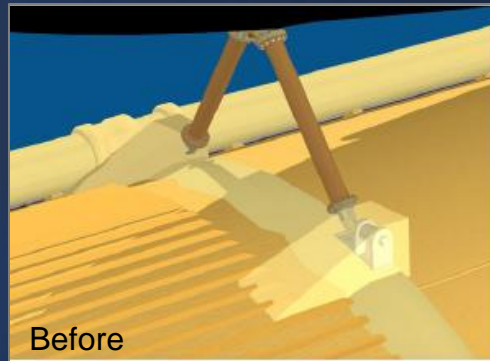
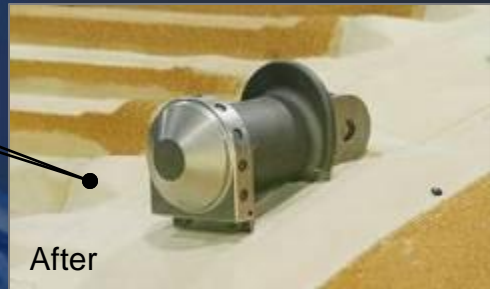
*LO2 Feedline Bellows TPS Drip Lip (3 Stations) & Heater @ XT 1106*

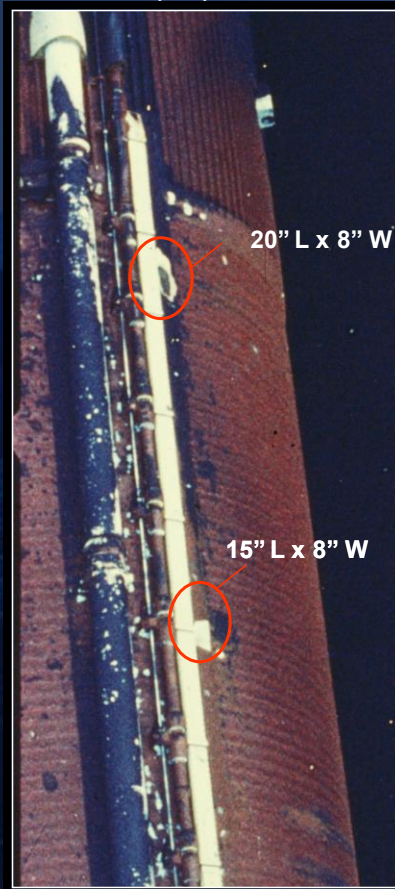
**STS-4/ET-4**

- LH2 tank PAL ramp loss

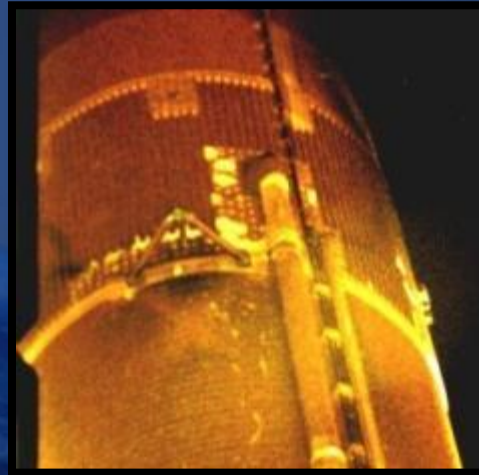
**STS-26/ET-19**

- Intertank foam loss (two tone acreage foam) 18 divots, 3" to 30" diameter

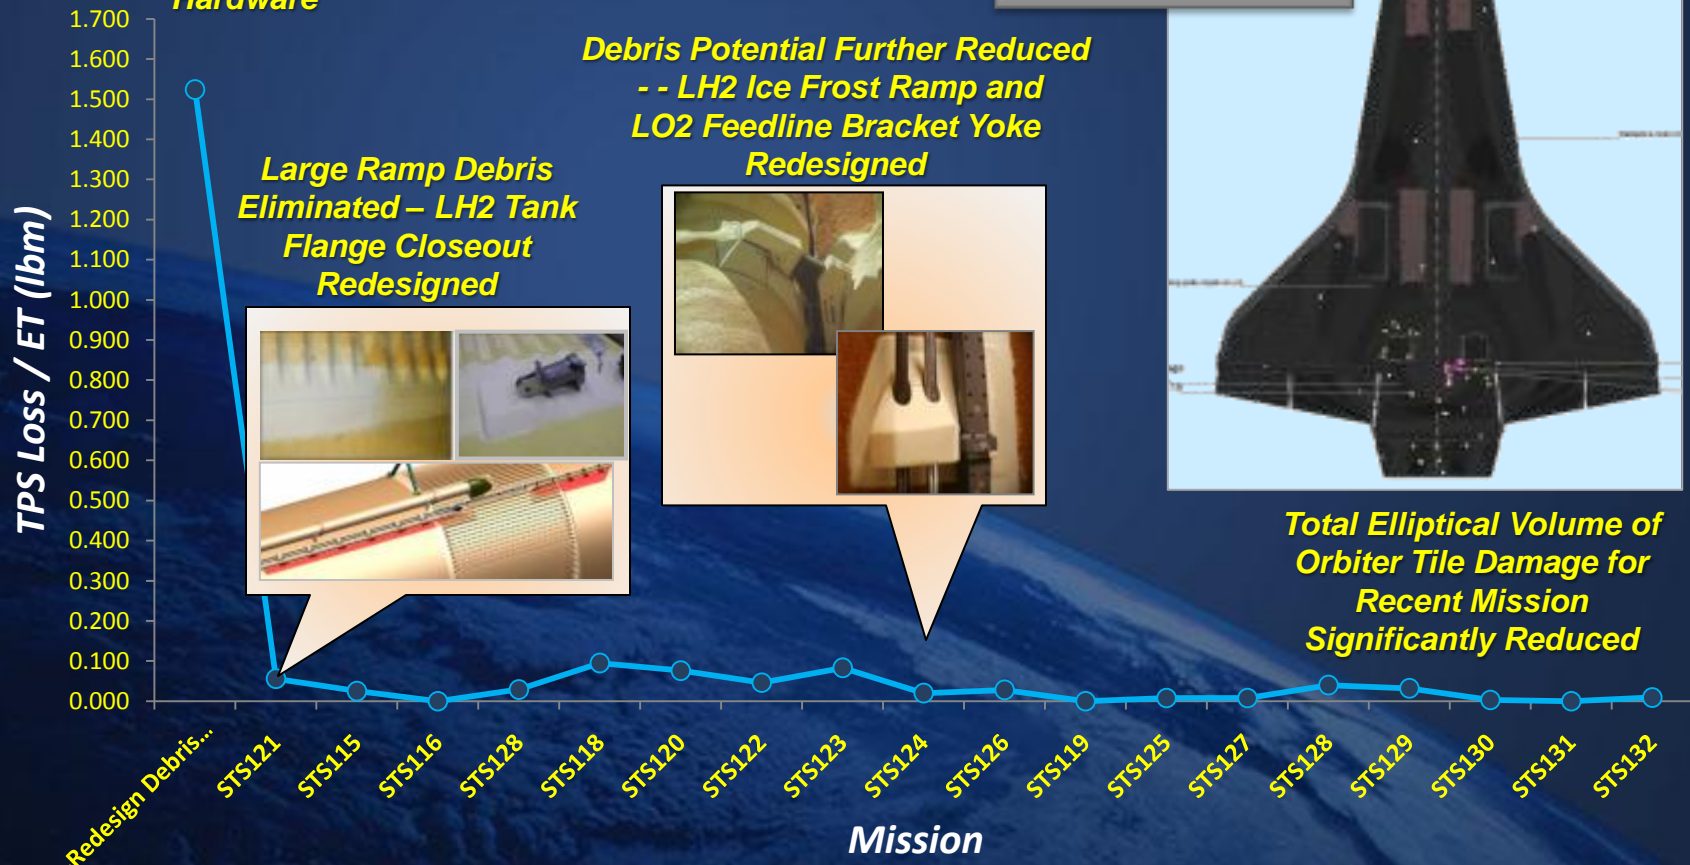
**Debris Potential for Pre-Redesigned External Tank TPS Hardware**

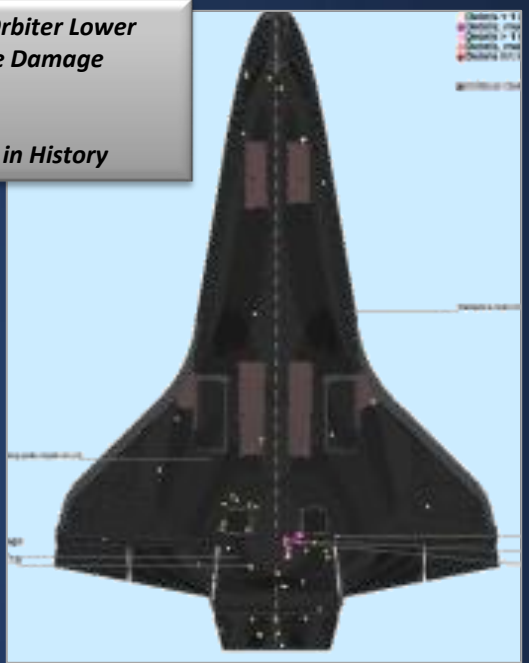
**Redesigns Significantly Reduced Debris Risk and Orbiter Tile Damage**

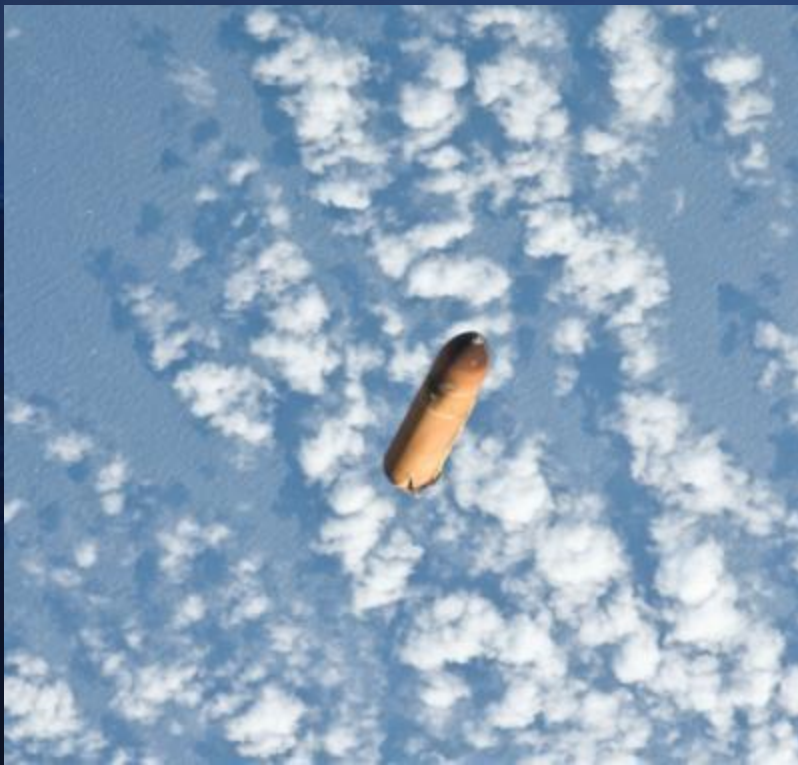
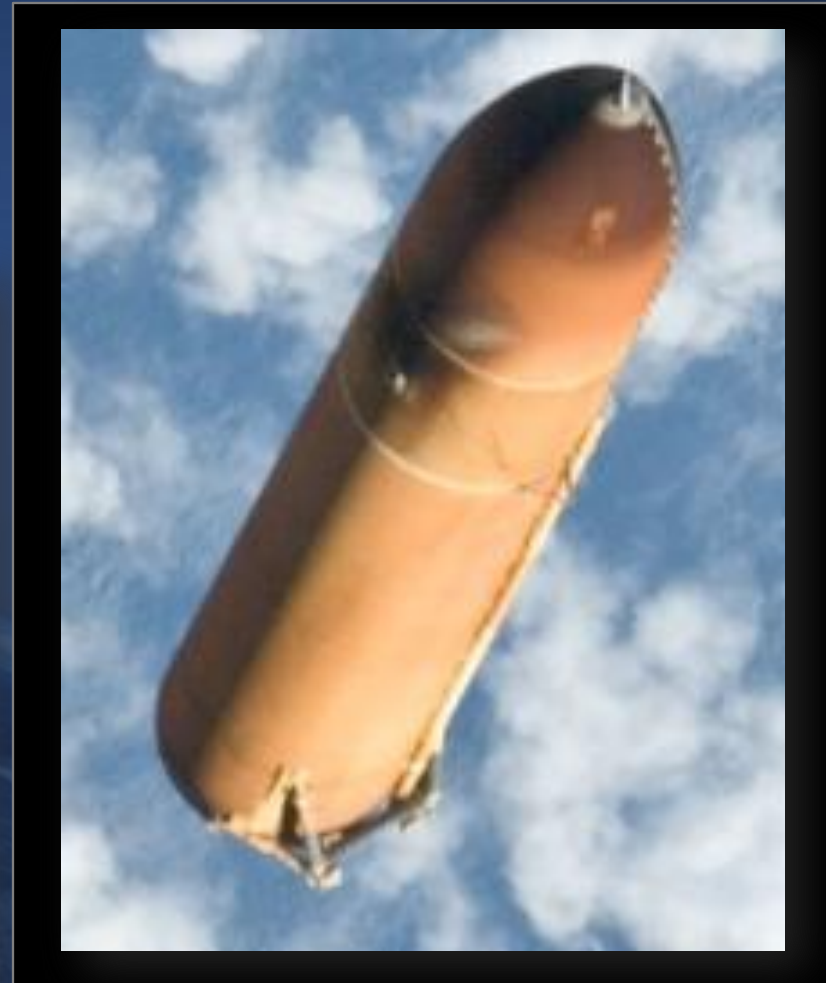
- *Separation imagery confirms TPS performance improvements*

*Outstanding External Tank Performance for STS-135 / ET-138  
- - Last Tank was the Best Tank!!*

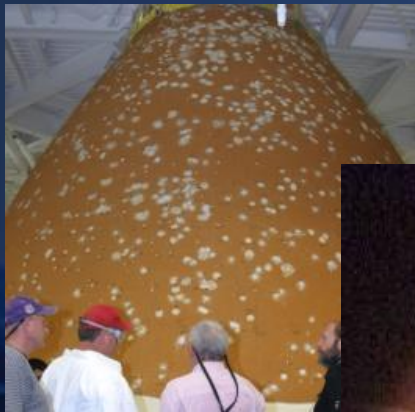
*ET-124 Damaged by Hail Storm on Pad*

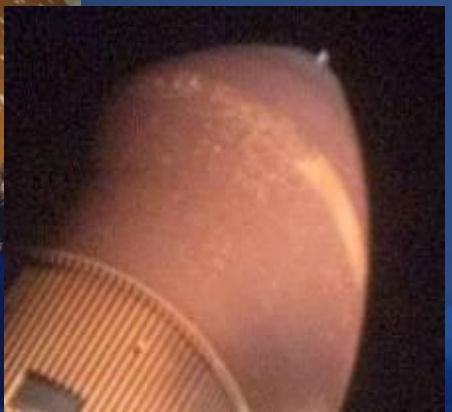
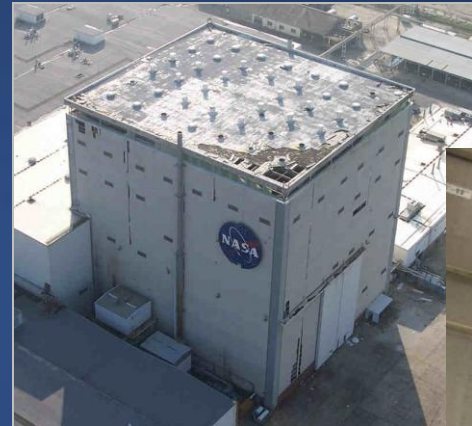
*ET-122 Damaged by Hurricane Katrina at MAF*

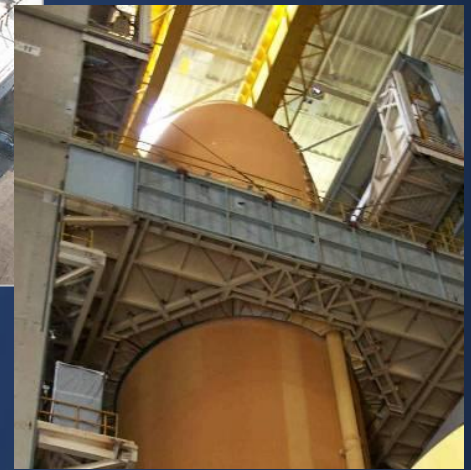
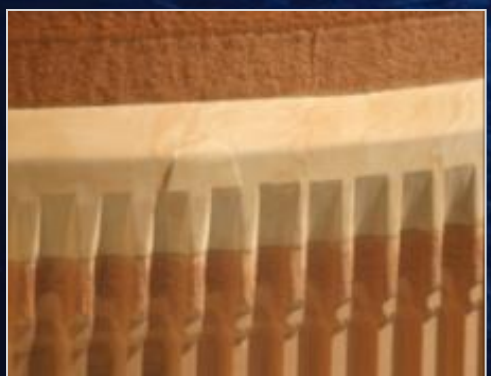
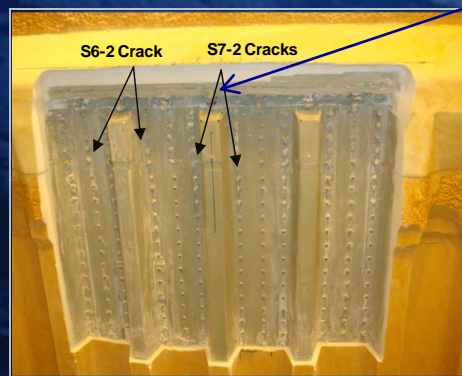
*ET-137 Intertank Stringer Cracks Observed during Loading of STS-133*
