REUSABLE SOLID ROCKET MOTOR—ACCOMPLISHMENTS, LESSONS, AND A CULTURE OF SUCCESS

D.R. Moore and W.J. Phelps
NASA Marshall Space Flight Center
Huntsville, Alabama

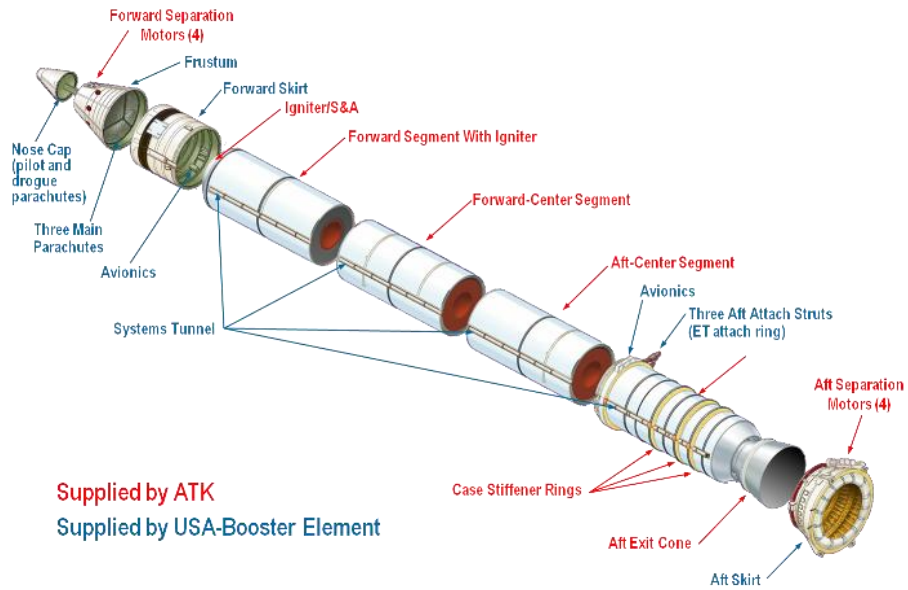
Figure 3. SRB/SRM Detail.

As of this date, the Space Shuttle Reusable Solid Rocket Motor (RSRM) was the largest diameter solid propellant motor used for space flight and the only large solid rocket motor (SRM) certified to launch humans into space. The RSRM basically consisted of four propellant-loaded steel case segments (forward, forward-center, aft-center, and aft) with a binding liner and thermal protecting insulation, a head end igniter system with a safe and arm device, and a multicomponent metal nozzle structure with thermal protecting carbon phenolic liners. The propellant mixture consisted of aluminum powder (fuel), ammonium perchlorate (oxidizer), iron oxide (burn rate catalyst), epoxy curing agent, and a polymer binder that held the mixture together. An assembled motor was 126 ft long, 12 ft in diameter, and contained approximately 1.1-million lbs_m of propellant. At lift-off of the Space Shuttle (Figs. 1 and 2), the two RSRMs provided 6.6-million lb_f thrust—the RSRMs provided 80% of the Space Shuttle lift-off thrust. Figure 3 is a graphical depiction of the SRB/RSRM detail.

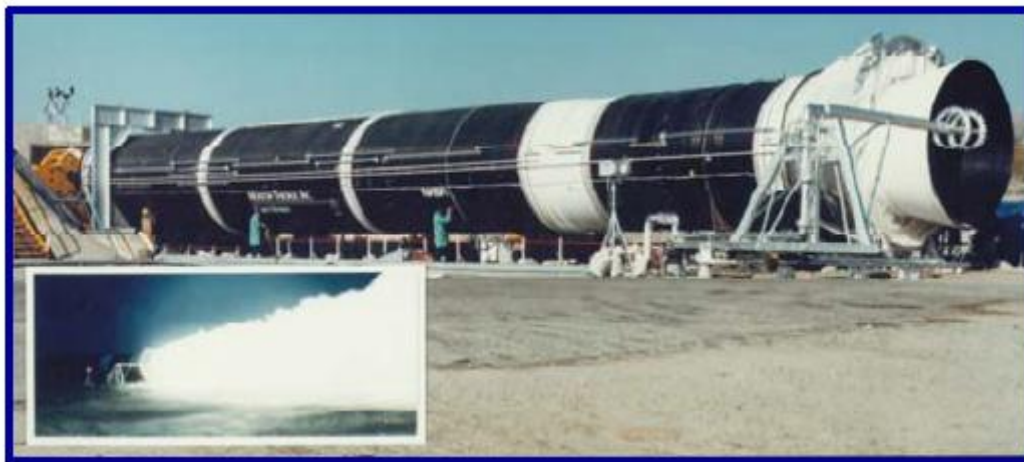
Figure 6. DM-7.

Two full-scale static tests, DM-6 and DM-7, were conducted in October 1984 and May 1985. A full-scale FWC Qualification Motor (QM-5) was assembled and ready to fire when the Challenger accident occurred. At that time, the first FWC flight motors were stacked and ready to support a July 1986 launch at the Vandenberg launch site in California. The FWC development and the plans to launch the Space Shuttle out of Vandenberg were subsequently abandoned.

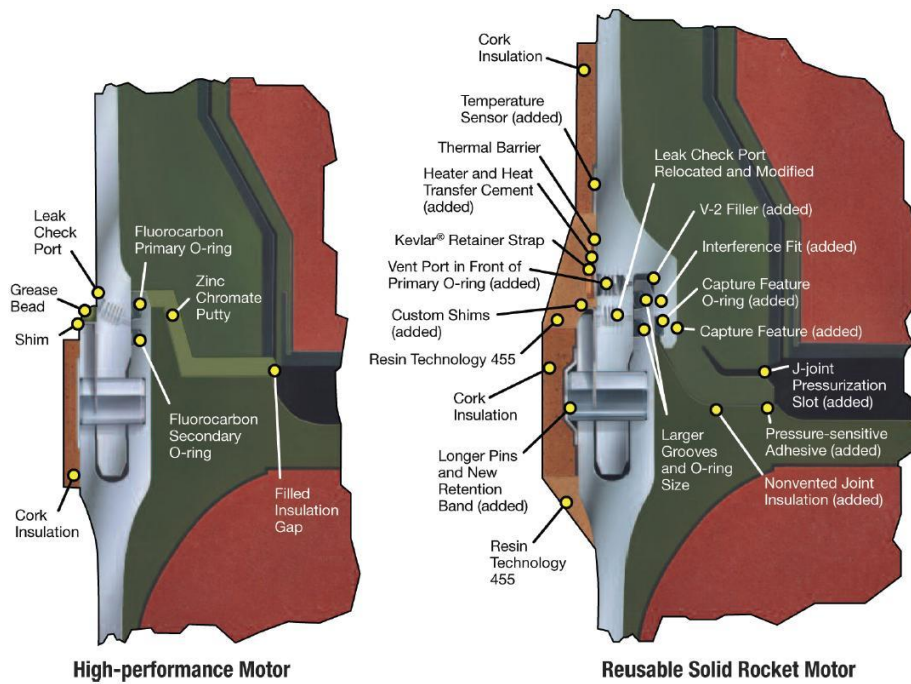
Figure 8. Field Joint Comparison.

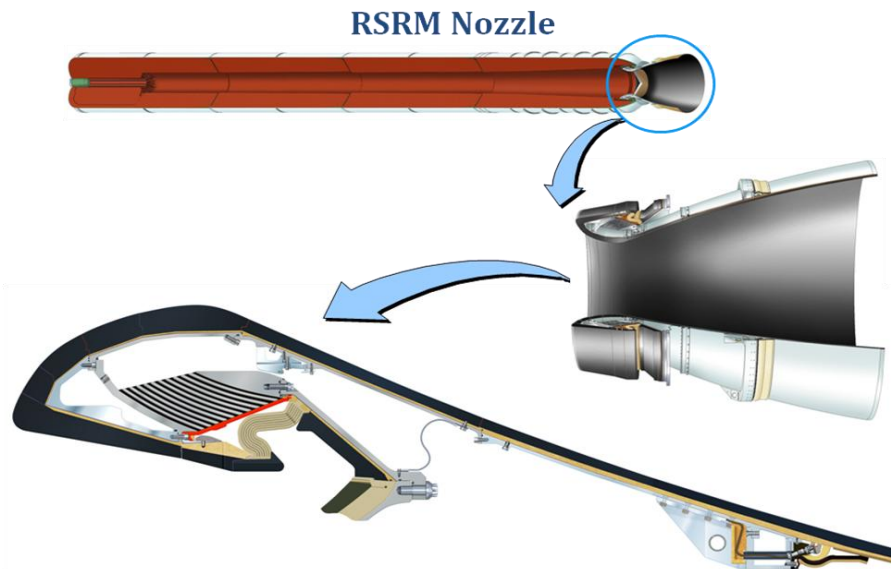
Figure 9. RSRM Nozzle.

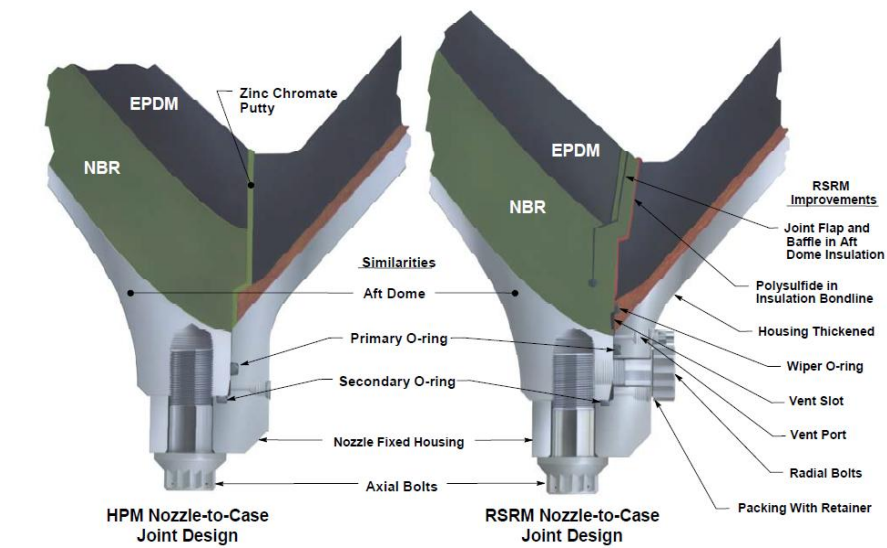
Figure 10. HPM and RSRM Return-to-Flight Joint Design.

Shortly after return-to-flight, an insulation J-leg thermal barrier was developed for the igniter inner and outer joints (Fig. 10).

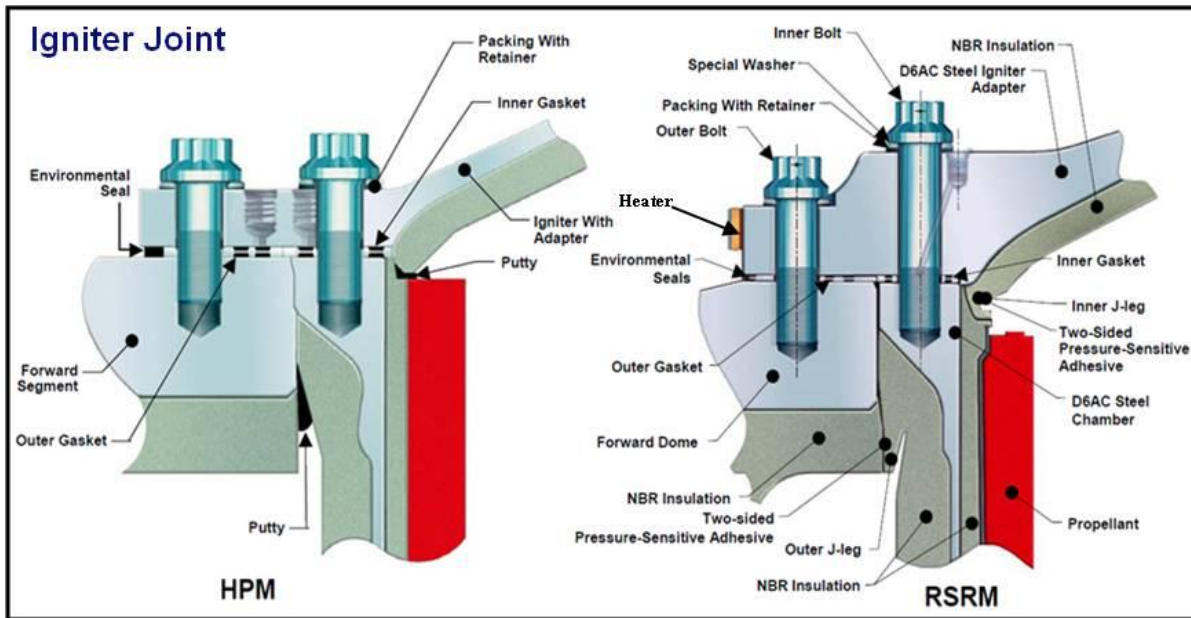
Figure 11. HPM and RSRM Igniter Comparison.

and joint heaters were added to the respective joints to ensure the ability of the o-ring to track any dynamic motion with a 2× margin. See Fig. 11 for a comparison of the HPM and RSRM designs and a description of the items listed above. Since these features were added, not one of the primary o-rings on the RSRM field joints or nozzle-to-case joints has been pressurized (over 700 total joints flown or tested).

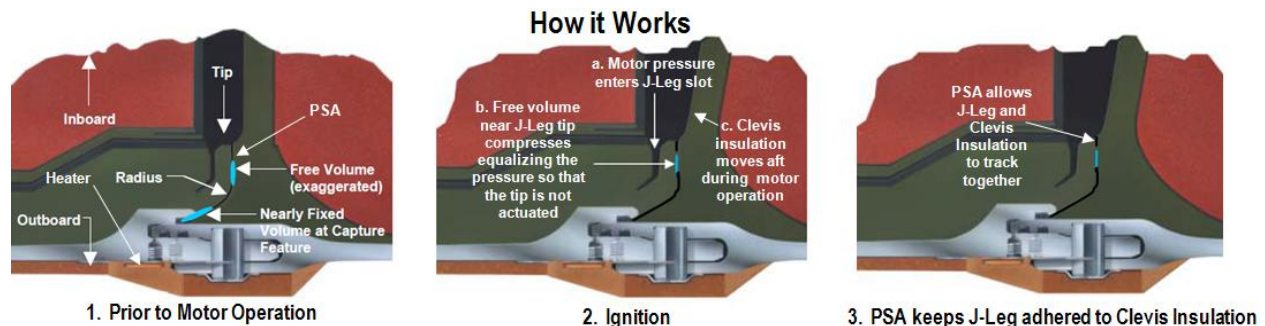
Figure 12. Pressure-Assisted Insulation J-leg.

The Presidential Commission on the Space Shuttle Challenger Accident concluded that the cause of the Challenger accident was the failure of the pressure seal in the aft field joint of the right SRB. The failure was due to a faulty design unacceptably sensitive to a number of factors. These factors were the effects of temperature, physical dimensions; character of materials; effects of reusability; processing; and the reaction of the joint to dynamic loading. One poor design characteristic leading to the cause of the accident was that the zinc chromate putty used between the mating tang and clevis field joint insulation was susceptible to the creation of gas paths and blow holes during segment stacking at KSC. During motor operation, these gas paths allowed hot gas and pressure to penetrate the joint setting up a condition for continuous high temperature gas flow which in turn eroded through the o-rings and allowed the gas to escape through the joint. The redesign team was faced with the challenge of coming up with a new design that solved this issue. The team considered several options, including an option that would allow the rapid pressurization of an open joint at motor ignition that would prevent the continuous gas flow through the putty experienced by the failed motor on Challenger. The team decided on a design solution that would attempt to totally stop the flow of gas into the joint. The selected design (Fig.8) added a J-leg to the tang-side insulation with matching clevis side insulation and included pressure sensitive adhesive to act as a sealing and bonding agent for the mating surface.³ Figure 12 shows how the pressure-assisted insulation J-leg works.

At ignition, motor gas enters the J-leg slot and with the aid of the pressure sensitive adhesive the J-leg tracks the clevis insulation keeping hot gas away from the downstream o-rings. This design was first used on RSRM-1 (STS-26R). Although it was considered a thermal barrier and not a seal, this design proved to be very successful, and except for the RSRM-55 (STS-78) special cause, never allowed gas into the joint. RSRM-55 used a new water-based PSA whose properties were adversely affected by the high humidity conditions during application at KSC; the fix was to switch back to the previously used

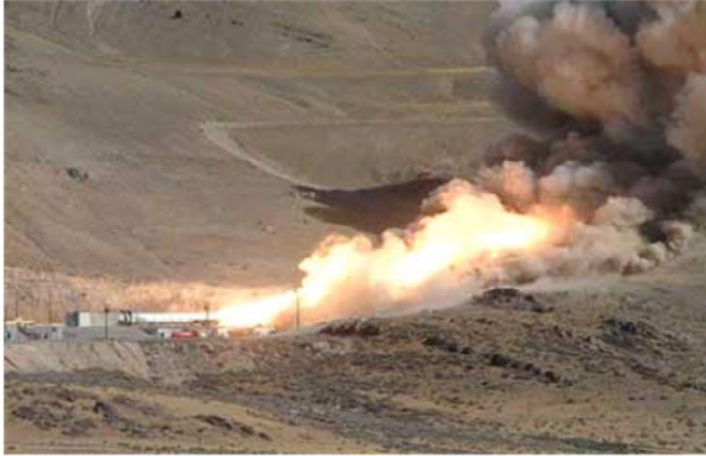
Figure 13. ETM-3 Static Test, October 23, 2003.

ETM-3 was successfully tested in test stand T-97 of the ATK plant in Promontory, Utah on October 23, 2003. Examples of innovations developed specifically for, or as a result of ETM-3, include: advanced coupled fluid structural interaction analysis that shortens run time from weeks or months to overnight, nozzle in-depth thermocouples, aft dome insulation in-depth thermocouples, field joint j-leg slot pressure transducers, erosive burning subscale test simulator and associated improved modeling techniques, and direct measurement of pressure and heat flux inside a motor chamber.

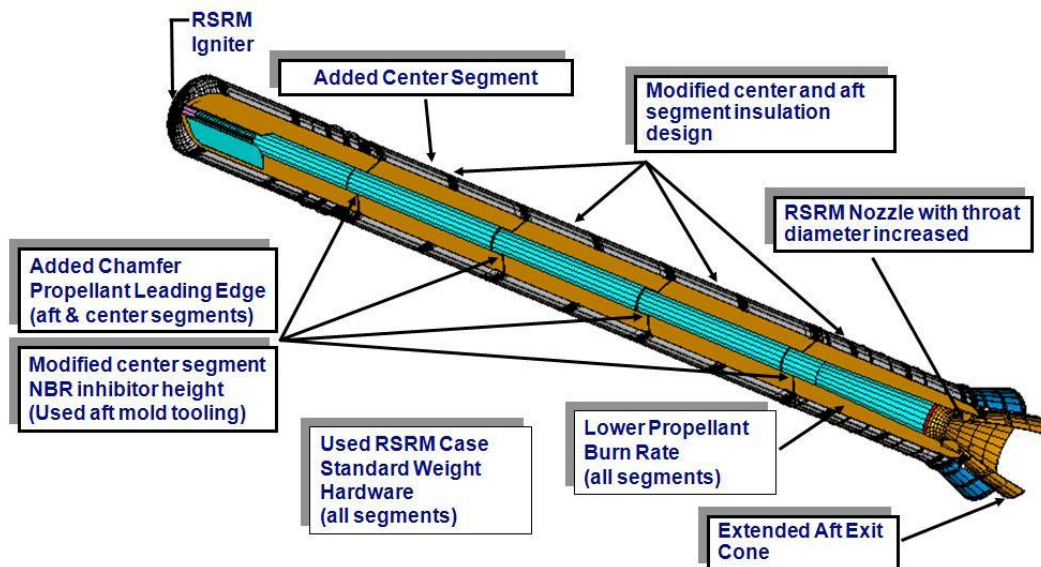
Figure 14. ETM-3 Modifications from RSRM.

ETM-3 (Fig. 14) included the following changes from the RSRM four-segment motor design: 1) added center segment (added 273,000 lb of propellant over the RSRM), 2) bored out nozzle throat, 3) reduced burn rate propellant, 4) extended aft exit cone, 5) added chamfer to propellant leading edges, 6) modified center segment rubber inhibitor heights, and 7) modified center and aft segment insulation design. ETM-3 was instrumented with 620 gauges and a total of 635 channels.

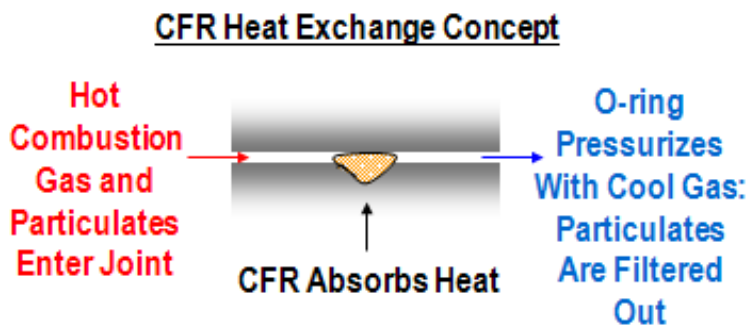
Figure 15. Carbon Fiber Rope Function.

In the late 1990s researchers at the NASA Glenn Research Center (GRC) were experimenting with braided carbon fiber rope and discovered that it had the ability to remove most of the thermal energy from a high temperature gas that passed through it without much noticeable damage after several minutes of exposure. The rope is very permeable and the high heat capacity of the carbon fibers allows for the efficient removal of heat (Fig.15).

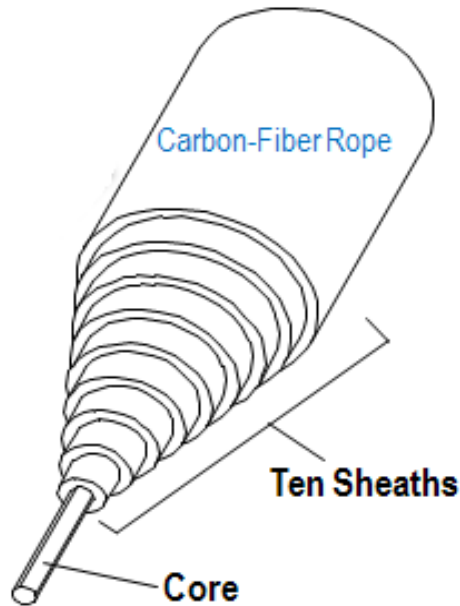
Figure 16. Carbon Fiber Rope.

ATK, seeking a design solution that would eliminate gas paths through thermal barriers, collaborated with GRC on the development of a carbon fiber rope configuration that could be used in RSRM applications. The final rope design consisted of a carbon fiber center core surrounded by ten sheaths of braided carbon fiber (Fig. 16).

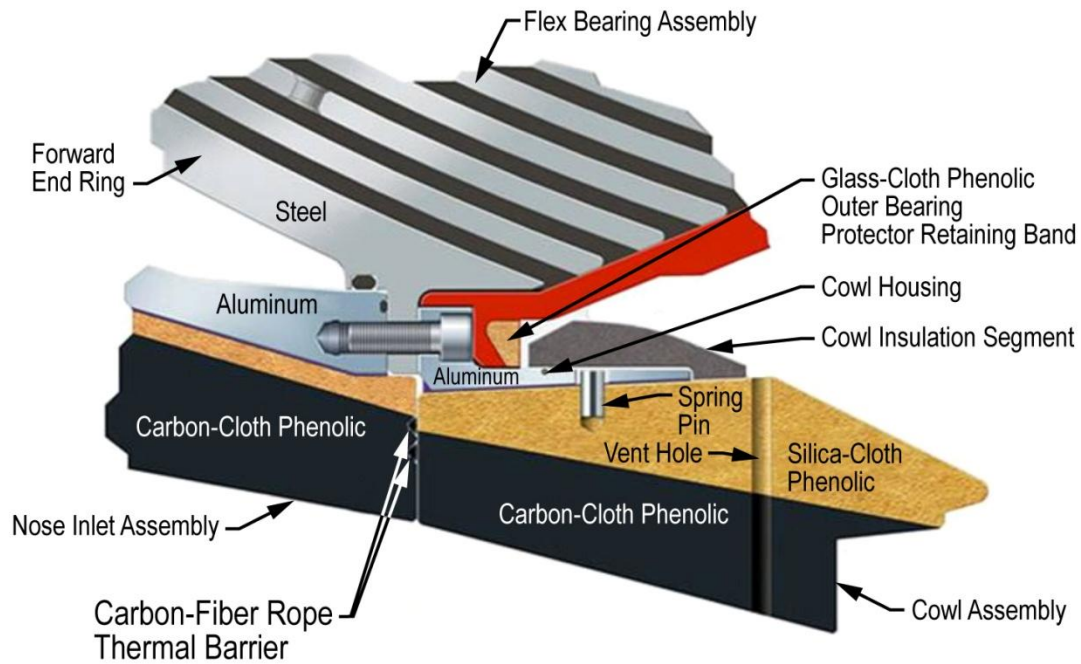
Figure 17. Nozzle Joint 2.

ATK and NASA developed nozzle design solutions for these thermal barrier gas paths that utilized the heat dissipating qualities of the carbon fiber rope (Figs. 17, 18, and 19).

The nozzle joint 2 and 5 designs eliminated the RTV thermal barriers (open volume allowed gas to fully pressurize the joint at ignition) and placed carbon fiber ropes upstream of the o-ring seals, cooling the hot combustion gases that passed through them to temperatures close to ambient. As an example of how well the new designs performed, photos of the typical joint 2 condition before and after incorporation of the carbon fiber rope design is shown in Figure 20. The nozzle-to-case joint design incorporated an insulation j-leg thermal barrier and downstream carbon fiber rope ahead of the o-ring seals that protected them from high temperature exposure in case the J-leg leaked. All incorporated carbon fiber rope designs eliminated thermal barrier gas paths and performed flawlessly after their incorporation on flight hardware.

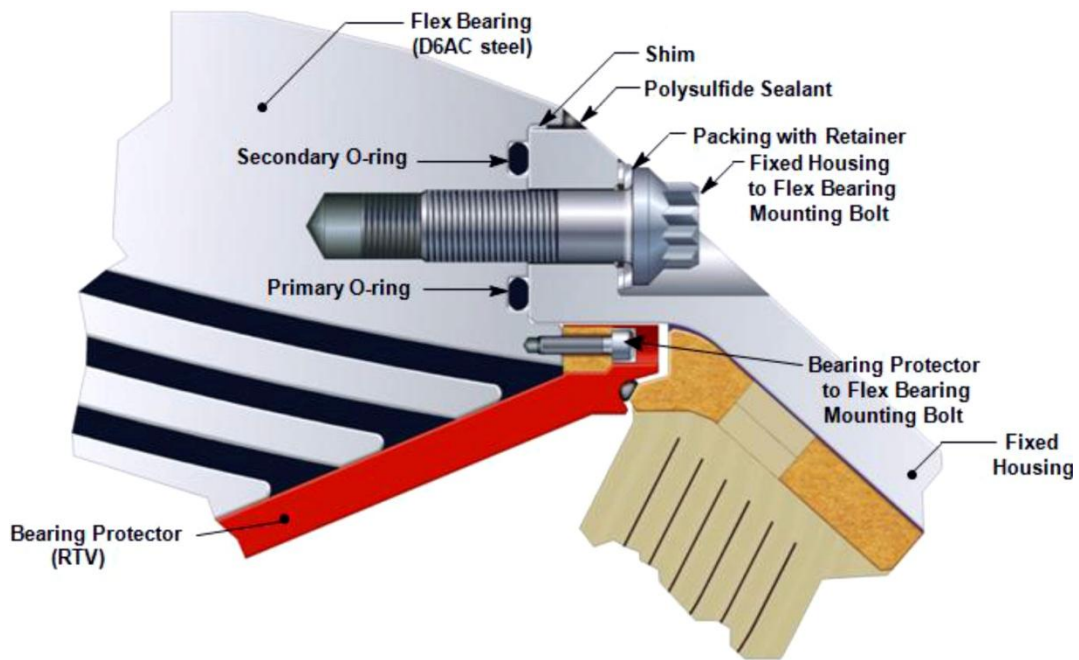
Figure 18. Nozzle Joint 5.

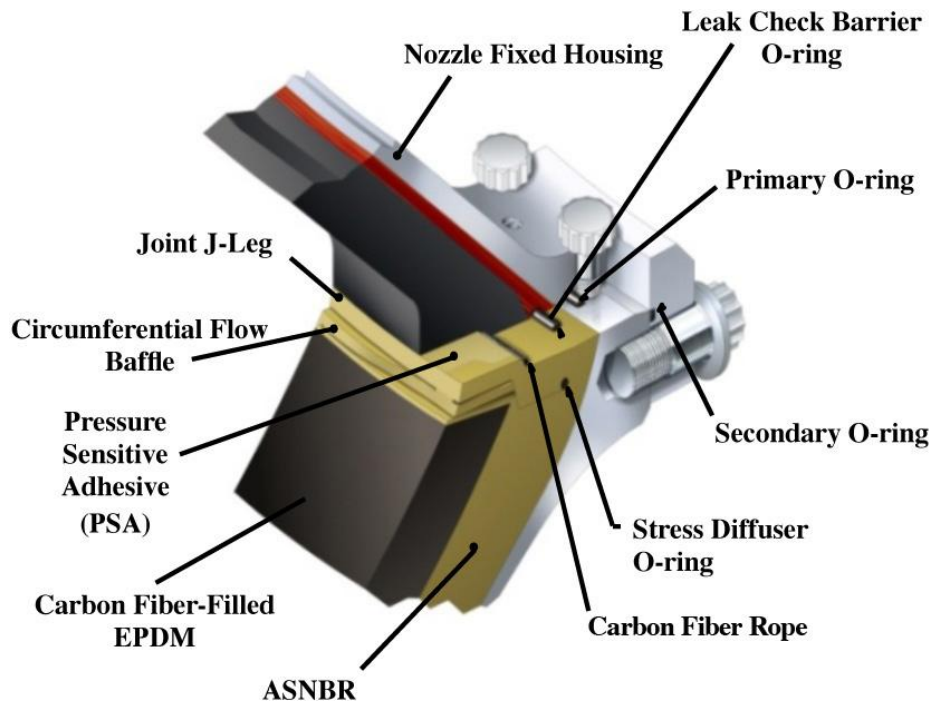
Figure 19. Nozzle-to-Case joint.

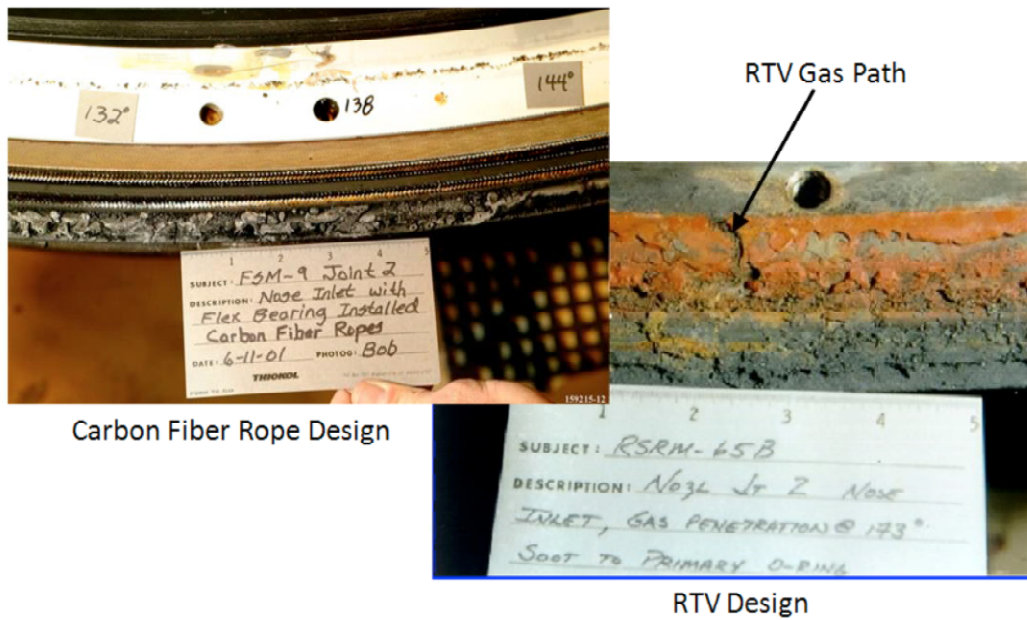
Figure 20. Joint 2 RTV and Carbon Fiber Rope Design Comparison.

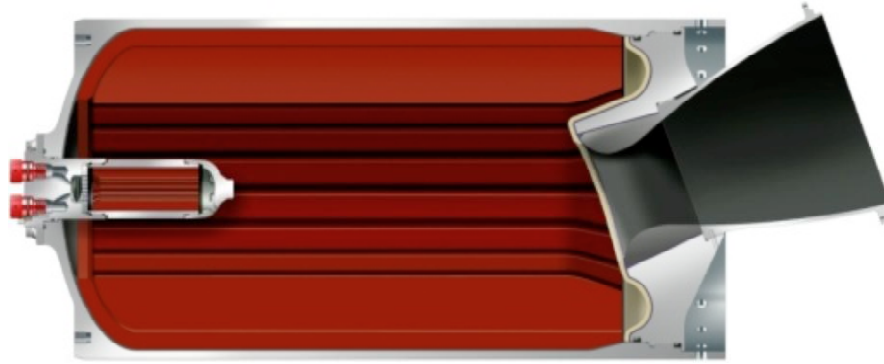
Figure 21. The ATK BSM.

The original shuttle BSM was designed by United Technologies Corporation, Chemical Systems Division (CSD). This design flew on the first 120 Shuttle missions. In October 2003, ATK received an alternate source contract to develop BSMs with selected design and processing upgrades to further enhance motor reliability. The ATK design was heavily based on the CSD design with specific enhancements based on RSRM design practices and modern analytical approaches. The ignition system was completely redesigned to address lessons learned from an investigation of erratic ignition pressures conducted by CSD, ATK, and NASA. Other components of the motor remained essentially unchanged from the CSD design with minor adjustments made to address obsolescence concerns and lessons learned during the baseline flight program. Improvements introduced with the ATK BSM (Fig. 22) included: (1) ATK manufactured only one motor configuration (at KSC, United Space Alliance performed the necessary BSM closeout depending on whether the BSM was mounted in the forward or aft position), (2) sling lined chamber (CSD was hand applied), (3) ATK BSMs were cast in batches of four motors rather than the 64 by CSD, (4) the design used a new stronger adhesive (TIGA), (5) redesigned graphite throat with improved margins, (6) interchangeable case and aft closures eliminated matched sets (7) incorporated new better resiliency low temperature o-rings, (8) increased o-ring squeeze, (9) added an igniter-to-case leak check port, and (10) redesigned igniter. During the development program for the ATK designed BSMs, CSD announced closure of the San Jose, CA facility that produced BSMs. This revelation led NASA to a sole source contract with ATK to manufacture the BSMs and eventually to the

first flight of ATK BSMs in the forward position on STS-122 and in all positions on STS-126. All ATK BSMs exhibited excellent performance through the end of the Shuttle Program.

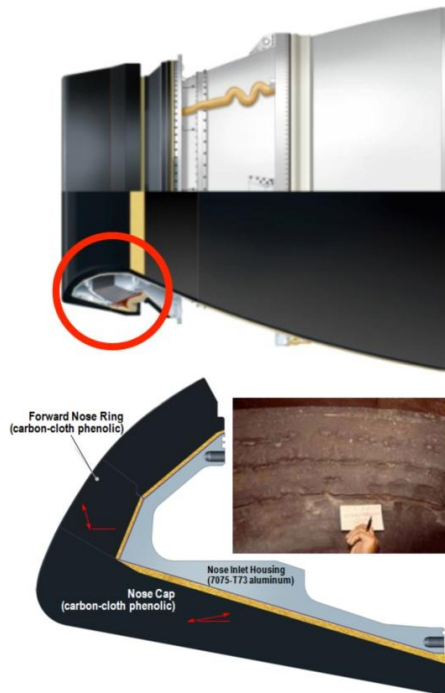
Figure 22. Nozzle Pocketing.

During the eighth Space Shuttle flight (STS-8), the carbon cloth phenolic (CCP) ablative rings on the forward nose of one of the nozzles (Fig. 22) exhibited a severe rate of material loss referred to as “Pocketing.”⁴ The ablative rings form the contour of the nozzle and protect the underlying metal structure from the super-hot exhaust gases. At the end of a nominal motor burn (123 s), there is usually enough material remaining to fire the nozzle a second time. However, the erosion rate on STS-8 was so great that only 8 s of ablative material remained. When carbon/phenolic plies are incorrectly oriented to the flow surface, stresses can exceed the hot charred material strength resulting in anomalous erosion.

Before the Challenger accident, in both flights and static firings, there had been eight pocketing events in 66 nozzles at the nose inlet and one pocketing event in 66 nozzles at the nozzle throat. The problem of pocketing at the nose inlet was completely eliminated with the ply angle change that occurred with the first RSRM flight. Over the next 9-plus years there were zero pocketing events on 170 nozzles. On the RSRM 56B nozzle (Sep. 96), both the RSRM 49A and RSRM 49B nozzles (Nov. 96), and the RSRM 57B nozzle (Aug. 97) throat ring nozzle pocketing returned with accompanying downstream erosion. Because of this problem, a significant effort to understand the nozzle pocketing began. This effort, which involved a widespread technical community, was referred to as an enhanced sustaining engineering (ESE) effort; fault tree methodology was used to understand the pocketing mechanism. Over a 24-month period there were 6,300 mechanical, thermal, and physical property tests conducted. There were 1,650 PTTB tests, 1660 LHME (Laser Hardened Material Evaluation Lab) tests, 43 subscale tests, dissections of eight full-scale motor nozzles, seven scrapped nozzles and wrap, and cure and dissection of 11 full-scale instrumented tests.

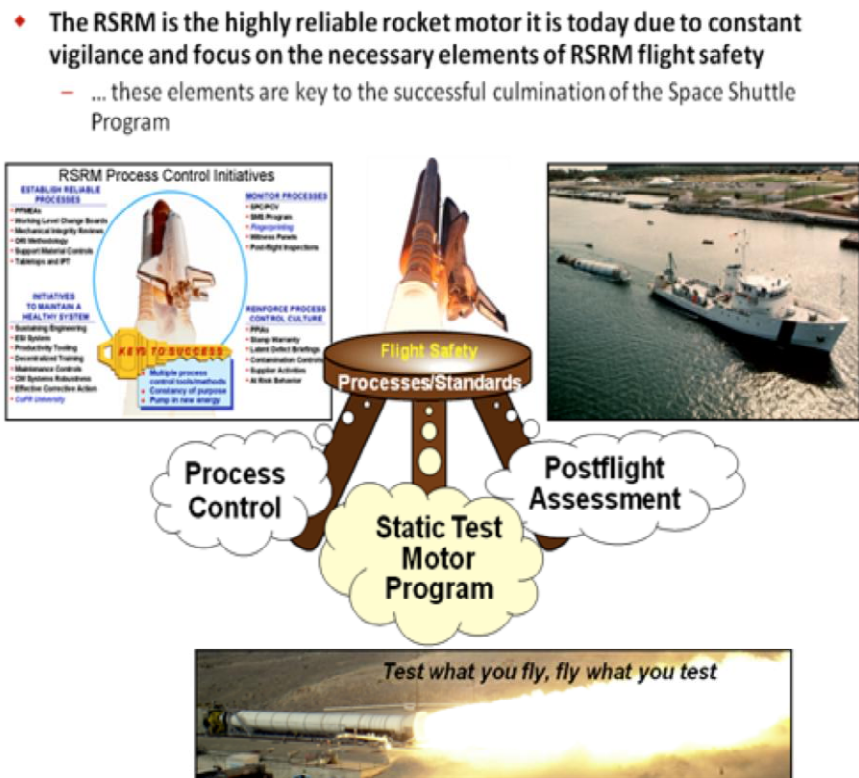
Figure 23. RSRM Overview.

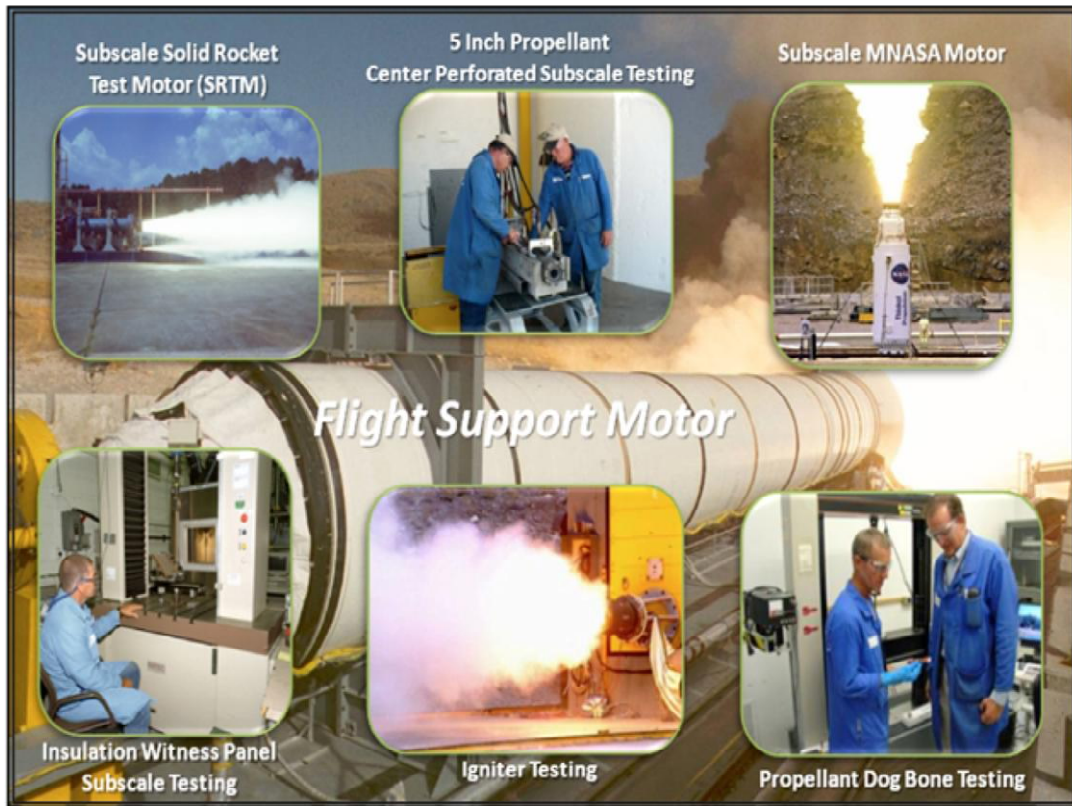
Figure 24. RSRM Testing.

Subscale testing covers the entire spectrum of tests that range from the dog-bone type tensile tests of propellant batches, witness panel peel and tensile testing of insulator materials that follow all flight hardware processes to small scale motor tests that include a 5-inch diameter Center Bore (5-in. CP) used to get propellant burn rate, and larger motor tests like the 70-lb char motor to evaluate insulation performance, the 24-inch diameter Solid Rocket Test Motor (SRTM) used to screen design or material change concepts and the 48-inch diameter MNASA Modified NASA Motor (MNASA) used for further screening and to check expected performance on a motor that closely resembles the RSRM (Fig. 24). The highest level test is the full-scale Flight Support Motor (FSM), a true replicate of the RSRM flight motor, but very highly instrumented to collect as much data as possible. As you might expect, these full-scale motors are very expensive and time consuming tests, we were only able to tests about one FSM per year on the RSRM program. The main purpose of the FSM changed somewhat from its original concept. Originally an FSM was going to be a flight unit taken off the line and tested to totally represent the other units being manufactured during the same time period. The FSM necessarily evolved to being the “Change Precursor”—many of the required changes on the RSRM Program (mostly obsolescence driven) required tests on full-scale static motors prior to flight. Our desire was to test all changes on static tests before flight. Part of the NASA culture to “test what you fly, fly what you test” was a derivative of the RSRM Program. It is this attention to testing coupled with an intensive post-fire inspection and intensive postflight inspection of all flight hardware and particular attention to process control makes up for the inability to green-run the RSRM.

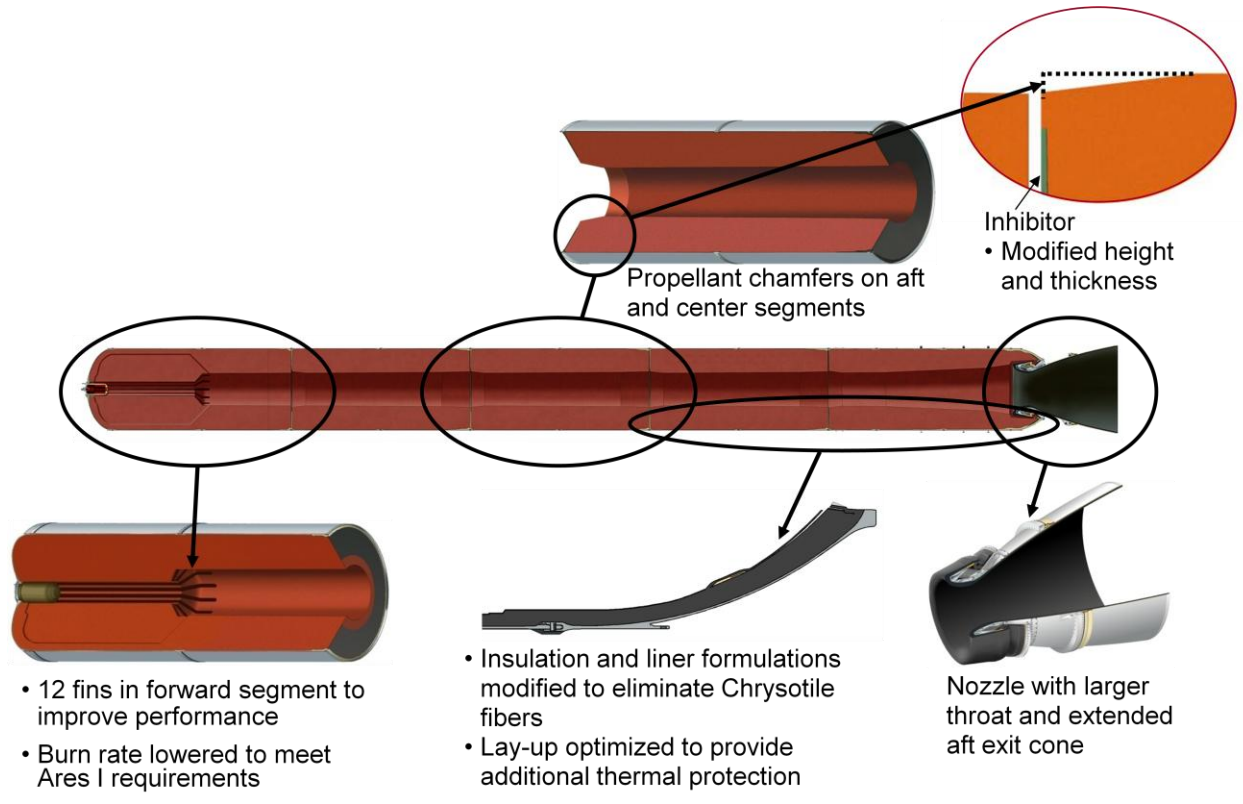
Figure 27. Changes from RSRM to RSRMV.

RSRM	ETM-3	RSRMV
Motor			
Overall Length (in.)	1,513.49	1,868.25	1,868.25
Case Diameter (in.)	146.08	146.08	146.08
Nozzle			
Throat Diameter (in.)	53.86	56.11	56.86
Exit Diameter (in.)	149.64	152.75	152.75
Expansion Ratio	7.72	7.41	7.22
TVC Vector Clearance at Throat (deg)	11.64	11.64	5.22
Ballistics			
Total Propellant Weight	1,106,000	1,366,000	1,383,000
Maximum Thrust	3,326,000	3,690,000	3,566,000
